# **Arborist Associates Ltd.**

## **An Arboricultural Assessment of the Trees on the Site Area at 'Killiney Beach Car Park', Station Road, Killiney, Co. Dublin**

**Prepared for: Dun Laoghaire Rathdown County Council**

**Date: 22<sup>nd</sup> September 2026**

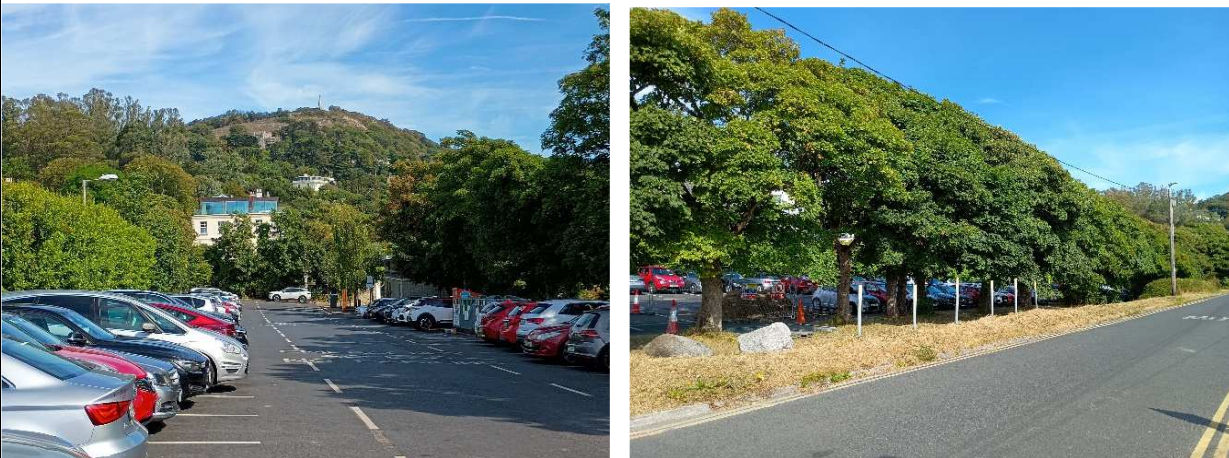
| Tree No. | Tree Species | Ht. (m) | Stem Dia. (mm) | Branch Spread (m) | | | | C-Ht. (m) | Age Class | Phys. Con. | Structural Condition<br>Other Comments | Preliminary Recommendation | ULE | Cat. Grade | RPA (radius) (m) |
|---|---|---|---|---|---|---|---|---|---|---|---|---|---|---|---|
| | | <b>The following three trees (Nos.1801-1803) are growing up together to form the one group with tree No.1802 being the larger and most important tree in the group.</b> | | | | | | | | | | | | | |
| 1801 | <b>Elm</b><br><i>Ulmus sp.</i> | 4 | 340 | 2 | 3 | 3 | 1 | 0 | Early<br>Mature | Fair | Poor<br>It is a single stem tree to c.4m where it has broken out or was topped in the past leaving a decaying stump. Its crown consists of stem suckers that have developed from low down. | Retain for now as part of the bulking of this area. | 10+ | C1 | 4.1 |

| Tree No. | Tree Species | Ht. (m) | Stem Dia. (mm) | Branch Spread (m) | | | | C-Ht. (m) | Age Class | Phys. Con. | Structural Condition<br>Other Comments | Preliminary Recommendation | ULE | Cat. Grade | RPA (radius) (m) |
|---|---|---|---|---|---|---|---|---|---|---|---|---|---|---|---|
| 1803 | <b>Broadleaved Lime</b><br><i>Tilia platyphyllos.</i> | 9 | 620 | 2 | 5 | 6 | 7 | 0 | Mature | Fair / Good | Fair<br>A single stem tree to c.6m from where its crown develops with broad union formations between the stems. Heavy Ivy growth extends high into its crown, increasing its windsail. There are multiple suckers developing around its base which are starting to develop into stems. | Cut Ivy at ground level at the present time.<br><br>Prune suckers back to target pruning points and clear around the base. | 20+ | B2 | 7.4 |

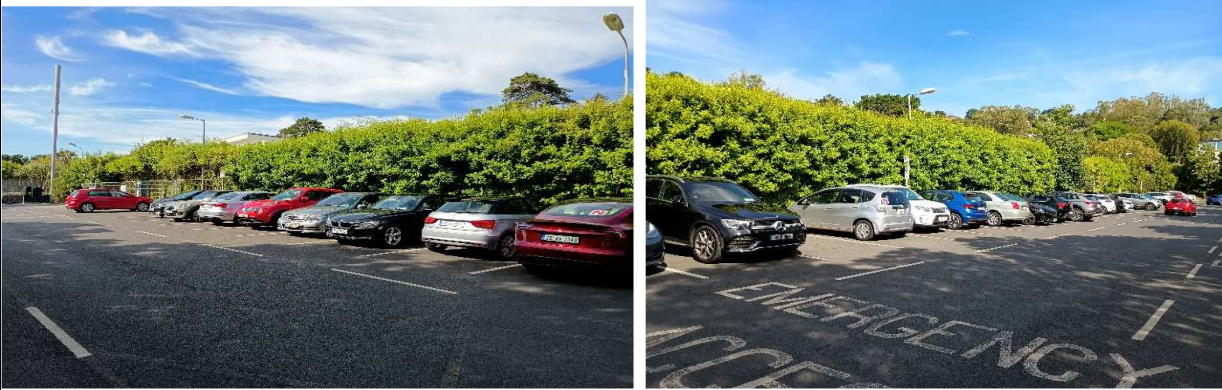
| Tree No. | Tree Species | Ht. (m) | Stem Dia. (mm) | Branch Spread (m) | | | | C-Ht. (m) | Age Class | Phys. Con. | Structural Condition<br>Other Comments | Preliminary Recommendation | ULE | Cat. Grade | RPA (radius) (m) |
|---|---|---|---|---|---|---|---|---|---|---|---|---|---|---|---|
| Hedge No. 1 | <b>Griselinia</b><br><b>Sycamore</b><br><b>Olearia</b><br><b>Elder</b><br><b>Bramble</b> | <p><b>It extends in a north to south direction along the western boundary of the car park.</b></p> <p>It is of a mature age class and is in fair condition physiologically and structurally. It is growing in a narrow, raised plant bed that varies in height as you move north along the boundary. It forms a screen between the car park and the Court Hotel to the west. It consists mainly of Griselinia with seedling Sycamore cut into the hedge line. There is a short line of larger Olearia at the north end of the hedge, extending above the general hedge line. It has been clipped in the past but is growing somewhat unmanaged at the present time and overhangs/ obstructs the footpath to the rear of the car park spaces and Bramble is developing through it. A short section at the southern end has been cut back hard to facilitate the installation of EV chargers.</p> | | | | | | | | | | <p>It would benefit from cutting, pruning to control height and spread and maintain a formal hedge structure. Cutting should also take it back from the footpath.</p> | -- | C2 | -- |

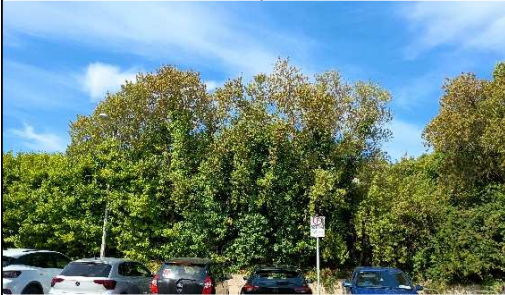
| Tree No. | Tree Species | Ht. (m) | Stem Dia. (mm) | Branch Spread (m) | | | | C-Ht. (m) | Age Class | Phys. Con. | Structural Condition<br>Other Comments | Preliminary Recommendation | ULE | Cat. Grade | RPA (radius) (m) |
|---|---|---|---|---|---|---|---|---|---|---|---|---|---|---|---|
| Tree No. 1 | <b>Sweet Chestnut</b><br><i>Castanea sativa.</i> | 10 | #700/350 | 3 | 3 | 5 | 4 | 1 | Mature | Fair/ Good | Fair/ Good<br>It is growing on the adjacent landside of the site boundary. It divides low down into two stems and the main stem divides again at c.6m. It appears to have been reduced in size in the past and has regrown to its current height. Part of its crown on the east side over sails the site boundary. | This tree is outside the management control of this site. | 20+ | B2 | 9.4 |

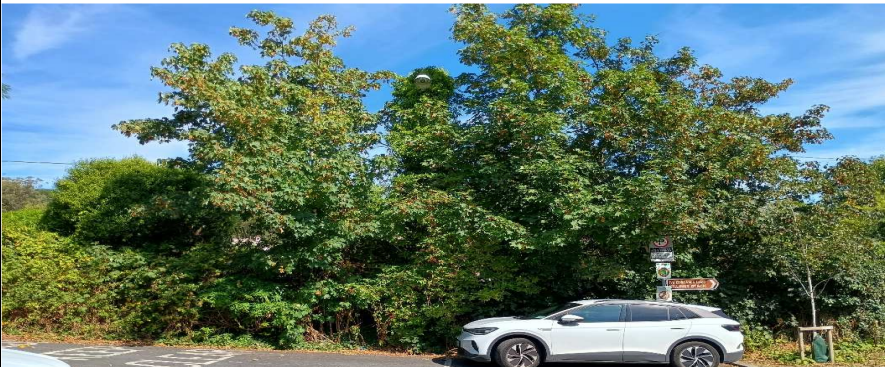
| Tree No. | Tree Species | Ht. (m) | Stem Dia. (mm) | Branch Spread (m) | | | | C-Ht. (m) | Age Class | Phys. Con. | Structural Condition<br>Other Comments | Preliminary Recommendation | ULE | Cat. Grade | RPA (radius) (m) |
|---|---|---|---|---|---|---|---|---|---|---|---|---|---|---|---|
| Shrub Bed No. 1 | <b>Pittosporum Elder Euphorbia, Sycamore Bramble</b> | <b>It extends east to west along the northern boundary.</b><br>It is of a mature age class and is in fair condition physiologically and structurally. It is growing in a narrow, plant bed between the site boundary wall and the car park surface. It consists of a mix of shrubs and with a number of seedling Sycamore developing above the general line. It has become overgrown due to lack of maintenance and | | | | | | | | | | Cut Ivy and Bramble and carry out general tidy up. | 10+ | C2 | -- |

| Tree No. | Tree Species | Ht. (m) | Stem Dia. (mm) | Branch Spread (m) | | | | C-Ht. (m) | Age Class | Phys. Con. | Structural Condition<br>Other Comments | Preliminary Recommendation | ULE | Cat. Grade | RPA (radius) (m) |
|---|---|---|---|---|---|---|---|---|---|---|---|---|---|---|---|
| | | Bramble and Ivy growth is colonising the plants. There is a public light located in the bed and the seedling Sycamore will require pruning to maintain clearance. | | | | | | | | | | | | | |
| 1804 | <b>Sycamore</b><br><i>Acer pseudoplatanus</i> | 10 | 160/<br>200/<br>250 | 3 | 3 | 1 | 4 | 1 | Early<br>Mature | Fair/<br>Good | Fair<br>It is a multiple stemmed tree from low down growing up above the shrubs, to the west of the public light. It has a somewhat distorted structure with an unbalanced crown. Ivy growth extends up into its crown. It is likely to impact the boundary wall to the north as it develops in size. | Cut Ivy and Bramble at the present time.<br>Tidy up around the base.<br>It will require pruning to maintain clearance around the public light. | 10-20 | C2 | 4.3 |

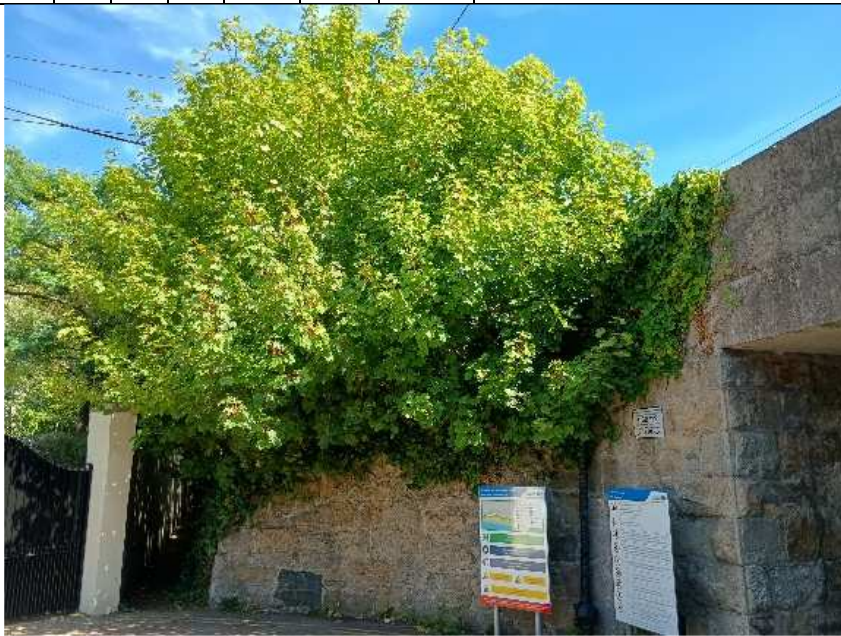
| Tree No. | Tree Species | Ht. (m) | Stem Dia. (mm) | Branch Spread (m) | | | | C-Ht. (m) | Age Class | Phys. Con. | Structural Condition<br>Other Comments | Preliminary Recommendation | ULE | Cat. Grade | RPA (radius) (m) |
|---|---|---|---|---|---|---|---|---|---|---|---|---|---|---|---|
| Tree No.2 | <b>Sycamore</b><br><i>Acer pseudoplatanus.</i> | A8 | A80<br>>10 stems | 3 | 4 | 3 | 4 | A2 | Early<br>Mature | Fair | A group of stems growing up together on a retained bank beside the underpass to the beach. They may have been coppiced in the past and regrown to their current size. | Requires no work at the present time. | 10+ | C1 | 3.0 |
| 1809 - 1811 | <b>Birch sp</b><br><i>Betula pendula sp</i><br>(3No. trees) | A short line of 3 No. trees planted in front (west side) of the toilet block in planting pits. The Silver Birch, located at the south end of the line, is somewhat older than the two Himalayan Birch located to the north. | | | | | | | | | | | | | |

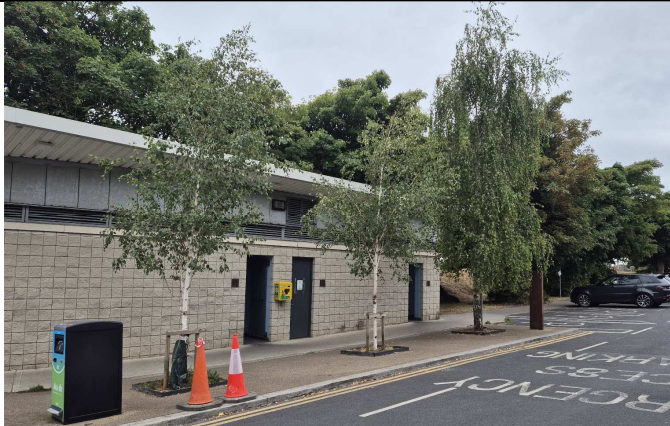
| Tree No. | Tree Species | Ht. (m) | Stem Dia. (mm) | Branch Spread (m) | | | | C-Ht. (m) | Age Class | Phys. Con. | Structural Condition<br>Other Comments | Preliminary Recommendation | ULE | Cat. Grade | RPA (radius) (m) |
|---|---|---|---|---|---|---|---|---|---|---|---|---|---|---|---|
| 1809 | <b>Silver Birch</b><br><i>Betula pendula</i> | 9 | 200 | 1 | 2 | 2 | 2 | 3 | Early Mature | Fair | Fair<br>It is a single stem tree planted in a tree pit in the hard surfaced area in front of the toilet block. It has no obvious defects. | It would benefit from pruning to lift lower branches to improve clearance over surrounding surfaces. | 10-20 | C1 | 2.4 |
| 1810 – 1811 | <b>Himalayan Birch</b><br><i>Betula utilis</i><br>(2 trees) | A6 | A80 | A2 | A2 | A2 | A2 | A2 | Semi Mature | Fair | Fair<br>They have been recently planted into planting pits in the hard surfaced area in front of the toilet block. The planting ties and stakes are still present. | Adjust planting ties and stakes as required.<br><br>Formative prune lower branches on tree No. 1811. | 20+ | C1 | 1.0 |

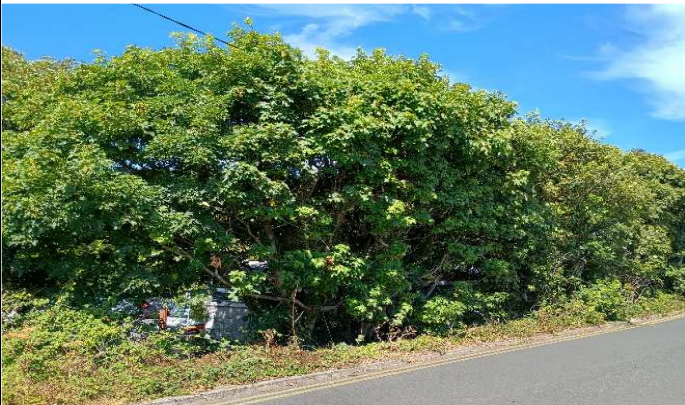
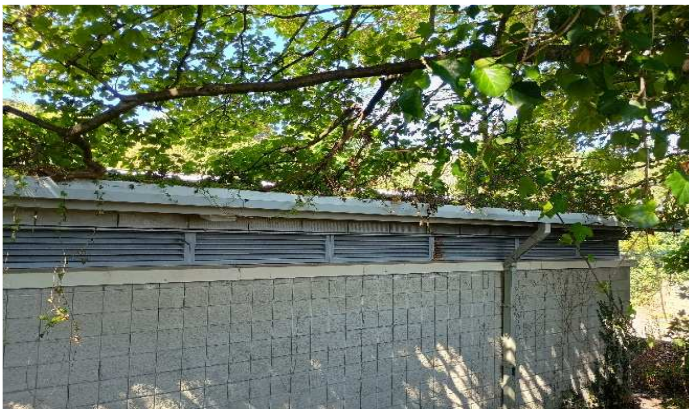
| Tree No. | Tree Species | Ht. (m) | Stem Dia. (mm) | Branch Spread (m) | | | | C-Ht. (m) | Age Class | Phys. Con. | Structural Condition<br>Other Comments | Preliminary Recommendation | ULE | Cat. Grade | RPA (radius) (m) |
|---|---|---|---|---|---|---|---|---|---|---|---|---|---|---|---|
| | | <p>The survey now moves to the trees located on the embankment to the rear of the toilet block and the grass verge located between the car park and Station Road. Tree nos.1813 – 1816 are growing on top of the embankment and their crowns have been pruned on the roadside (east) to maintain clearance over the road. There is an overhead utility extending north to south through the crowns of these trees. The branches on the west side of their crowns extend over the roof of the toilet block and are resting on the roof in some cases.</p> | | | | | | | | | | | | | |

| Tree No. | Tree Species | Ht. (m) | Stem Dia. (mm) | Branch Spread (m) | | | | C-Ht. (m) | Age Class | Phys. Con. | Structural Condition<br>Other Comments | Preliminary Recommendation | ULE | Cat. Grade | RPA (radius) (m) |
|---|---|---|---|---|---|---|---|---|---|---|---|---|---|---|---|
| 1814 | <b>Sycamore</b><br><i>Acer pseudoplatanus.</i> | 8 | 5 stems<br>A340 | 2 | 2 | 2 | 7 | 2 | Mature | Fair/ Good | Fair<br>It is a multiple stemmed tree from low down growing on the top of a steep embankment beside the road. It has been pruned on the roadside (east) to maintain clearance over the road. There are decaying stems / stubs in the center. Branches on the west side extend out over the roof of the toilet block. Light Ivy growth is starting to develop up the main stems. There is an overhead utility line extending north to south through its crown. | Prune branches on the west side back by 1-2m to clear the roof. | 20+ | B2 | 9.1 |

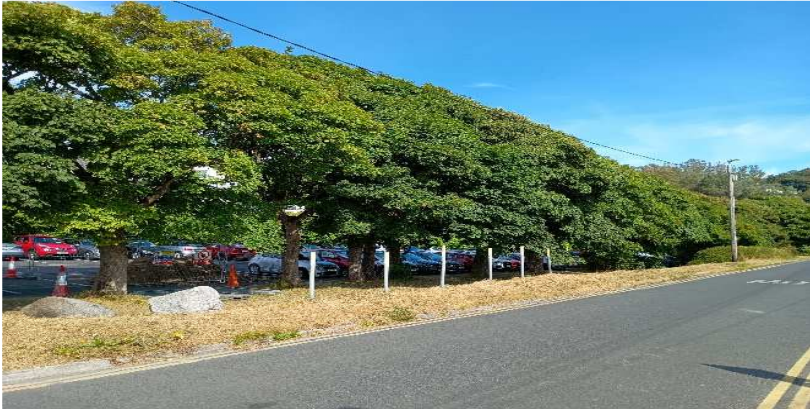
| Tree No. | Tree Species | Ht. (m) | Stem Dia. (mm) | Branch Spread (m) | | | | C-Ht. (m) | Age Class | Phys. Con. | Structural Condition<br>Other Comments | Preliminary Recommendation | ULE | Cat. Grade | RPA (radius) (m) |
|---|---|---|---|---|---|---|---|---|---|---|---|---|---|---|---|
| | | <p><b>The following trees are located on a linear grass verge running between the car park to the west and Station Road to the east.</b></p> <p>The crowns of these trees have been shaped by pruning/ cutting and sea winds and are asymmetrical to the west as a result. Their lower branches have been removed to raise up their crowns and crown overhangs over the car parking spaces have been reduced back previously. There are some decay wounds in the trees as a result. There have been some ground level changes around these trees over the years.</p> | | | | | | | | | | | | | |

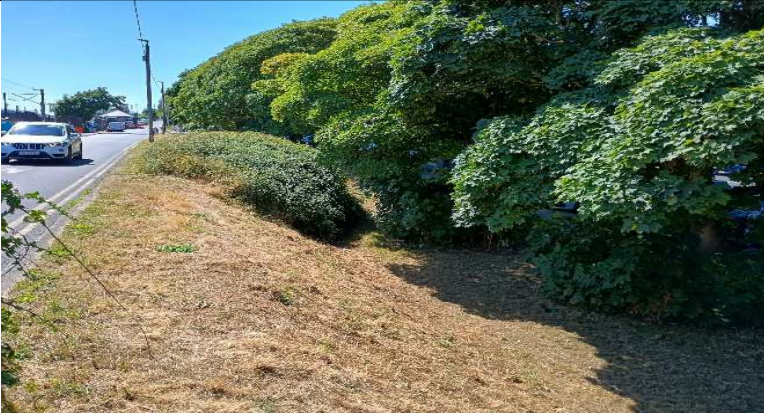
| Tree No. | Tree Species | Ht. (m) | Stem Dia. (mm) | Branch Spread (m) | | | | C-Ht. (m) | Age Class | Phys. Con. | Structural Condition<br>Other Comments | Preliminary Recommendation | ULE | Cat. Grade | RPA (radius) (m) |
|---|---|---|---|---|---|---|---|---|---|---|---|---|---|---|---|
| 1817 & 1818 | <b>Sycamore</b><br><i>Acer pseudoplatanus</i><br><br>2 trees | A12 | A800 | A6 | A5 | A6 | A6 | A3 | Mature | Fair | Fair<br>A pair of close planted trees that have grown up together with a combined canopy. Heavy Ivy growth extends high into their crowns, increasing their windsail and limiting the visual assessment. Tree No. 1817 is showing some signs of stress in its upper crown, possibly due to drought. | Cut Ivy at ground level at the present time.<br><br>Review again in twelve months. | 20+ | B2 | 9.6 |
| 1819 | <b>Sycamore</b><br><i>Acer pseudoplatanus</i> | 12 | 470 | 4 | 3 | 5 | 4 | 3 | Mature | Fair/<br>Good | Fair<br>Originally a twinned stem tree from c.1m, the west stem has been lost / removed in the past and the wound has calloused over. Light Ivy growth is extending up the main stem. Suckers are developing around the base of the main stem. | Prune basal suckers back to target pruning points. | 20+ | B2 | 5.6 |

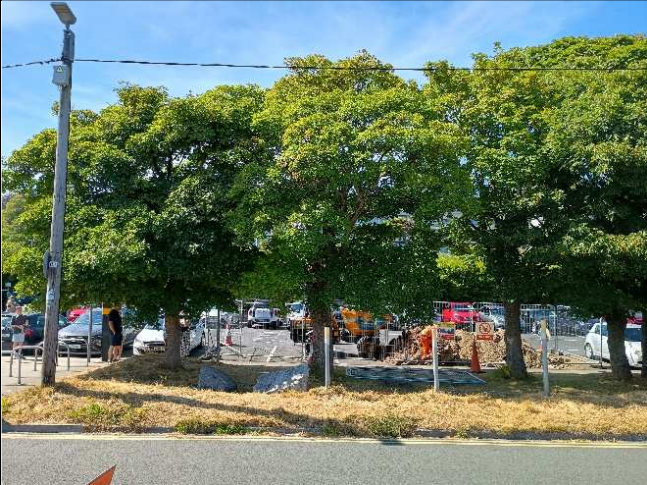
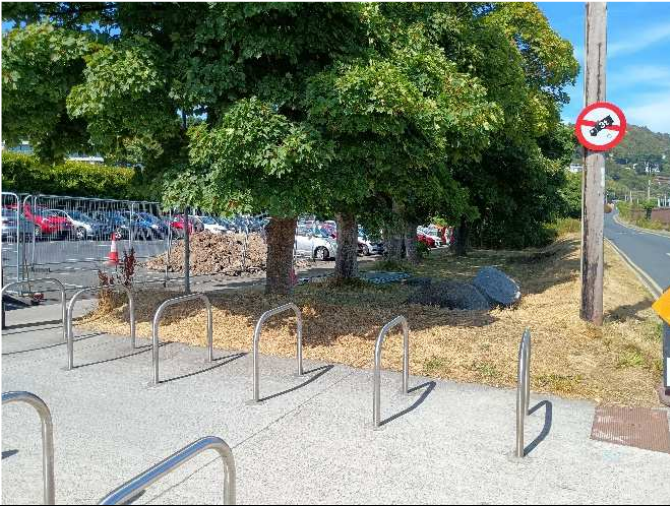
| Tree No. | Tree Species | Ht. (m) | Stem Dia. (mm) | Branch Spread (m) | | | | C-Ht. (m) | Age Class | Phys. Con. | Structural Condition<br>Other Comments | Preliminary Recommendation | ULE | Cat. Grade | RPA (radius) (m) |
|---|---|---|---|---|---|---|---|---|---|---|---|---|---|---|---|
| 1825 | <b>Sycamore</b><br><i>Acer pseudoplatanus</i> | 14 | 760 | 5 | 3 | 5 | 6 | 3 | Mature | Fair/<br>Good | Fair<br>It is a twin stemmed tree from c.2m up with an acute union formation between the stems. There are signs of significant damage to the base on the south side at c.4m where the main stem has been cut / lost in the past. There are decay pockets developing on some of the stems and there is a dead stub on the south side at c.2m. | It will require pruning in the short term to address structural issues caused by decay. | 20+ | B2 | 9.1 |
| <b>Tree Line</b><br>1826 -<br>1831 | <b>Sycamore</b><br><i>Acer pseudoplatanus</i><br>6 trees | A13 | A480 | A2 | A2 | A5 | A5 | A3 | Mature | Fair | Fair<br>A short line of six close planted trees forming a short line. The trees show various signs of past damage in their crowns and ground levels appear to have been raised around their bases. Tree No. 1826 has decay pockets in the main stem at c.2m and 2.5m on the east side. Tree No. 1829 is a twin stem tree from c.1.6m with an acute union formation between the stems and the east stem has broken out in the past at c.2.5m leaving a decaying stump. The stems in the lower crown of Tree No. 1830 have been cut /lost in the past with decay pockets developing at these sites and there is also a decay pocket developing at the site of a branch loss on the south side at c.5m. A concrete slab has been laid in the recent past as part of the installation of a cycle rack within c.2m of the base of Tree No. 1831 on the south side. The upper crown contains some light deadwood, and minor decay pockets are developing on the main stem at c.2m on the west side. | Make safe dead/ unstable growth.<br>They will require pruning in the short term to address structural issues caused by decay. | 20+ | B2 | 5.8 |
