**Title: Stage 1 DMURS Quality Audit,
Incl. Stage 1/2 Road Safety Audit
For;
Proposed Development at Lehaunstown, Cherrywood.**

Client: Dun Laoghaire Rathdown County Council.

Report reference: 2232R01

VERSION: FINAL (21-6-2024)

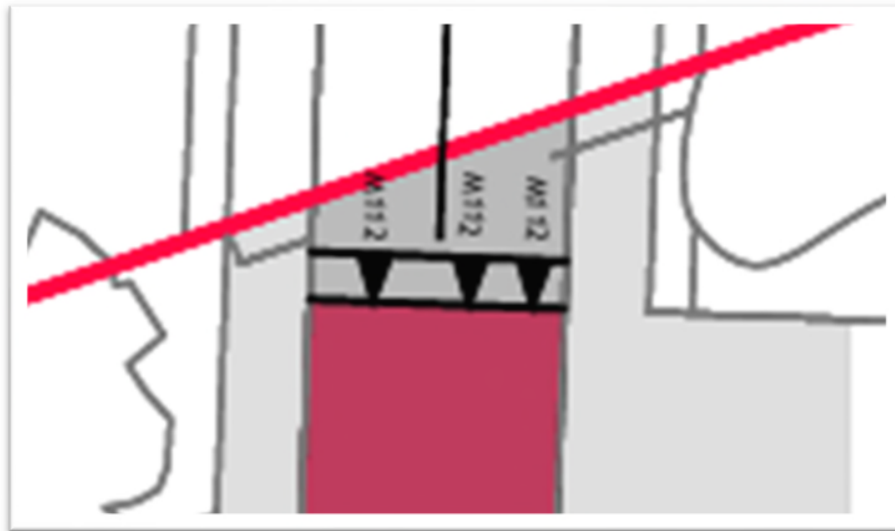
Drawing 232250-PUNCH-XX-XX-DR-C-0461 Rev P04, Raised Tables.

The kerb heights at the carriageway edge are to be 125mm. It is unclear what height the raised tables are to be and what taper length is to be provided. Too steep of a taper and too high of a table could lead to grounding and injury to vehicle occupants. Too shallow of a taper and height could lead to ineffective traffic calming, higher speeds and higher injury severity if a vulnerable road user is struck.

It is recommended that appropriate table heights and taper gradients be provided.

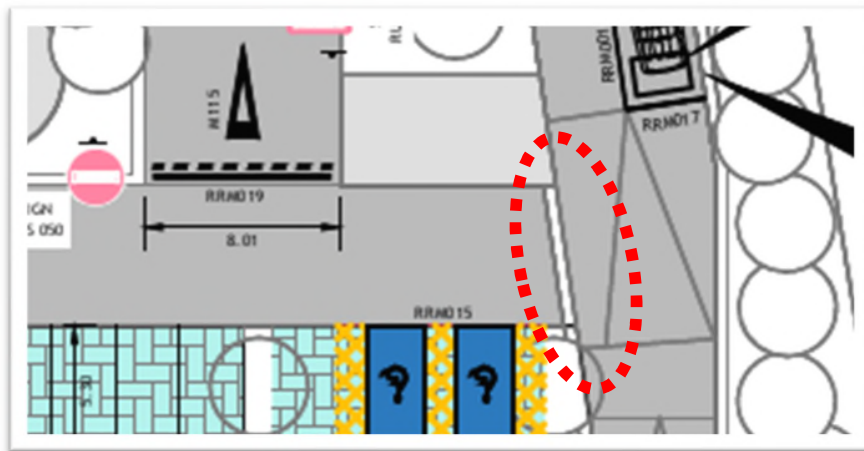
Drawing 232250-PUNCH-XX-XX-DR-C-0461 Rev P04, Link Between Street 1 and Street 2.

There is a wall/structure between Street 1 and Street 2 close to the entry to the basement. It is unclear what height this wall is to be. A low level wall (kerb) may not be seen by drivers and they may travel over it if unfamiliar with the area and a low wall may be climbed over by children leading to falls.

It is recommended that a suitable height wall be provided.

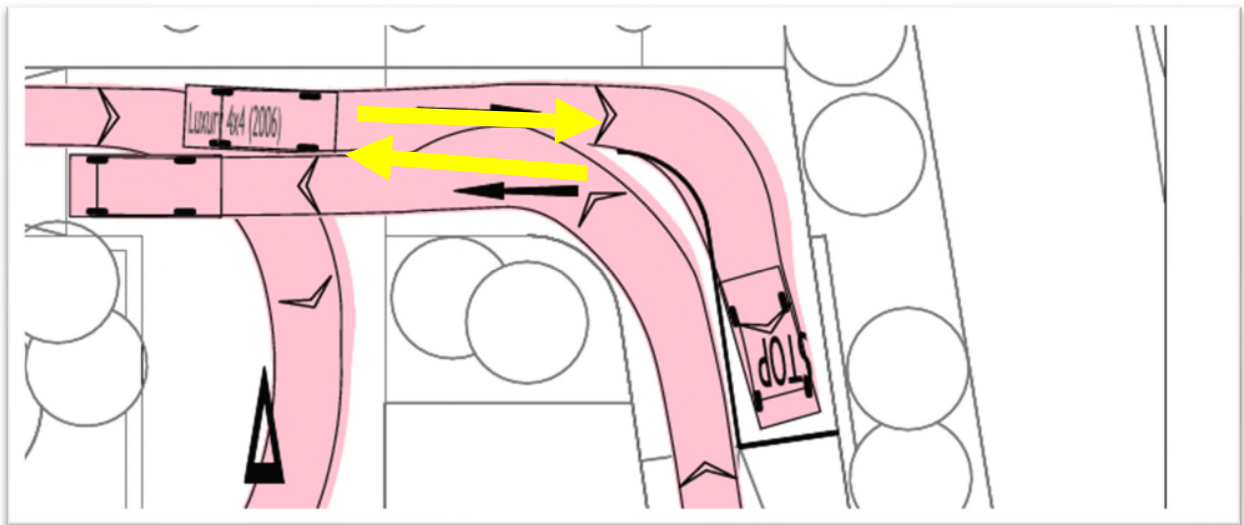
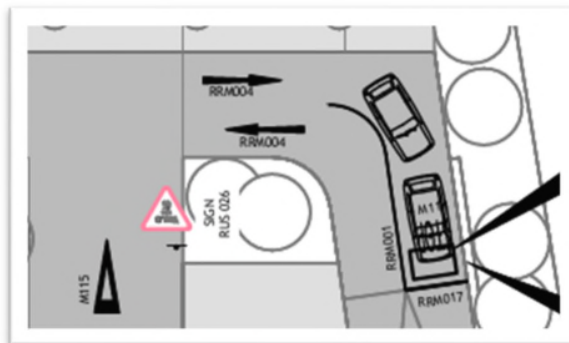
Drawing 232250-PUNCH-XX-XX-DR-C-0461 Rev P04 & 232250-PUNCH-XX-XX-DR-C-0602 Rev P02,
Entrance to basement.

There is a risk of side-swipe collisions of vehicles entering and exiting the car park if a queue forms as far as the tight bend when a vehicle is exiting.

It is recommended that a suitable width of carriageway be provided for cars to pass without overlapping swept paths when waiting at the stop line of the signals for the basement car park.

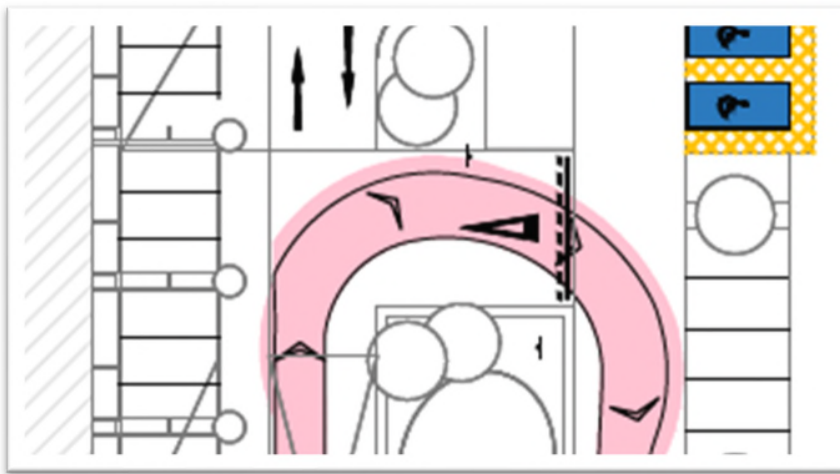
Drawing 232250-PUNCH-XX-XX-DR-C-0601 Rev P02,

The entrance and exit of the one-way sections at Street 2 are very wide and have proposed yield control. This could lead to higher turning speeds and more severe collisions if a vulnerable road user is struck. The wide areas could also lead to informal two-way use by some residents. A wider area is needed for the swept path of refuse vehicles however these are only occasional vehicles.

It is recommended that the widths be minimised and overrun areas be provided for occasional larger vehicles. Stop control should be provided to ensure drivers check for pedestrian and cyclist activity.

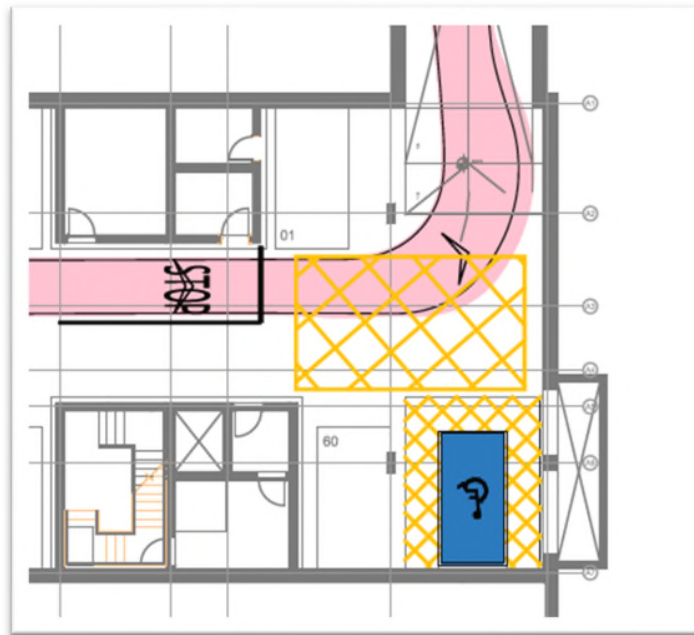
Drawing 232250-PUNCH-XX-XX-DR-C-0603 Rev P02, Basement.

Users of the disabled parking space and spaces 01 and 60 will be within the shuttle signals. They could meet with incoming vehicles whose drivers do not expect oncoming traffic resulting in head-on collisions.

It is recommended that a detection system for these spaces be provided to stop incoming traffic.

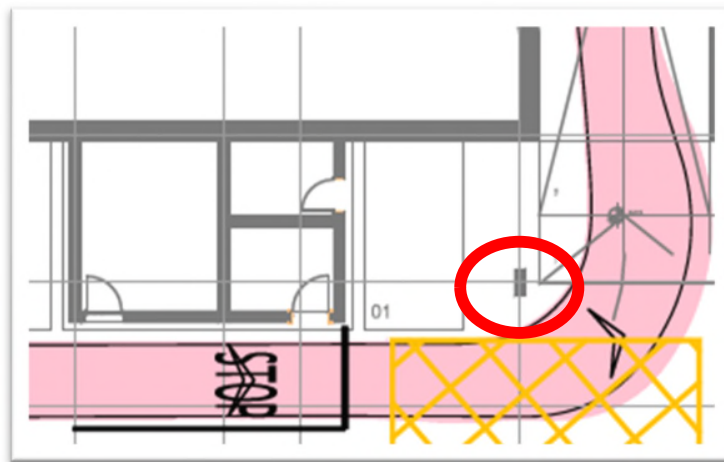
Drawing 232250-PUNCH-XX-XX-DR-C-0603 Rev P02, Basement.

There is an exposed structural column at the base of the ramp. There is a risk that drivers may not see it leading to side swipe collisions and material damage of vehicles.

It is recommended that the column be relocated.

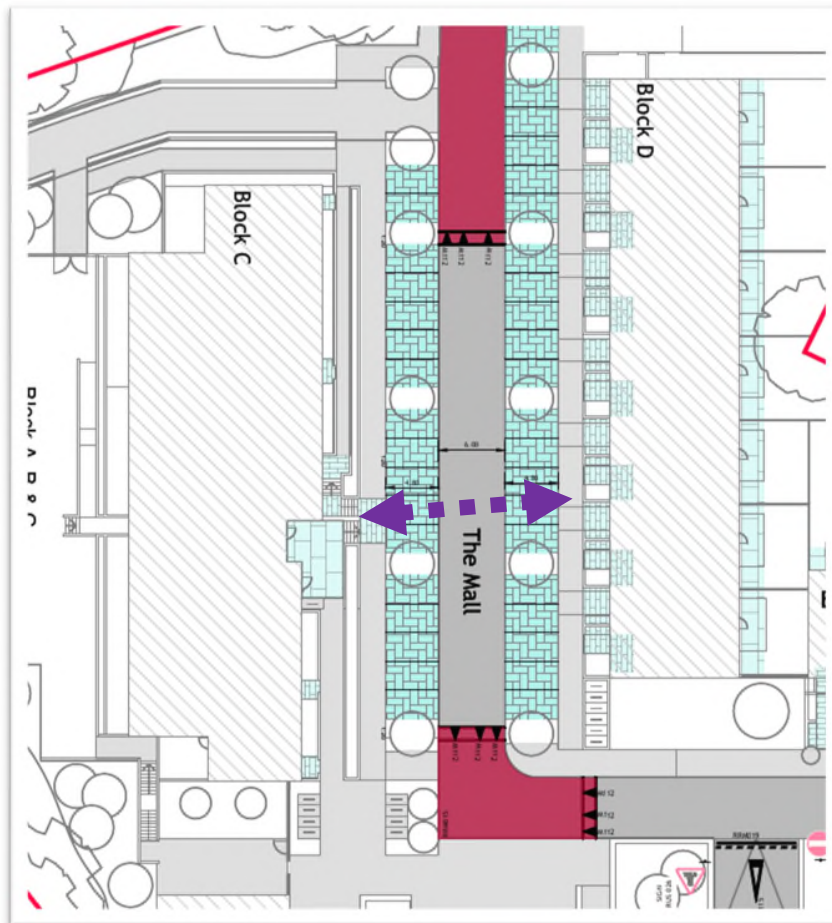
Drawing 232250-PUNCH-XX-XX-DR-C-0461 Rev P04, The Mall.

There is perpendicular parking on both sides of 'The Mall'. There is no direct area for pedestrians to cross between Block C and Block D except at either end.

It is recommended that the potential desire line in the centre of the blocks be assessed and a crossing area be provided if such a demand is predicted.

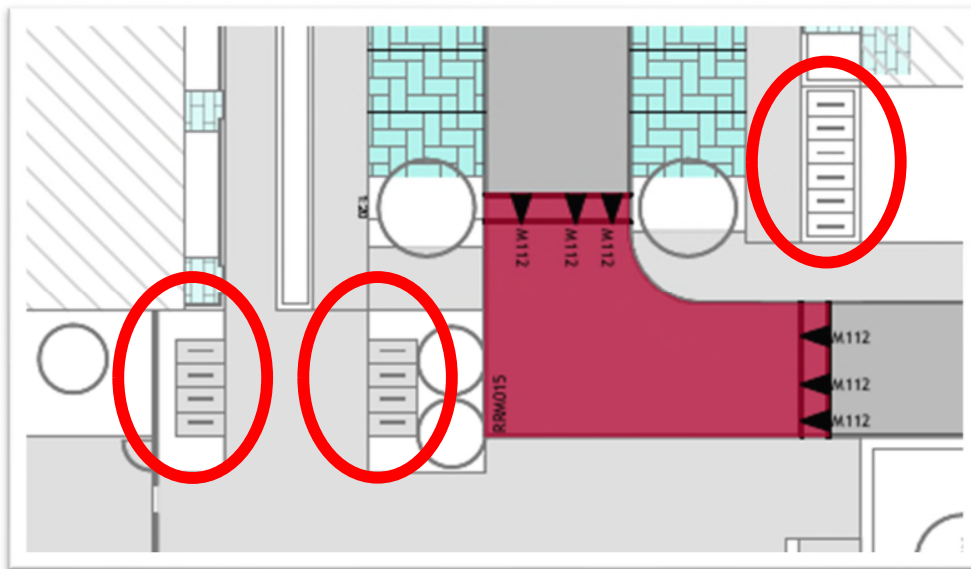
Drawing 232250-PUNCH-XX-XX-DR-C-0461 Rev P04, The Mall.

Cycle parking is shown on the surface level. It is unclear if there is any sheltered and secured parking. A lack of shelter can lead to a reduction in bicycle use and an increase in car usage.

It is recommended that a suitable proportion of sheltered and secure bicycle parking be provided.

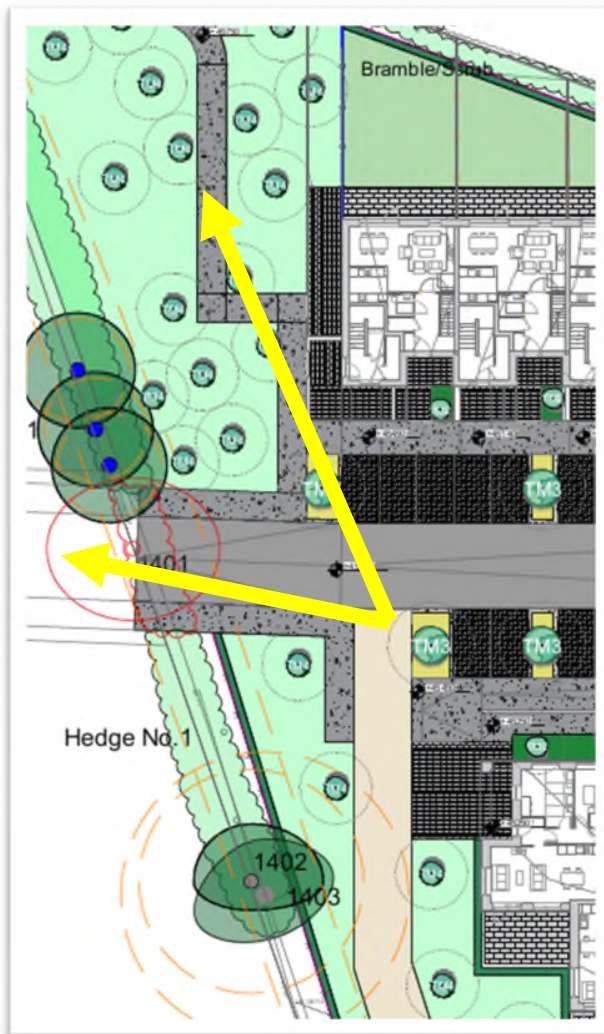
Drawing 531-PD-01 Rev B, Landscape Design Plan.

The proposed greenway terminates at The Mall. There is no further link for cyclists towards Lehaunstown Lane or to Grand Parade.

It is recommended that a continuity of cycle facilities to the adjacent road network be developed.
