Arborist Associates Ltd.

An Arboricultural Assessment of the Tree Vegetation within the Site Area off 'Lahauntstown Lane' at Cherrywood, Dublin 18.

Prepared for: ABK Architects

Date: 10th April 2024

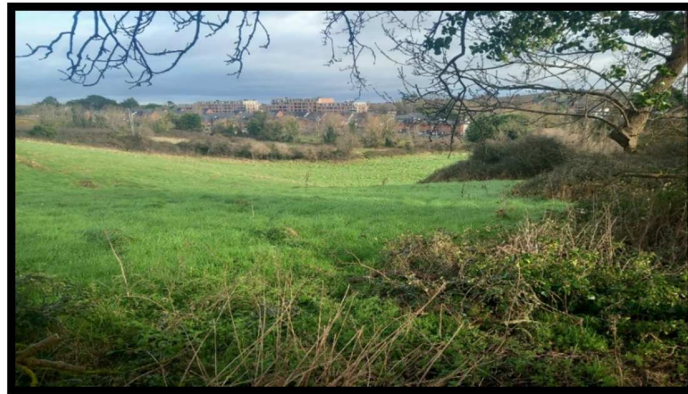
Figure 2: A view across the site from south to north towards Hedge No.4 A and B.

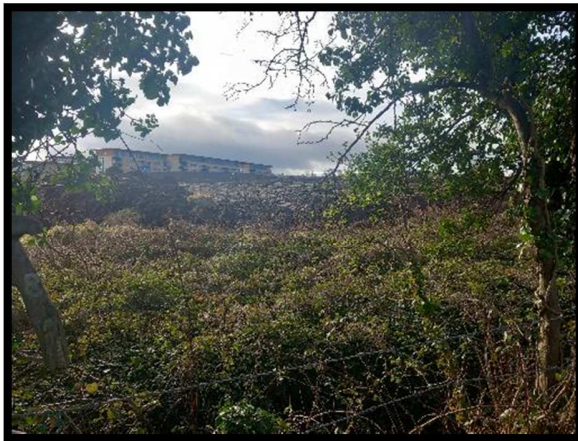
Figure 3 Above: Shows the soil alterations taking place close to Hedge No.2 on the adjoining land side.

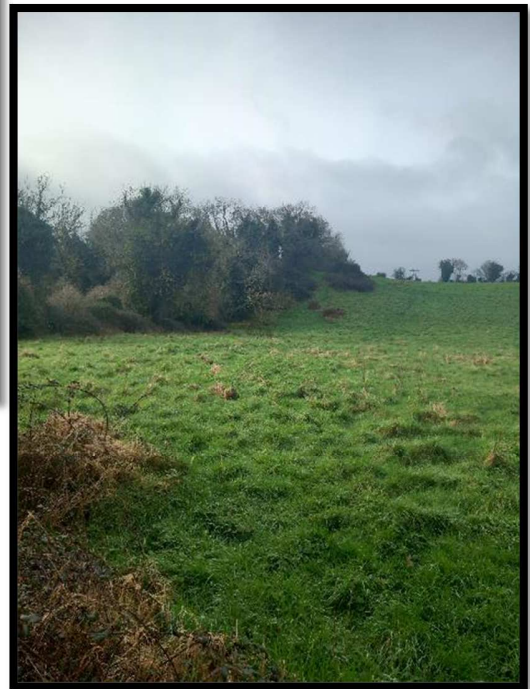
Figure 4 right: A view from the bottom of the site facing Hedge No.2
