ARBORICULTURAL ASSESSMENT REPORT

LEHAUNSTOWN LAND CHERRYWOOD SDZ CO. DUBLIN

Project No.
TCAR006

Date
03/11/23

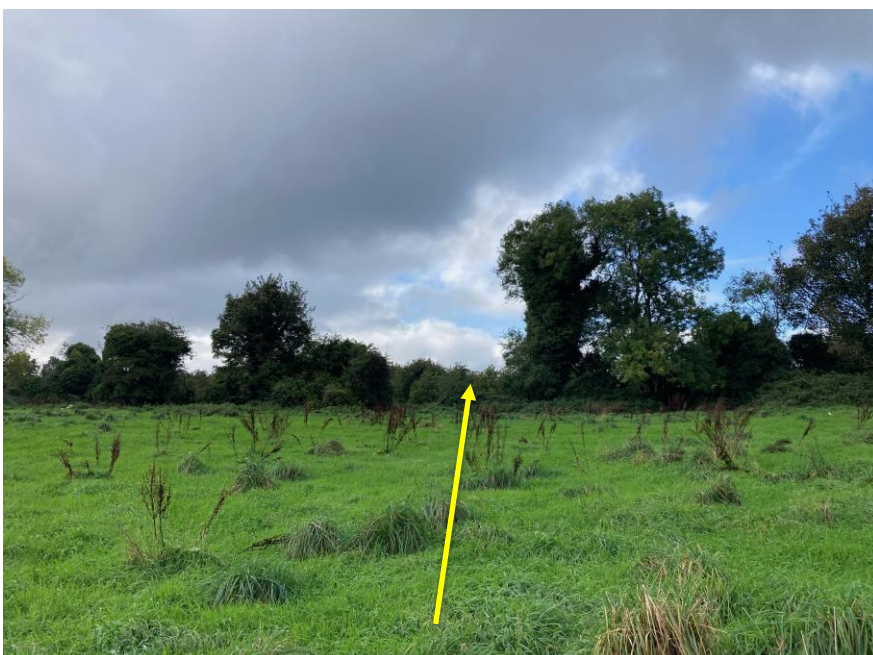
As there is no ditch separating the site from the neighbouring fields the standard trees are very likely to have roots extending into the site. The estimated constraints / root protection area varies from 3m to 12m where larger standard trees are located.

A 6m gap in the hedgerow represents a potential location for linking the subject site to the neighbouring area to the west (image 3).

Image 3. Hedgerow #1. Note fragmented nature of hedgerow with occasional hawthorn and 6m gap (arrowed) which provides potential for linking the subject site to the neighbouring

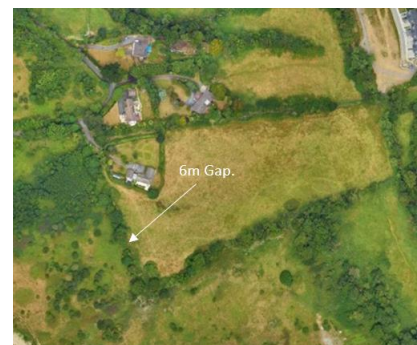
Image 4. Hedgerow #1. Gap in hedgerow arrowed

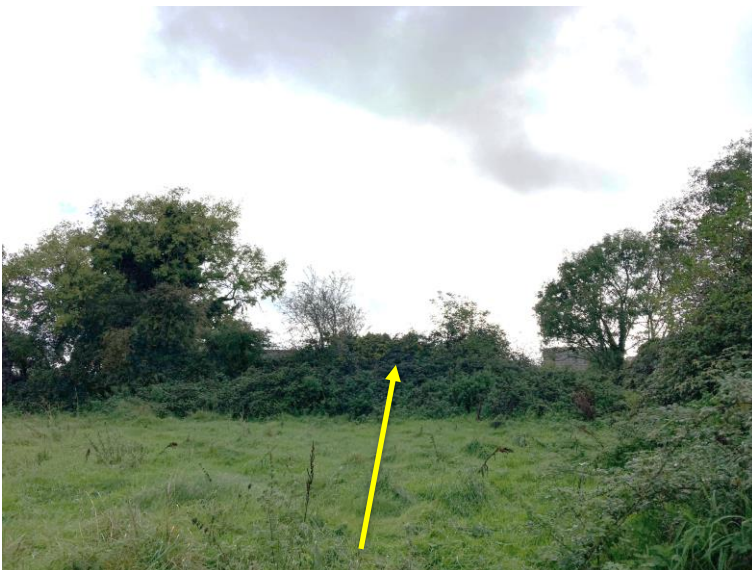
A 19m gap in the hedgerow represents a potential location for linking the subject site to the neighbouring area to the south (images 5 & 6).

Image 5. Hedgerow #2. A 19m gap at the north-western corner (arrowed & image 6) provides potential for linking the subject site to the neighbouring lands

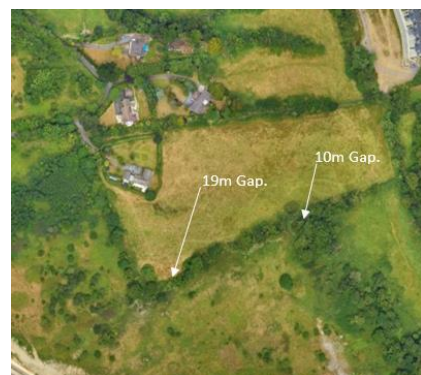
Image 6. Two gaps in hedgerow #2 provide potential for linking the subject site to neighbouring lands to the south.

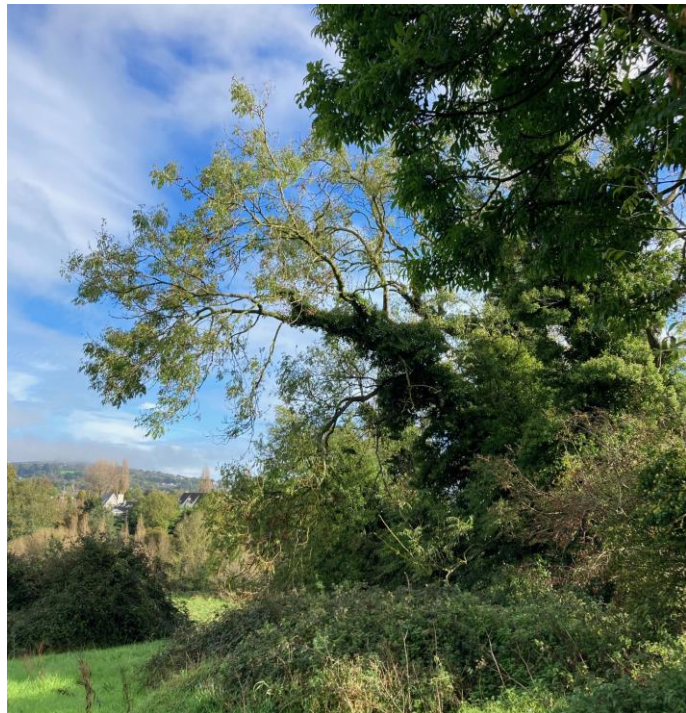
The estimated constraints / root protection area ranges from 3m to 10m at the locations of mature standard trees. A number of the ash have extended limbs up to 7m over the site (image 7) which may also pose a constraint.

Large limbs overhang the site may represent a constraint on development however appropriate pruning and tree management can reduce this constraint without adversely impacting on trees. Note that the tree in image 7 is an ash. The future for ash trees is limited generally due to ash dieback. The nature and structure of this hedgerow varies over its length (images 5 & 8)

Image 7. Ash tree overhanging site

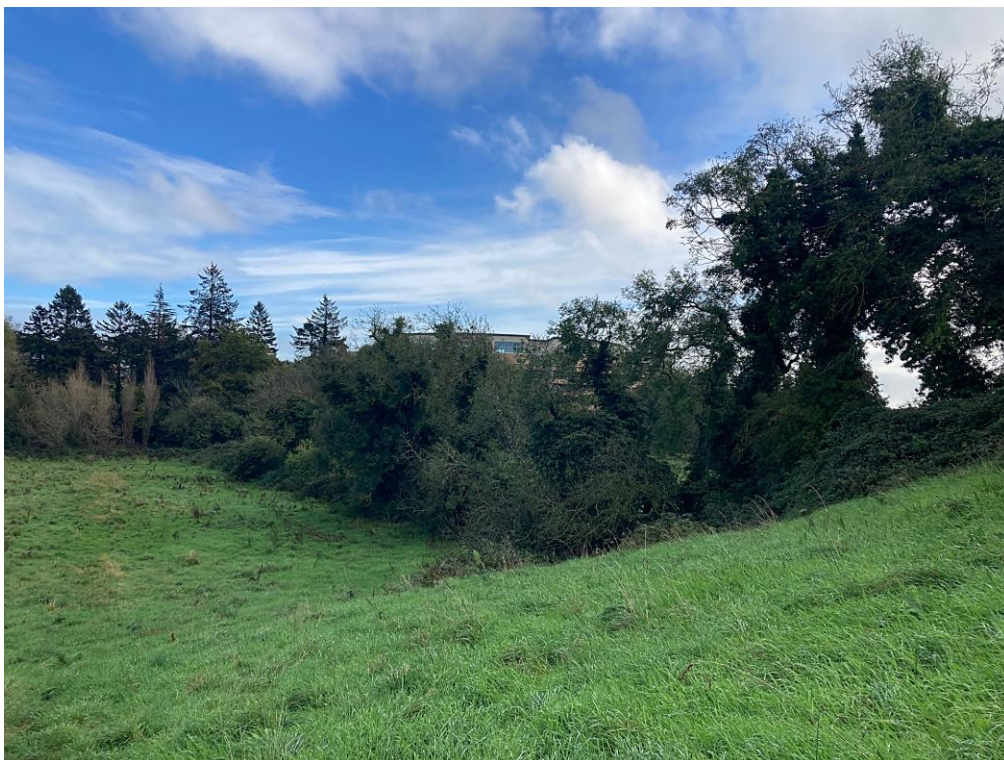
Image 8. Sloping nature of site and variation in structure of hedgerow in comparison with section shown in image 5

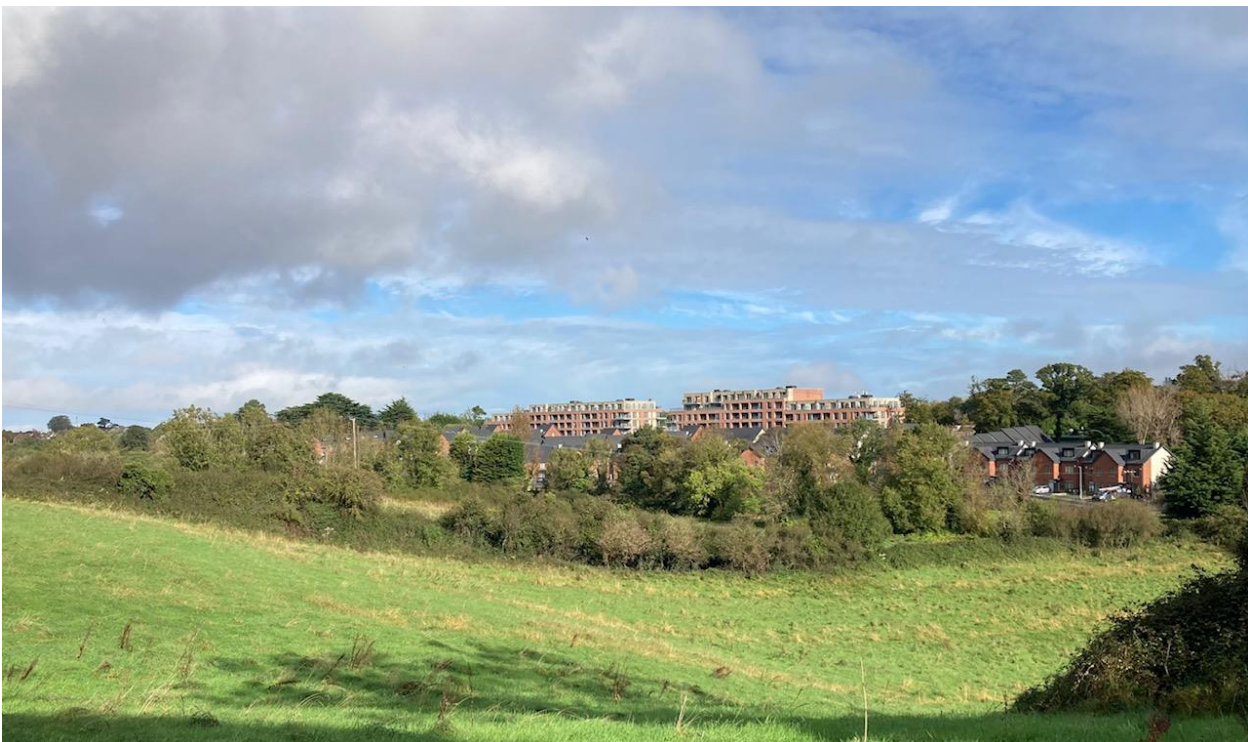
A field boundary hedgerow which has been reduced to an average height of 2.25m. Bramble now dominating large sections of the hedge. No standard trees present. Ash present at juvenile stage only and vulnerable to ash dieback. Blackthorn self-seeding into field.

This section of the boundary between the site and neighbouring lands (image 9) on the northern boundary does not impose a constraint on development in terms of root growth into the site as there are no standard trees present.

Image 9. Eastern section of northern boundary

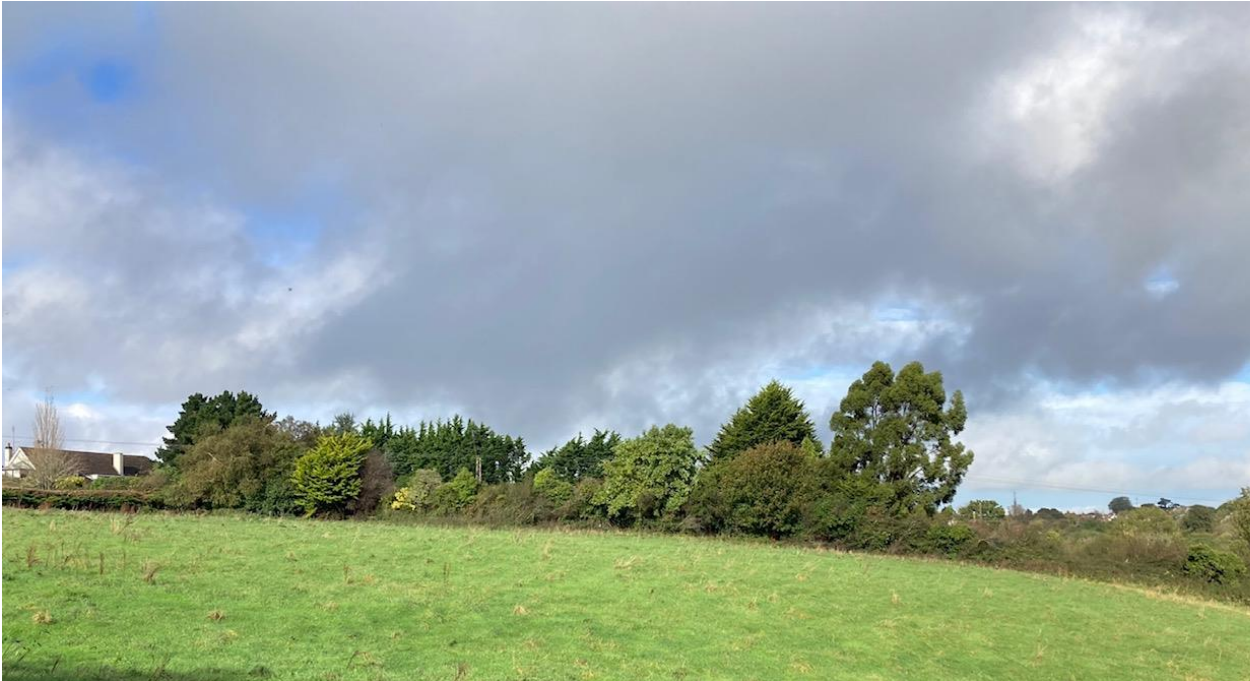
The section of the boundary with the ornamental trees and shrubs represents a constraint in terms of potential root growth into site. This is considered to be in the region of approximately 4m. There is very limited limb overhang over site.

Image 10. Western section of northern boundary

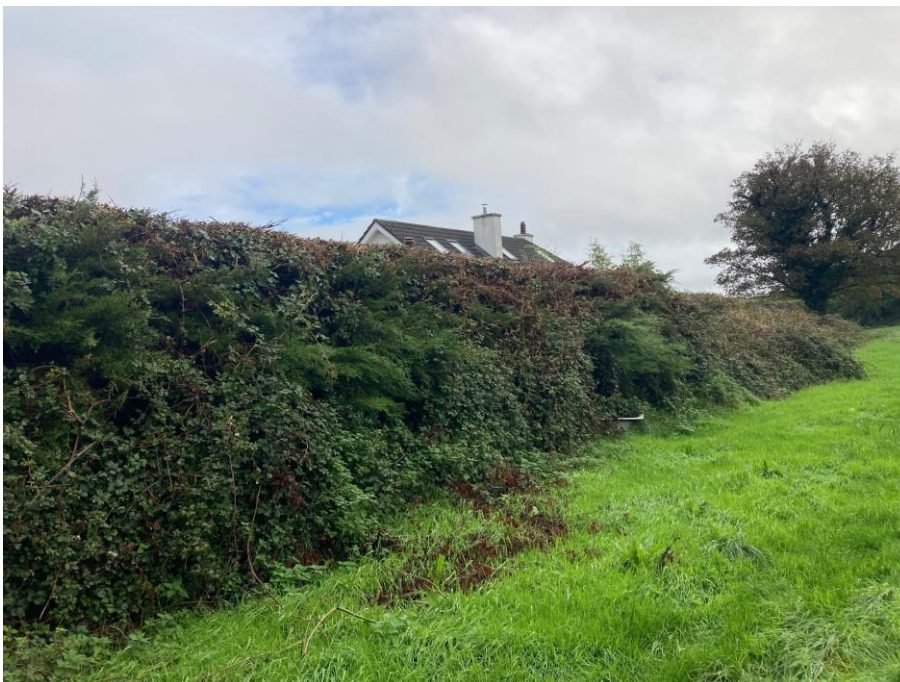
The western section borders two private gardens which contain a. mixed ornamental trees and shrubs b (image 10). a low Leyland cypress hedge (image 11) with a single sycamore tree.

Image 11. Leyland cypress hedge at rear of private property

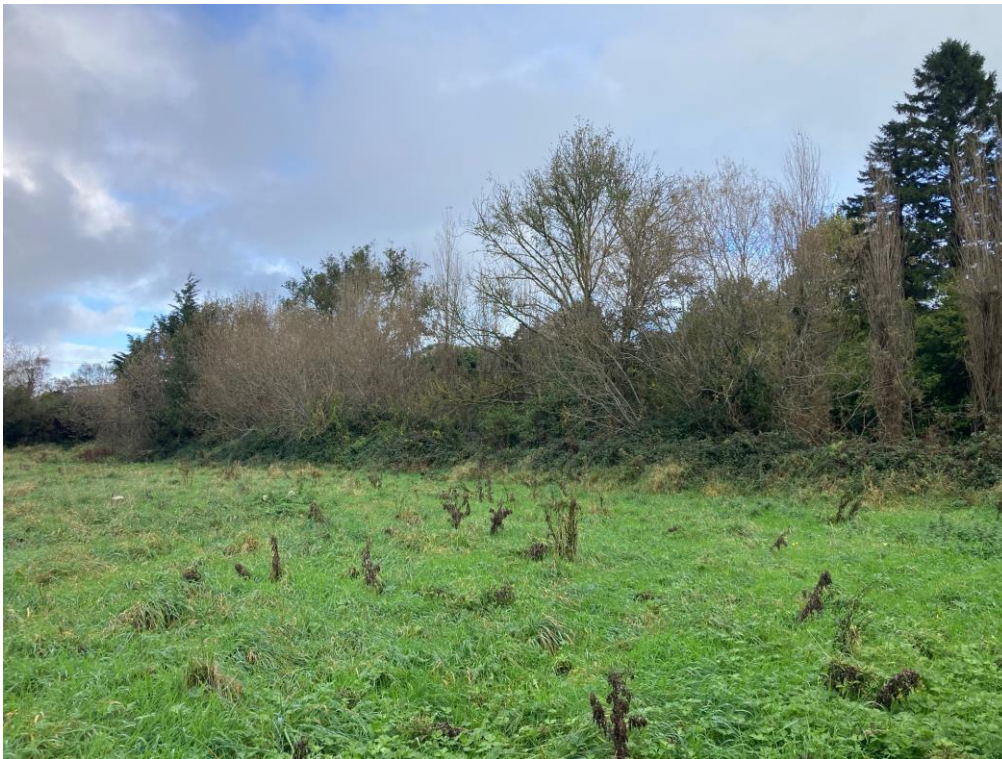
Naturally regenerating vegetation at a low waterlogged section of the site adjacent to a stream (image 12). The willow are all multi-stemmed possibly due to past grazing pressure. Occasional alder are developing within the willow scrub. With grazing pressure no longer in place this area of vegetation is likely to extent into the wet areas of this section of the site.

The nature of the ground in this area and the restrictions around development near streams and rivers are more of a constraint than the vegetation itself.

Image 12. Scrub vegetation within wetland area on eastern boundary

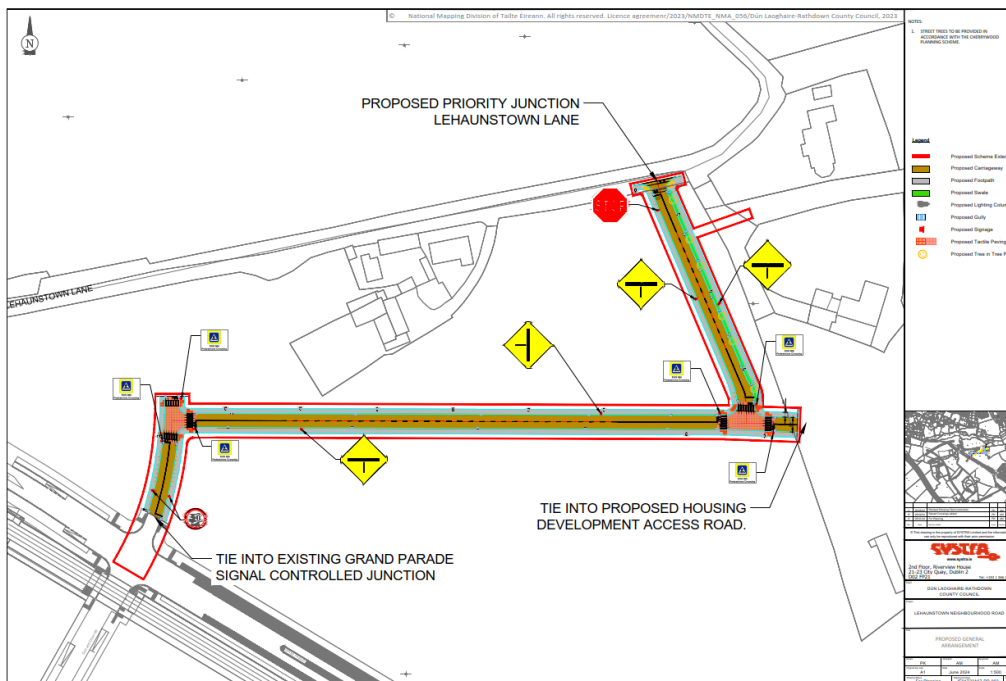
Image 14. Proposed General Arrangement

A construction access route of 4m is proposed through HR1 at an existing gap in the hedgerow. Following completion of construction works the gap will be replanted with suitable native species as agreed with the project ecologist.

A new, permanent 11m opening is proposed to be made in HR1 to connect the site with the road layout within the site to the west.

In terms of linking the subject site to the neighbouring lands and the need for construction access the two locations shown on image 14 represent a permanent 11m gap in the hedgerow to facilitate the link road and a temporary 4m construction access route. This report is not designed to outline the ecological impact of the proposed works however from an arboricultural perspective the permanent loss of 11m of hedgerow is not considered significant if improvements are made to the structure of retained hedgerows and their management in the future.
