**10 EBLANA AVENUE
DÚN LAOGHAIRE**

**ARCHITECTURAL HERITAGE
IMPACT ASSESSMENT**

4th April 2024

**Historic Building Consultants
Old Bawn
Old Connaught
Bray**

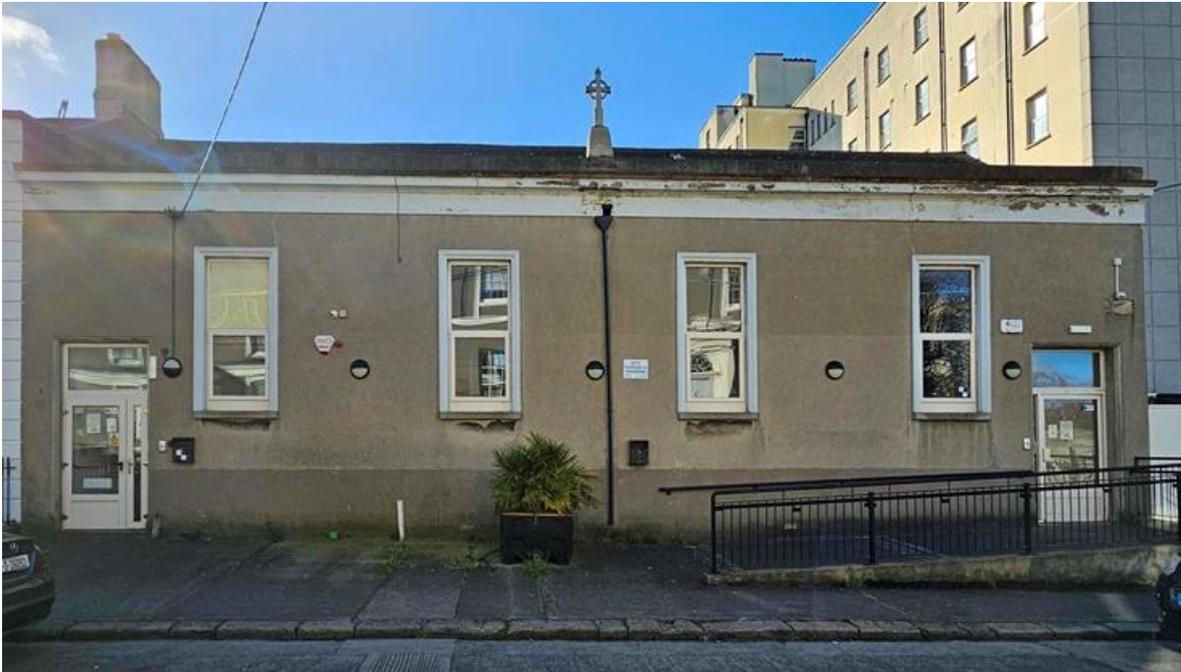
Plate 1: Street frontage of 10 Eblana Avenue

Number 10 Eblana Avenue is a single-storey, six-bay building set back slightly from the street behind a paved area, the mass concrete of the footway continuing to the façade of the building. The street façade is rendered with sand and cement and topped by a parapet faced with Roman cement and painted. The building is symmetrical, with doorways at either end, four windows between the doors and a downpipe descending at the mid-point. At the western end of the building a door provides access to a narrow walkway leading to the rear.

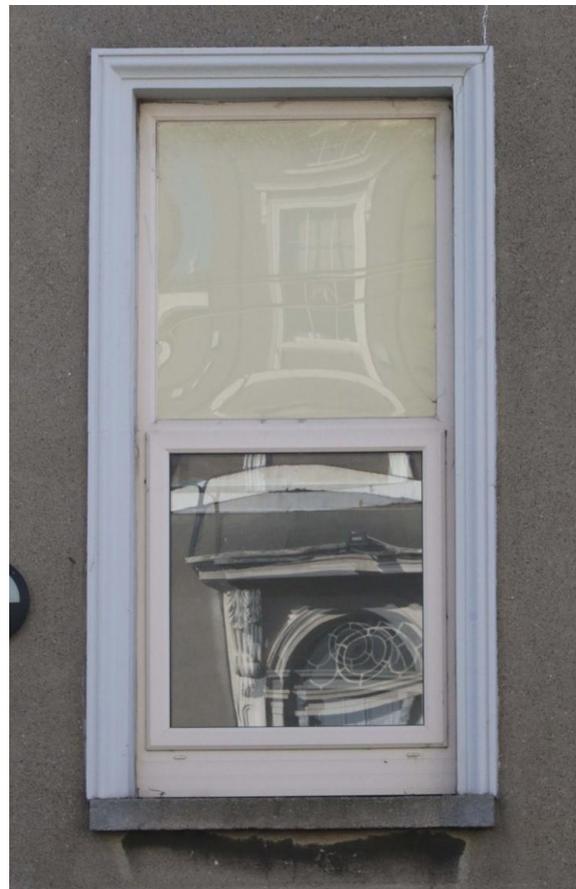
Plate 4: Typical window in front facade

The windows are of uPVC, divided by a horizontal division into two panes, the lower of which is a top-hung casement, while the upper pane is fixed. The windows have a moulded architrave of Roman cement, painted resting on a granite sill.

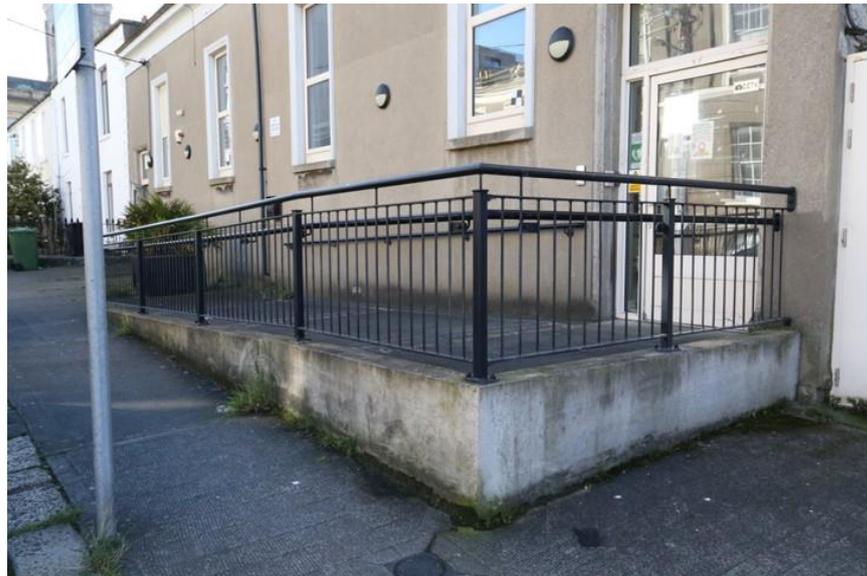
Plate 5: Ramp at western end of frontage

At the western end of the building frontage a concrete ramp provides mobility access to the western doorway. The ramp is guarded by steel railings.

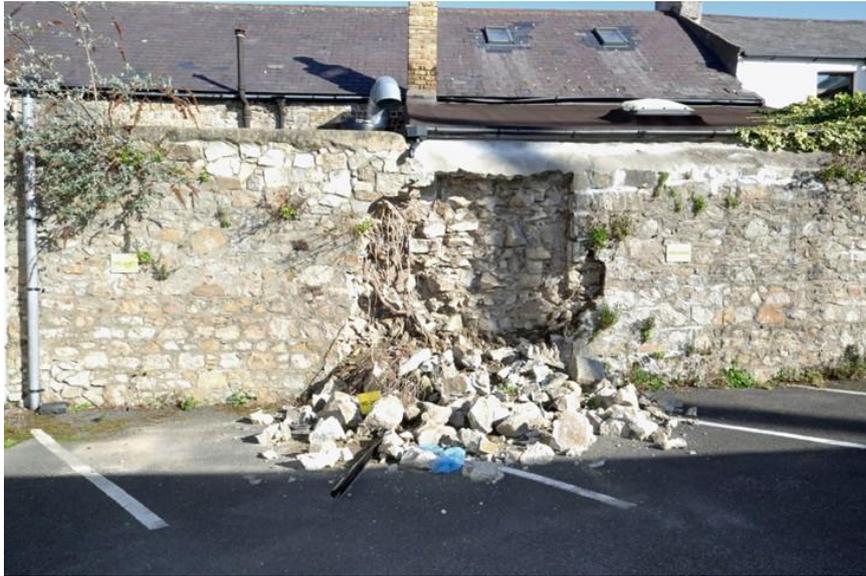
Plate 8: Rear boundary wall, with 10 Eblana Avenue beyond

The southern, or rear, boundary wall is marked by a high wall of granite rubble. At the time of the survey in February 2024 a section of the southern face of this wall had collapsed. At the right-hand end of the collapsed section is a straight vertical line suggesting the former existence of a door or window, though this is not evident on the inner face of the wall.

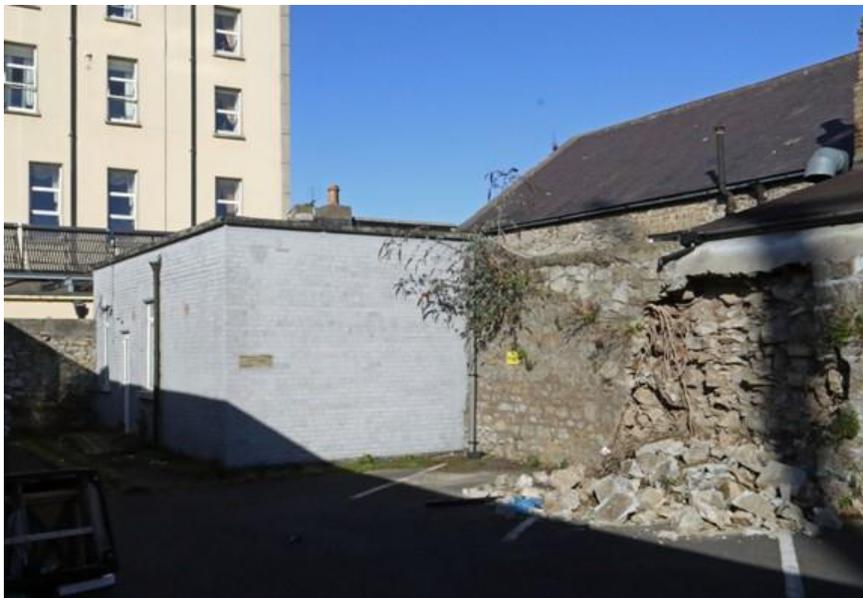
Plate 9: Extension at rear of 10 Eblana Avenue

Beyond the original rear boundary of 10 Eblana Avenue is a rear extension and this is described below. The rear of the original building has two projecting returns, one to the east, the other to the west, with an open yard between. The main building has an A roof with a covering of blue Bangor slates and is gabled at the western end, the eastern end being attached to the adjacent building.

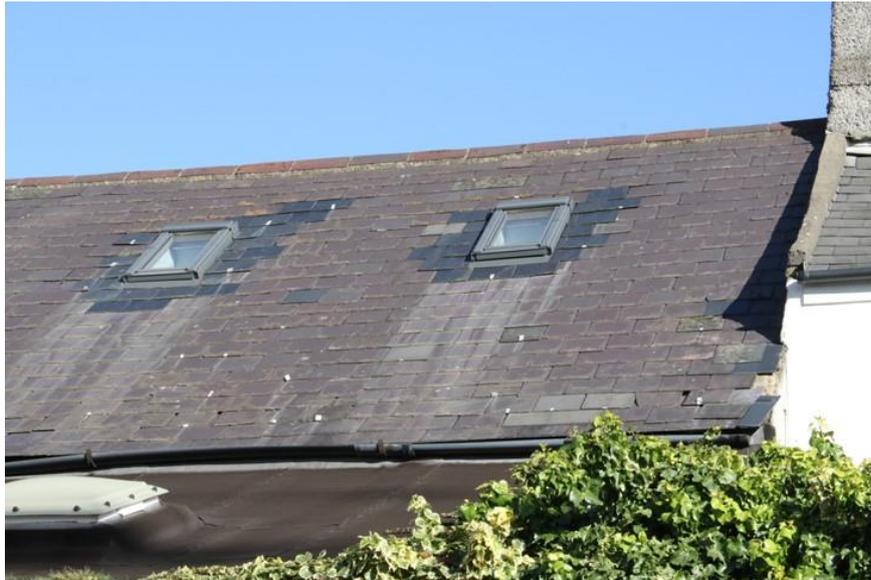
Plate 10: Roof of 10 Eblana Avenue at the eastern end

The roof of the main building has two skylights set into the rear slope. These are later additions as is made clear by the use of fibre-cement slates around the skylights. There are some slipped slates and earlier repairs are evident from the presence of a significant number of tingles. The roofs of the two returns are of shallower pitch and have a covering of roofing felt, each having one skylight.

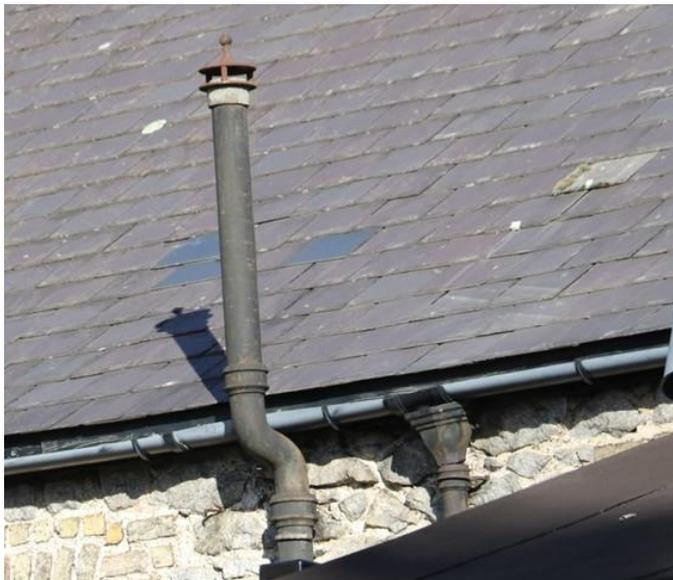
Plate 11: Gutter, downpipe and vent pipe

The gutter to the rear of the main roof is of uPVC and is fixed to a timber fascia. The downpipe and hopper are of cast iron as is a vent pipe rising up the rear elevation.

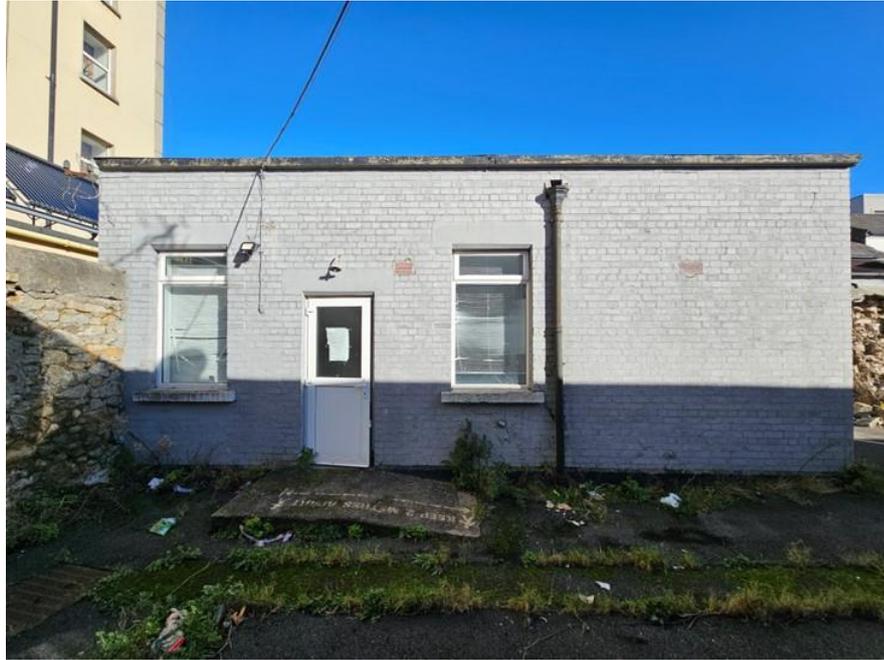
Plate 13: Southern face of rear extension

As noted above, the extension to the rear lies outside the original stone wall boundary within adjacent land. The extension is flat roofed, with a parapet, and is faced with buff-coloured brick, painted grey, laid in English garden wall bond. There are no windows or doors in the eastern elevation. One doorway, off centre on the southern elevation, is flanked by windows. A cast-iron hopper and downpipe drain the roof through the parapet.

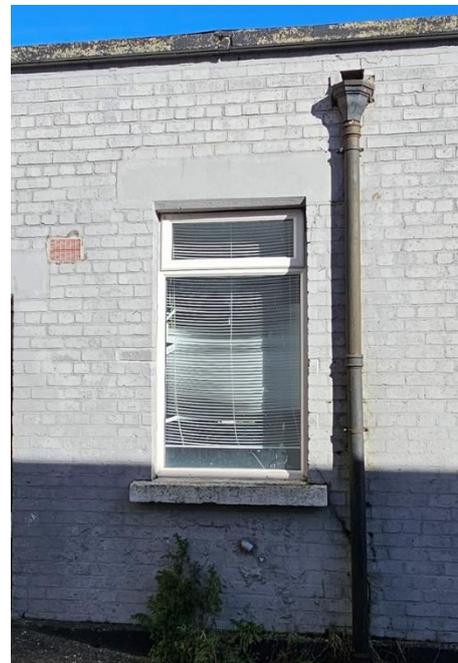
Plate 14: Window in rear extension

The two windows are of uPVC with one large pane topped by a smaller top-hung casement. The windows are set in openings spanned by a deep precast concrete lintel. The sills are of granite and are painted. A shallow concrete ramp approaches the doorway.

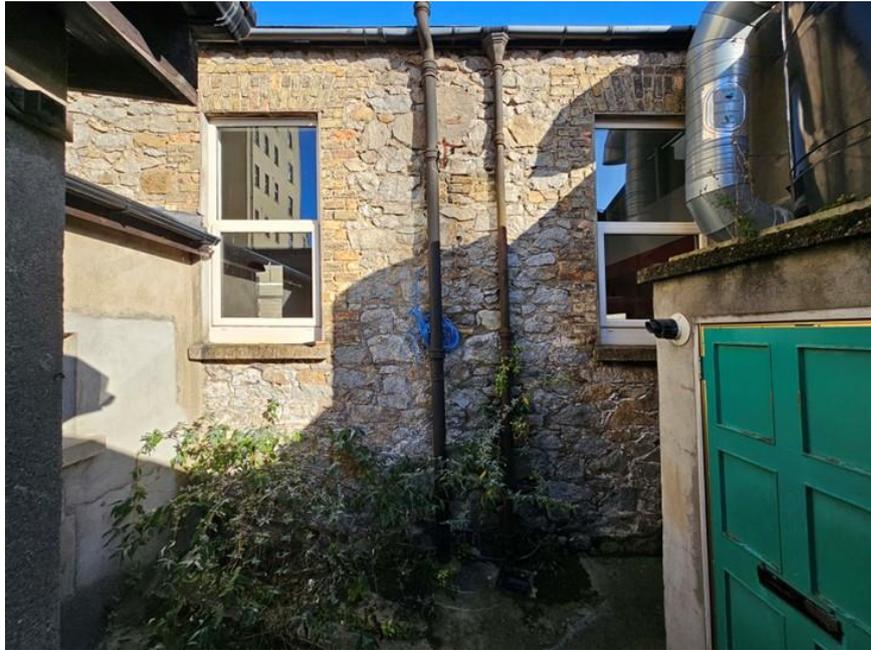
Plate 16: Rear façade of main building

The rear of the main building is visible within the yard. It is faced with granite rubble. The windows are uPVC, similar to those at the front. The window openings are lined with buff-coloured brick, with flat brick arches. The openings are lined with sand and cement in the reveals and heads, though one Roman cement facing survives in the soffit of one window opening.

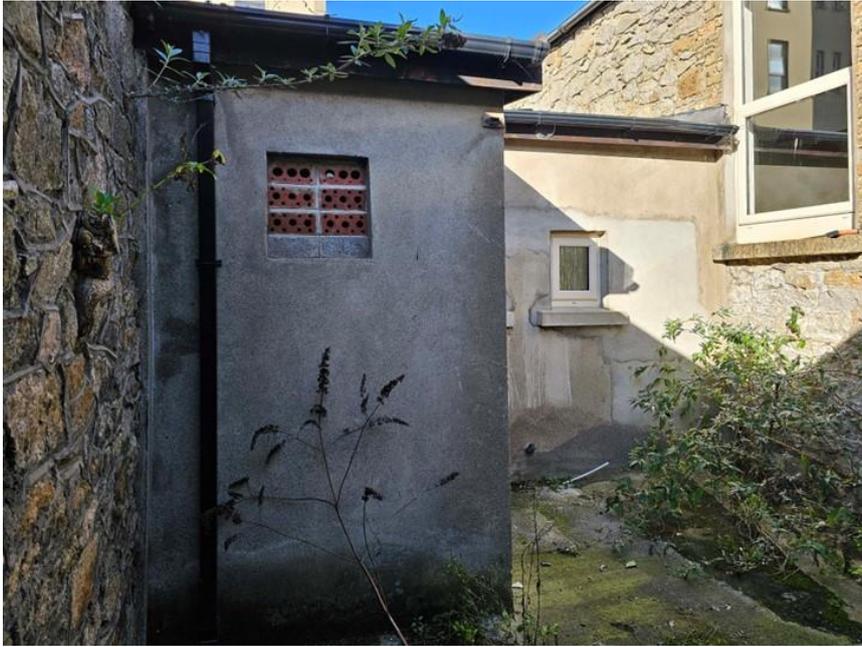
Plate 19: Western return

The roof of the western rear return has a covering of felt. The external façade is rendered with sand and cement, facing into the rear yard. A chimney rises from the western wall of the return, near the rear, the stack being rendered with sand and cement, and it carries a single pot. The rainwater goods are of profiled PVC, fixed to a timber fascia. Two small windows of uPVC have precast concrete sills. A small projection runs into the yard near the rear of the return. This has no window, while an opening is infilled with perforated brick.

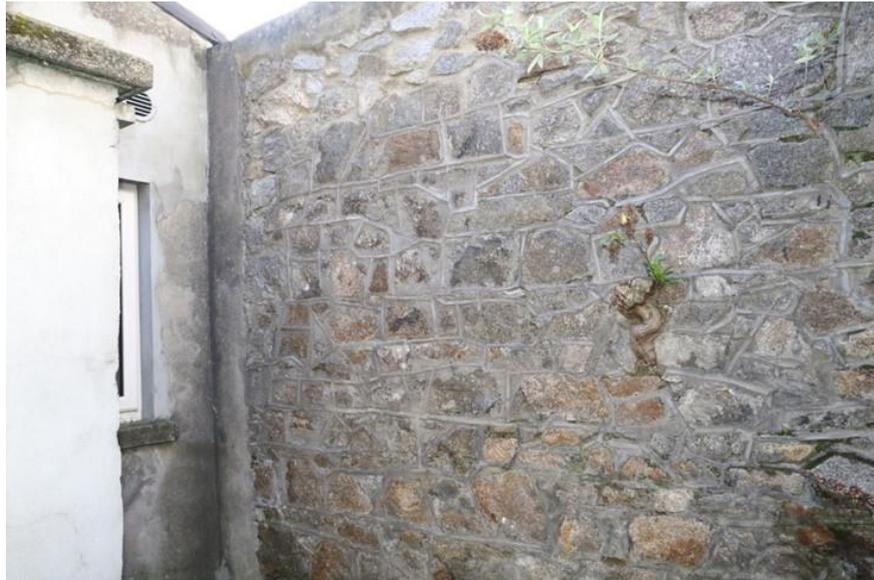
Plate 22: Wall at rear of yard

The rear boundary wall on the southern side of the yard is of rubble granite without render. It has been repointed in sand and cement.

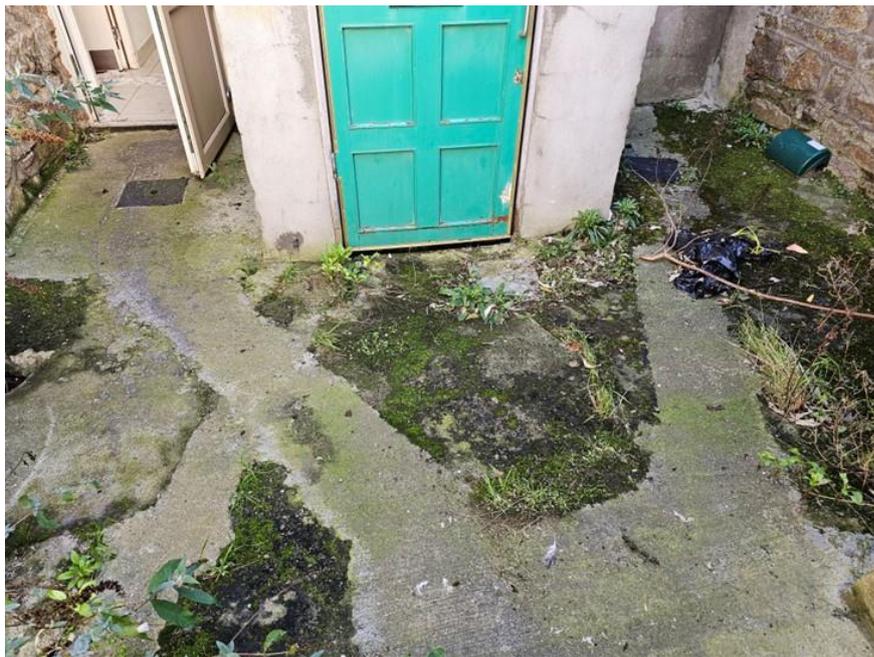
Plate 23: Paving in yard

The yard is paved with concrete, with repairs where services have been provided below the surface.

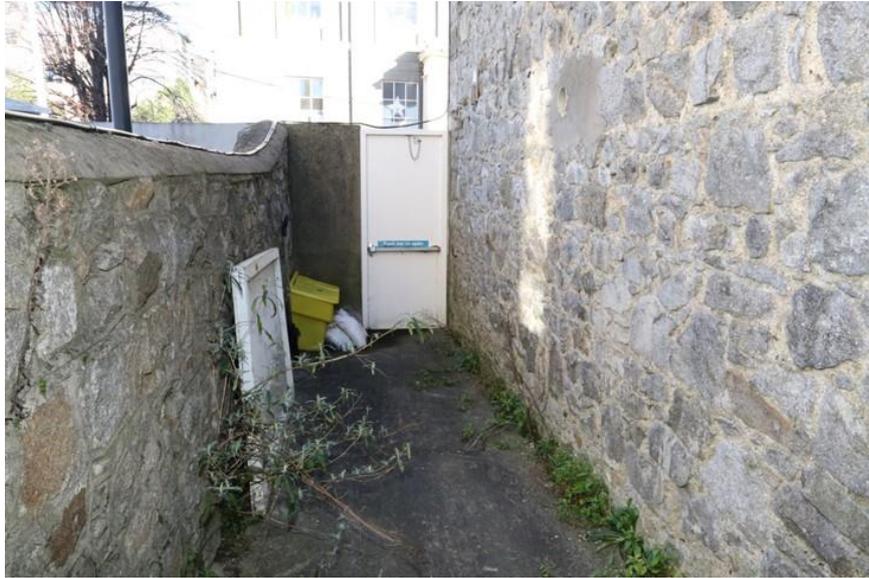
Plate 24: View to front of passageway

As noted above, a passageway runs alongside the western boundary of the building. This gives access to the rear of the building via a doorway set in a lean-to addition at the side of the western rear return. This extension is faced with sand and cement render and has a door of uPVC. The roof of the lean-to is slated and has upstands at the ends, with precast concrete copings. The surface of the passageway is of concrete. The boundary wall to the west is of rubble granite.

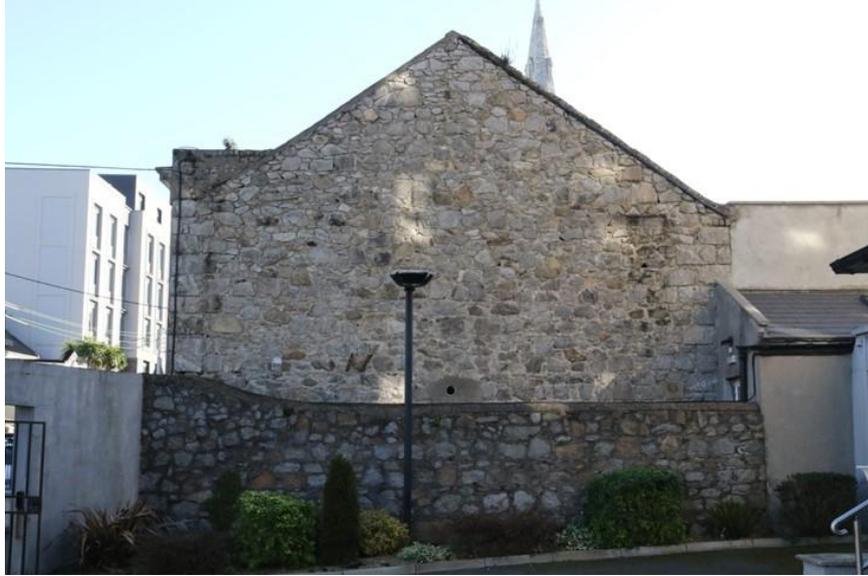
Plate 26: Western gable of building

The western gable of the building is of rubble granite without coursing and is not rendered. The gable at the southern slope has a capping of brick, while the gable at the northern slope has no coping, the slates being cemented to the top of the wall.
