Baseline Tree Survey Report

Dun Laoghaire County Council

Hillcrest Road, Dublin.

Arbor-Care (Ltd) Professional Consulting Tree Service,

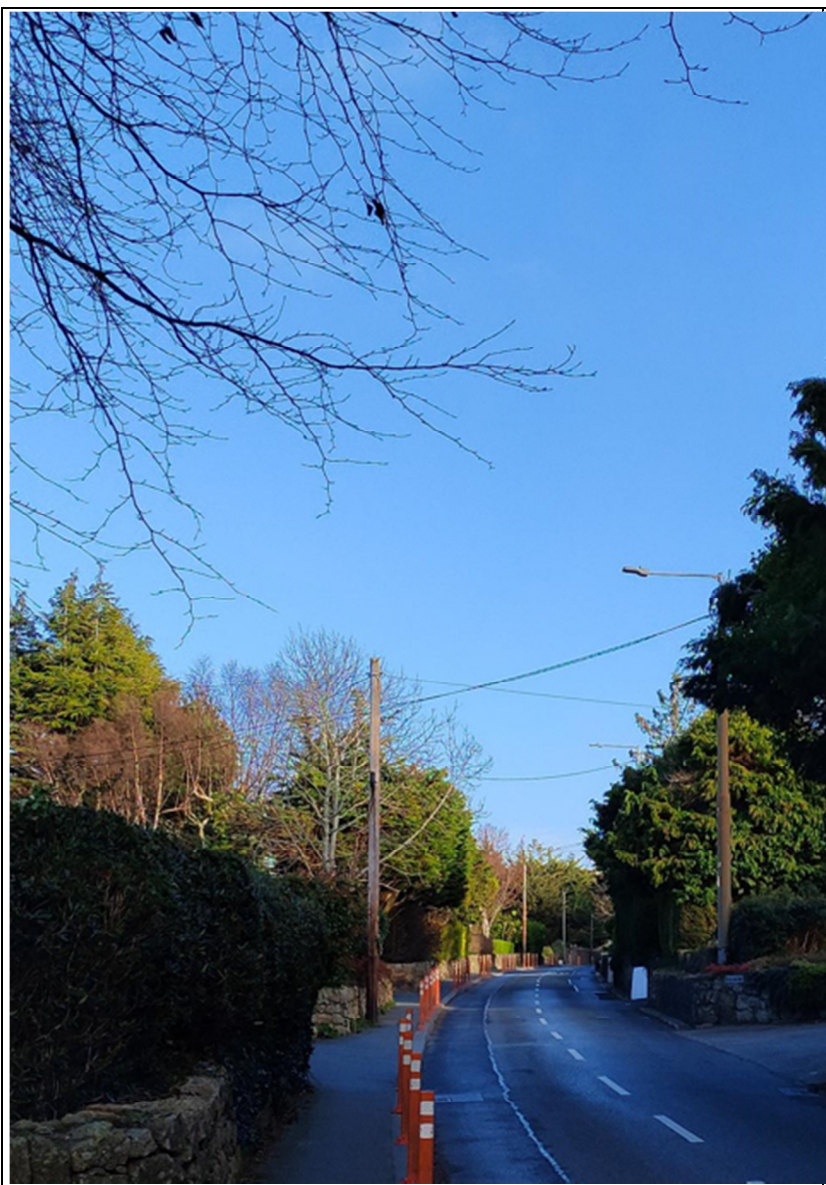
Hillcrest road looking east

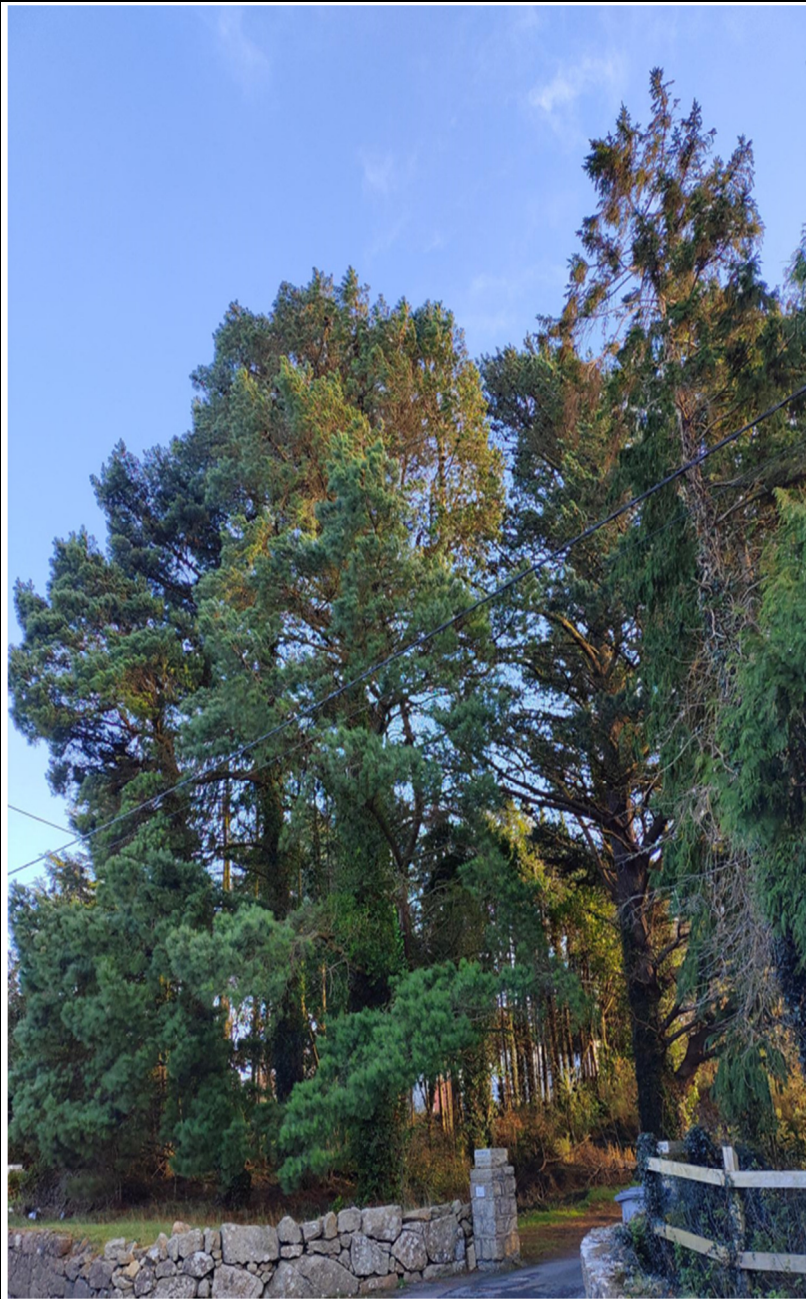
Large conifers to the front of a property
