# **Arborist Associates Ltd.**

## **A Condition Assessment of the Trees within 'Clarinda Park', Dún-Laoghaire, Co. Dublin.**

**Prepared for: JB Barry & Partners Limited.**

**Date: 8<sup>th</sup> September 2023**

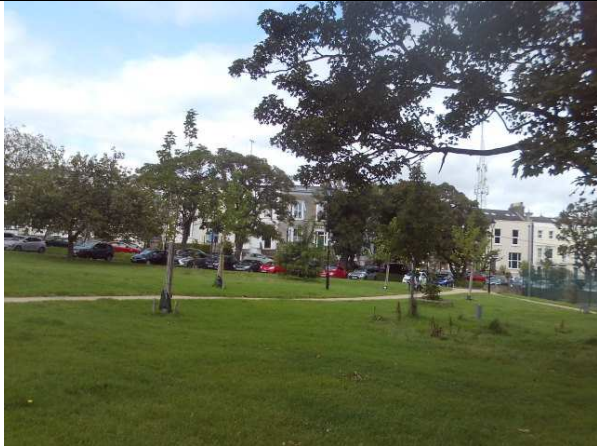
<b>Tree Line No. 2</b>	<b>London Plane</b> <i>Platanus × acerifolia</i> (6 in total) <b>Sycamore</b> <i>Acer pseudoplatanus</i> <b>Fir</b> <i>Abies sp.</i> <b>Oak</b> <i>Quercus robur</i>	Young	5	70	2	2	2	2	2	Fair	Fair It consists of a wide spacing double line of trees planted on either side of the centre pathway. They are still attached to their tree ties and stakes and are beginning to establish. One of these trees has been broken. There are weeds growing around their bases.	Mulch the area around their bases to protect them during the grass maintenance and to reduce competition.  Adjust tree ties and stakes as they grow.	-	C2
0225	<b>Deodar Cedar</b> <i>Cedrus deodara</i>	Semi Mature	7	180	1	2	2	1	0	Good	Good It is establishing well with a slightly asymmetrical crown with a branch formation down to ground level with an acute union formation between some branches. It has	Remove lower branches to a height of c. 1.5m in order to raise up its crown in order to open up the area underneath.	40+	C1
