A Condition Assessment of the Trees along 'Georges Street', Dún-Laoghaire, Co. Dublin.

Prepared for: JB Barry & Partners Limited.

Date: 8th September 2023

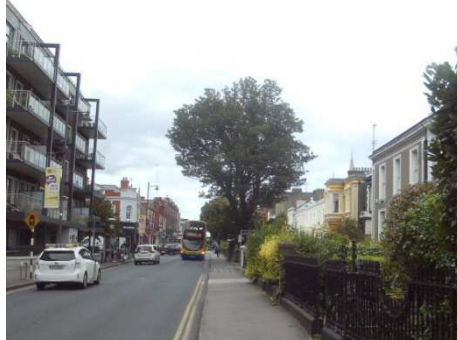
Tree No	Tree Species	Age	Ht (m)	TD (mm)	Crown Spread (m)				C. Ht (m)	Phys. Condition	Structural Condition/Comments	Works Required	Remaining Years	Category
					N	S	E	W						
<p>A Condition Assessment of the trees on 'Georges Street' Dún – Laoghaire, Co. Dublin.</p> <p>The assessment of these trees works from east to west in direction along this street.</p>														
Tree No. 1	Sycamore <i>Acer pseudoplatanus</i>	Mature	23	1250	7	7	10	8	2	Fair	<p>Fair</p> <p>It is a large prominent, visual tree located on the north side of 'Georges Street'. It is located on the inside the front boundary failing of a private property. The visual assessment of this tree has been carried out from the roadside only and may be limited as a result. Some lower scaffold limbs/ branches have been removed or raised in order to raise up its crown over the years with decay pockets at the old wounds as a result. There is some epicormic growth developing on the main trunk. The area around its base is surfaced in paving.</p>

The management of this tree line is located outside the control of this site area.	20+	B2

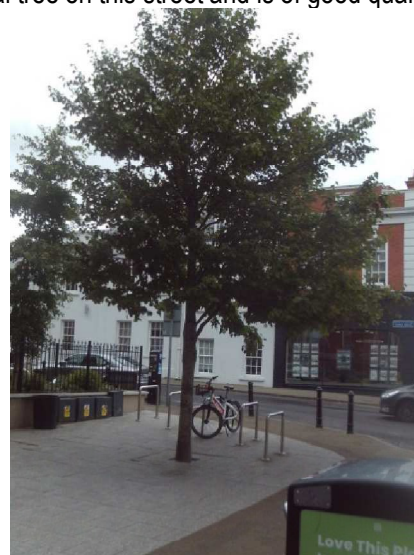
Tree No	Tree Species	Age	Ht (m)	TD (mm)	Crown Spread (m)				C. Ht (m)	Phys. Condition	Structural Condition/Comments	Works Required	Remaining Years	Category
					N	S	E	W						
										proper planting pit at the junction of 'Georges St.' and 'Corrig Ave'. The lower branches have been pruned/ removed in order to raise up its crown. It is a focal tree on this street and is of good quality.	It will require pruning from time to time to maintain clearance over the surrounding surfaces. The paving area around its base will also require some adjustment as this tree grows in size.			
0249	Robinia <i>Robinia pseudoacacia</i>	Young	6	90	1	1	1	1	0	Good	Good It has been planted into a shrub bed with paving around its base just north of the junction of 'Haigh Terrace.' with Georges St. It has a low crown formation down to ground level with epicormic growth on the lower stem. It has suffered branch breakage on the eastern side, possibly due to recent winds (Storm Betty) leaving its crown more	Remove lower epicormic growth in order to raise up its crown and to open up the area underneath.	40+	C1

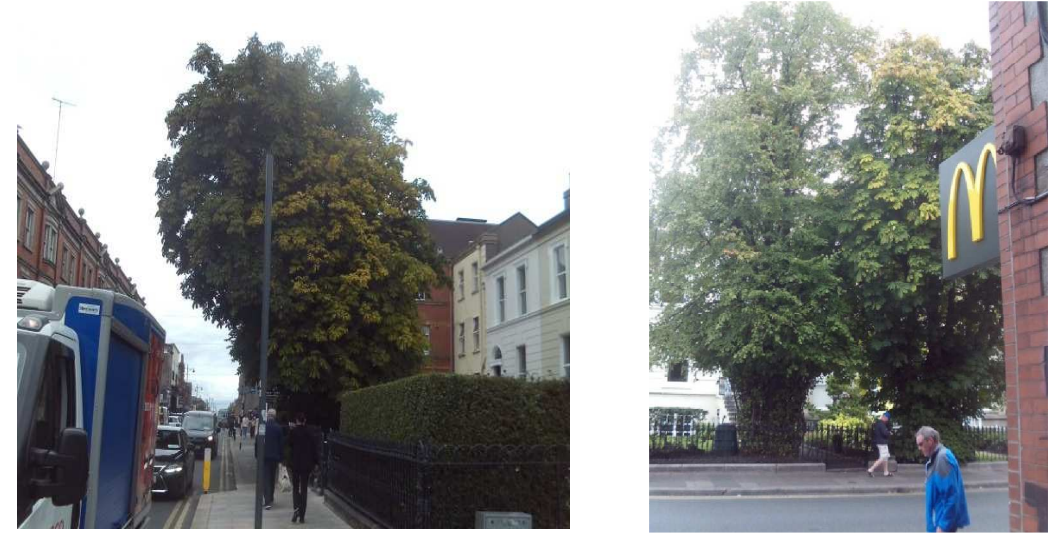
Tree No. 2	Horse Chestnut <i>Aesculus hippocastanum</i>	Mature	17	850	5	6	5	5	2	Fair	Fair A prominent visual tree, it is located within the front lawn area of House No.97 and inside the boundary railing with the public footpath. The visual assessment has been limited to the road side only and may be limited as a result. There is epicormic growth and basal suckers present. Its crown size has been heavily reduced / pruned over the years and it currently has a small compact crown of re-growth. Minor lifting is occurring on the footpath/ pavement outside the boundary railing and this is most likely attributed to by the tree roots.	Management is in private ownership. It would benefit from ongoing maintenance of the lower epicormic growth and basal suckers.	20+	B2

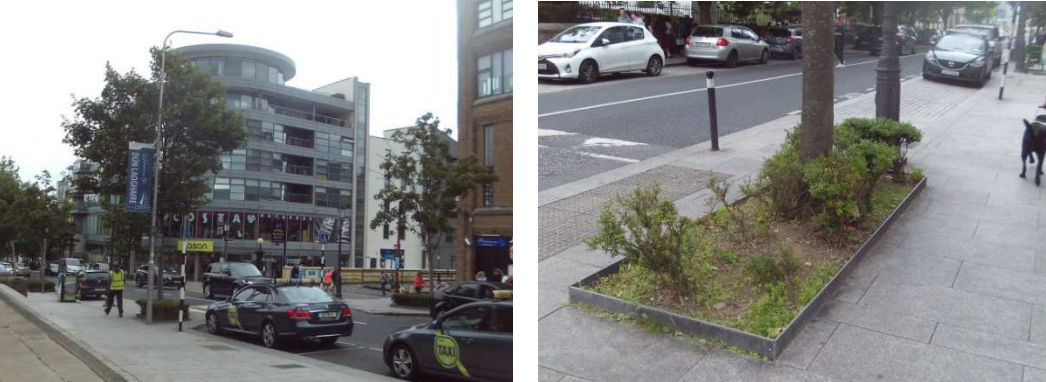
0250	Sycamore <i>Acer pseudoplatanus</i>	Mature	12	500	5	6	6	6	4	Fair	Fair It is a large, prominent visual tree and it has been incorporated into the paved area around its base. The lower limbs/ branches have been removed in order to raise up its crown and some pruning wounds have been created as a result. Its crown is slightly thin, an indication of stress related issues, possibly due to its growing environment and impacts from past construction works. Lighting has been attached to its crown and the ties and wires may cause structural damage.	Remove the electoral wires and the lighting within its crown along with dead/ unstable growth.	20+	B2
0251 - 0254	Hornbeam <i>Carpinus Betulus</i> (4 in total)	Early Mature	11	210	2	2	2	2	2	Fair/ Good	Fair They are located within a linear shrub bed along the east façade of the church building and their crowns are beginning to grow in onto the building. The area around their bases is in soft landscape with paving to the east outside this area. The lower branches	It will require further pruning to maintain clearance with the building. They may eventually	20+	C2

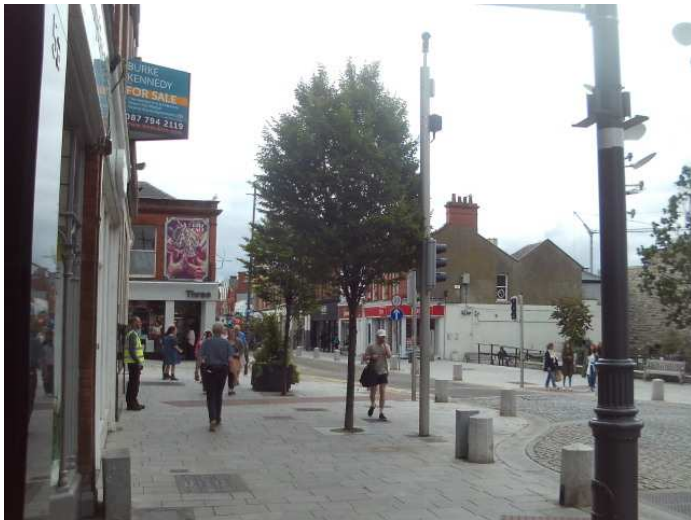
0261	Hornbeam <i>Carpinus</i>	Semi Mature	9	140	1	1	1	1	3	Fair/ Good	Fair It has been planted into the streetscape into a	It will require repeat pruning to maintain	20+	C2

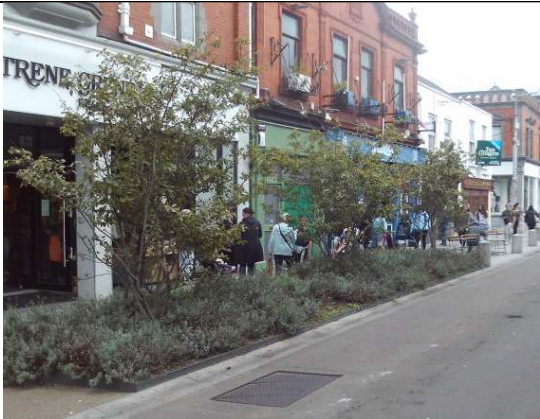
0263	Bay Laurel <i>Laurus nobilis</i>	Semi Mature	4	90	-	-	-	-	1	Fair/ Good	Fair It is located in a planter 3m north/south x 2m east/west on Convent Rd. It has a clear stem to a height of c.1.5m with suckers developing from its base. It has been maintained as a formal shape.	Maintain basal suckers.	20+	C1

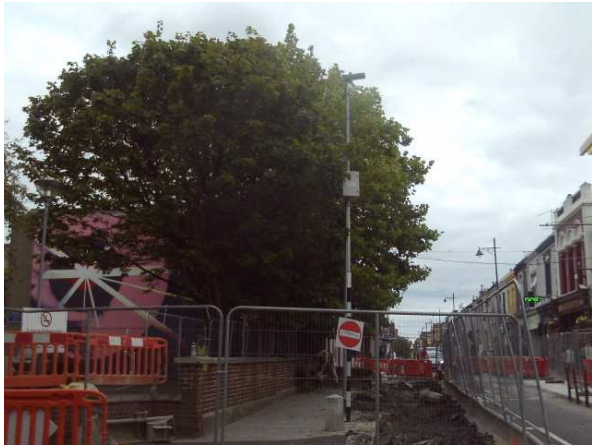
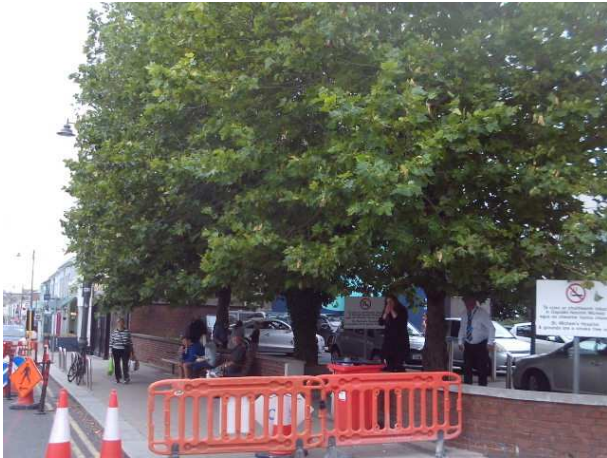
</div> <p>The following gives details on these trees.</p>														
0264	London Plane <i>Platanus × acerifolia</i>	Early Mature	16	500	4	5	3	4	3	Fair	Fair It is growing within a confined space inside the front boundary wall. Its crown has received some pruning previously to reduce its size in the past and again in more recent times to raise up its crown and to take back from the buildings. It currently has a low crown formation.	Carry out additional pruning to maintain clearance with the surrounding surfaces and structures. Remove the lighting attached to the main scaffold limbs and	20+	B2

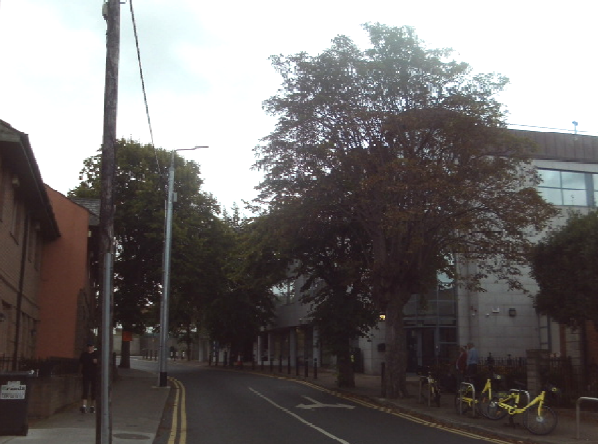
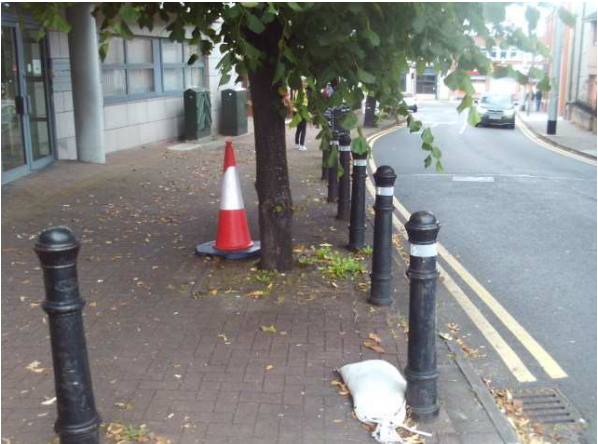
</div>														
0270	Lime <i>Tilia sp.</i>	Mature	15	520	7	4	3	5	2	Fair	Fair It is located on the east side of Library Road within the footpath and is growing in a confined space. The area around this tree has been resurfaced in recent years. It has received ongoing pruning to raise up its crown, in particular on the roadside and with the adjoining building, however its crown is beginning to grow up onto the building again. A	Prune crown in particular the lower branches in order to maintain clearance with the surrounding surfaces/ structures, in particular the building on the east side.	20+	C2

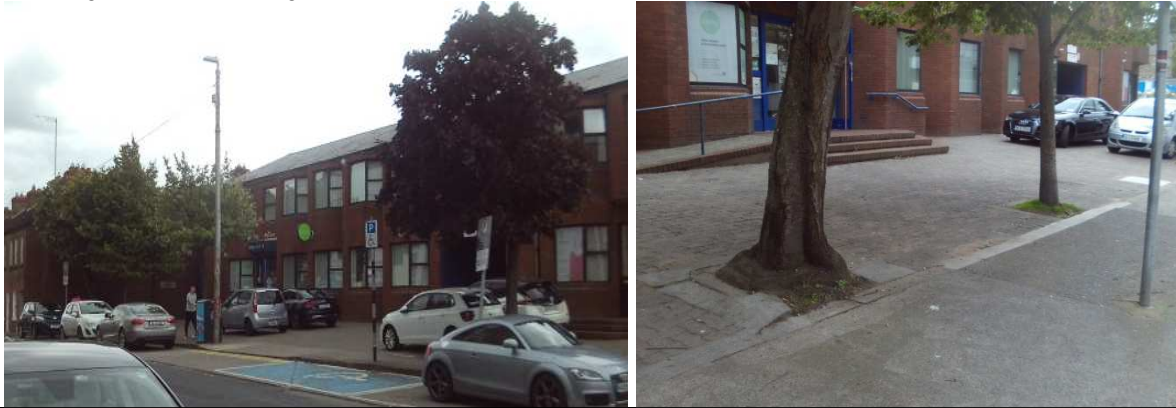
Tree No	Tree Species	Age	Ht (m)	TD (mm)	Crown Spread (m)				C. Ht (m)	Phys. Condition	Structural Condition/Comments	Works Required	Remaining Years	Category	
					N	S	E	W							
	<i>hippocastanum</i>									has been allowed to develop. Pruning has been carried out on lower branches in order to raise up its crown. It is growing on the footpath surface on a small opening with structural damage occurring to the surrounding surfacing.	footpath caused by tree base and roots.				
	Georges Street / Cumberland Street	<p>The following four trees are located within a paved surfaced area outside the 'Employment & Support Service' building on the south side of 'Georges St.'</p> <p>They are located within a paved area on the south side of the public footpath and consist of 2No. Whitebeam, 1No. Lime & 1 No. Purple Leaf Maple. They are growing within small openings within this paved area with some structural damage occurring to the surrounding pavement.</p>

The openings around the base of these trees could be enlarged to reduce pressure being caused by the tree root and the extent of structural damage.
