**Site Address:** No 9 Georges Place and Wash House

**Survey Date:** 23/01/2025

## Introduction

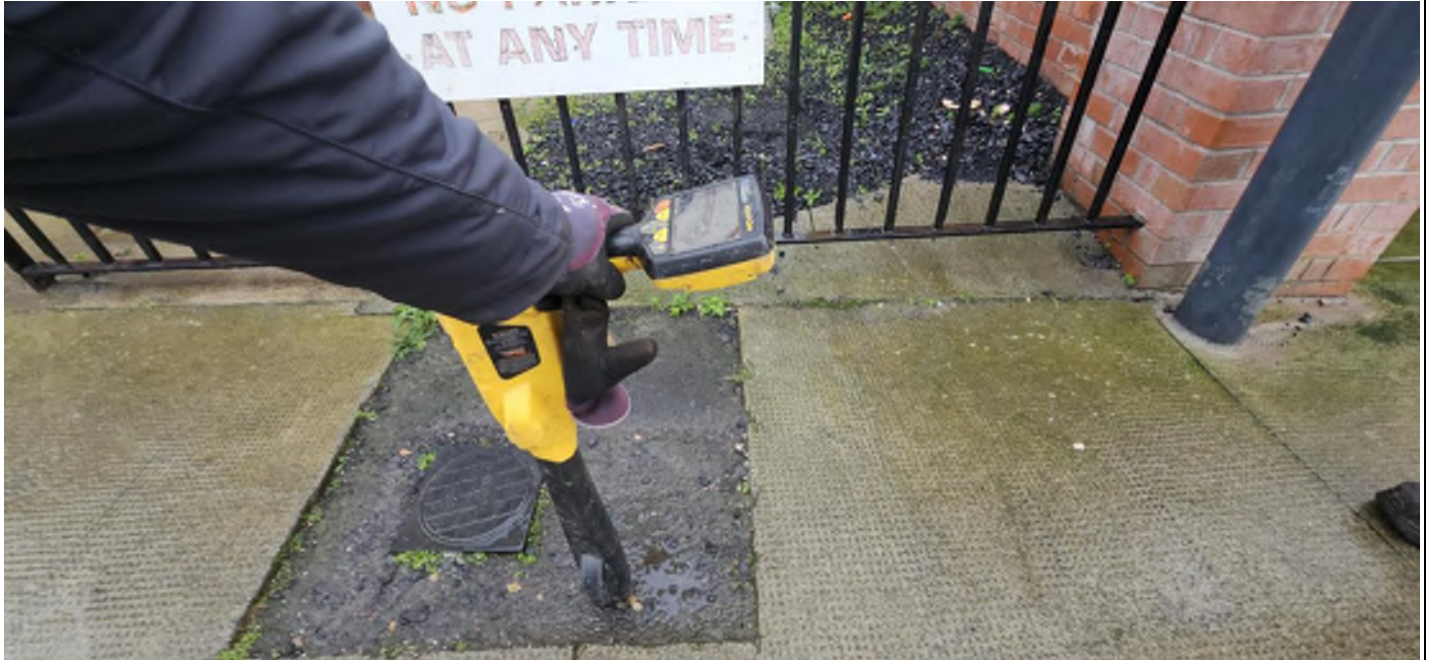
MBT Location

The MBT node point is located at a T-junction, showing a drainage line running along the right-hand side of the development.

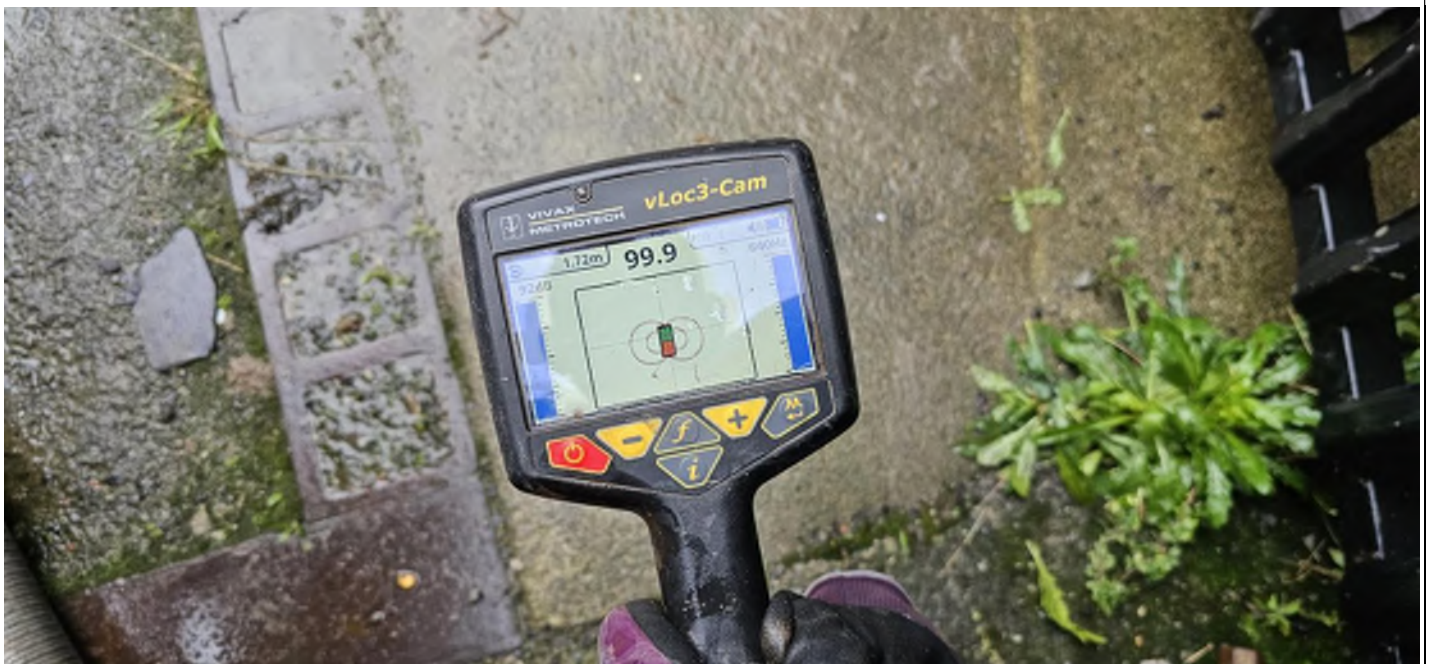
TR2 Location

The node point TR2 corresponds to a 100mm trap. However, there is no surface access to inspect this trap. It is suspected that it may be a surface water drain for the Weighbridge or a Buchan trap that was covered in the past.

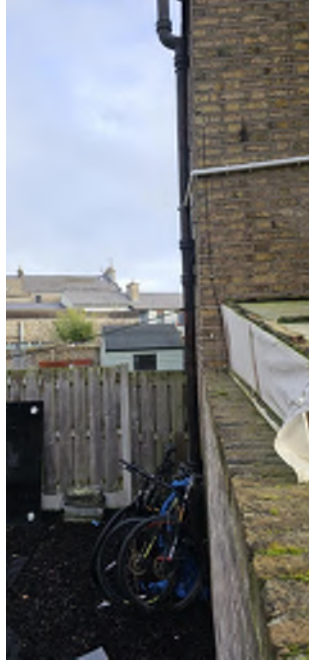
OFS Location

Upon conducting a CCTV inspection from the toilet referenced LWC, a solid obstruction was detected at a T-junction serving an external stack referenced OFS. To inspect this outfall line and remove the obstruction, an external chamber is required. Based on our assessment, we suspect that a chamber is buried in the garden of the new domestic development at the rear.

- Access is needed to the rear property to further investigate and resolve the obstruction.
- The suspected chamber must be excavated, as it is not visible from the surface.
- Additional surveys using CCTV and sonde detection will confirm the drainage route.

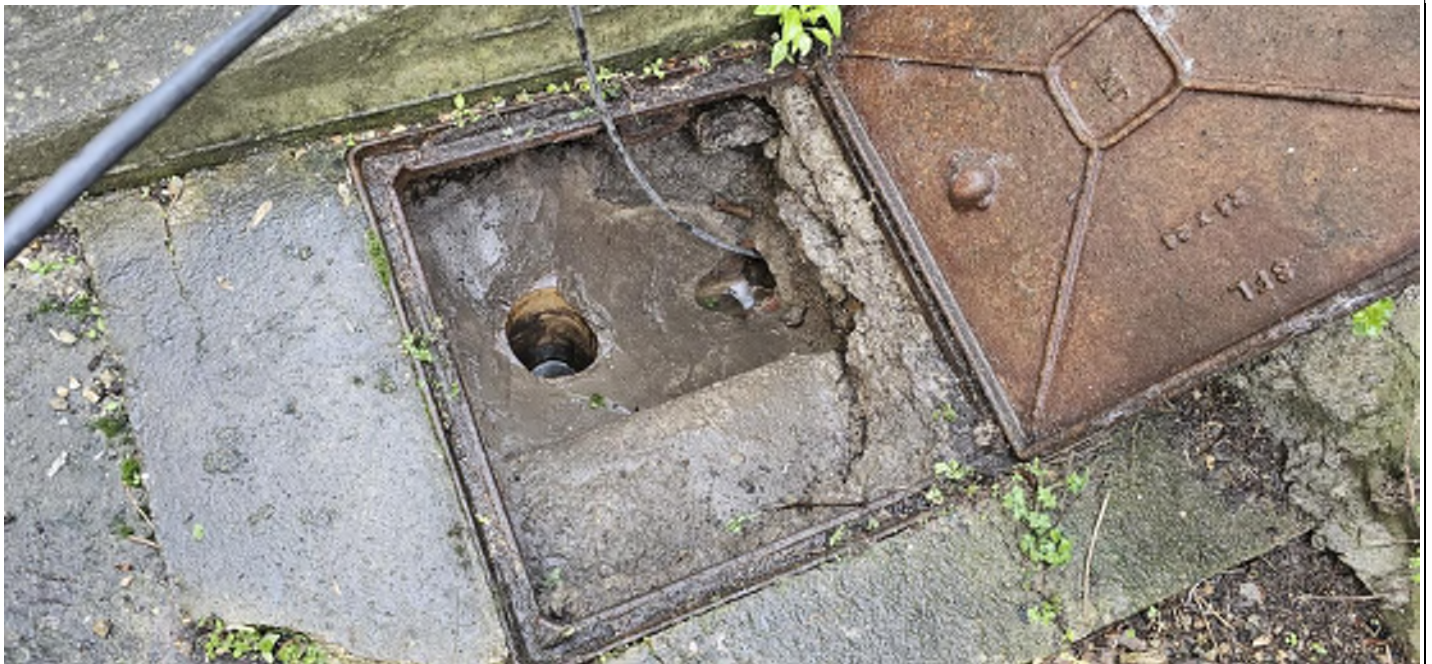
BTMH Internal

The BTMH node point corresponds to a manhole chamber. Inside this chamber, a deconstructed Buchan trap was found. It appears that the trap was previously broken down to remove a blockage, but its current condition has left it completely defective.

The defective state of the trap allows rodents to bypass the barrier, leading to burrowing within the chamber and contributing to structural instability.

- Excavating and removing the existing outfall chamber BTMH.
- Installing a new PVC outfall line fitted with a mechanical rat flap to prevent rodent access.
- Securing the new pipe with fiberglass resin lining for a seamless and structurally sound transition from PVC to clay.

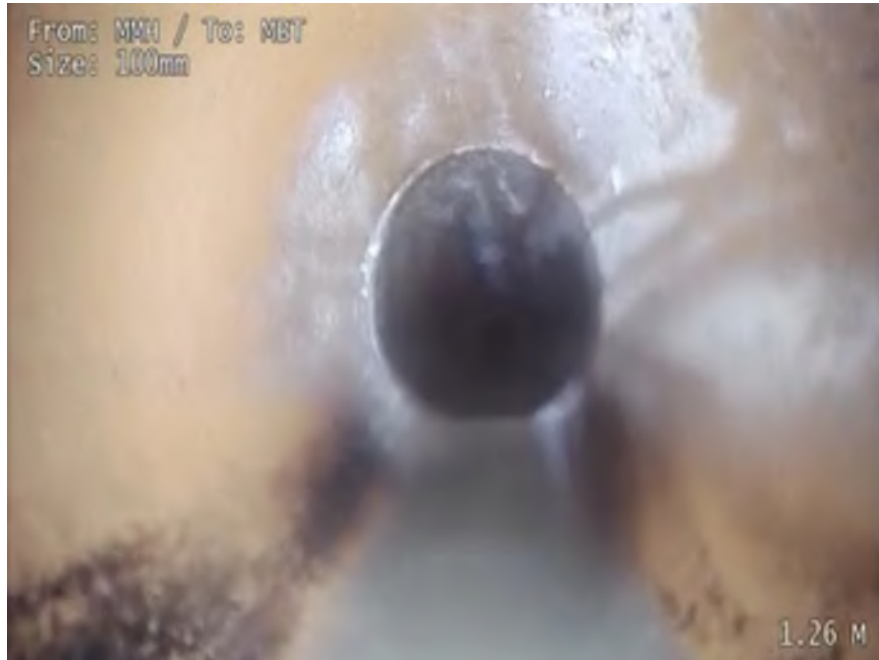
S1C3

00:00:14 - 1.26 m  
Joint displaced 10mm

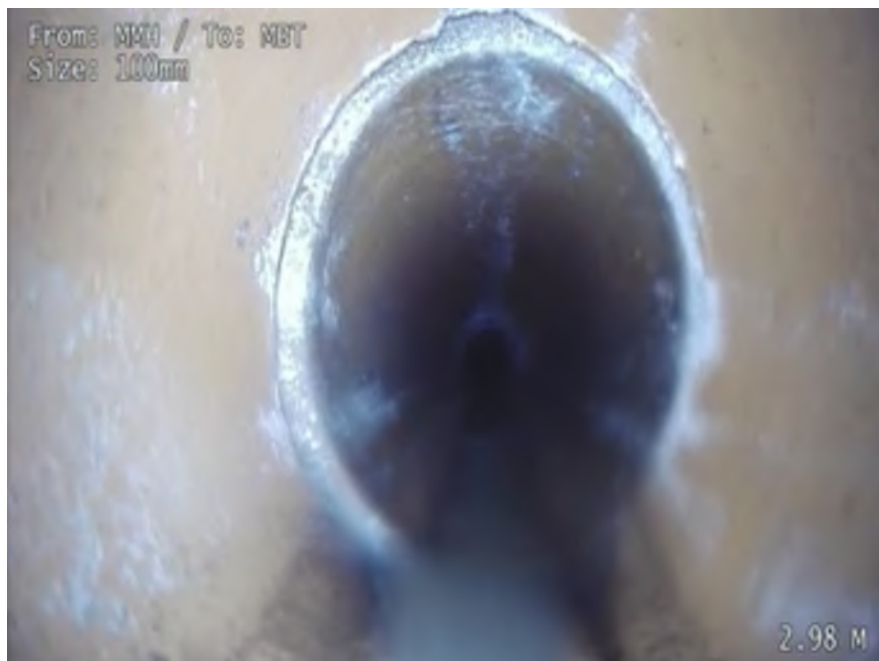
S1C4

00:00:22 - 2.98 m  
Open joint 5mm

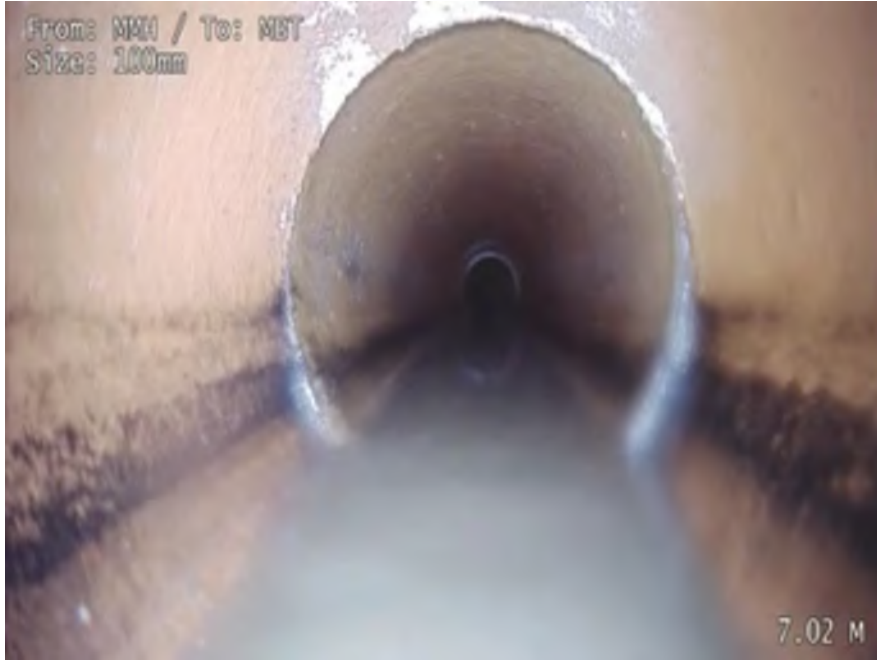
S1C5

00:00:35 - 7.02 m  
Joint displaced 10mm

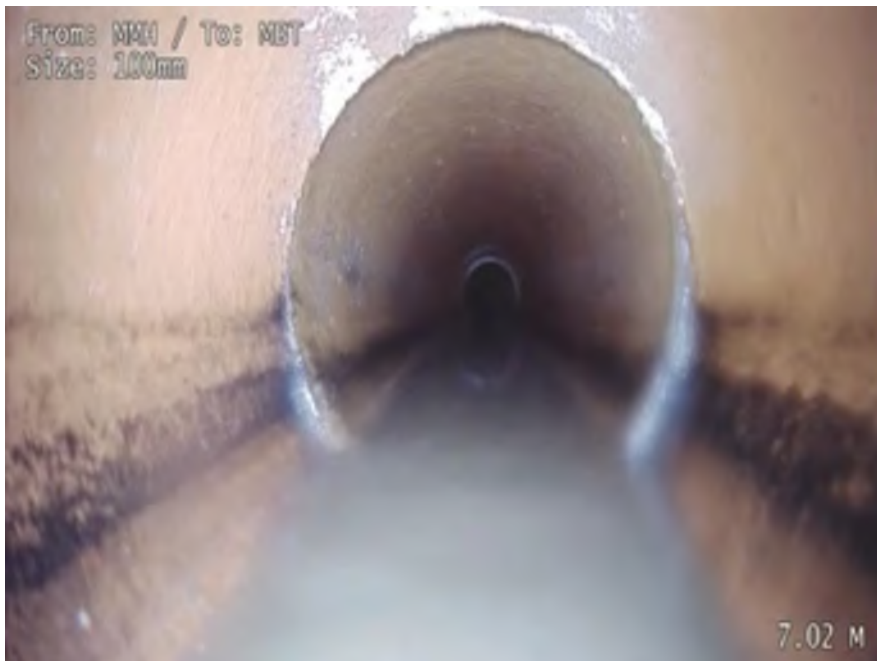
S1C6

00:00:35 - 7.02 m  
Deformed vertically 5% - Remark: line dipped, waste water retention observed

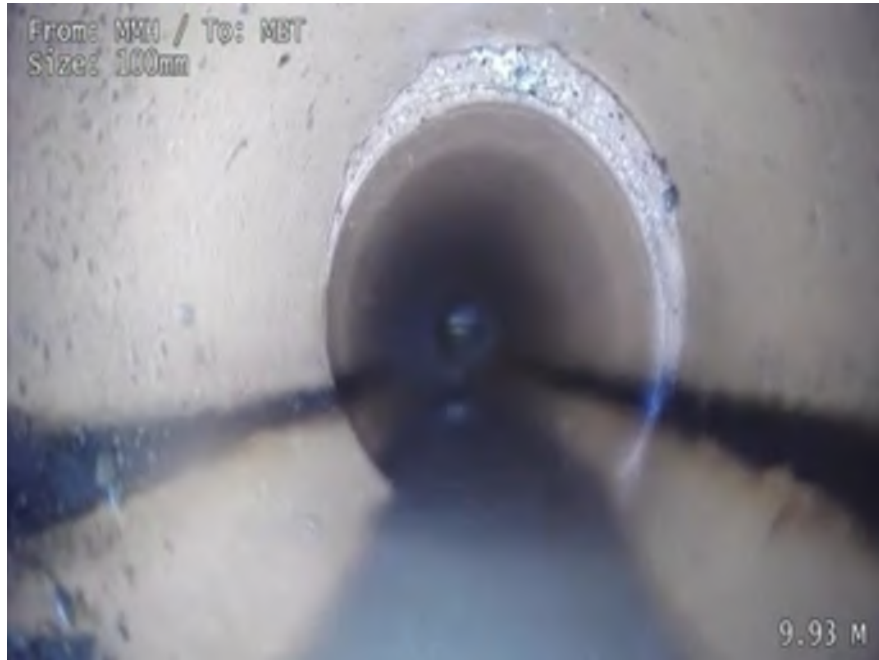
S1C7

00:00:48 - 9.93 m  
Joint displaced 10mm

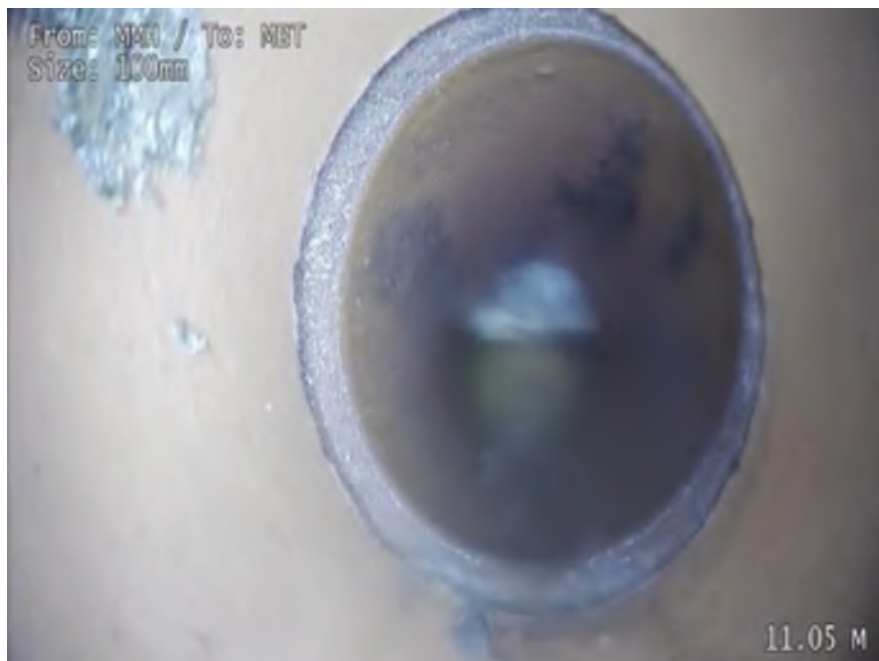
S1C8

00:00:55 - 11.05 m  
Open joint 10mm

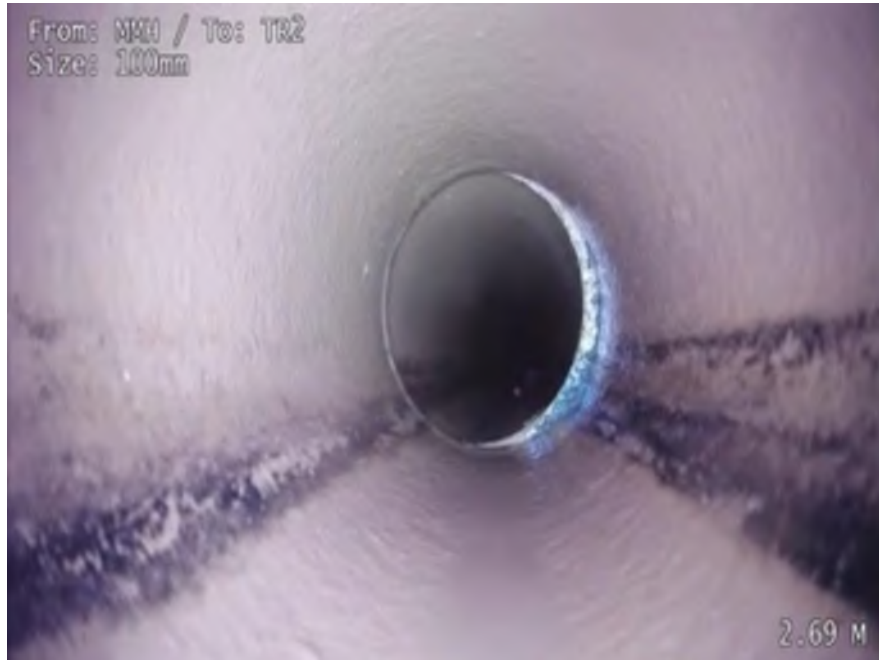
S2C3

00:00:09 - 2.69 m  
Joint displaced 10mm

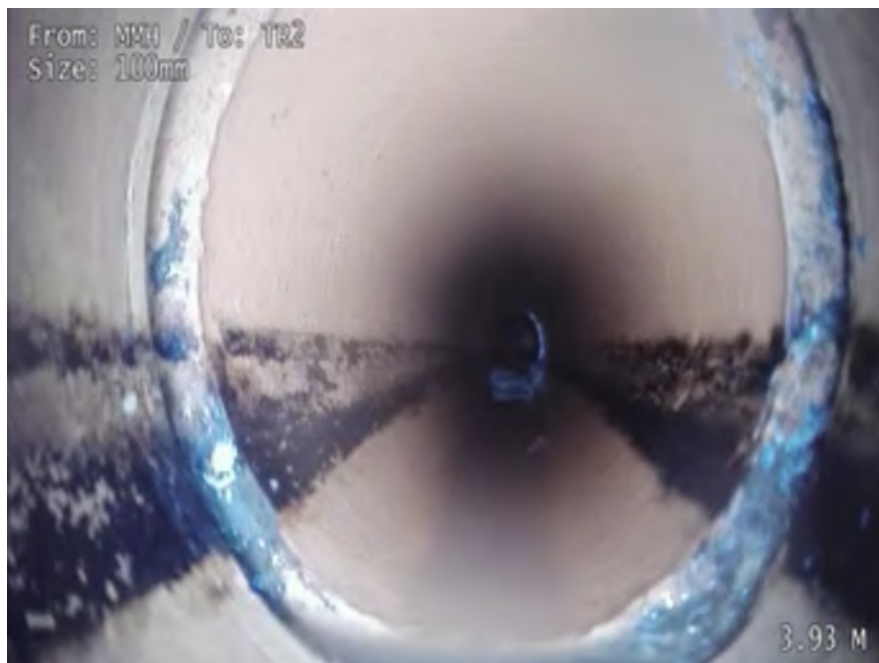
S2C4

00:00:12 - 3.93 m  
Open joint 10mm

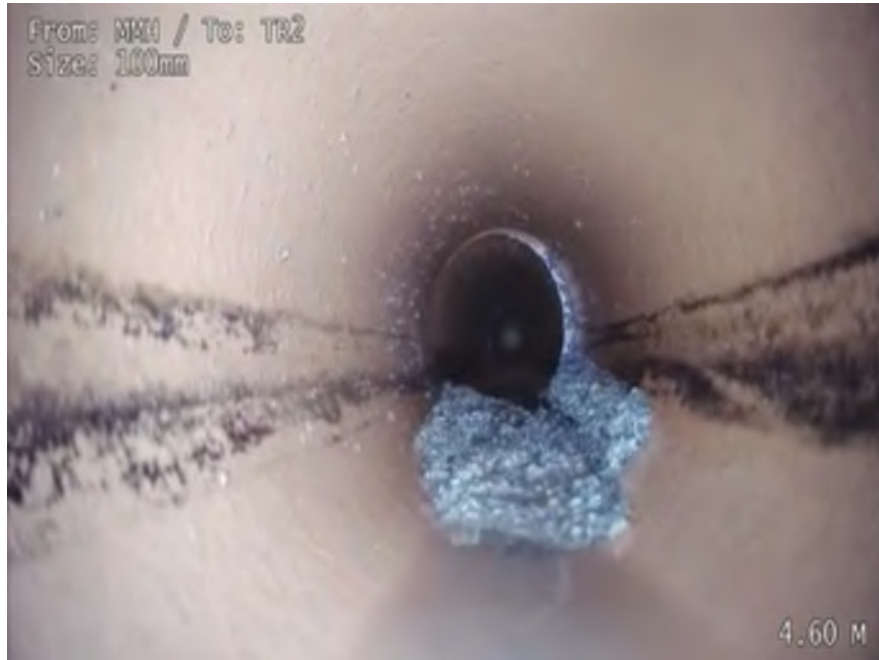
S2C5

Other attached deposits at 6 o'clock 10% cross-sectional area loss - Remark CONCRETE

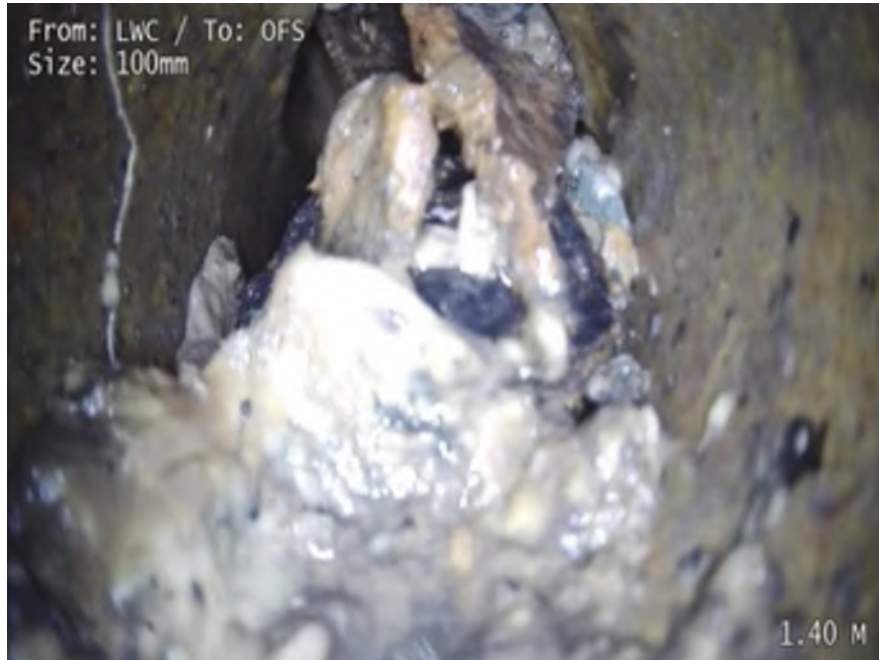
S4C5

Other obstacles, other at 12 o'clock 90% cross-sectional area loss - Remark: UNKNOWN OBSTICLES PREVENTING SURVAY

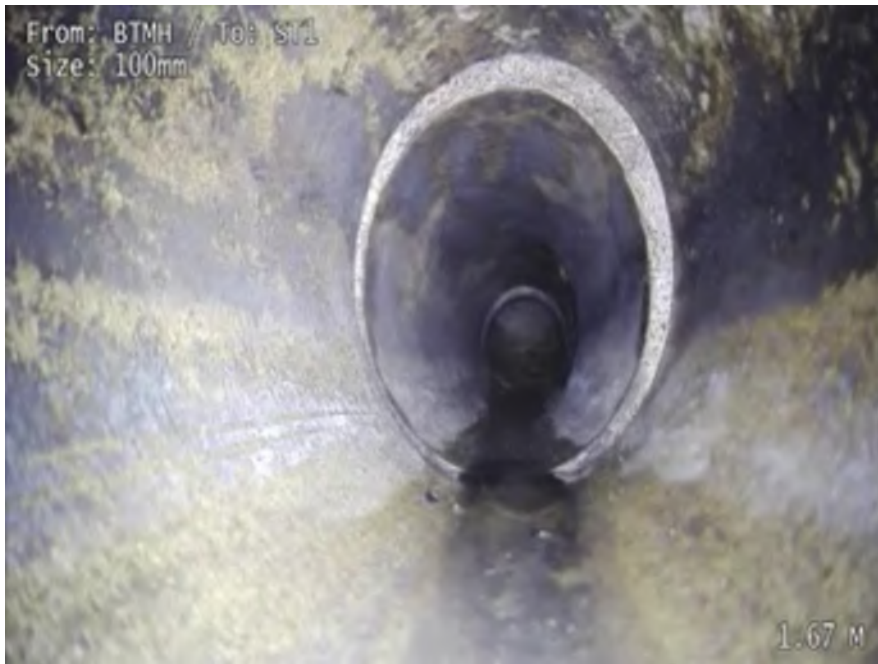
S5C3

00:00:08 - 1.67 m  
Joint displaced 10mm

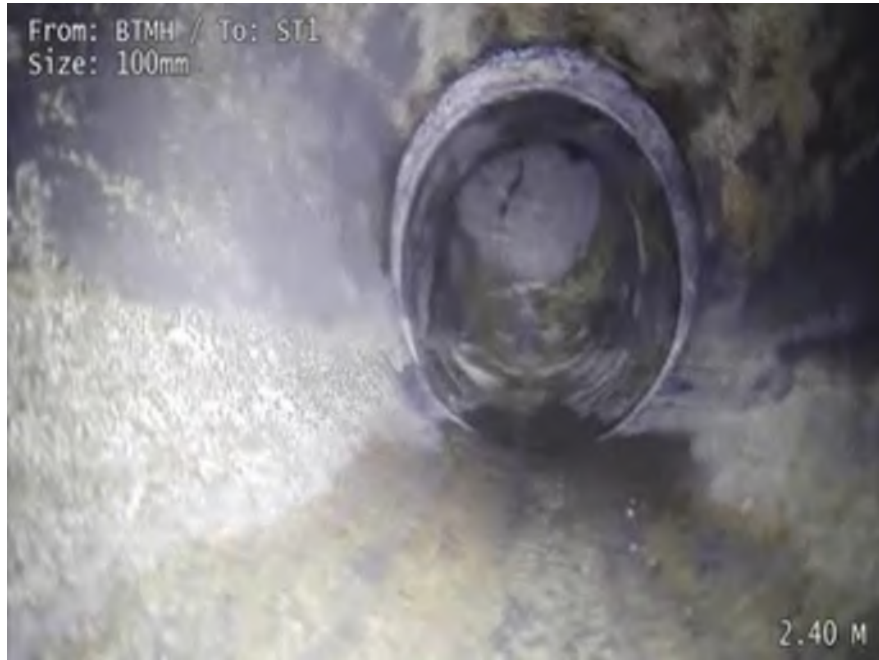
S5C4

00:00:18 - 2.40 m  
Joint displaced 10mm

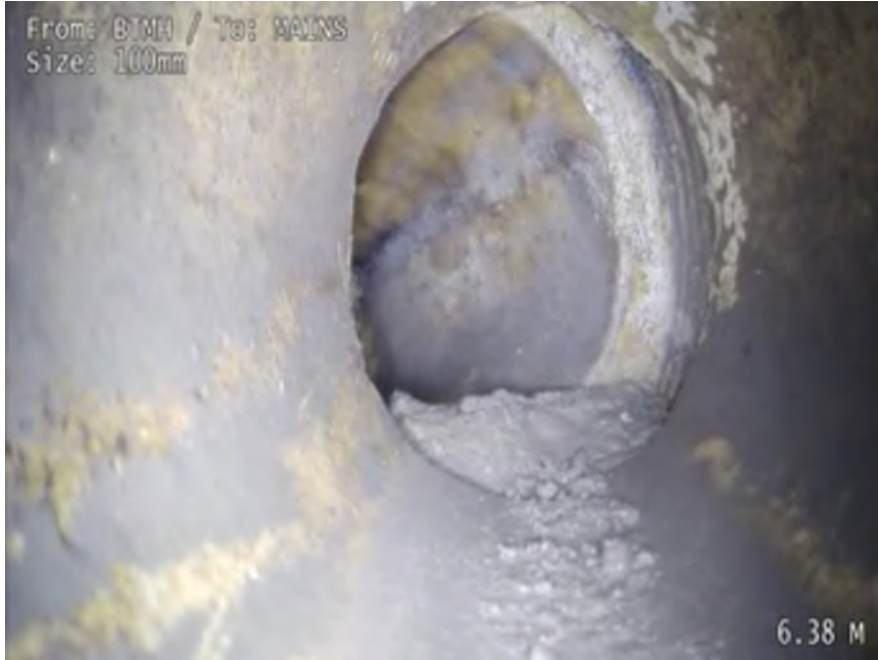
S6C3

00:00:24 - 6.38 m  
Joint displaced 15mm
