Renovation and extension of No. 9 George's Place and the former Wash House, Kelly's Avenue, Dún Laoghaire

10th February 2025

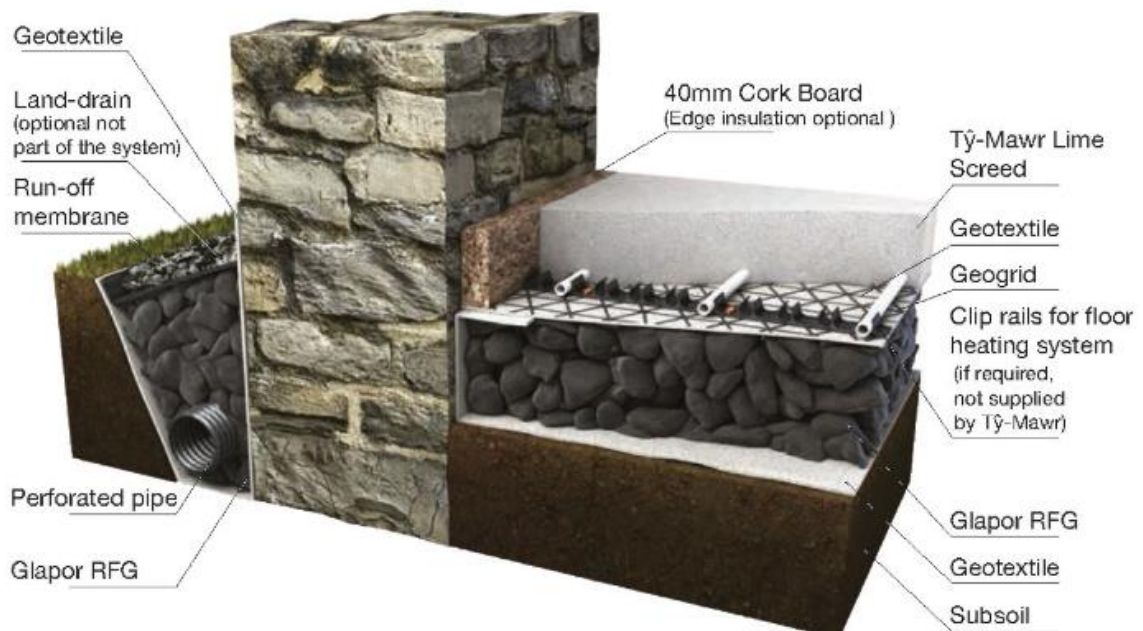
Figure 1. Example of 'breathable' limecrete floor

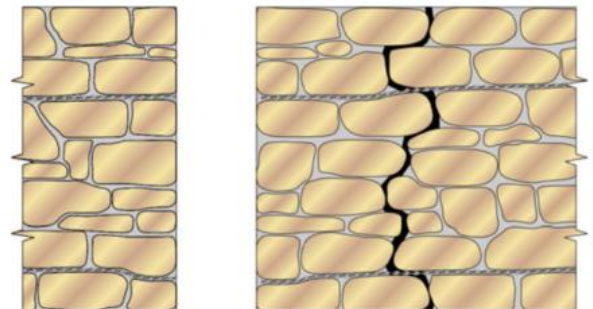
N.B. Pointing may be carried out as soon as is convenient after the HeliBond has started to gel.

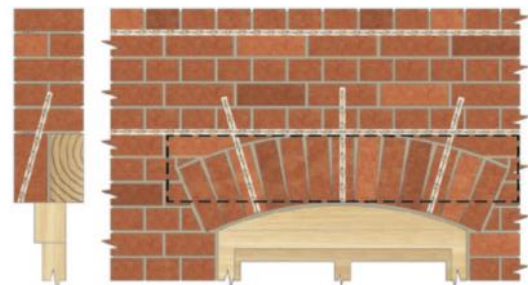
14. Wind the CemTie into the nozzle and ensure that it is fully covered in grout.
15. Insert the nozzle to the full depth of the drilled hole and pump the CemTie and grout.
16. Make good the CemTie holes and point up the remaining slots with a suitable matching mortar. Make good the cracks with an appropriate Helifix bonding agent depending on the width of the crack.
17. Clean tools with clean, fresh water.

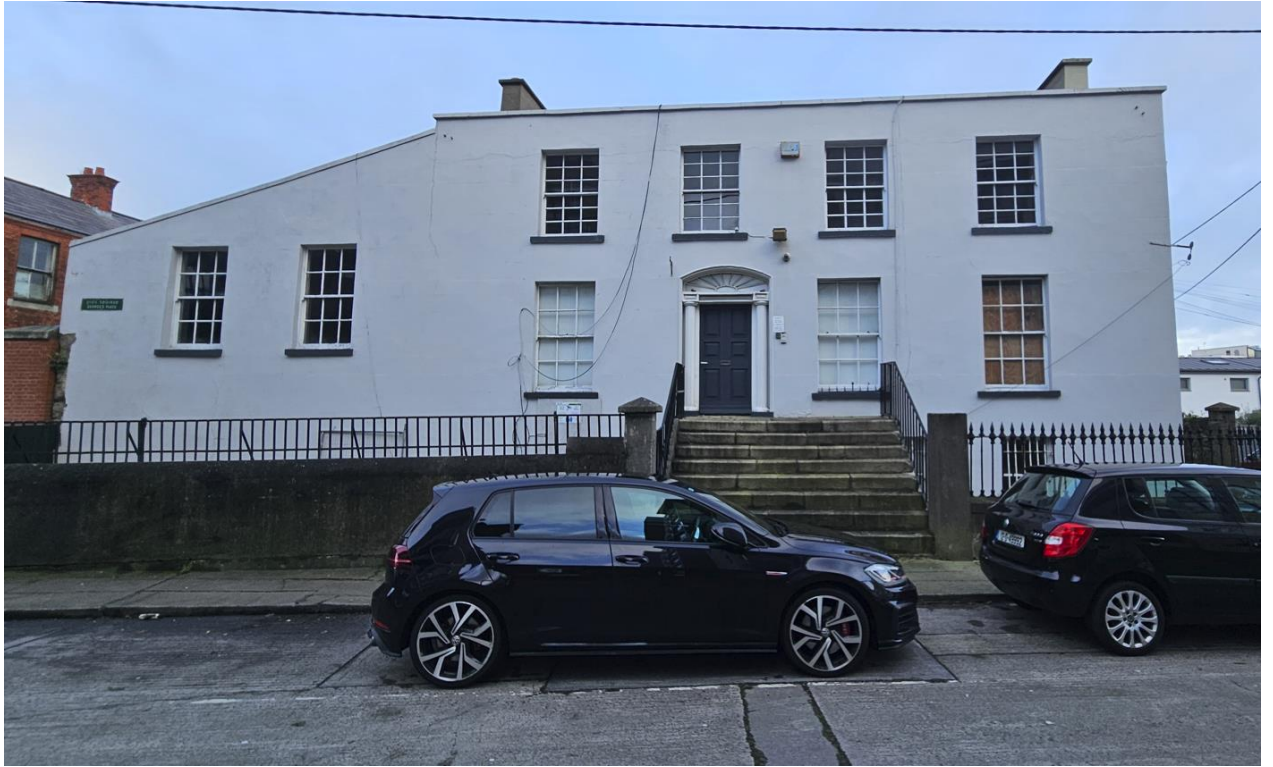
Image 1. View of front facade of No. 9 (south-west facing)

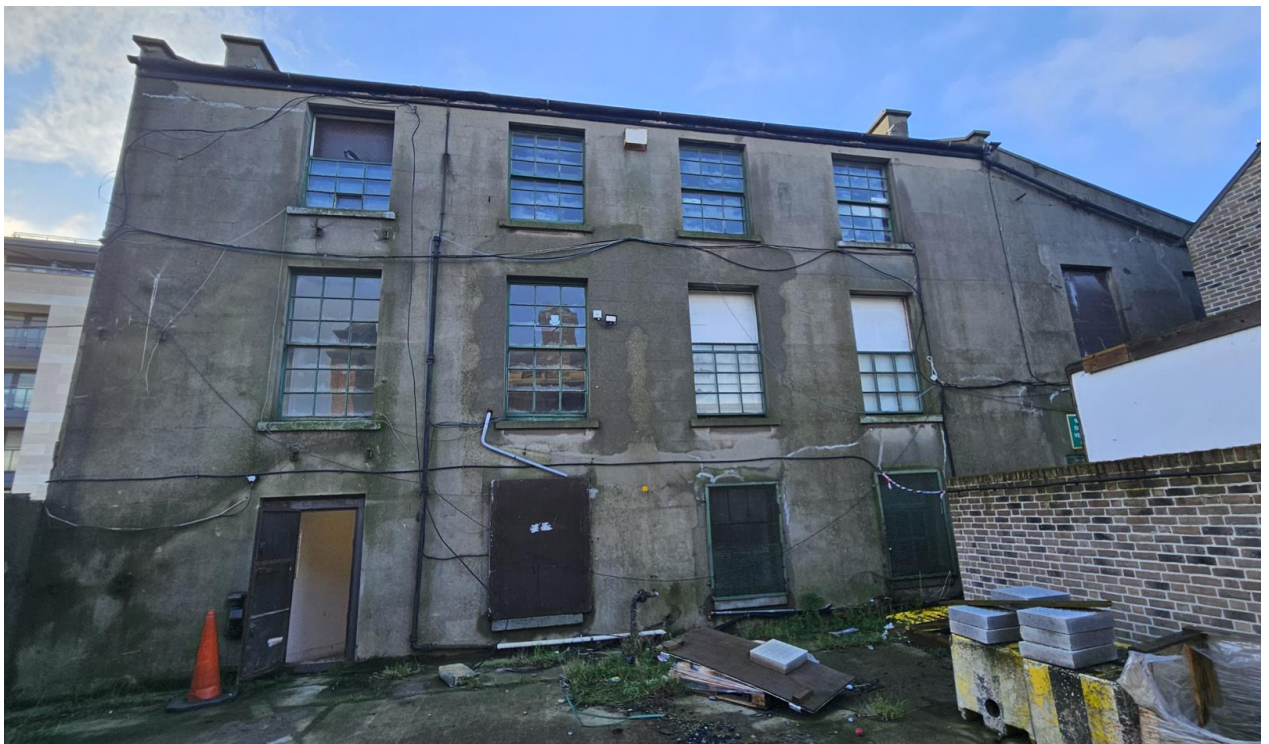
Image 4. View of side wall of No. 9 Georges Place (north-east facing). Note the missing down pipes, excessive redundant cables, various cracks to wall, algae staining to render

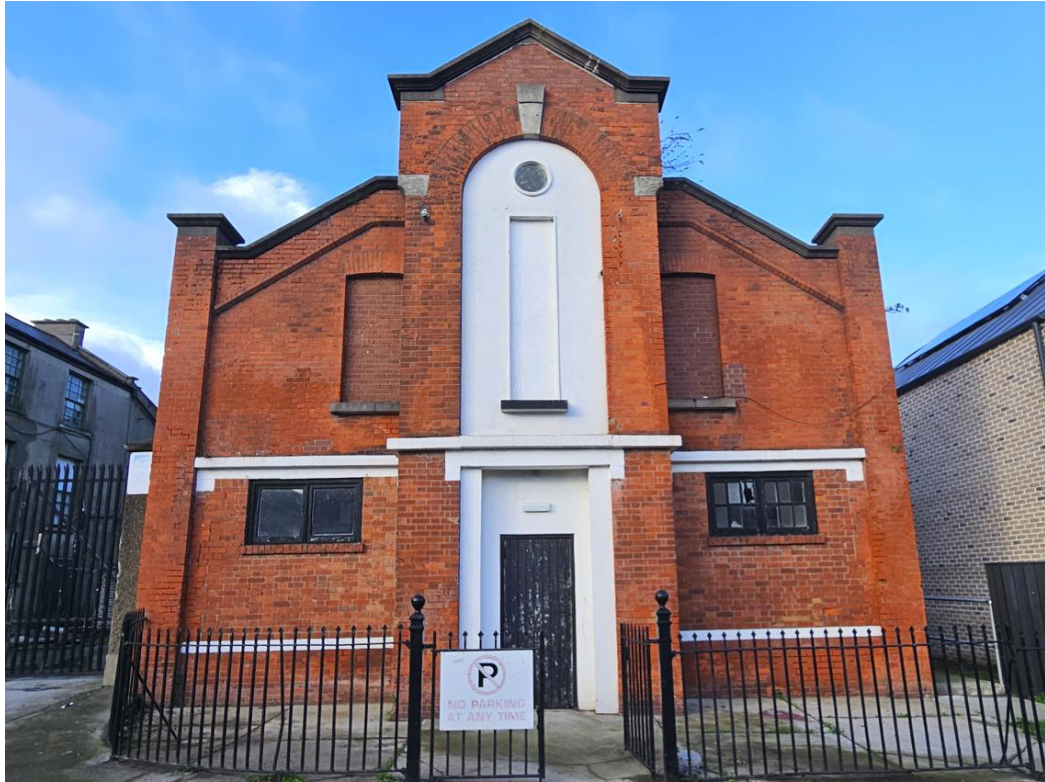
Image 5. View of front wall of the former Wash House building (south – east facing).
Vegetation growing at high level is visible

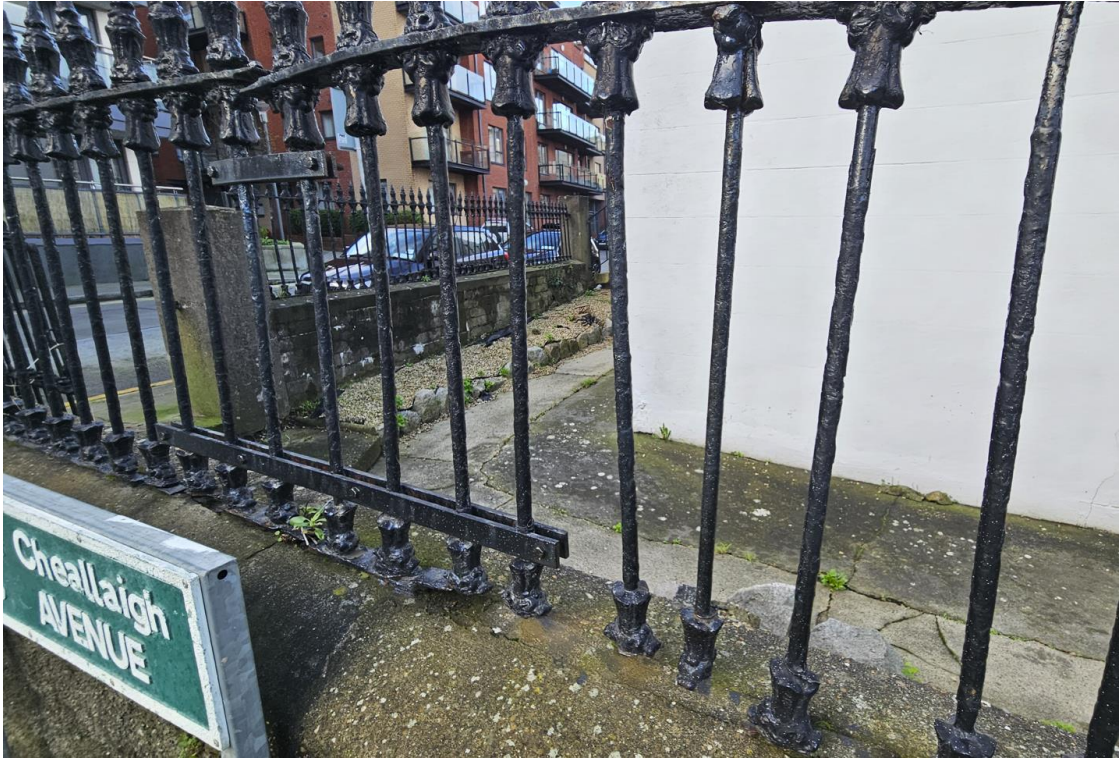
Image 9. Close up view of damaged railings requiring repair

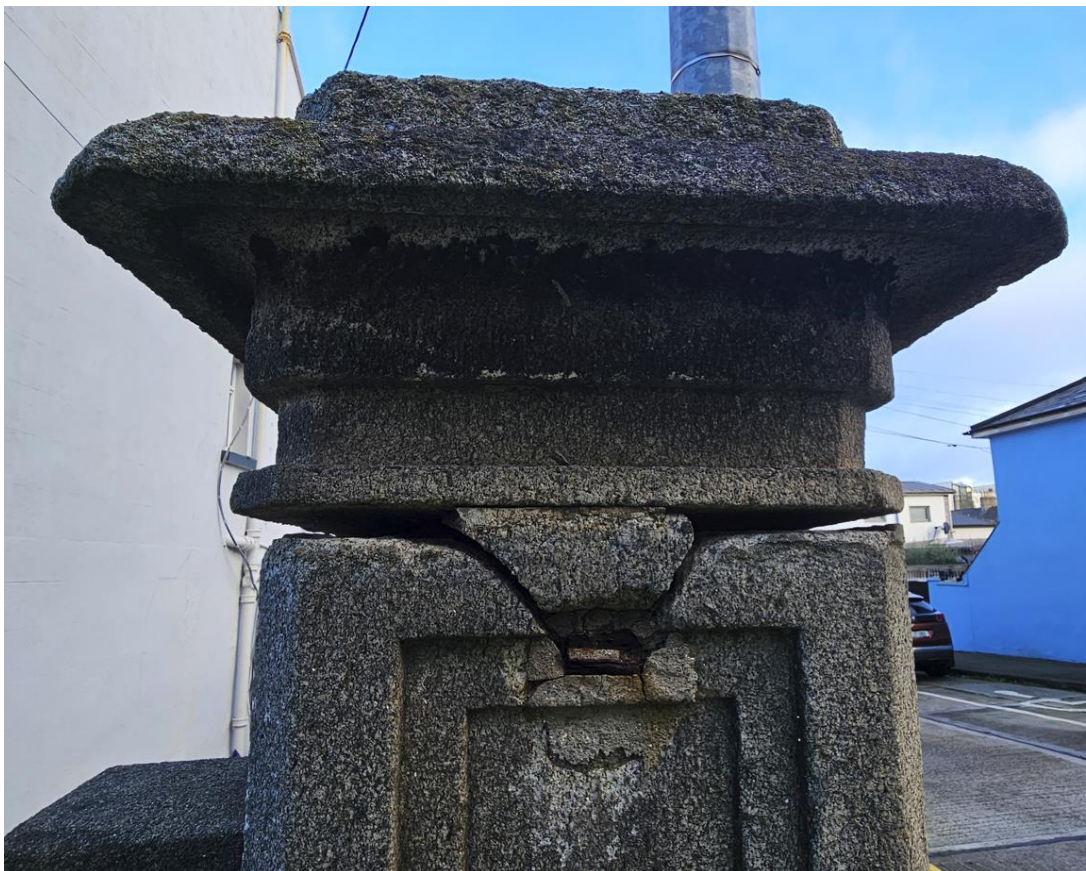
Image 10. Close up view of boundary corner stone pillar. Metal insert has corroded causing expansion and cracking and raising of stone cap

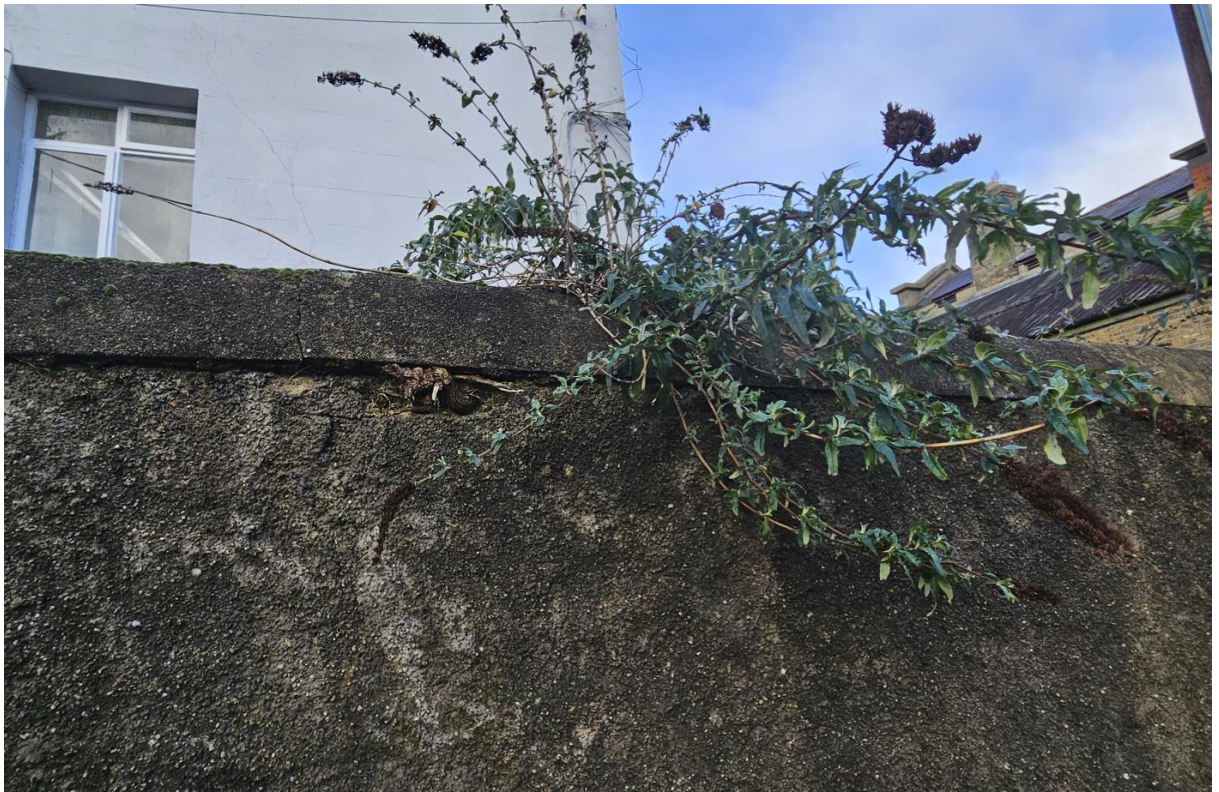
Image 11. Vegetation growth in boundary wall

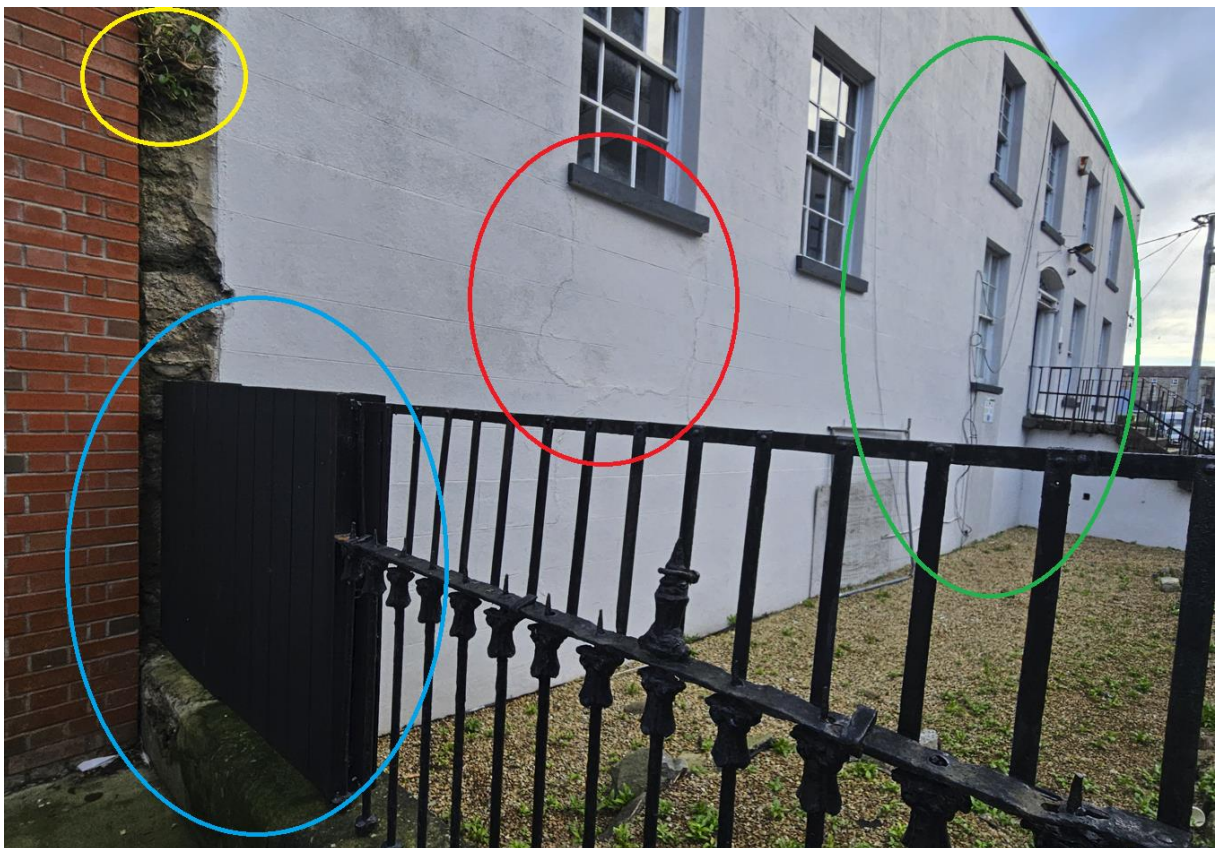
Image 12. Front elevation with vegetation growing from wall (yellow circle), cracking to wall (red circle), redundant cables hanging from building (green circle) and missing section of railing (blue circle)

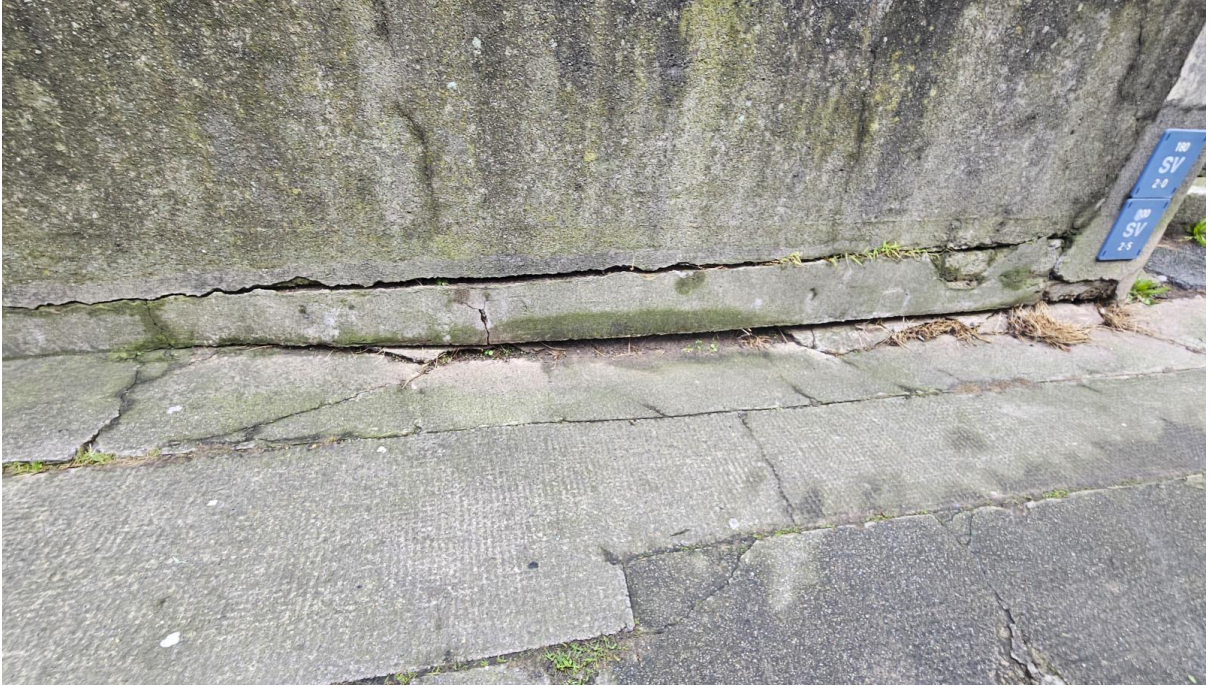
Image 13. Close up view of external front boundary wall. Cracking to base requires investigation

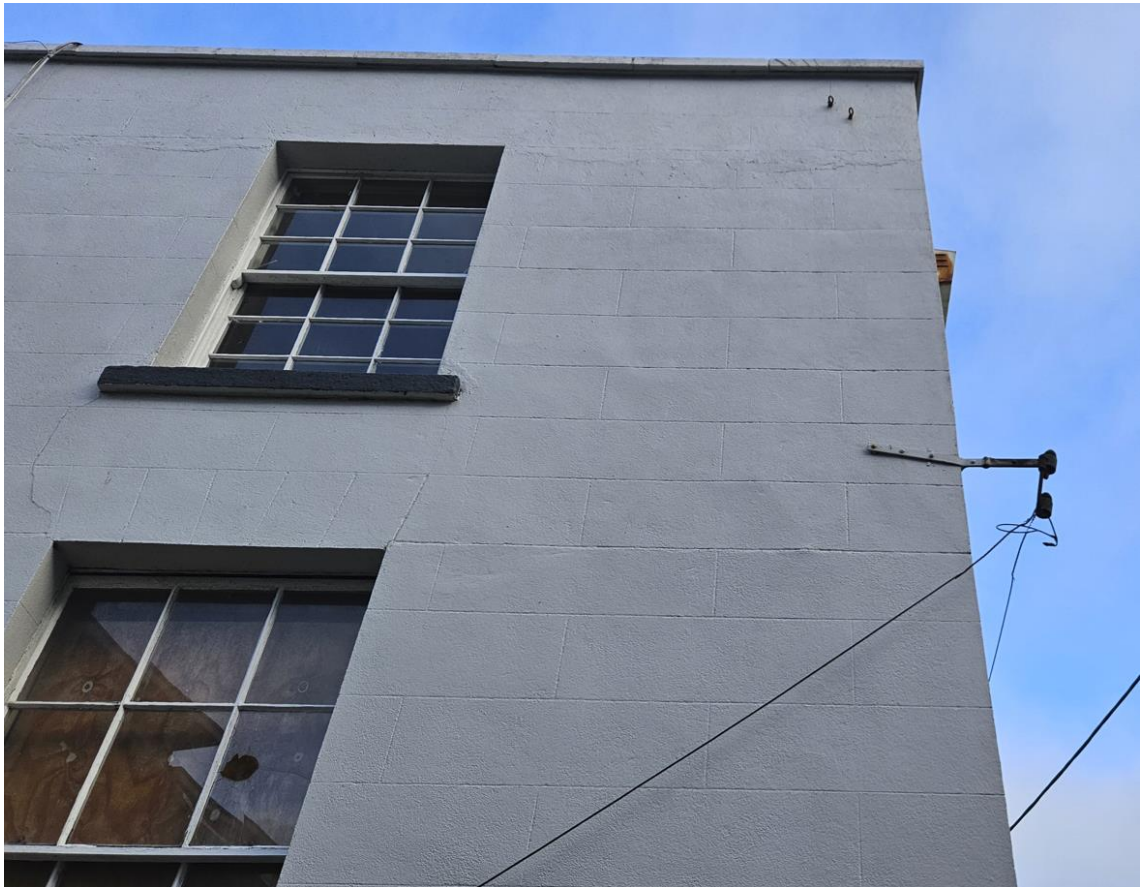
Image 14. External view of front elevation. Remove loose redundant cables and associated metals supports.

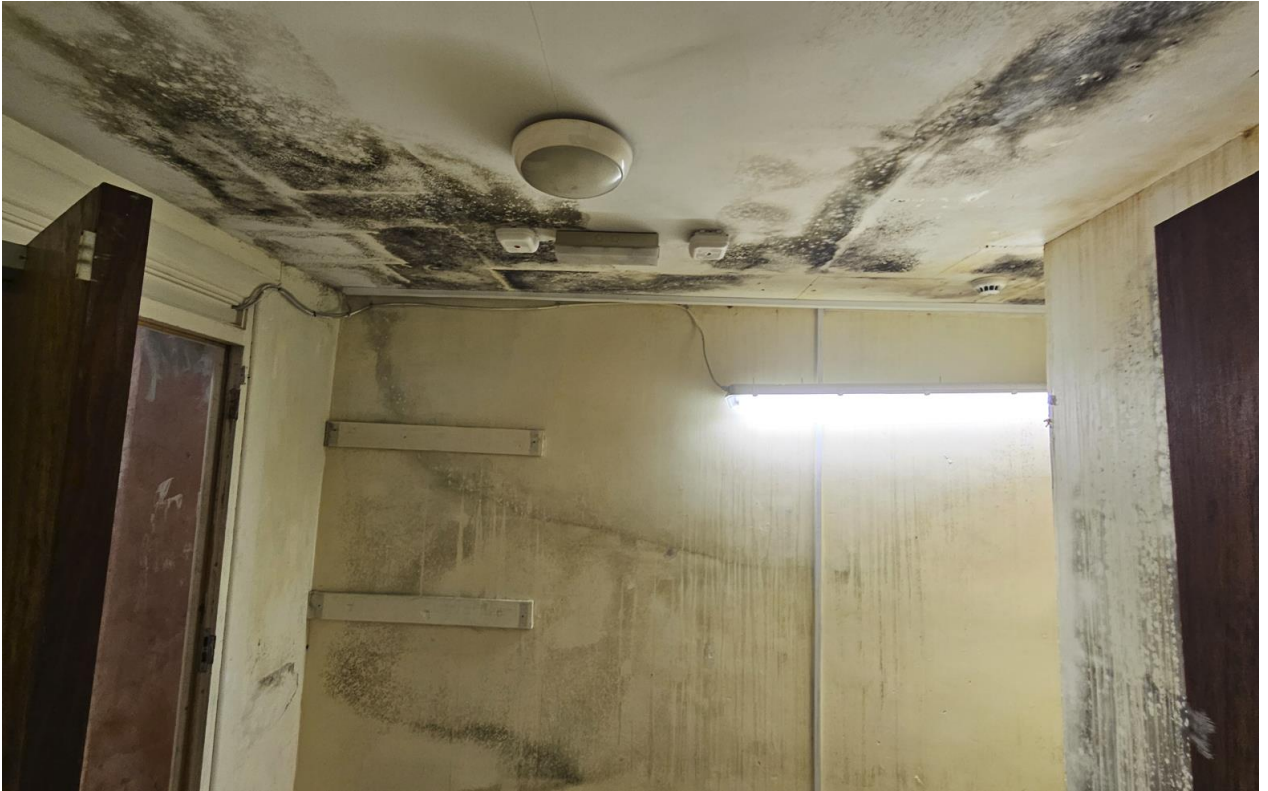
Image 15. Internal view of lower ground floor corridor. Signs of mould, algae, wet and water staining from roof leak three levels above.

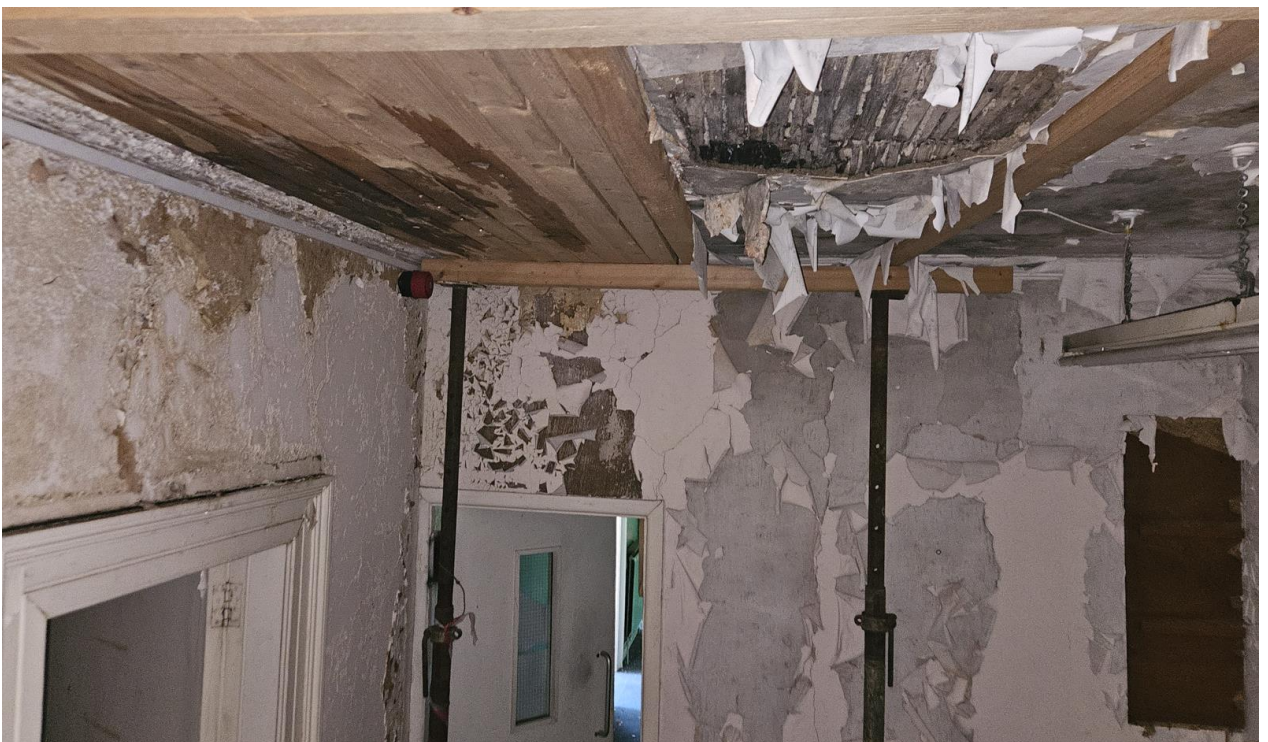
Image 16. Upper ground floor corridor ceiling has failed and is being support by temporary props and a timber deck.

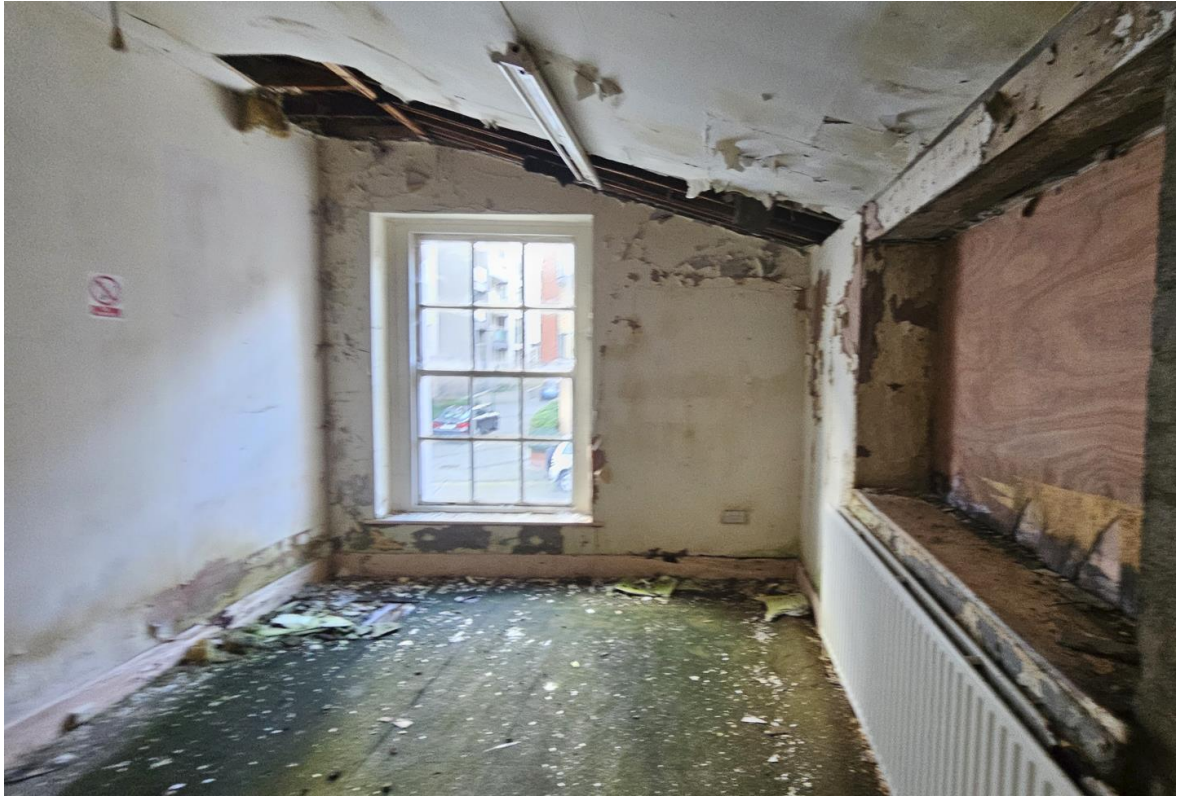
Image 17. Upper ground floor, side extension, northwest room. Roof, floor and walls damage caused by water ingress

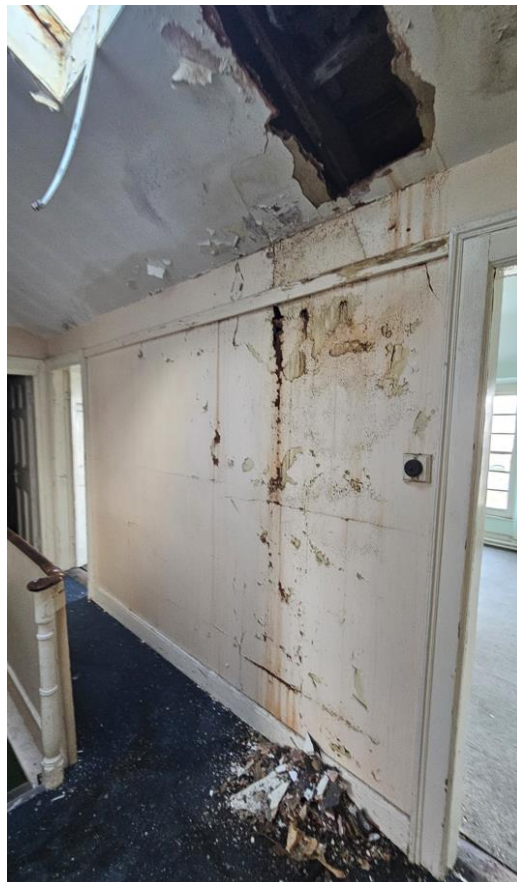
Image 18. First floor corridor spine wall, damage caused by roof leak

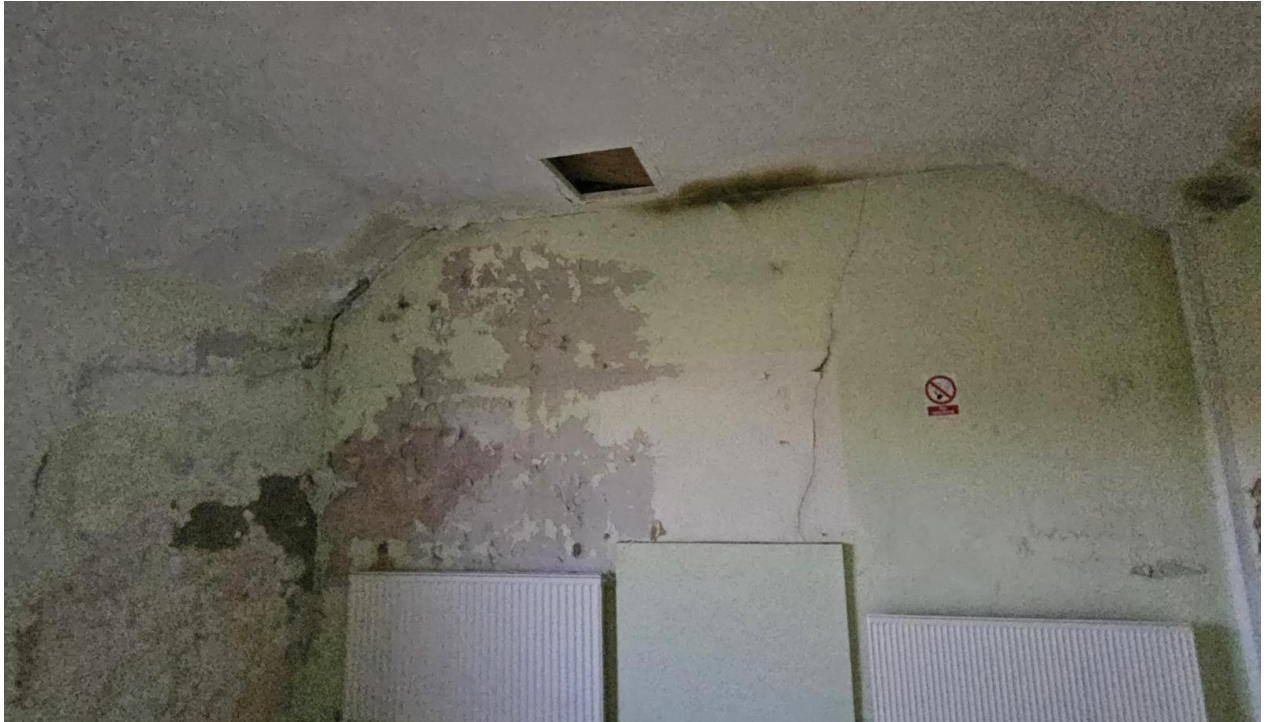
Image 19. First floor rear room masonry dividing wall. Damage caused by damp ingress and crack visible requiring repair

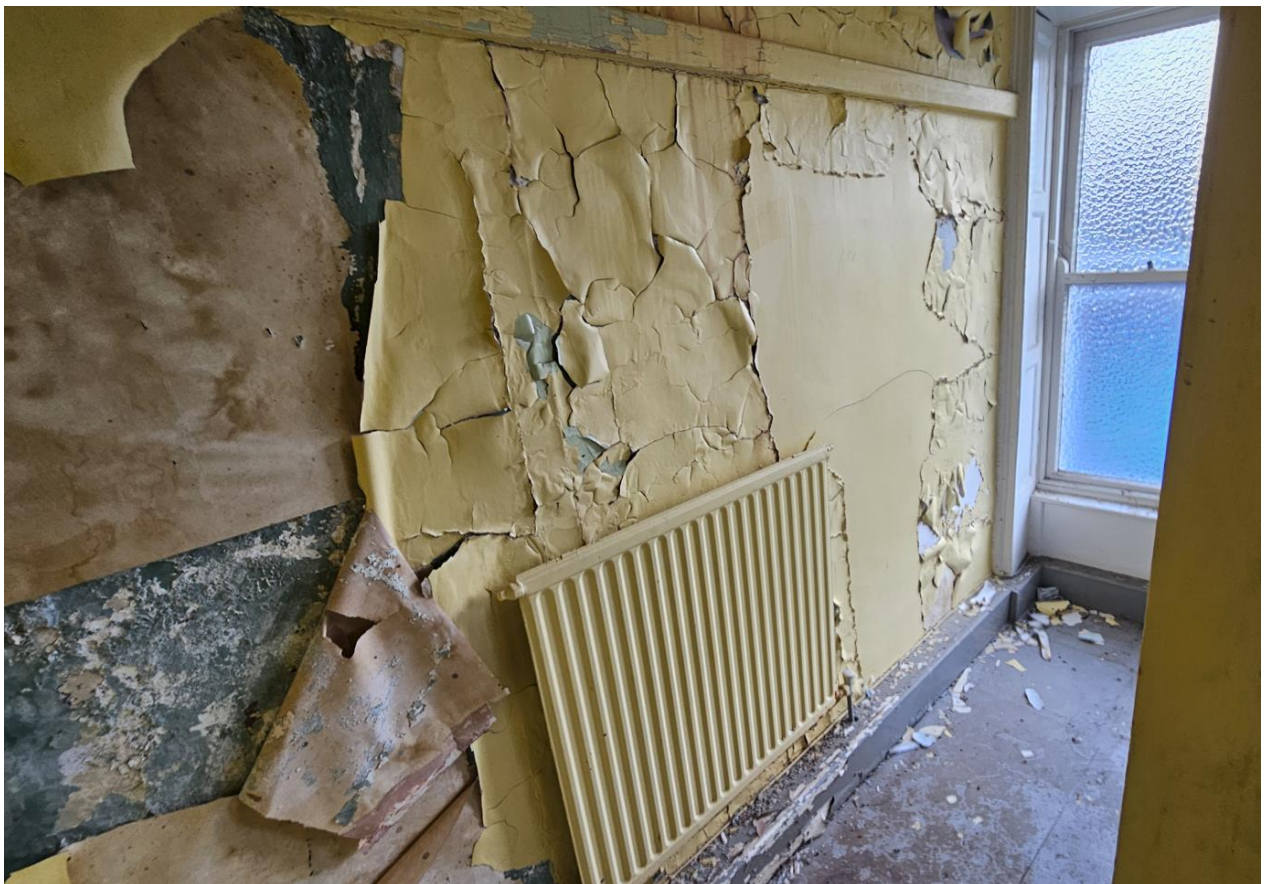
Image 20. First floor gable toilet room. Damage to plaster to internal wall

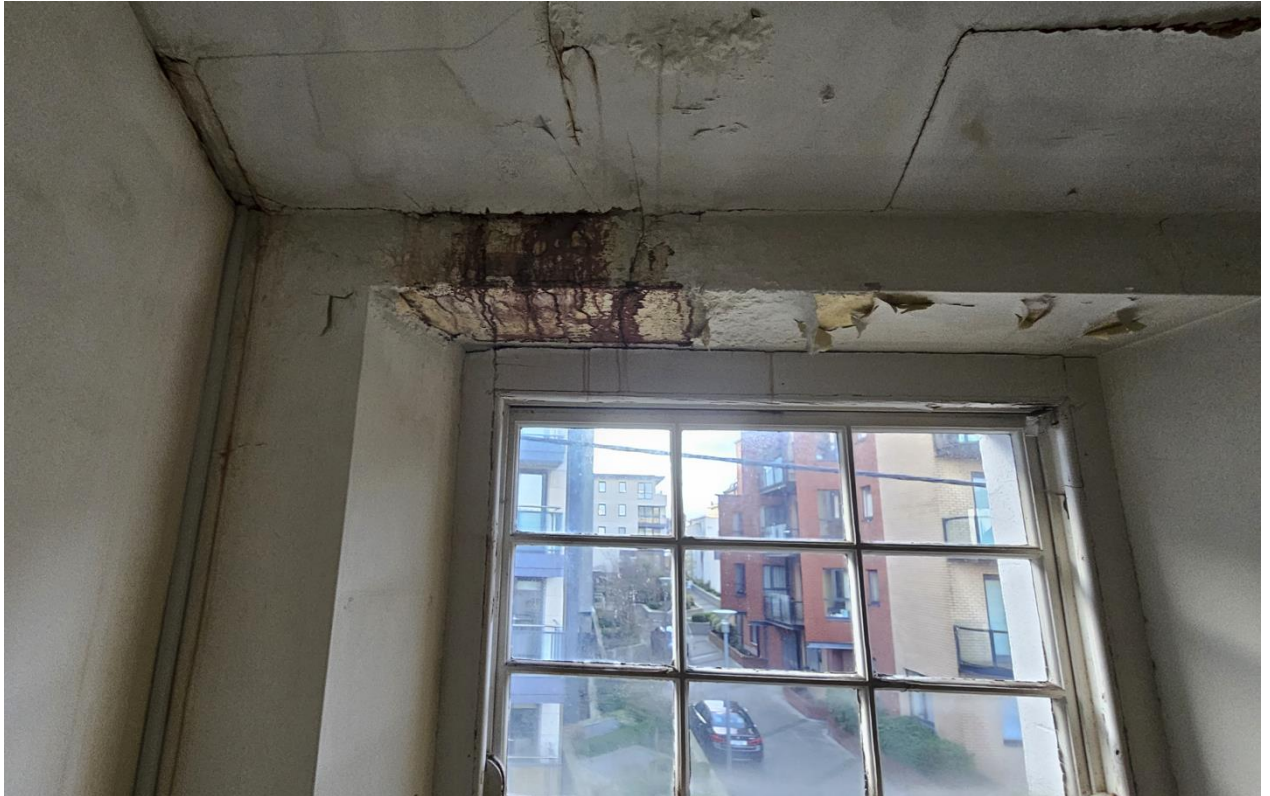
Image 21. First floor gable wall, evidence of damaged window lintel

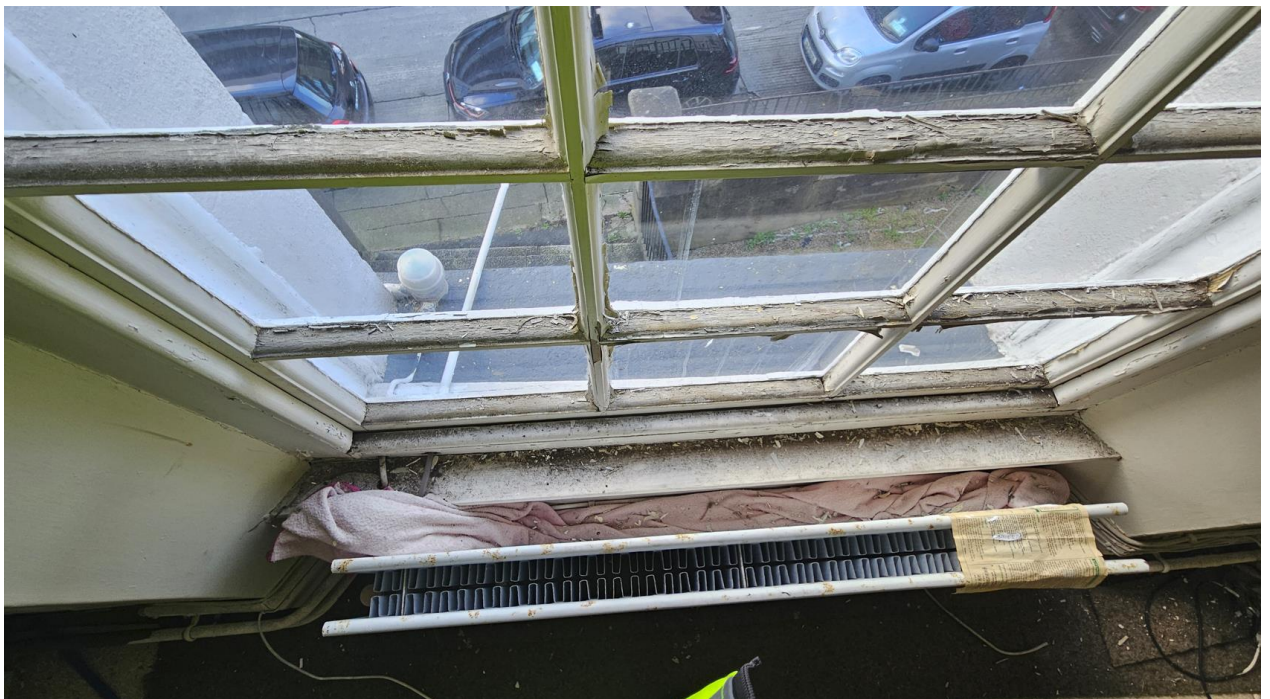
Image 22. Typical condition of timber windows. Requires refurbishment.

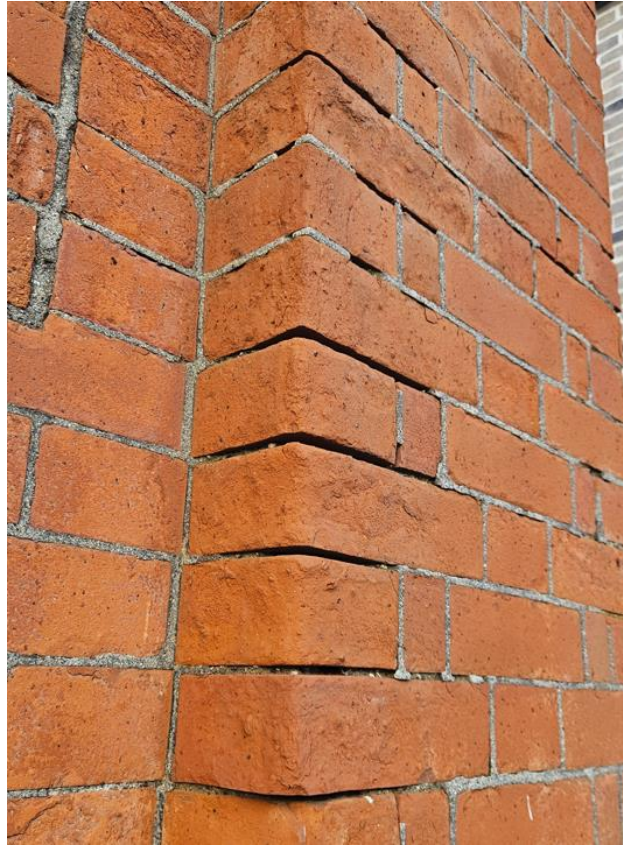
Image 23. Wash House building. Example of washed-out mortar joints

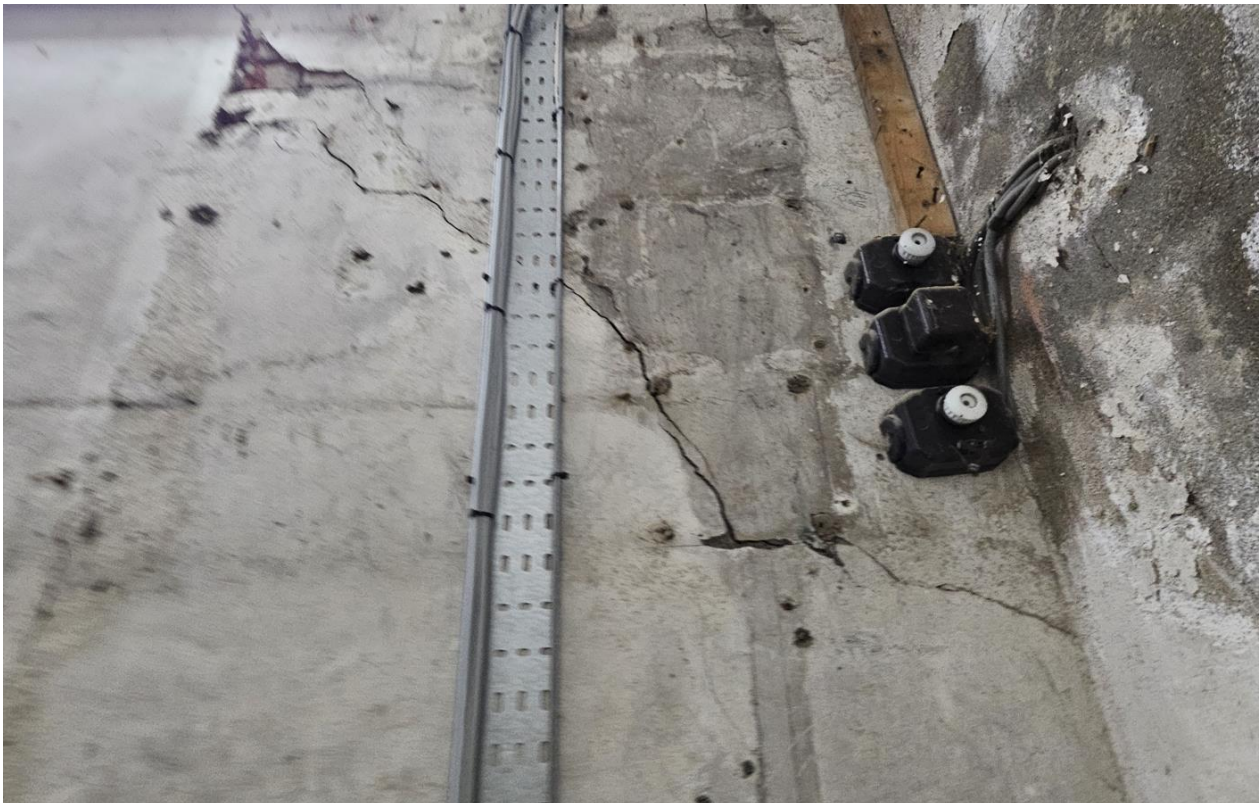
Image 24. Wash House building. Example of cracking to internal walls requiring repair

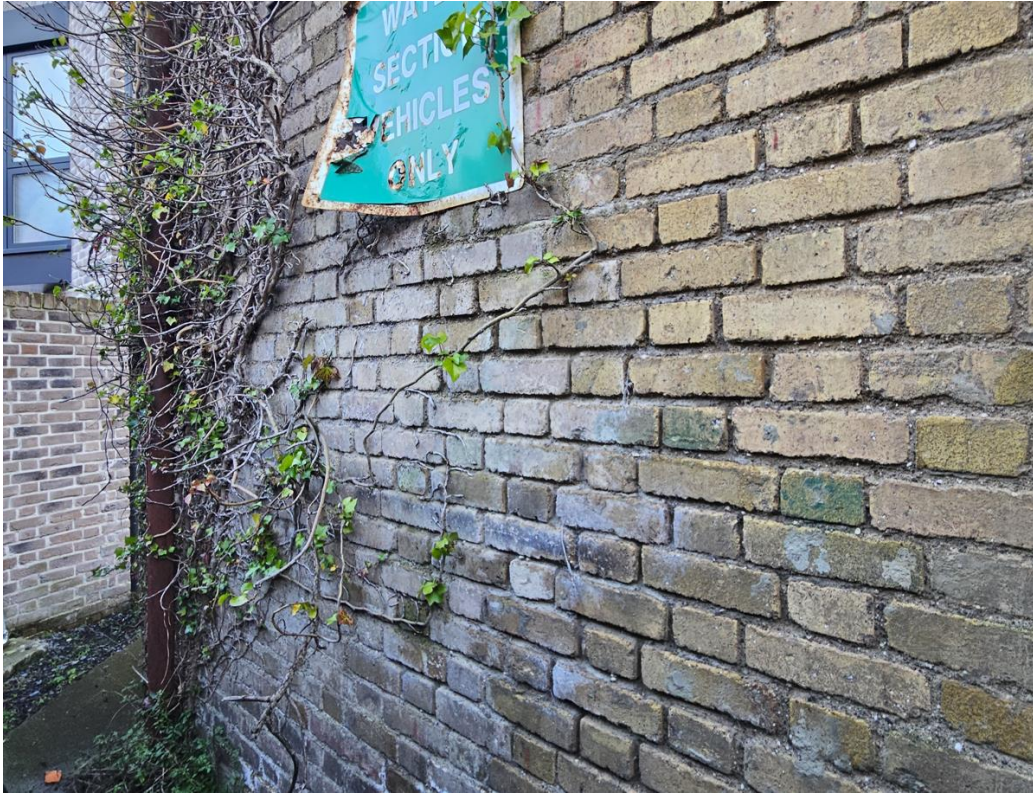
Image 25. Wash House building. Example of washed-out mortar joints

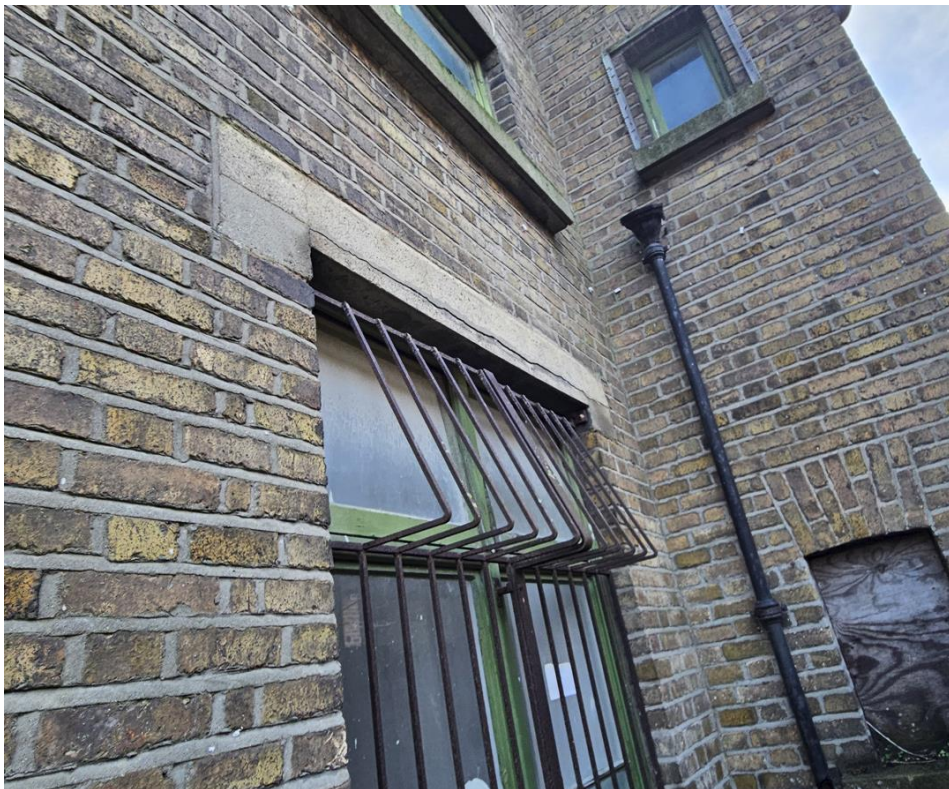
Image 26. Wash House building. Example of cracked/ debonded concrete window cill

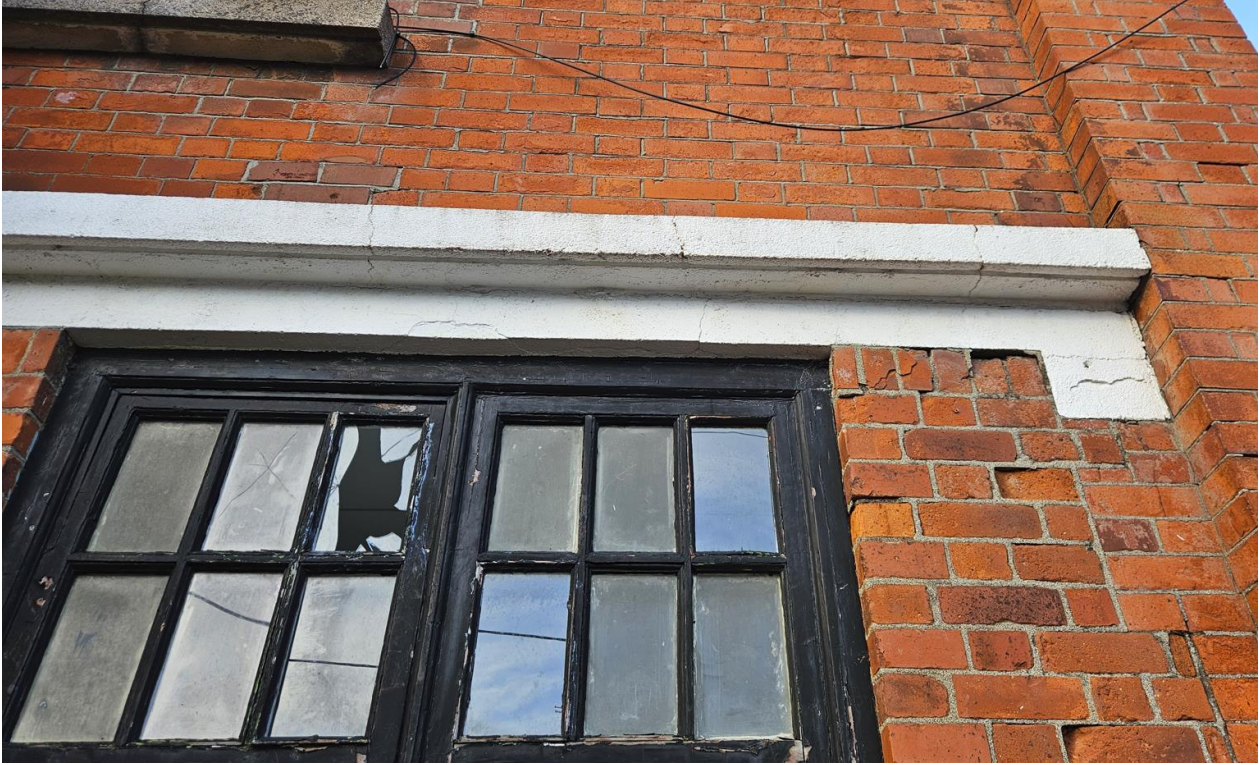
Image 27. Wash House building. Example of cracked/ debonded concrete window cill

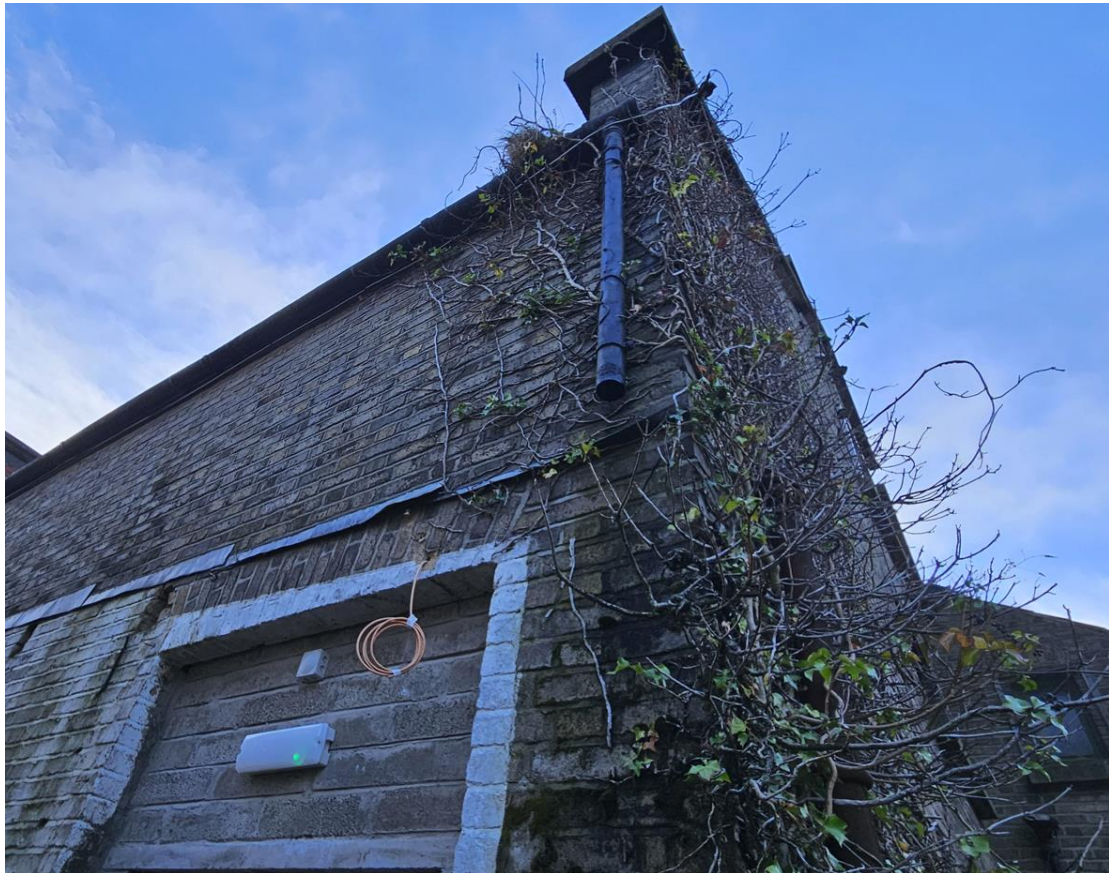
Image 28. Wash House building. Missing section of down pipe and vegetation growth causing damp issues internally
