Renovation and extension of No. 9 George's Place and the former Wash House, Kelly's Avenue, Dún Laoghaire

10th February 2025

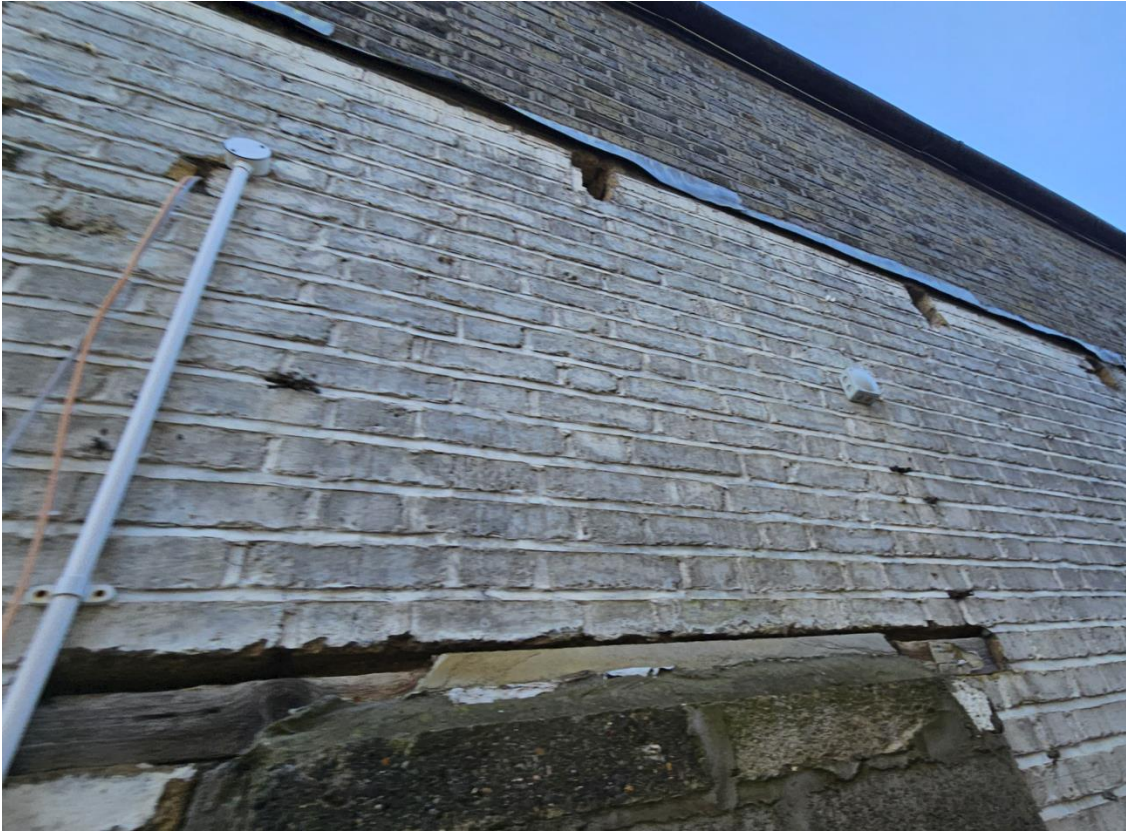
Image 29. Wash House building. Exposed timber lintels and high level holes in external wall.

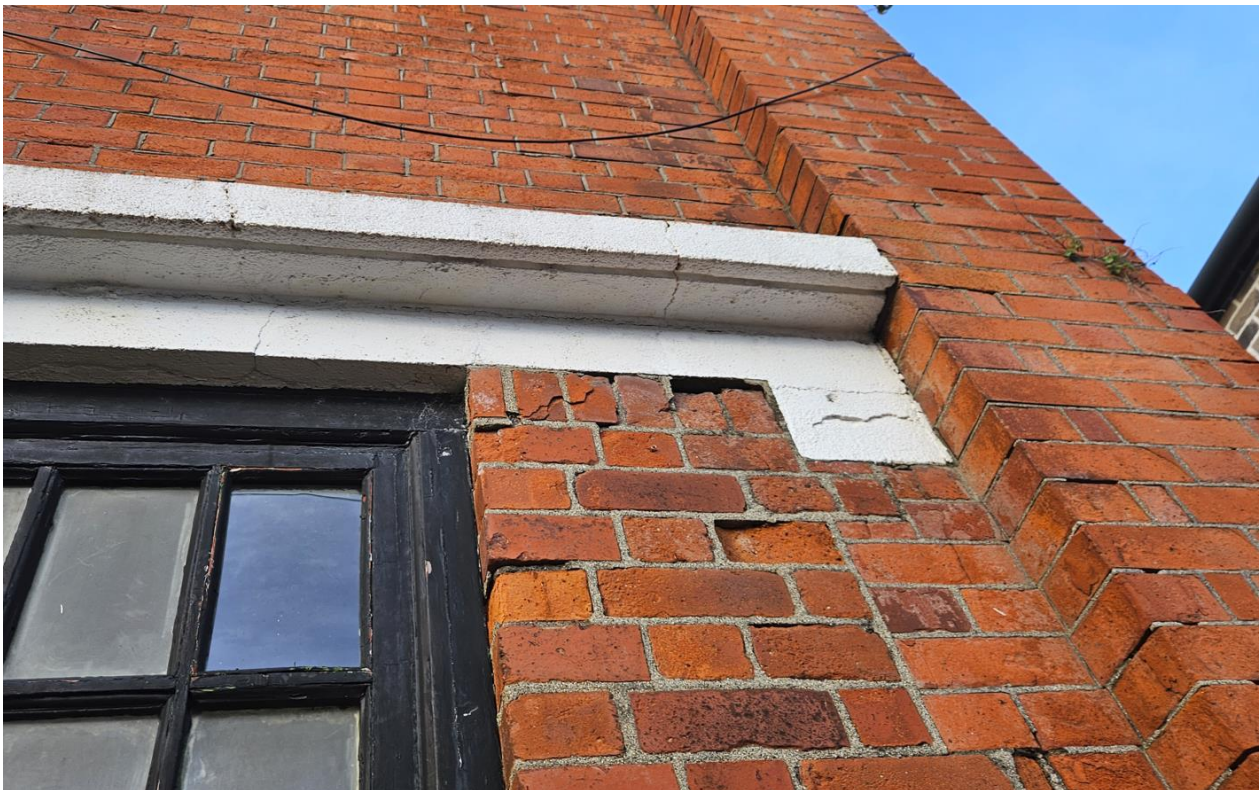
Image 30. Wash House building. Missing and damaged brick faces
