**BUILT HERITAGE INVENTORY
OF PARKS
IN DUN LAOGHAIRE-RATHDOWN**

MARLAY PARK

**REPORT PREPARED FOR
DUN LAOGHAIRE-RATHDOWN COUNTY COUNCIL**

August 2018

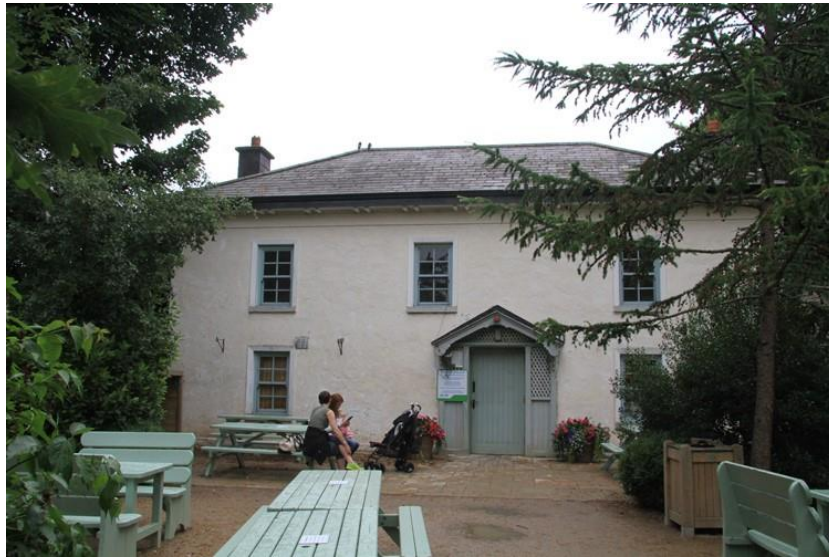
Plate 6: Head gardener's cottage

Three-bay, two-storey house with slate roof and bracketed eaves.

The house has been refurbished for use as a café, with significant alterations internally.

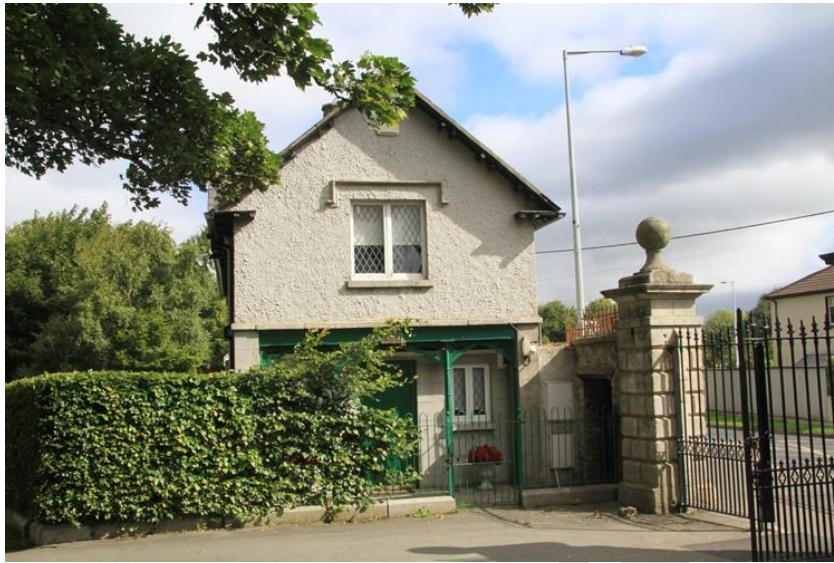
Plate 7: Gate lodge at Ballinteer Avenue

Three-bay, two-storey lodge; gable-ended. Built in tudor style with hood moulds over the windows and with bracketed barges. Front door is in southern gable, which is slightly set back at ground floor level behind the face of the façade above, the overhang being supported on a cast iron beam supported on two quatrefoil-section cast iron columns with pierced brackets.

The unusual iron feature at the front door lifts this building into a higher significance category. The recess of the front door is not sufficient to form a veranda or to give shelter.

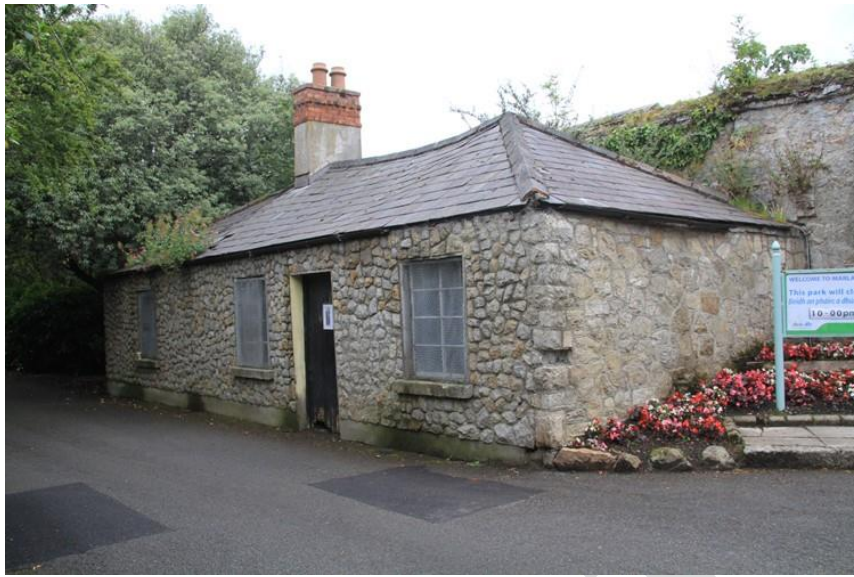
Plate 8: Lodge near western gate

Four-bay, single-storey gate lodge, set back from the boundary within the gateway. Hipped, slated roof. Chimney stack rising from ridge is crowned with machine-made red brick.

The lodge would have been built when the gateway was opened up to the west of the walled garden. The front façade and eastern façade have been rebuilt unsympathetically, faced with rubble granite.

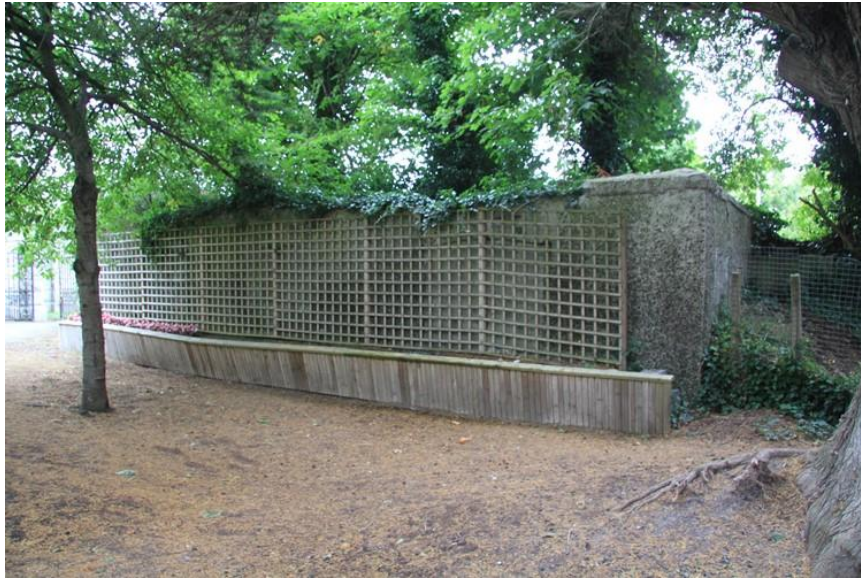
Plate 9: Ruined gate lodge

Walls of a disused gate lodge with opes stopped up.

The lodge would have gone out of use when the new gateway was opened up further to the west in the mid- to late-nineteenth century.

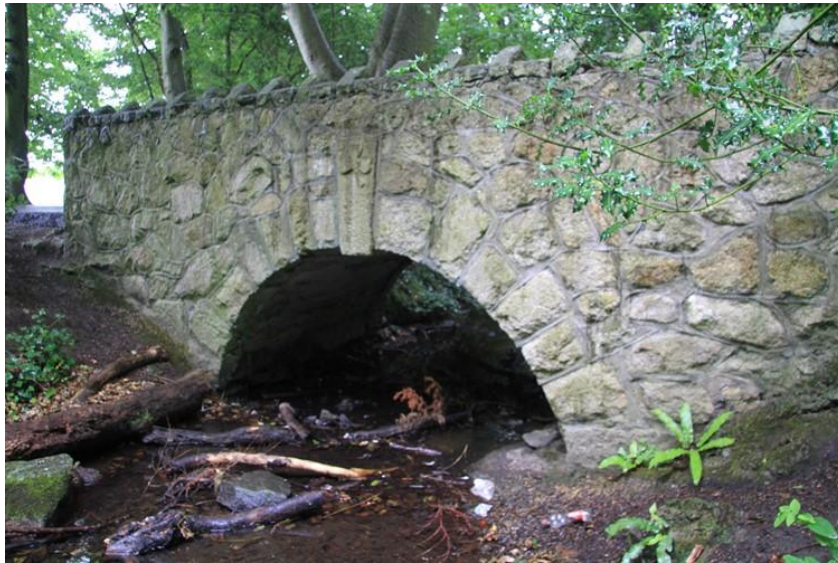
*Plate 40: Bridge 5***Description:**

Single-arched bridge of granite; barrel of arch is plank-centred and has a significant amount of concrete. Arch ring is of squared rock-faced granite with prominent keystone on downstream side bearing a shamrock in relief. Spandrels are of granite rubble. The coping stones are alternate vertical and horizontal granite rubble.

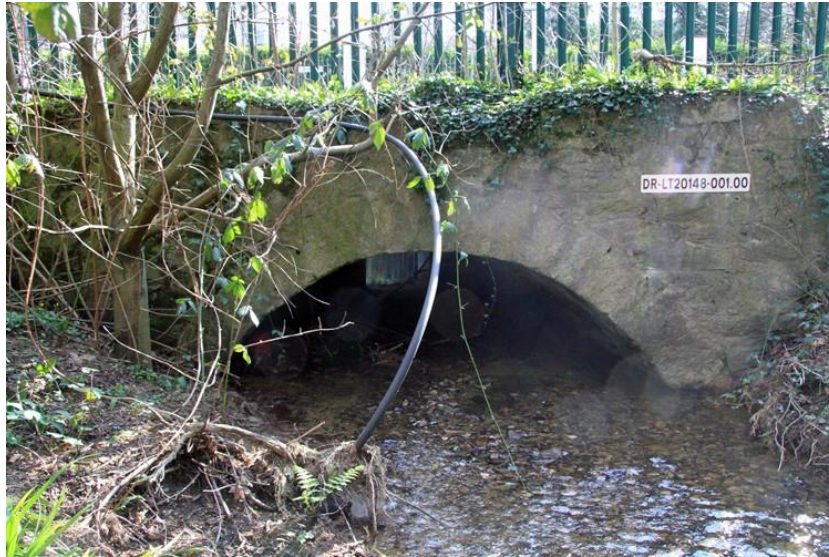
Plate 54: Bridge 19

Single-arched segmental bridge with roughly-shaped granite ring stones and rubble-granite spandrels. The original parapets are missing, and a steel palisade railing runs along the deck.

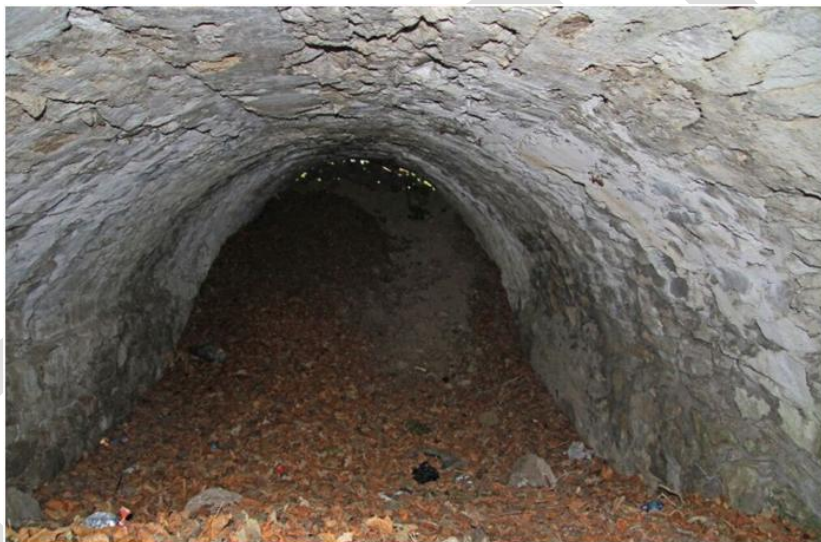
*Plate 61: Tunnel at bridge 25***Description:**

Externally, this bridge appears to have no function and to consist of a segmental granite arch, without spandrels. It is, however, a tunnel that has been buried due to the raising up of the ground to the front to provide for the roadway between the farm yard and the gates. This is a buried tunnel with a roughly semi-circular vault of rubble granite. It runs to the western boundary of the park, a distance of about six metres

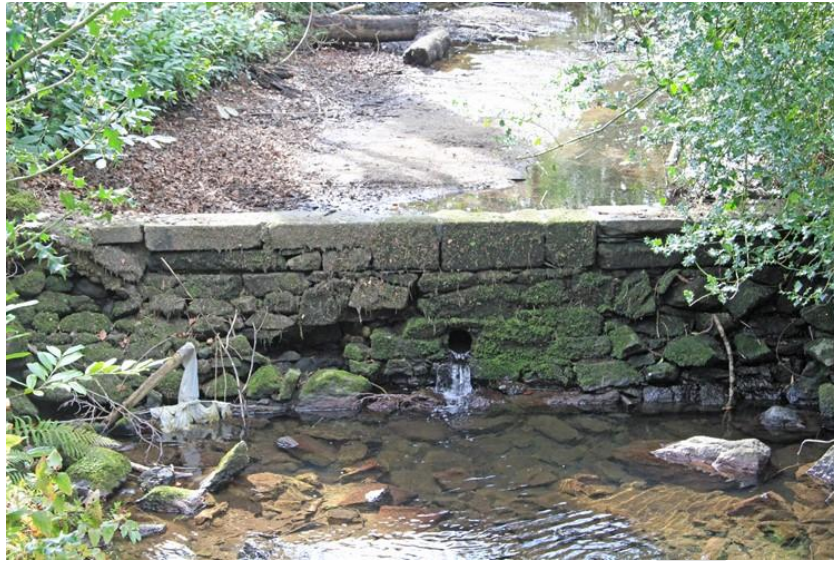
Plate 64: Weir number 1

Description: A small weir approximately 600mm high, constructed of granite. The upper courses are of cut granite to provide a level top for the weir, while the lower part of the weir is of rubble, with small stones. The weir would originally have held back an area of water to form a small lake or pond, but a pipe has been inserted into the masonry to carry the water through and the weir is no longer functioning. The stonework is not in good condition.

Comment:.. If this weir was to be brought back into use it would require significant repairs and possible partial reconstruction.

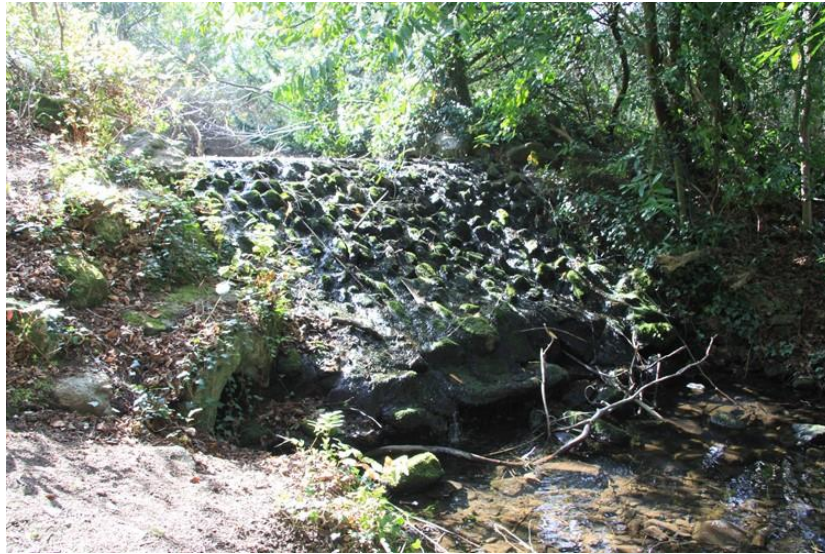
Plate 65: Weir number 2

Description: A substantial weir faced with rubble stone, though the nature of the construction is unknown without taking samples of the core of the weir. This weir was constructed to create the smaller of the two lakes, probably in the eighteenth century, as was discussed in the historical background above. On the eastern side of the weir, near the base, there is a stone arch, which is the portal of a culvert that discharges into the river.

Comment: The condition of this weir should be monitored, as there appears to have been loss of masonry at the base. The Regional significance has been assigned as this weir is an integral part of the lake that it holds back and hence should have the same heritage value.
