Re: An Arboricultural Assessment on the Site Area Proposed for an All-Weather Football Pitch and Associated Site Works on the Grounds of 'Oatlands College', Stillorgan, Co. Dublin.

An Arboricultural Assessment on the Site Area Proposed for an All Weather Football Pitch and Associated Site Works on the Grounds of 'Oatlands College', Stillorgan, Co. Dublin.

Prepared for: Dún-Laoghaire Rathdown County Council

Date: 15th March 2023

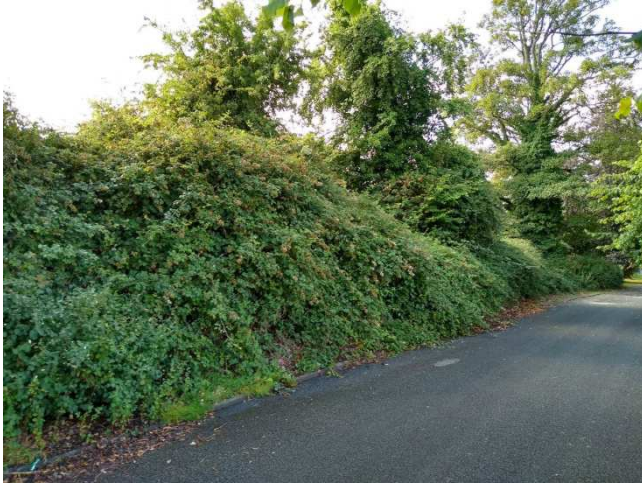
Tree No.	Tree Species	Ht. (m)	Stem Dia. (mm)	Branch Spread (m)	C-Ht. (m)	Age Class	Phys. Con.	Structural Condition Other Comments	Preliminary Recommendation	ULE in years	Cat. Grade
								N-north S-south E-east W- west Phys.-physiological.	A- average		
		A condition assessment of the trees around the football pitches at 'Oatland's College', Stillorgan, Co. Dublin.									
		The assessment starts along the southern boundary.									
Hedge No.1	Bramble <i>Rubus fruticosus</i> Dogrose <i>Rosa canina</i> Hawthorn <i>Crataegus monogyna</i> Ash <i>Fraxinus excelsior</i> Sycamore <i>Acer pseudoplatanus</i> Beech <i>Fagus sylvatica</i>	It is growing up through a chain link fence with vegetation located on the adjoining landside of the boundary fence. It is of a mature age class in fair condition both physiologically and structurally. It consists predominately of Bramble, Dogrose, clumps of Hawthorn with Ash and Sycamore trees developing throughout to form part of the bulking. The bulk of the Ash and Sycamore are being heavily suppressed by Ivy. Due to lapsed management Bramble is encroaching out onto the access roadway, creating a broader hedge structure. It contains some dead sections of trees, in particular Elm and Sycamore and these are posing a risk to this area. Isolated Ash and Beech are beginning to develop above the general hedge line. It has some value for screening along the boundary.

Make safe large size dead/ unstable growth and trim in encroaching hedge species. Cut back to clear access roadway. Plant up openings/ gaps in order to rejuvenate and rebuild this hedge.	C2

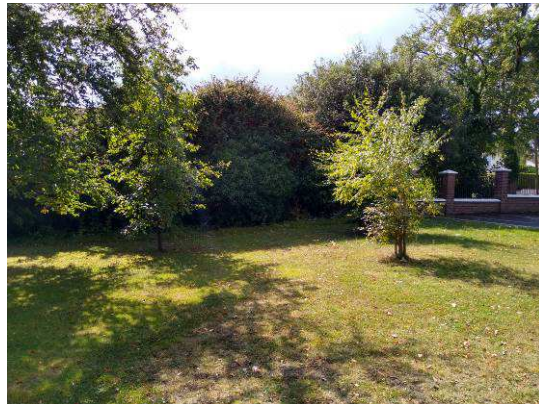
1628	Flowering Cherry <i>Prunus kanzan</i>	9	470	5N 6S 6E 5W	3	Mature	Fair	Fair Some lower scaffold limbs/ branches have been removed in the past in order to raise up its crown creating pruning wounds with stubs remaining as a result. This pruning has also left its crown more asymmetrical and weighed out to the south. The crown is thin and sparse on the west side with minor dead wood present. There are crossing branches with stem fusion present. It has suffered bark wounding on surface roots. There is an	Prune stubs back to target pruning points. Prune lower branches to improve clearance over the surrounding surfaces.	10+	C1

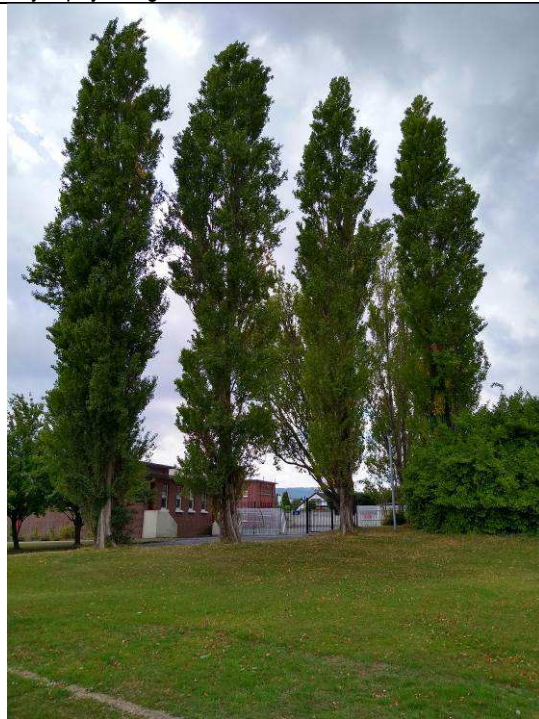
1644-1647	Lombardy Poplar <i>Populus nigra 'italica'</i>							They form part of a visual line of trees within these grounds. They have independent crowns and are not dependent on one another for support/ shelter.			-

The following gives details on these trees and the assessment works from west to east.									
1644	Lombardy Poplar <i>Populus nigra 'italica'</i>	28	640	4N 2S 1E 2W	4	Mature	Fair/ Good	Fair It is a tall tree, twin stem from c.3m. Some lower branches have been removed in the past in order to raise up its crown over the surrounding surfaces/ structures.	Cut Ivy at ground level at the present time.	20+	C2
1645	Lombardy Poplar <i>Populus nigra</i>	27	580	2N 2S	4	Mature	Fair/ Good	Fair It is a tall, central tree and it contains deadwood	Remove dead/ unstable growth. Monitor its condition on a twelve	20+	C2

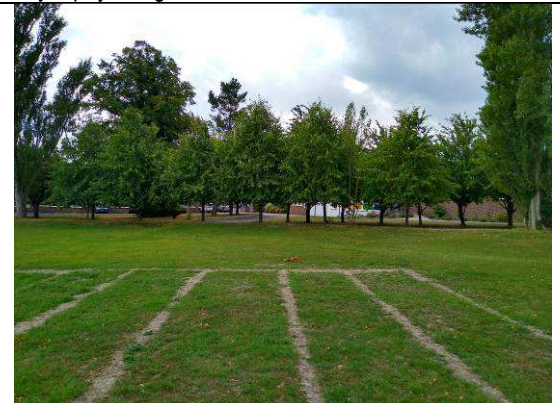
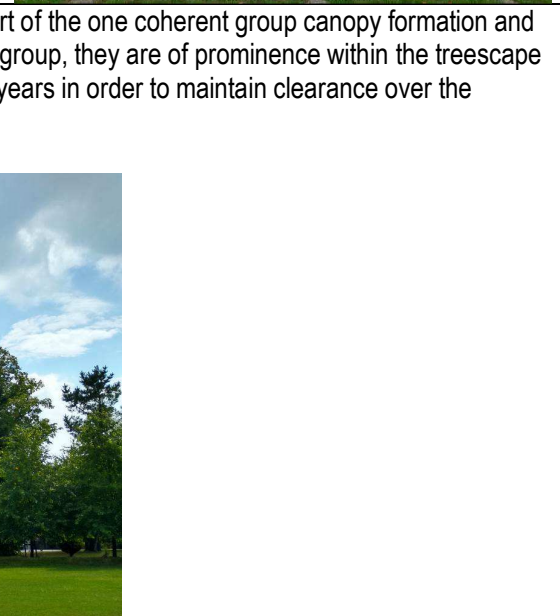
Tree Group (1654-1659)	Lombardy Poplar cv. <i>Populus nigra</i> <i>'italica'</i> cv. (6 in total)	They are growing up together in a line and are forming part of the one coherent group canopy formation and are dependent on one another for support/ shelter. As a group, they are of prominence within the treescape of this area. They have received some pruning over the years in order to maintain clearance over the surrounding surfaces.

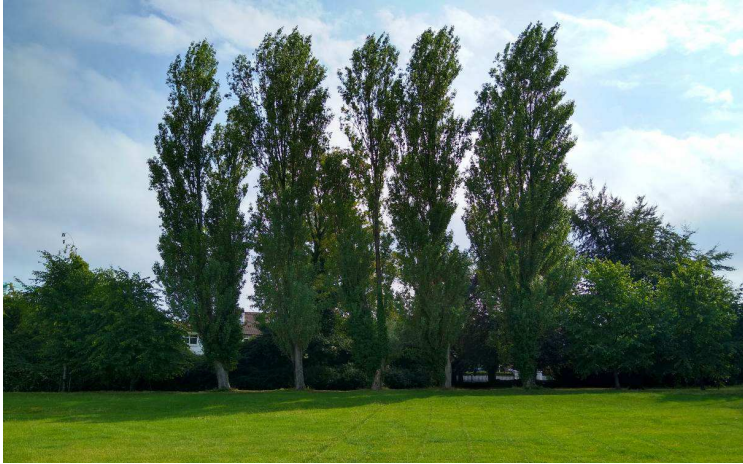
<p>The following gives details on these trees working from west to east.</p>									
1664	Lombardy Poplar cv. <i>Populus nigra</i> 'italica' cv.	24	690/ 570	4N 6S 3E 3W	3	Mature	Fair	Fair The lower limbs/ branches have been removed in the past in order to raise up its crown and some pruning wounds have been created as a result. It is a tall tree with epicormic growth developing on the main trunk due to being exposed to the light. It forms a twin-stemmed tree from c.1m up. Heavy Ivy growth extends up into the crown, increasing the wind sail.	Remove dead/ unstable growth and lighten in heavy side limbs/ branches by 1-2m Cut Ivy at ground level.	10-20	C2

1665	Lombardy Poplar cv. <i>Populus nigra</i> 'italica' cv.	24	670/ 330/ 320	4N 6S 3E 1W	3	Mature	Fair	Fair It is growing up within a group and forms a central tree and will be left more open/ exposed by the removal of Tree No.1666. It contains heavy side	Remove dead/ unstable growth and reduce end weight on the heavy/ exposed side limbs/ branches by c.1-2m in order to	10-20	C2

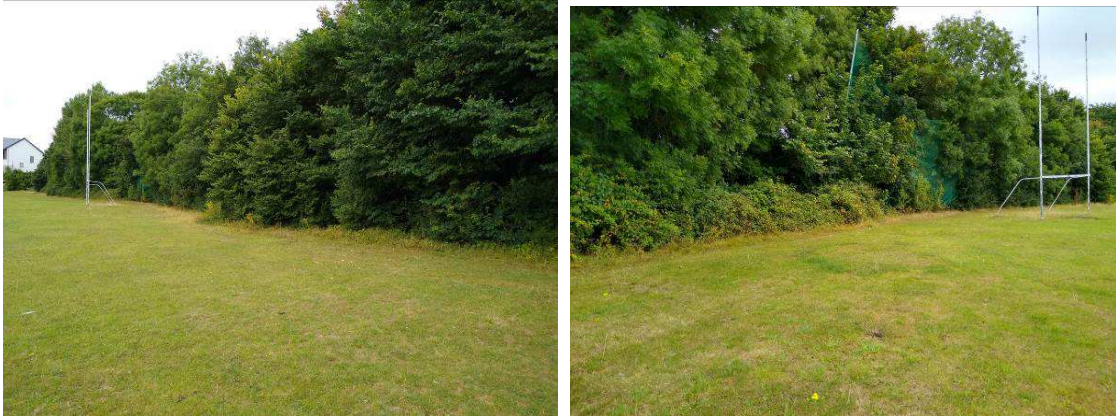
<table border="1"> <thead> <tr> <th>Ht. (m)</th> <th>Stem Dia.(mm)</th> <th>Branch Spread (m)</th> <th>C-Ht. (m)</th> </tr> </thead> <tbody> <tr> <td>A 8</td> <td>--</td> <td>A 3N,3S</td> <td>--</td> </tr> </tbody> </table>	Ht. (m)	Stem Dia.(mm)	Branch Spread (m)	C-Ht. (m)	A 8	--	A 3N,3S	--	<p>The following are the more prominent trees within this hedge line working from east to west.</p>					
Ht. (m)	Stem Dia.(mm)	Branch Spread (m)	C-Ht. (m)															
A 8	--	A 3N,3S	--															
1674	Elm <i>Ulmus glabra</i>	16	320/ 280/ 280/ 380/ 100	3N 7S 7E 4W	4	Mature	Fair	Fair Multiple-stemmed from base with an acute union formation between stems. Originally self-seeded into this area, it is located out (south) from the hedge line. The crown is extending out over the adjacent building to the east. It is not integral to the overall group canopy formation in this area.	Cut back branches over hanging the adjacent building. The lower branches could also be removed in order to open up this area underneath. Monitor for infection by 'Dutch Elm' disease.	10-20	C1							
1675	Elm <i>Ulmus glabra</i>	16	520/ 560	5N 5S 6E 6W	4	Mature	Fair	Fair/ Poor Twin-stemmed from base and was initially three – stemmed but one stem would appear to have broken out or was cut back leaving a stump which	Cut Ivy at ground level and tidy up the area around its base. Trim back from the building.	10-20	C2
