**Proposed Development of Shanganagh Park  
Masterplan – Phase 1, Shankill, Co. Dublin  
PC/PKS/03/21**

**Appendix 6 – Tree Survey & Report**

**Re: An Arboricultural Assessment of the Site Area for the Sports Facility Project at 'Shanganagh Park', Shankill, Dublin 18.**

## **An Arboricultural Assessment of the Site Area for the Sports Facility Project at 'Shanganagh Park', Shankill, Dublin 18.**

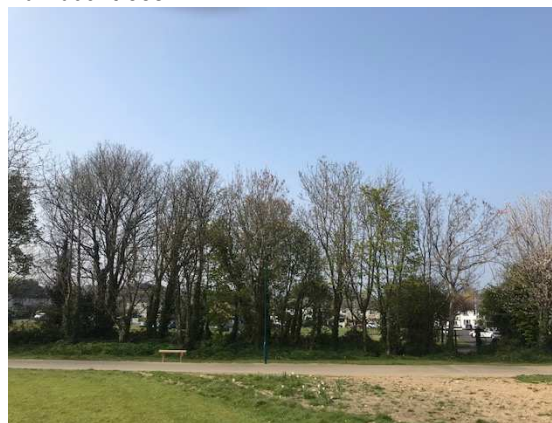
Tree No.	Tree Species	Ht. (m)	Stem Dia. (mm)	Branch Spread (m)				C-Ht. (m)	Age Class	Phys Con.	Structural Condition Other Comments	Preliminary Recommendation	Remaining years	Category Grade
				N	S	E	W				N-North S-South E-East W-West Ht.- Height C- Crown Phy Con.- Physiological Condition	A- Average Dia.- Diameter Cat.- Category		
	Hawthorn <i>Crataegus monogyna</i> Bramble <i>Rubus fruticosus</i>										crown overhang into the green area in 'St Anne's Park' and the public footpath in Shanganagh Park, respectively. They have value as screening in this area. These trees are growing as one coherent group with a combined group canopy formation and they are dependent on each other for support/ shelter. Their category grade is based on the merits of the tree belts as a whole and not as individual trees.			
		<p><b>The following trees are located south of the public path out from Tree Belt No.1.</b></p> <p>They have been planted at wide spacing in recent years and are growing on an open grass area running parallel with the public path. They are beginning to establish and have sufficient space to develop. They will provide good long-term tree cover of interest in this area.</p>											40+	C2

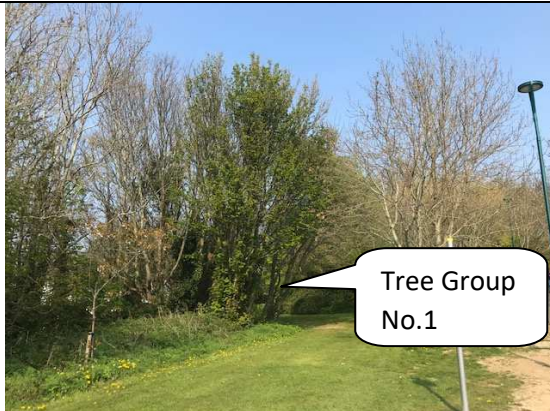
<b>Tree Group No.1</b>	<b>Ash</b> <i>Fraxinus excelsior</i> <b>Sycamore</b> <i>Acer pseudoplatanus</i> <b>Grey Willow</b> <i>Salix cinerea</i>	A 14	A 300 (4 stems)	A 4	A 4	A 4	A 4	A 3	Early Mature	Fair	Fair They are located in the north-east corner of the site area. They make up the outer-canopy formation of Tree Belt No.1 and they are a prominent group of trees in this area. Ivy cover is extending into their crowns and increasing their crown windsail.	Cut Ivy at ground level where heavy on trees.	40+	A2

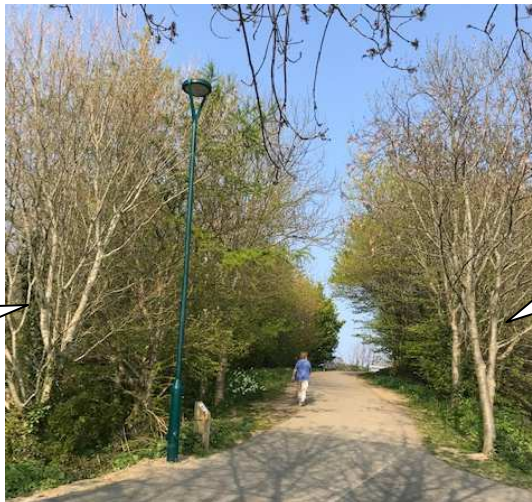
<b>Tree Group No.2</b>	<b>Ash</b> <i>Fraxinus excelsior</i> <b>Sycamore</b> <i>Acer pseudoplatanus</i> <b>Beech</b> <i>fagus sylvatica</i> <b>Field Maple</b> <i>Acer campestre</i> <b>Alder</b> <i>Alnus glutinosa</i> <b>Poplar</b> <i>Populus sp.</i> <b>Larch</b> <i>Larix decidua</i>	A 8	A 220	A 3	A 3	A 3	A 3	A 3	Semi Mature	Fair/ Good	Fair It consists of a group of trees located on the north side of the public footpath that leads to the pedestrian bridge over the railway line and it has colonized the embankment in this area. It is a prominent group of trees in this area and it has an upper-canopy of Ash, Sycamore, and Larch with some Alder, Poplar and Beech in places. The lower-canopy consists of Field Maple predominantly with some Dogwood in places and Bramble throughout the undergrowth. There is a narrow linear strip of grass dividing this tree group from the public footpath and their lower branches have been pruned to provide clearance in this area. A lot of these trees have been drawn up for the light due to overcrowding/ competition and this	Remove any dead/ unstable growth that endangers the public footpath to the south. Continue current maintenance to maintain clearance with the public footpath to the south. They would benefit from light selective thinning to allow the better quality trees space to develop.	40+	B2

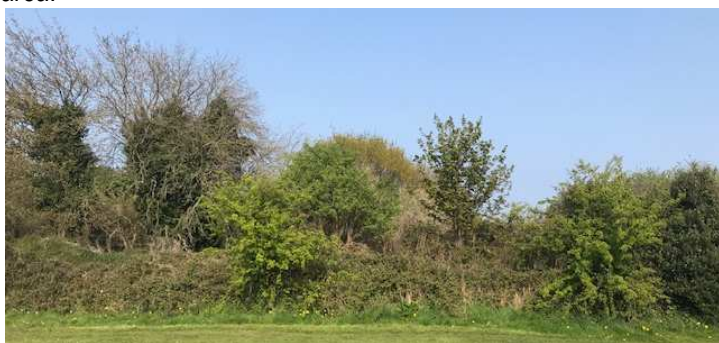
Tree No.	Tree Species	Ht. (m)	Stem Dia. (mm)	Branch Spread (m)				C-Ht. (m)	Age Class	Phys Con.	Structural Condition Other Comments	Preliminary Recommendation	Remaining years	Category Grade
				N	S	E	W				N-North S-South E-East W-West Ht.- Height C- Crown Phy Con.- Physiological Condition	A- Average Dia.- Diameter Cat.- Category		
	<div>Elder <i>Sambucus nigra</i> Gorse <i>Ulex europaeus</i> Dog Rose <i>Rosa canina</i> Ash <i>Fraxinus excelsior</i> Willow <i>Salix sp.</i> Field Maple <i>Acer campestre</i></div>	of Field Maple in the lower canopy and Ivy cover is heavy on some of these trees. It has value as screening in this area.

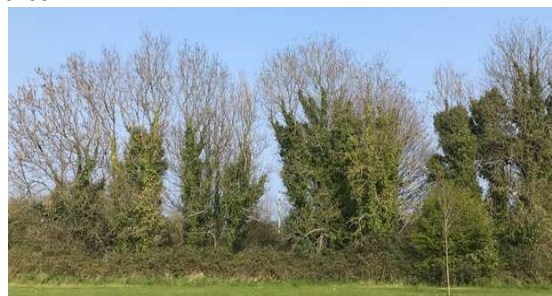
Tree Group No.4	Ash <i>Fraxinus excelsior</i>	A 14	A 240 (4 stems)	A 5	A 5	A 5	A 5	A 3	Early Mature	Fair	Fair It is a prominent group of trees within Hedge No.1. They are growing up as a group with a combined group canopy formation and they depend on each other for support/ shelter. Some of their crowns overhang towards the railway line. Heavy Ivy cover is extending into their crowns and this	Remove large size dead/ unstable growth. Cut Ivy at ground level where heavy and remove to a height of 2m to allow for a more detailed assessment of their bases	20-40	B2

Tree No.	Tree Species	Ht. (m)	Stem Dia. (mm)	Branch Spread (m)				C-Ht. (m)	Age Class	Phys Con.	Structural Condition Other Comments	Preliminary Recommendation	Remaining years	Category Grade
				N	S	E	W				N-North S-South E-East W-West Ht.- Height C- Crown Phy Con.- Physiological Condition	A- Average Dia.- Diameter Cat.- Category		
											increasing the windsail of their crowns and restricting the visual assessment to some degree. There is some deadwood within their crowns of a small size. There are some younger Ash trees located at the southern end of this tree group and together they will provide the long-term tree cover in this area. They have value as screening in this area.	and lower trunks. Their crowns may require pruning away from the railway line in the future.		
1321	Ash <i>Fraxinus excelsior</i>	10	200 (6 stems)	4	4	5	4	2	Semi Mature	Fair	Fair It is growing at the southern end of Hedge No.1 next to the boundary with the railway line. It is multiple-stemmed from base with light Ivy cover beginning to extend into its crown. Bramble is also growing through its lower crown and it has a small crown overhang toward the railway line.	Cut Ivy at ground level. Its crown may require pruning away from the railway line in the future.	20-40	B1

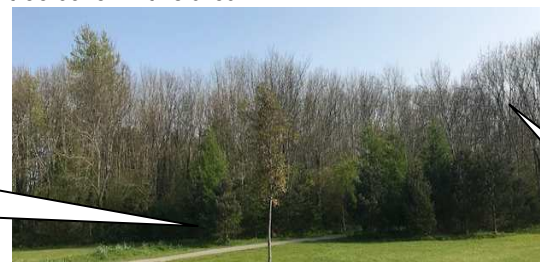
Tree Group  
No.5

<b>Tree Group No.5</b>	<b>Scots Pine</b> <i>Pinus sylvestris</i>	A	A	A	A	A	A	0	Young	Fair/ Good	Fair/ Good It is located at the southern end of the site area in front of Woodland Block No.1 and consists of mixed pine species growing on either side of the path. They have good potential for the long term tree cover in this area.	Maintain a larger weed-free area around its base with mulch. They may require some selective thinning as they grow in size to recue density and competition.	40+	C2
	<b>Larch</b> <i>Larix decidua</i>	5	180	2	2	2	2

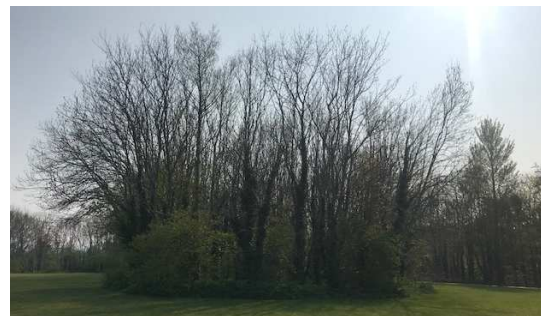
Tree No.	Tree Species	Ht. (m)	Stem Dia. (mm)	Branch Spread (m)				C-Ht. (m)	Age Class	Phys Con.	Structural Condition Other Comments	Preliminary Recommendation	Remaining years	Category Grade
				N	S	E	W				N-North S-South E-East W-West Ht.- Height C- Crown Phy Con.- Physiological Condition	A- Average Dia.- Diameter Cat.- Category		
<b>Tree Belt No.3</b>	<b>Ash</b> <i>Fraxinus excelsior</i> <b>Sycamore</b> <i>Acer pseudoplatanus</i> <b>Oak</b> <i>Quercus robur</i> <b>Beech</b> <i>Fagus sylvatica</i> <b>Rowan</b> <i>Sorbus aucuparia</i> <b>Cherry</b> <i>Prunus avium</i> <b>Norway Maple</b> <i>Acer platanoides</i> <b>Field Maple</b> <i>Acer campestre</i> <b>Hazel</b> <i>Corylus avellana</i> <b>Horse Chestnut</b> <i>Aesculus hippocastanum</i> <b>Willow</b> <i>Salix sp.</i> <b>Bramble</b>	A 13	A 280	A 4	A 4	A 4	A 4	A 3	Early Mature	Fair/ Good	Fair It is located north of Tree Belt No.2 and it protrudes out into the open grass area. It has an upper-canopy of predominantly Ash and Sycamore with some Horse Chestnut, Oak and Norway Maple in places. It has a lower canopy of Cherry, Hazel, Willow and Field Maple with some Rowan and Beech in places. There is Bramble throughout its understory and there are self-seeded trees developing such as Ash, Sycamore and Rowan. Their lower branches have been removed to raise up their crowns resulting in pruning wounds. Ivy cover is beginning to extend into some of their crowns. These trees are growing as one coherent group with a combined group canopy formation and they depend on each other for support/ shelter. Their category grade is based on their merits as a tree belt and not as individual trees.	Remove any dead/ unstable growth that endangers the public footpath to the south and west. Continue current maintenance to maintain clearance with the public footpaths. Cut Ivy at ground level where heavy on trees. They would benefit from ongoing, light, selective thinning to allow the better quality trees space to grow and develop.	40+	B2

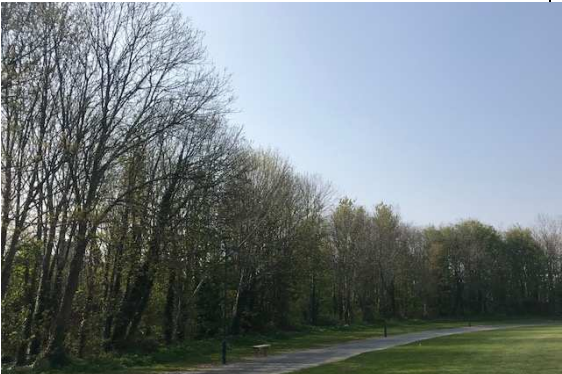
Tree No.	Tree Species	Ht. (m)	Stem Dia. (mm)	Branch Spread (m)				C-Ht. (m)	Age Class	Phys Con.	Structural Condition Other Comments	Preliminary Recommendation	Remaining years	Category Grade
				N	S	E	W				N-North S-South E-East W-West Ht.- Height C- Crown Phy Con.- Physiological Condition	A- Average Dia.- Diameter Cat.- Category		
	<b>Horse Chestnut</b> <i>Aesculus hippocastanum</i> <b>Willow</b> <i>Salix sp.</i> <b>Hawthorn</b> <i>Crataegus monogyna</i> <b>Bramble</b> <i>Rubus fruticosus</i>										increasing wind-loading in some trees. These trees are growing as one coherent group with a combined group canopy formation and they depend on each other for support/ shelter. Their category grade is based on their merits as a tree belt and not as individual trees.
