# Arborist Associates Ltd.

## An Arboricultural Assessment of the Site Area at “The Gate Lodge” at Cabinteely Park, Dublin 18.

Prepared for: Dùn-Laoghaire Rathdown County Council

Date: 28<sup>th</sup> June 2024

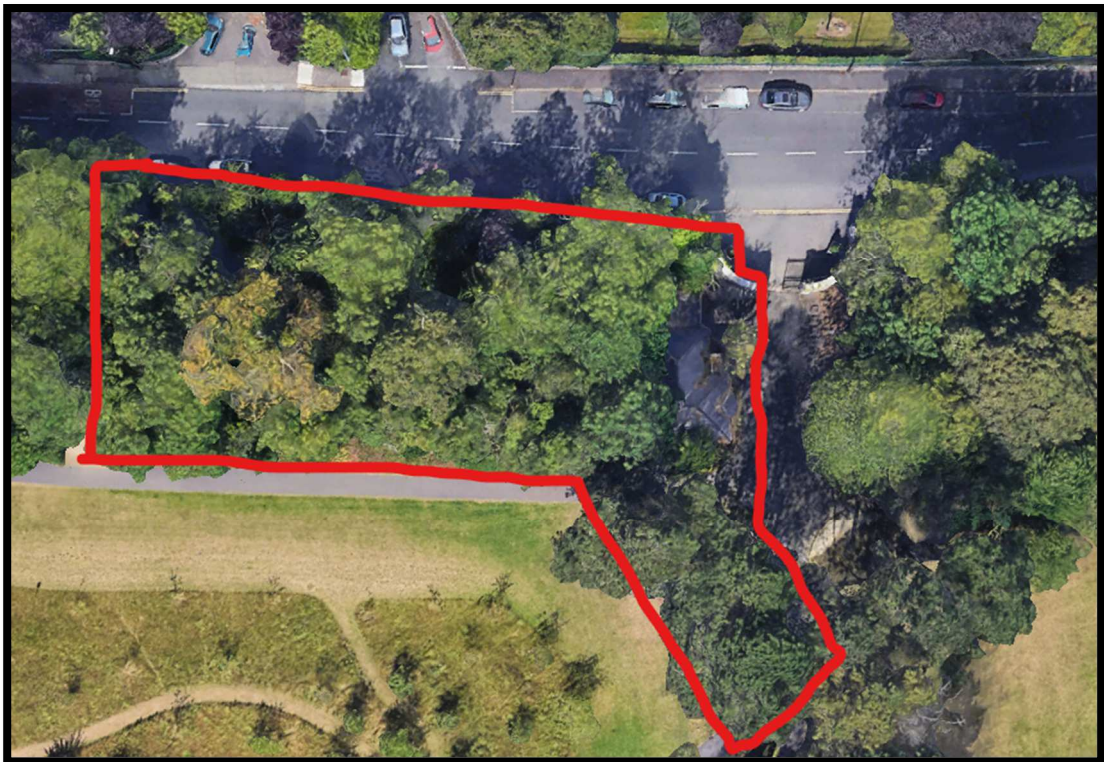
**Figure 1:** Shows the site area at 'The Gate Lodge' with the survey area outlined indicatively in red.

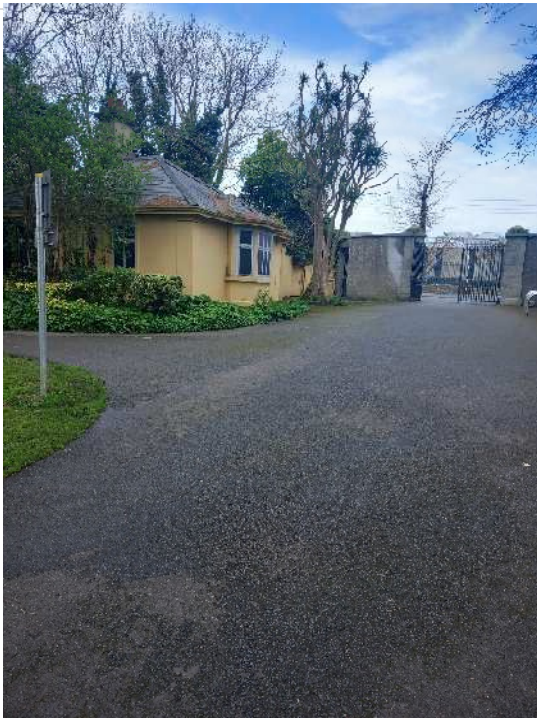
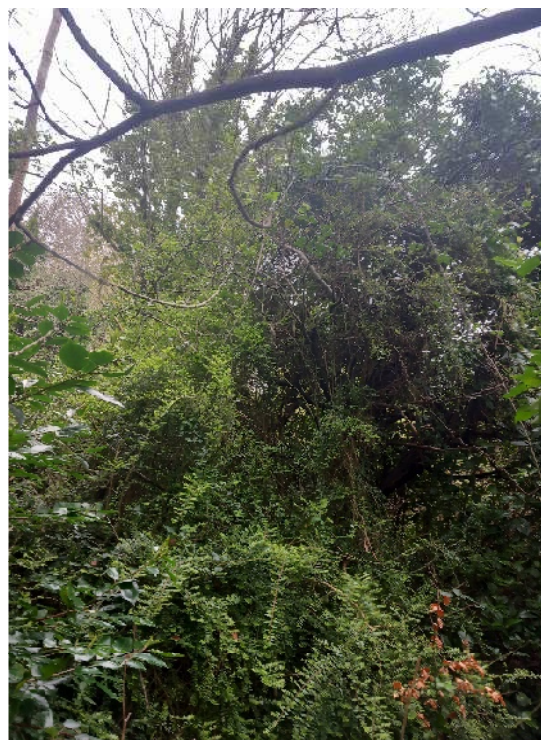
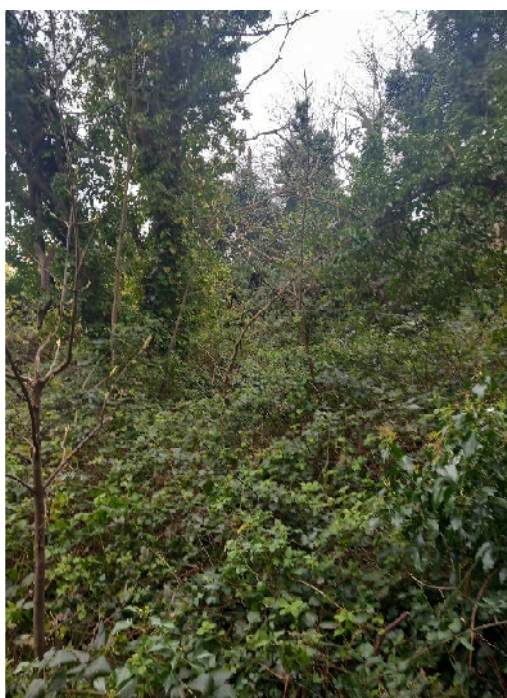
- 4.2 The bulk of the site area I suspect once formed the garden area of this gate lodge with the remnants of a few Apple trees remaining. The area is overgrown with scrub vegetation and self-seeded trees establishing due to lapsed management for a good number of years and as a result, the area is difficult to access. Along its southern boundary with the perimeter path around the park, a linear shrub border had been planted some years back to tidy up this area.

**Figures 2-4:** The front of 'The Gate Lodge' and the rear garden area of the property.
