# **Arborist Associates Ltd.**

## **An Arboricultural Assessment on the Site Area for the 'Kilbogget Park Sports Pavillion Project', Churchview Road, Cabinteely, Dublin 18.**

**Prepared for: Dun Laoghaire Rathdown County Council**

**Date: 28<sup>th</sup> April 2026**

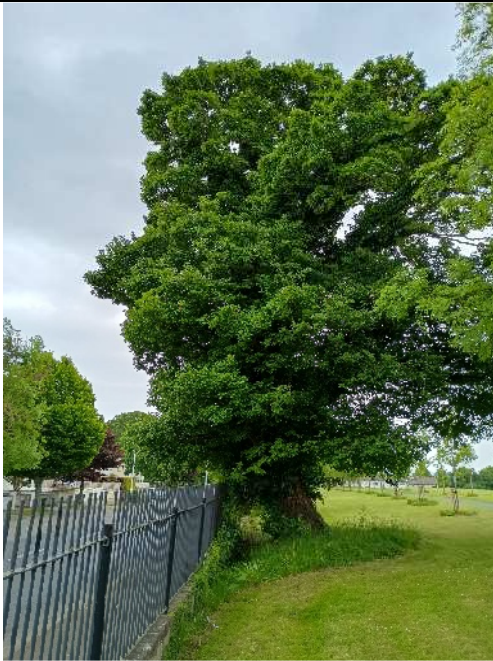
<p><b>Photograph 1 shows the above line of Ash trees along boundary. Photograph shows Tree No.1293.</b></p>									
1293	<b>Oak</b> <i>Quercus sp.</i>	17	1200	6	7	6	8	2	Mature	Fair	Fair A single stem tree growing close to the site boundary with a slight lean to the east towards the road. The crown contains some minor deadwood and heavy Ivy growth extends high into the crown, increasing the windsail and limiting the visual assessment. There is a decay area on the buttress root at the base on the west side.	Cut Ivy at ground level. Remove dead / unstable growth.	20+	B2	14.4

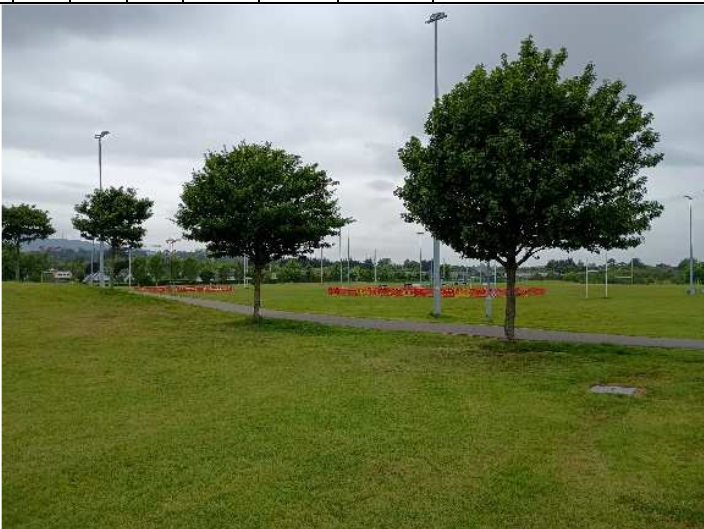
<b>Tree Group</b> 0950 - 0960 (11 trees)	<b>Oak</b> <i>Quercus robur.</i>	A.7	A.230	A3	A3	A3	A3	A2	Semi Mature	Fair / Good	Fair / Good A group of eleven, single stem trees planted in a triangular grass area as a group at close spacing. As they develop, the crowns will merge leading to a combined group canopy. There is some mower damage evident at the base of some of the trees. Tree No.0950 is a	No works required at the present time. They would benefit from the area around their bases being mulched.	40+	B2	2.8

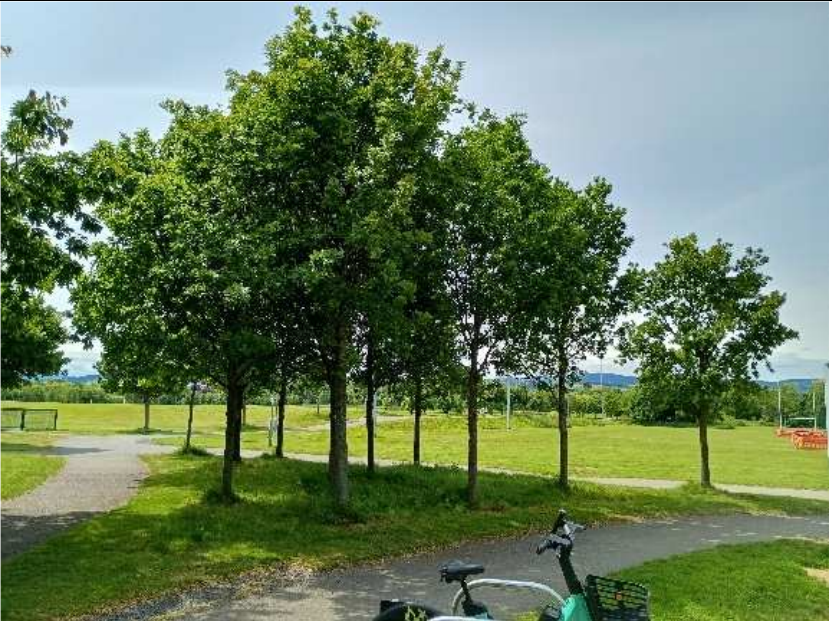
<b>Tree Group</b> 0961 – 0974 (14 trees)	<b>Elm</b> <i>Ulmus glabra</i> <b>Oak</b> <i>Quercus petraea</i> <b>Ash</b> <i>Fraxinus excelsior</i> <b>Horse Chestnut</b> <i>Aesculus hippocastanum</i>	<p><b>This tree group is located to the west of the Seapoint RFC Clubhouse and to the north of the Cabinteely Boys FC clubhouse.</b></p> <p>It consists of mixed age class and species of trees in varying condition. They are located in a wide grass area, part of which has been developed as an outdoor seating area with paving and part of which has been used for the placement of steel shipping containers for use as storage areas. It is likely that some soil damage and root disturbance may have occurred during these developments, in particular around the larger trees. The Ash trees are vulnerable to 'Ash Dieback Disease' (<i>Hymenoscyphus fraxineus</i>) and some of the trees are showing signs of infection and early decline at present. The Elm are vulnerable to infection with 'Dutch Elm Disease' (<i>Ophiostoma ulmi</i>) and will require ongoing monitoring. The group forms a significant feature in the local tree scape and has been graded as such.</p>									Monitor the Ash and Elm trees for advancing disease infection.		C2

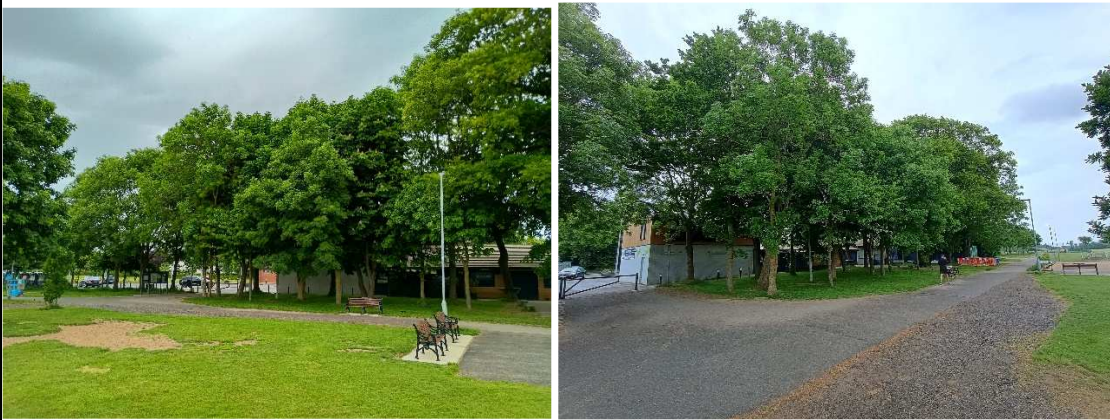
<b>Tree Group</b>	<b>Horse Chestnut</b> <i>Aesculus hippocastanum.</i> <b>Ash</b> <i>Fraxinus excelsior</i> <b>Lime</b> <i>Tilia platyphyllos</i> <b>Oak</b> <i>Quercus sp.</i> <b>Sycamore</b> <i>Acer pseudoplatanus.</i> <b>Norway Maple</b> <i>Acer platanoides</i> <b>Cherry</b> <i>Prunus sp.</i>	<p><b>This tree group is located to the north of the paved seating area to the rear of the Seapoint RFC Clubhouse building.</b></p> <p>It consists of a mix of species of a semi mature to early mature age class. They form a significant tree feature in this part of the site as a group of trees and are of more value as a group that as individual trees.</p>										20+	B2
