**Proposed Development of Fernhill Park &
Gardens, Stepside, Co. Dublin with Works
within the Curtilage of the Protected
Structure (Fernhill House)
PC/PKS/01/17**

Appendix 10 – Road Safety Audit

Fernhill Park & Gardens,
Rosemont Entrance,
Enniskerry Road, Co. Dublin

Road Safety Audit Stage 1

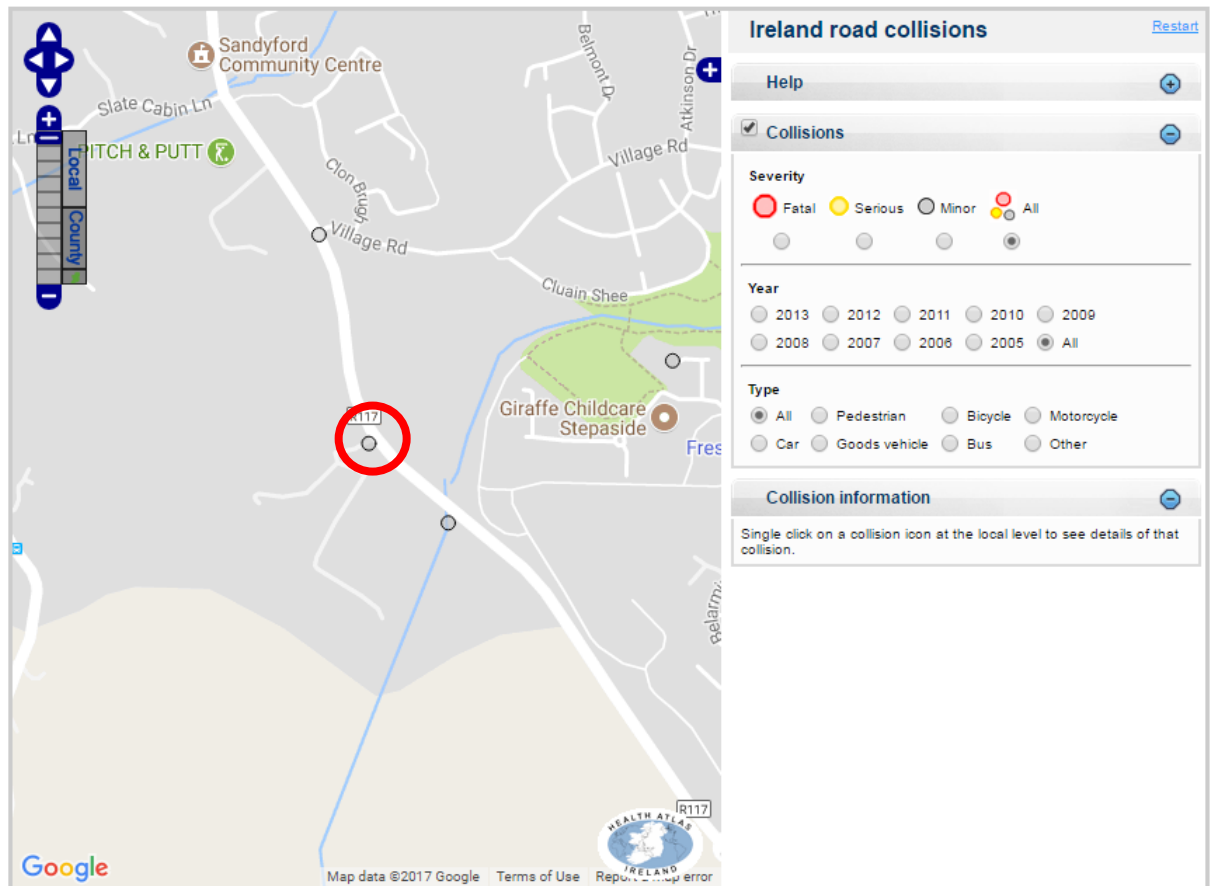
Figure 2 RSA Collision Records (2005-2013) in vicinity of the study area (www.RSA.ie)

- The RSA database of road collisions was examined to establish if there are any existing safety issues in the vicinity of the site that were not evident from the site visit. The database provides collision records for the period 2005 to 2013, with Figure 2 below outlining the recorded collision locations over the nine year period.
- One minor collision was recorded at the junction of the Enniskerry Road/Rosemont School entrance. This accident occurred in 2010 and involved a single motorcycle collision.

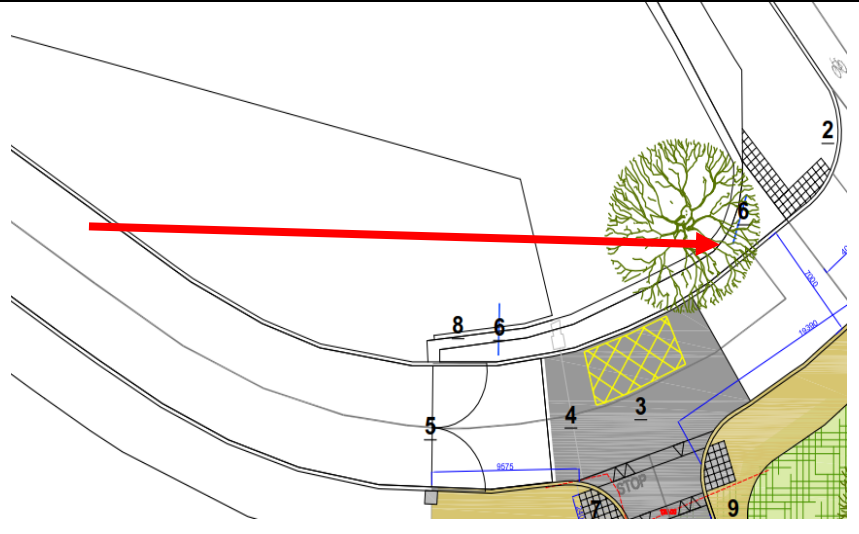
Problem 4.2.1:

Location	Rosemont School Access Road	
Drawing	DRP-2315-06	
Summary	Limited visibility for motorists exiting the school on approach to the signalised junction	
Description		<p>There is a bend on the existing school road and forward visibility to the Enniskerry Road junction is reduced due to the boundary wall. No signage has been provided on the school access road to indicate to motorists exiting the school that a new signalised junction is ahead. The reduced forward visibility to the junction and lack of signage may result in some motorists approaching this junction at excessive speed resulting in collisions with pedestrians or rear end collisions.</p>
Recommendation:		
		<p>To improve awareness of the new junction, appropriate signage should be provided on the access road for vehicles exiting the school to indicate a signalised junction is ahead.</p>

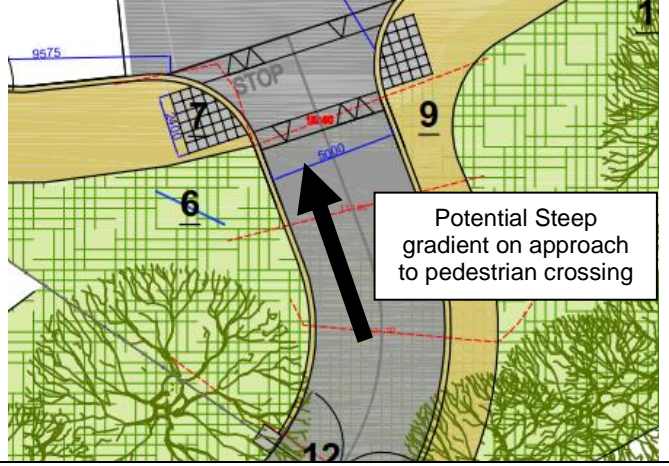
Problem 4.2.2:

Location	Access road to park entrance	
Drawing	DRP-2315-06	
Summary	Steep gradient on access road to priority junction	
Description		
<p>From the site visit, the existing gradient of the park access road on approach to the priority junction appears to be steep. There is a risk of vehicles approaching the priority junction at speed; which may result in a collision with pedestrians crossing the priority raised crossing.</p>		
Recommendation:		
<p>Clarification should be provided on the gradient of this road on approach to the junction. The gradient on the immediate approach to the junction should be gentle. Anti-skid surfacing should be provided on the approach to the junction to improve motorist's control of their vehicles in all weather conditions.</p>		
Problem 4.2.3:

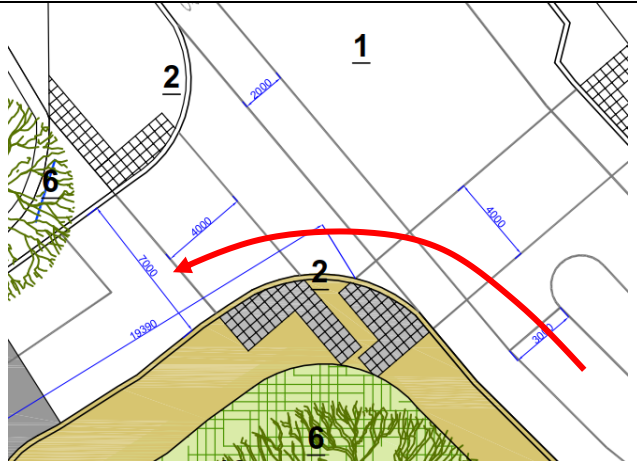
Location	Signalised Junction

Drawing	DRP-2315-06	
Summary	No tracking provided for large vehicles through the junction	
Description		
<p>No auto-tracking is provided for large vehicles turning left from the Enniskerry Road NB into the access road for the school and park. If a coach/bus entering the school grounds does not have sufficient room to manoeuvre the left turn, the vehicle may overrun the stop line at the access road, which could result in a collision with motorists in the opposing lanes.</p>		
Recommendation:		
<p>Tracking of the largest anticipated vehicle should be provided in order to make sure it does not overrun the stop line at the access road.</p>

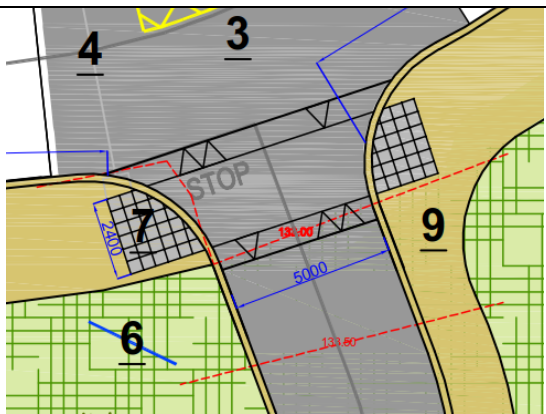
Problem 4.3.1:

Location	School Access/Park Access Junction	
Drawing	DRP-2315-06	
Summary	STOP line located on pedestrian crossing	
Description		
<p>The STOP line for the side road is located on the pedestrian crossing. The STOP line is not provided at the first point of conflict with pedestrians. The location of this stop line could lead motorists to mount the crossing at speed, unaware of pedestrians, potentially causing a collision.</p>		
Recommendation:		
<p>The proposed crossing is as per Design Manual for Urban Roads and Streets (DMURS) guidance; however, the National Cycle Manual recommends a two stage approach for vehicles. For the 1st stage, motorists stop at a setback stop line location before the raised crossing to allow pedestrians to cross. In the 2nd stage, motorists proceed on to the crossing to the junction at a slow speed, giving time to see pedestrians and cyclists approaching the junction. This two stage approach should be incorporated at this crossing location with the stop set back before the raised crossing.</p>

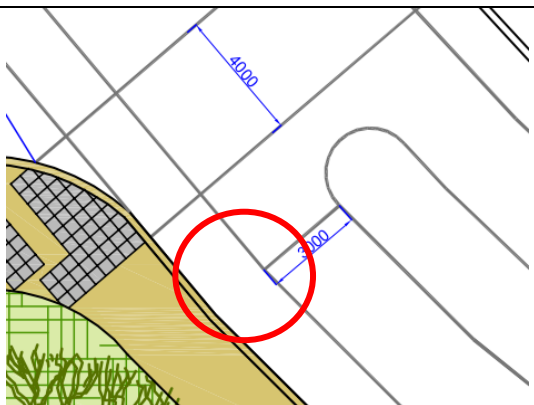
Problem 4.3.2:

Location	Enniskerry Road Northbound	
Drawing	DRP-2315-06	
Summary	No stop line provided for cyclists	
Description		
<p>No stop line is provided at the signalised junction for cyclists travelling northbound in the cycle lane. Cyclists may fail to stop at the junction resulting in collisions with pedestrians or vehicles.</p>		
Recommendation:		
<p>A cycle stop line should be provided at this location.</p>

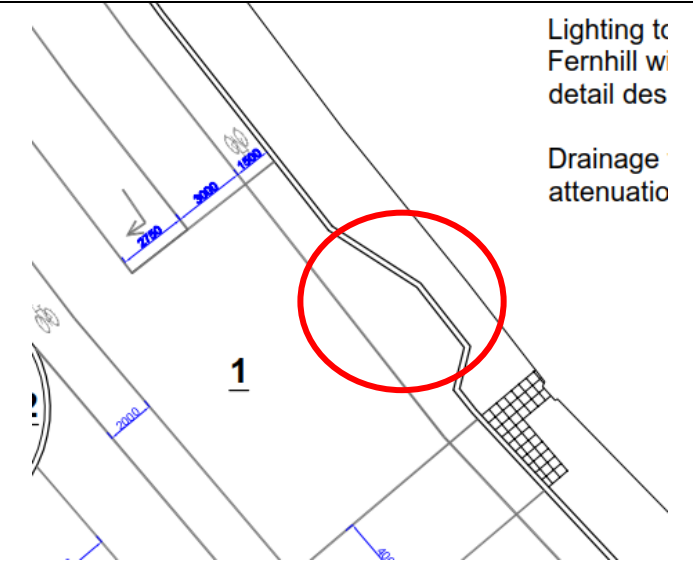
Problem 4.4.1:

<i>Location</i>	Enniskerry Road Southbound Cycle Lane	
<i>Drawing</i>	DRP-2315-06	
<i>Summary</i>	Clarification of Box turn for Cyclists	
Description It would appear that a box turn has been provided in order for southbound cyclists to turn right, however, there are no road markings to determine this. Clarification is needed from the designer. If this is a box turn, cyclists will need to be provided with a stage with no other conflicting/opposing turning movements.		
Recommendation:		
Clarification should be provided as to whether this is a box turn for cyclist right turn movement. A staging diagram should be provided to demonstrate safe stages for cyclists to turn right.

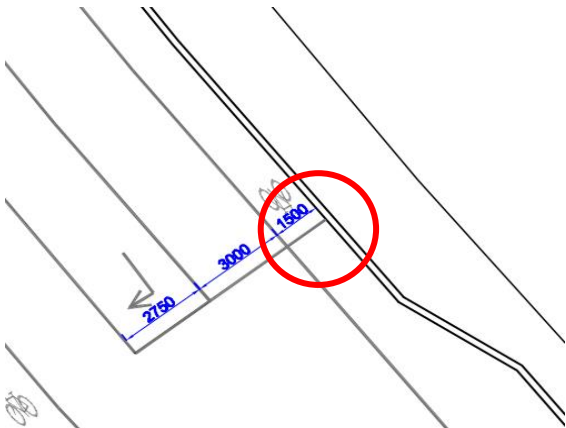
Problem 4.4.2:

Location	Enniskerry Road Southbound	
Drawing	DRP-2315-06	
Summary	Inadequate width of cycle lane	
Description		
The southbound cycle lane is narrow with a width of 1.5m and does not meet the National Cycle Manual Standard along a 50km/hr main road. Sub-standard cycle facilities could cause cyclists to veer out of the cycle lane which could result in a collision with vehicles.		
Recommendation:		
The width of the cycle lane should be increased to a minimum of 1.75m to meet the standards in the National Cycle Manual.

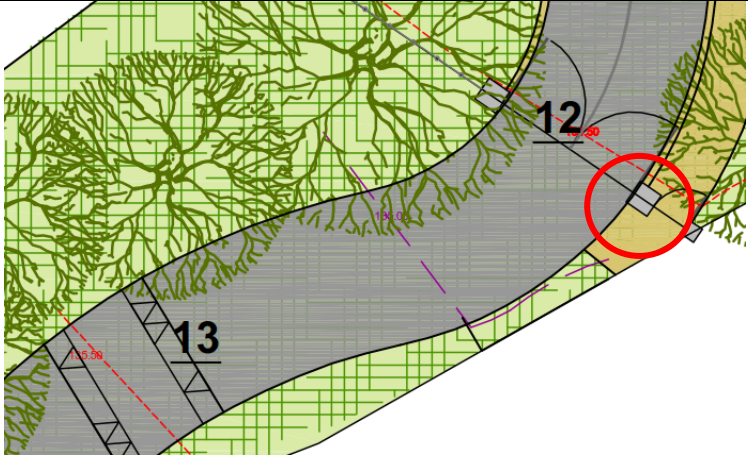
Problem 4.4.3:

Location	Park access road at shared surface area	
Drawing	DRP-2315-06	
Summary	Impaired visibility of pedestrians entering the shared surface	
Description		
<p>The proposed gates and pillars are located along the road at the point where the pedestrian footpath terminates and where pedestrians move into the shared space area on to the road. The location of the pillar may impair the visibility of drivers approaching the area to pedestrians making the change from footpath to shared surface. This reduced visibility may result in drivers failing to see pedestrians on time as they step onto the shared space resulting in a collision.</p>		
Recommendation:		
<p>Speed reducing measures should be provided close to the location of the shared surface. Signage should be implemented to alert drivers to the presence of pedestrians.</p>

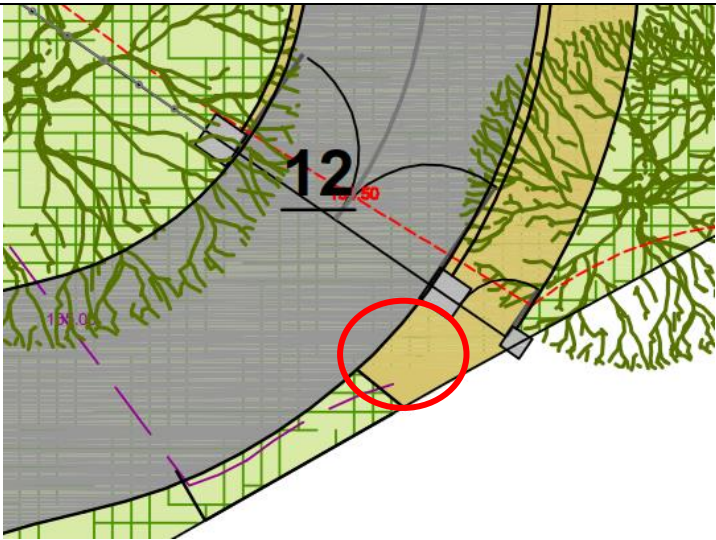
Problem 4.4.4:	
<i>Location</i>	Access Road at Shared Surface Area
<i>Drawing</i>	DRP-2315-06
<i>Summary</i>	No dropped kerb indicated for pedestrians
<div> <div>

</div> </div>	
Description	
No dropped kerb has been provided for pedestrians from the footpath to the shared road surface. This hinders pedestrian accessibility, in particular, for vulnerable road users and disabled users.	
Recommendation:	
A dropped kerb should be provided on the footpath.

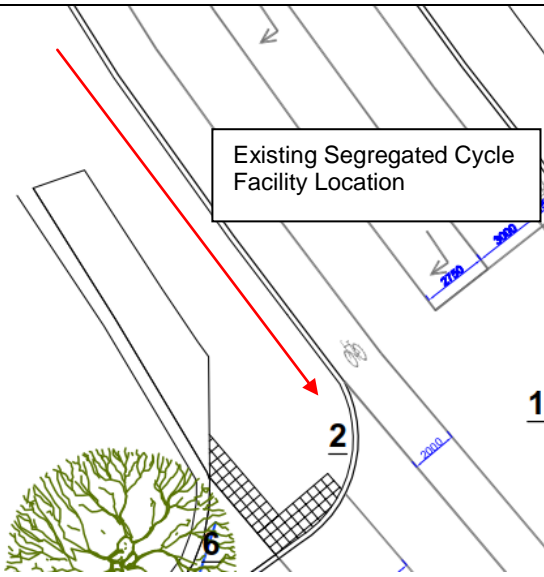
Observation 4.7.2:

<i>Location</i>	Enniskerry Road	
<i>Drawing</i>	DRP-2315-06	
<i>Summary</i>	Clarification of retention of two-way cycle facility	
Description		
At present, there is a two-way cycle facility in place on the west side of the road. Cyclists travelling southbound are accommodated on a segregated facility beside the footpath. The drawing does not show this facility being retained.		
Recommendation:		
Clarification is needed on the retention of this segregated facility.
