# Arborist Associates Ltd.

## A Condition Assessment of the Trees Within the Site Area for the 'Sandyford Civic Park Project'.

Prepared for: Dun Laoghaire Rathdown County Council

Date: 20<sup>th</sup> November 2025

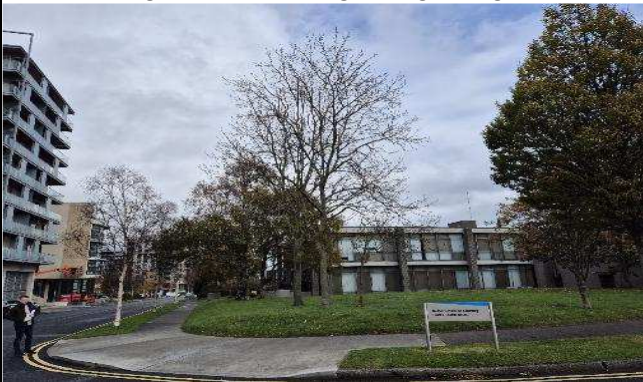
0302	<b>Rowan</b> <i>Sorbus aucuparia</i>	3	90	2	0	1	0	2	Semi Mature	Fair/ Poor	Poor It is growing from underneath the crowns of Tree Nos.0303 & 0304 with an asymmetrical crown drawn up and out for light as a result. It is of poor quality with dieback evident within its crown. There are suckers growing from its base with grass around its base also.	It will possibly need to be <b>removed</b> in the short term. It requires no work at present.	<10	U	1.1

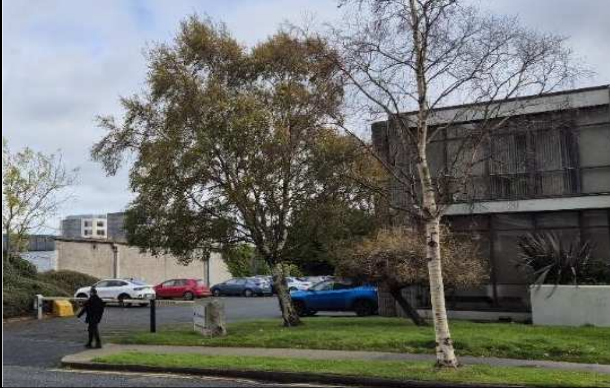
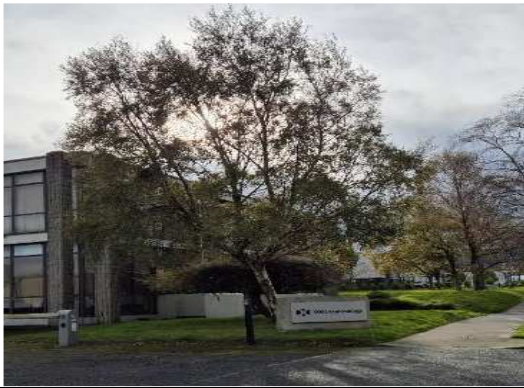
<p>The following three trees are growing as a group and were planted at close spacing.</p> <div style="display: flex; justify-content: space-around;">

Tree No.	Tree Species	Ht. (m)	Stem Dia. (mm)	Branch Spread (m)				C-Ht. (m)	Age Class	Phys. Con.	Structural Condition Other Comments	Preliminary Recommendation	ULE	Cat. Grade	RPA (radius) (m)
				N	S	E	W								
				N	S	E	W				N-north S-south E-east W-west C-Ht.-crown height, Dia.-diameter Phys.-physiological.	ULE-useful life expectancy Cat.-category, A-average			
0305	<b>Birch</b> <i>Betula pendula</i>	9	270	0	5	0	4	3	Early Mature	Fair/ Poor	Fair/ Poor It has an asymmetrical crown due to its group growing environment and its upper crown is in declining health with its upper crown dead impacting on its structure. Its lower branches were pruned/ removed previously to raise up its crown.	Remove dead top and prune its crown to reshape/ balance particularly lower branch.	10+	C2	3.2
0306	<b>Birch</b> <i>Betula pendula</i>	9	310	4	5	4	0	1.5	Early Mature	Fair	Fair It forms part of the group canopy formation with the other trees and has an asymmetrical crown as a result. Its lower branches were pruned/ removed to raise up its crown previously.	It requires no immediate attention at present.	20+	B1	3.7

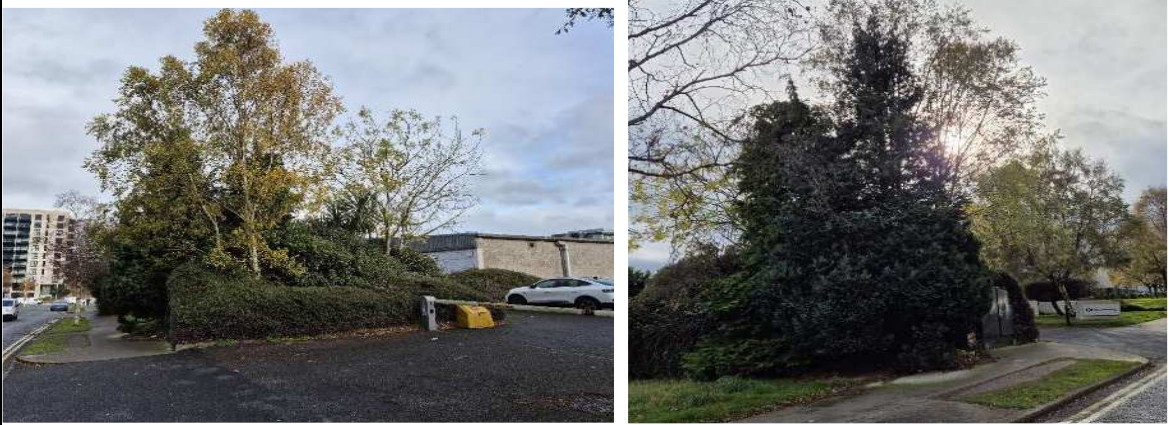
<p>The following two trees are located within this shrub border.</p>											
0310	<b>Birch</b> <i>Betula pendula</i>	12	220 90	3	3	3	4	2	Early Mature	Fair	Fair It is multiple-stemmed from base and has a slightly asymmetrical crown due to its group growing environment. There are shrubs growing around its base and lower crown.	Tidy up undergrowth.	20+	B1	2.8
0311	<b>Lawson Cypress</b> <i>Chamaecyparis lawsoniana</i>	10	230	2	1.5	1	1	0	Early Mature	Fair/ Good	Fair It forms part of a group and is slightly asymmetrical as a result. It has a conical habit and branch formation to ground level. Its lower branches are growing out over the public footpath obstructing the footpath.	It would benefit from pruning of its lower branches to raise up its crown to open up the area underneath and to open up the public footpath.	20+	C2	2.8

0312	<b>Lawson Cypress cv</b> <i>Chamaecyparis lawsoniana cv</i>	9	190	2	1	1	1	0	Early Mature	Fair	Fair It is growing within a group environment and the lower branches are being suppressed out due to competition.	It would benefit from the removal of its lower branches to open up the area underneath and cut back undergrowth.	20+	C2	2.3
0313	<b>Ash</b> <i>Fraxinus excelsior</i>	4	180 140	1	0.5	0	0.5	2	Semi Mature	Fair/ Poor	Poor As part of management and restoration of the shrub border,	<10	U	2.7

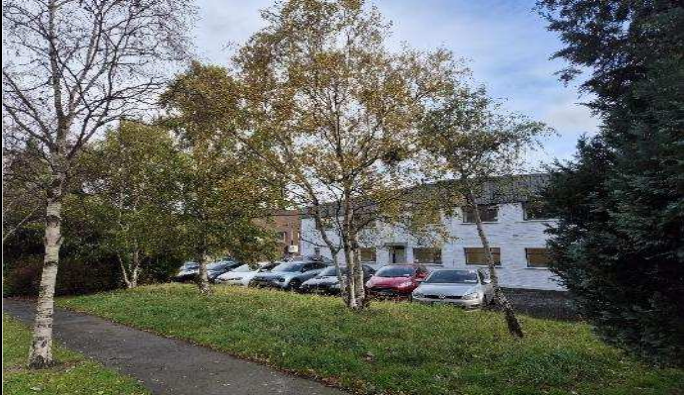
The following trees are growing in a line on a wide grass margin/ verge.

0315	<b>Birch</b> <i>Betula pendula</i>	5	100	2	0	1	1	2	Semi Mature	Fair/ Poor	Poor It is of poor structure/ quality and is leaning. There is bark wounding at its base with some decay developing into the underlying timber. It has limited potential.	It requires no work at present but may possibly need to be <b>removed</b> in the short term as part of management.	<10	U	1.2
0316	<b>Birch</b> <i>Betula pendula</i>	10	160 120 100	3	3	3	4	2	Early Mature	Fair/ Good	Fair It is multiple stemmed from base and basal suckers have been maintained. Its lower branches have been pruned/ removed to raise up its crown.	It requires no work at the present time.	20+	B1	2.7

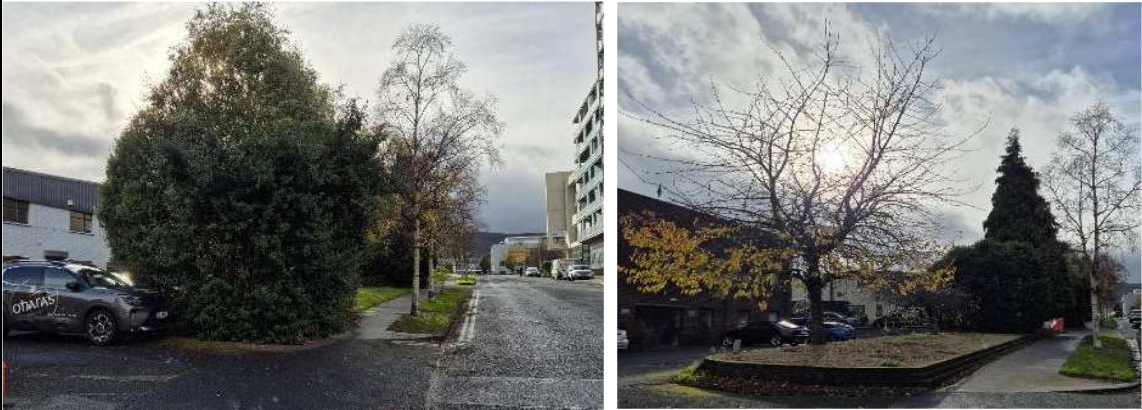
0319	<b>Lawson Cypress</b> <i>Chamaecyparis lawsoniana</i>	12	400 300 240	3	2	2	2	0.5	Early Mature	Fair/ Good	Fair It is located in a raised planter and is beginning to cause some structural damage to the brick	It may require some pruning of its lower branches for clearance.	20+	B1	6.6

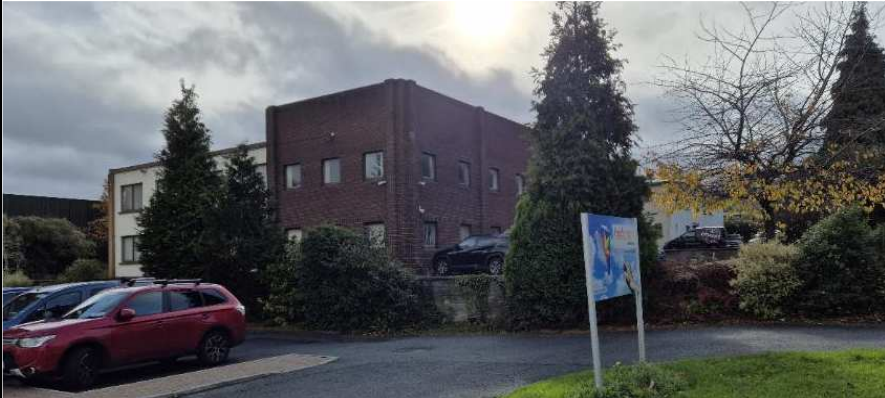
<b>The following trees are located in this shrub border.</b>					
0324	<b>Lawson Cypress</b> <i>Chamaecyparis lawsoniana</i>	9	300	1	1	2	2	0	Semi Mature	Fair/Good	Fair It has a good conical habit and is growing tight to the boundary retaining wall which may lead to structural damage to the wall in the long term. The boundary wall may restrict root development and have an impact on its stability. Its lower branches were trimmed in to	Monitor the boundary wall for damage and any stability issues.	10+	C1	3.6

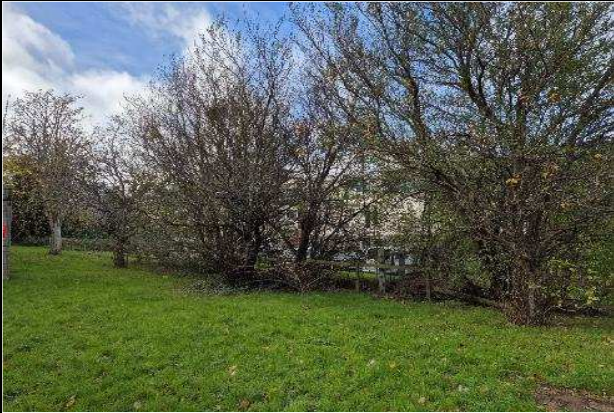
0330 - 0331	<b>Cherry Plum</b> <i>Prunus cerasifera</i>	A6 6	A50 60 60 40	A2 2	A2 3	A2 2	A2 3	A0 0	Semi Mature	Fair	Fair/ Poor They are suckering from a planted tree that was here once and this has been allowed to established due to lapsed management. They have a bushy undergrowth.	They require no work at the present time.	10+	C1	1.0 1.1

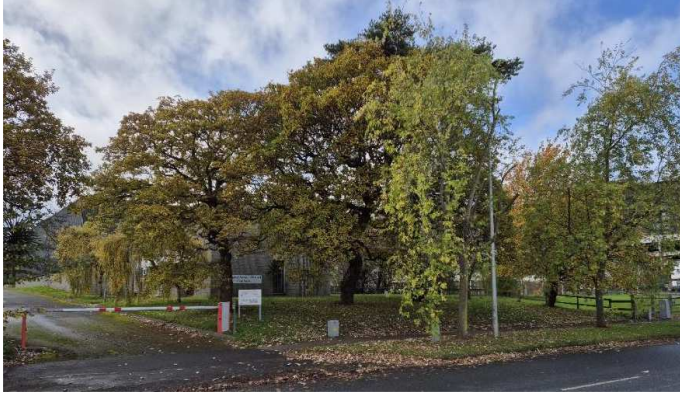
0332	<b>Whitebeam</b> <i>Sorbus aria</i>	12	470	7	4	6	5	1.8	Mature	Fair	Fair It sub-divides at a height of c. 1.6m into multiple-stems and it has a low crown although its lower branches were pruned/ removed previously to raise up its crown. It has a slight lean on its main trunk.	It will require further pruning of its lower branches for clearance with the surrounding surfaces.	20+	B2	5.6
0333	<b>Rowan</b> <i>Sorbus aucuparia</i>	9	280	3	3	2	4	2	Mature	Poor	Poor It is in declining health with large areas of dead bark and decay developing on its main trunk.	It will need to be <b>removed</b> as part of management.	<10	U	3.4

0334	<b>Rowan</b> <i>Sorbus aucuparia</i>	6	220	1	0	1	0	2	Mature	Dead	Poor It is becoming decayed/ unstable.	It will need to be <b>removed</b> as part of management.	<10	U	2.6
0335	<b>Swedish Whitebeam</b> <i>Sorbus intermedia</i>	8	230	2	3	3	3	1.0	Mature	Fair	Fair It is suckering heavily from base.	It requires no work at the present time.	10+	C1	2.8
0336	<b>Scots Pine</b> <i>Pinus sylvestris</i>	16	690	6	4	6	3		Mature	Fair	Fair It is a prominent, visual tree that forms part of the group canopy formation with a slightly asymmetrical open crown I suspect due to a	Make safe large pieces of dead/ unstable growth and prune in heavy exposed side branches by up to 2m to reduce weight	20+	B2	8.3

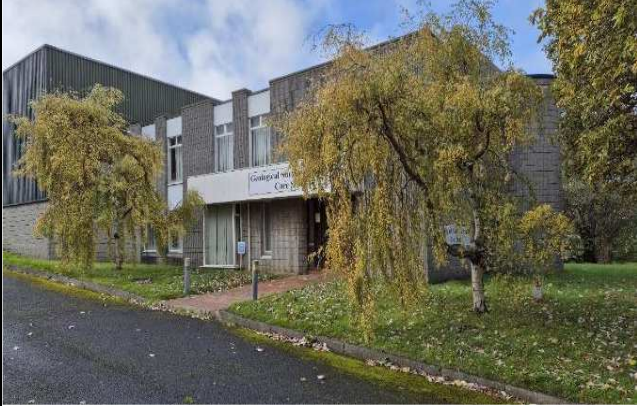
0339	<b>Weeping Birch</b> <i>Betula pendula</i> "Youngii"	4	220	2	3	4	2	1.5	Early Mature	Fair/ Good	Fair It has a good habit and a low crown. There is some bark wounding caused to its base from grass maintenance.	Mulch area around its base to protect its base.	20+	C2	2.6
0340	<b>Weeping Birch</b> <i>Betula pendula</i> "Youngii"	6	210	4	2	3	2	1.8	Early Mature	Fair/ Good	Fair It is located to the left of the entrance of the building. It has a weeping habit and a low crown to near ground level. There is some bark wounding to its base caused during grass maintenance.	It may require some additional pruning of its lower branches for clearance over the surrounding surfaces.  Mulch area around its base to protect its base.	20+	C2	2.5

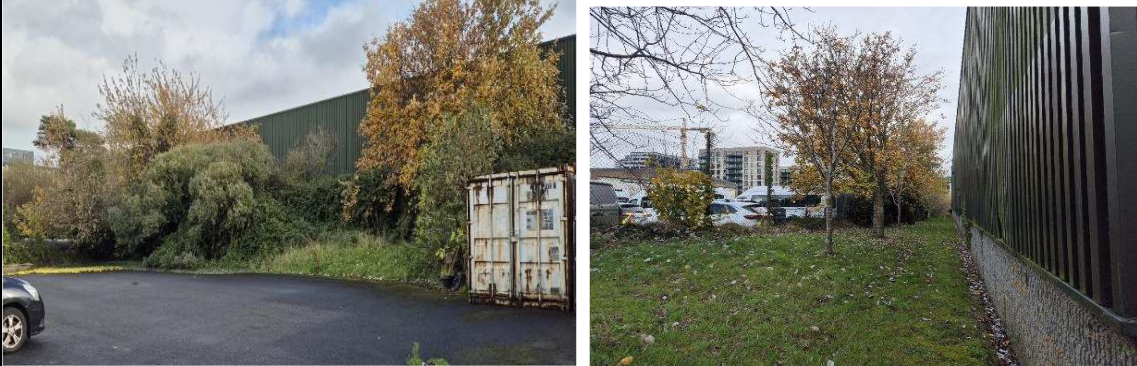
0341	<b>Ornamental Crab Apple</b> <i>Malus 'Golden Hornet'</i>	6	170	3	3	3	1	1.8	Mature	Fair/ Poor	Fair/ Poor It is suckering heavily from base and has a heavy infestation by 'Wooly Aphid' on its main trunk and branches. Its crown structure development has been affected due to overcrowding.	Remove basal suckers and retain as part of bulking.  Cut back competing vegetation where possible.	10-20	C1	2.0
0342	<b>Cherry Plum</b> <i>Prunus cerasifera</i>	9	6st. A260	5	5	5	5	1.8	Mature	Fair/ Good	Fair It is multiple-stemmed from base and is growing up through the fence line which is causing structural damage to some stems and damage to the fence. There is acute union formation between some stems which may lead to structural weakness. It is growing in a group environment.	Tidy up undergrowth.	10-20	C1	7.6

0343- 0345	<b>Cherry Plum (Group)</b> <i>Prunus cerasifera</i>	8  8	200 100 100  100 110 90	4  3	2  2	4  0	2  5	2  1	Mature	Fair/ Good	Fair They are growing in a bushy form and are multiple-stemmed from base with a lot of suckering expanding out the size of this group. They provide bulking in this area between the buildings. There is some debris piled in around their bases. Some of them are growing up	Retain as a group structure and tidy up undergrowth.	10-20	C2	2.9  3.4

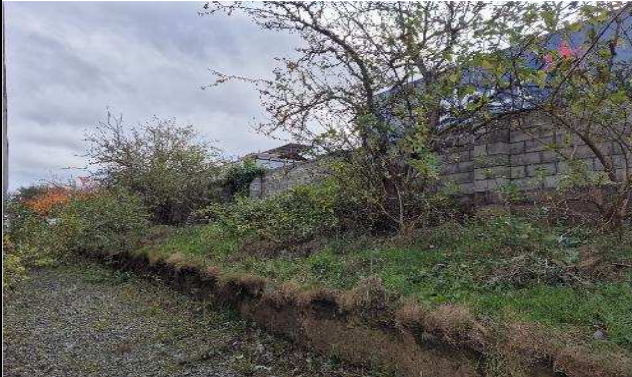
<p><b>The following trees are located on the southern boundary to the back of the GSI Cold Store building.</b> There is a lot of natural regeneration occurring in this area with Bramble and Buddleia predominantly.</p>

0357	<b>Ornamental Crab Apple</b> <i>Malus 'Golden Hornet'</i>	5	160 90 80	2	2	3	3	1.8	Early Mature	Fair/ Poor	Fair/ Poor It is growing on a bank and excavations on its north side have come to within 2.5m of its base possibly causing some root damage. It is suckering heavily from base and its side	Prune lower branches to clear the boundary wall.  Remove basal suckers.	10+	C1	2.4

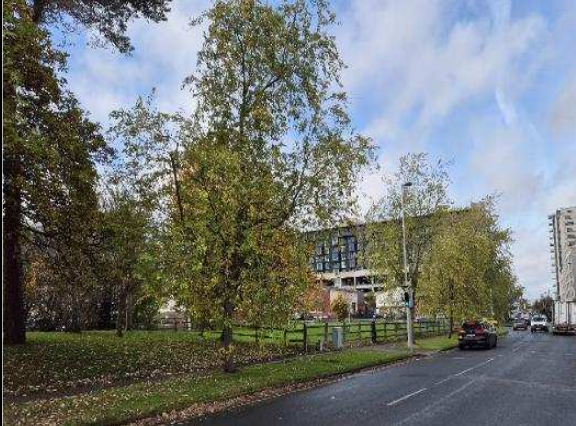
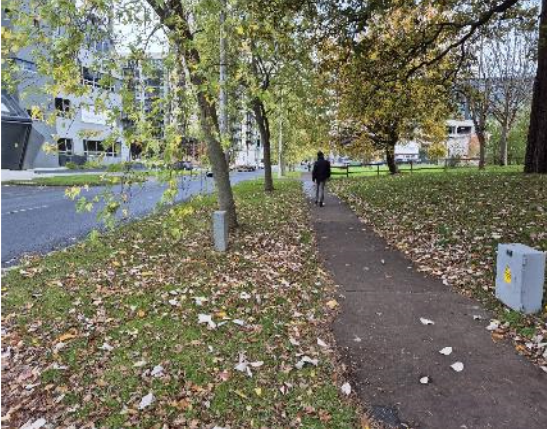
<p>The following trees are located on a wide grass verge running between the roadside kerb and the public footpath on the south side along Carmanhall Road. They have space to develop and they have some value to the treescape of the area.</p>									<p>Mulch area around the base of the trees to protect them from damage during grass maintenance. These trees will require pruning from time to time to maintain clearance over the surrounding surfaces.</p>

0359	<b>Silver Maple</b> <i>Acer Saccharinum</i>	9	300	2	1	2	6	3	Early Mature	Fair/ Good	Fair It is located within 1.5m of a public light pole to its west. It has been heavily cut back in recent times to reduce obstruction of lighting which	It will require further pruning of its lower branches for clearance and pruning of its crown for clearance of the public lighting.	10+	C1	3.6

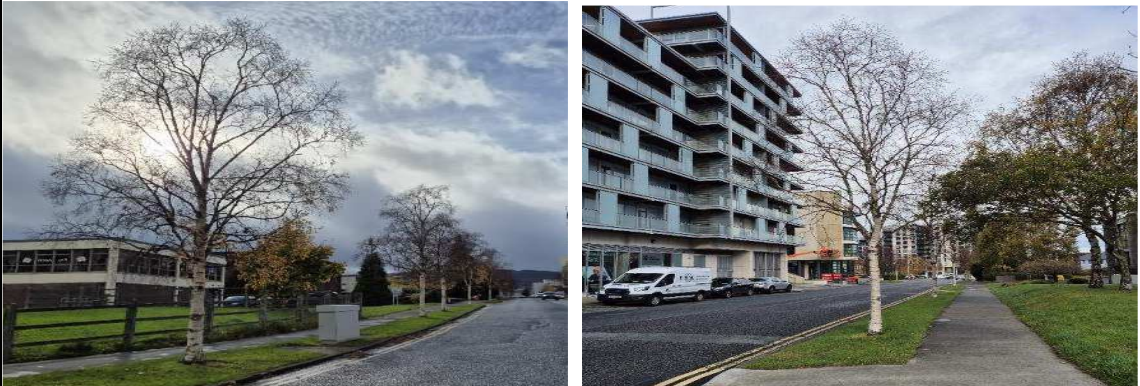
Mulch area around their bases to protect bases and lower trunks from damage during grass maintenance.			
0365	<b>Birch cv</b> <i>Betula cv</i>	8	220	3	2	2	2	2	Early Mature	Good	Fair/ Good There is some bark wounding to its base caused by grass maintenance. Its lower branches were pruned/ removed previously to raise up its crown.	It requires no work at the present time.	20+	B1	2.6
0366	<b>Birch cv</b> <i>Betula cv</i>	8	190	3	3	3	2	3	Early Mature	Fair/Good	Fair/ Good It is centrally located on the grass verge. Its lower branches were pruned/ removed to raise	It requires no work at the present time.	20+	B1	2.3

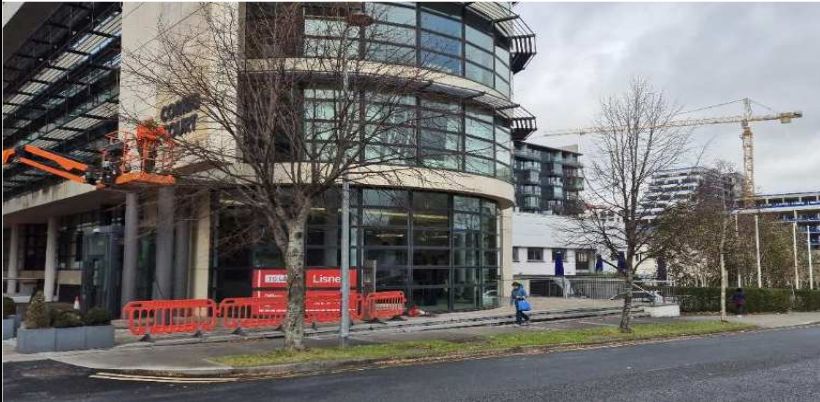
<p><b>The following gives details.</b></p>															
0377	Lime <i>Tilia sp</i>	8	290	4	3	3	4	2	Semi Mature	Fair/Good	Fair It is growing in a narrow grass verge c.1m wide and there is surfacing coming within 1.5m of its base on the south side. This is a confined growing space and it has a public light pole located within 1m of its base on the north side. Its crown is growing around the public light causing obstruction. Its lower branches have been pruned/ removed to raise up its crown previously and there is some epicormic growth up along its main trunk as a result. It will potentially outgrow this space and cause structural damage to the surrounding surfaces.	Remove lower epicormic growth and basal suckers at present.  To alleviate public lighting, it may require excessive pruning.  It will likely require removal in the future as part of management.	10+	C1	3.5

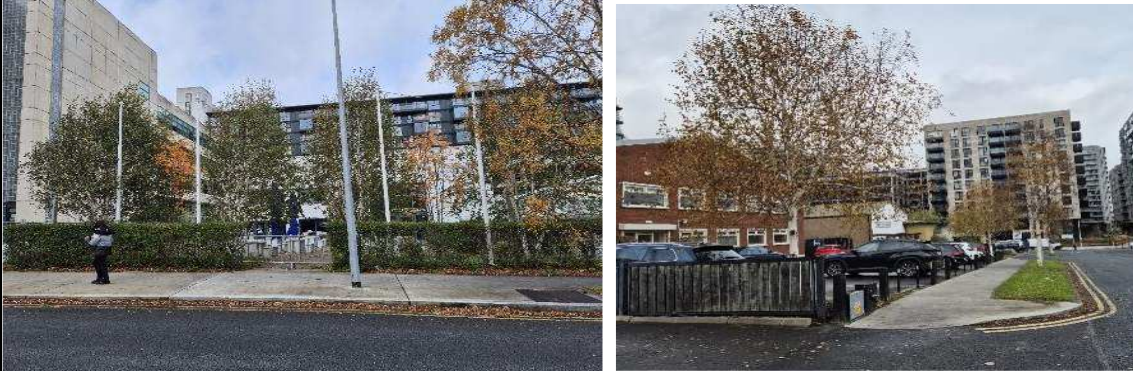
Tree Line No.2	<b>Paper Birch</b> <i>Betula Papyrifera</i> (4 Trees) <b>Rowan cv</b> <i>Sorbus aucuparia cv</i> (2 Trees)	6	160	2	2	2	3	1.6	Semi Mature	Fair/ Good	Fair/ Good They were planted inside hedge No.1 on a soft landscaped area and are multiple-stemmed trees from base. They were planted here to form a screen and have established well.	Management is outside the control of the site area.	20+	C2	1.9
Tree No.1	<b>Birch</b> <i>Betula pendula</i>	6	150	3	2	3	3	2.5	Early Mature	Fair/ Good	Fair It was planted in a small triangular space on the west side of the public footpath in private ownership. It is establishing well and its lower branches were pruned/ removed to raise up its crown.	It will require further pruning of its lower branches for clearance.	20+	C1	1.8

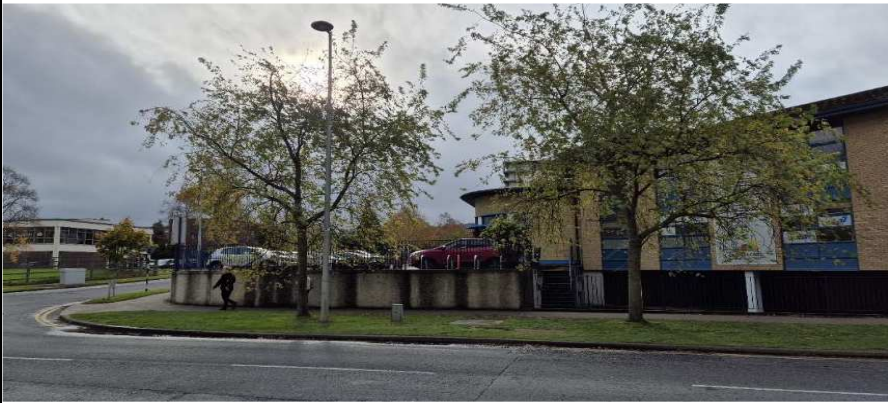
Tree No.	Tree Species	Ht. (m)	Stem Dia. (mm)	Branch Spread (m)				C-Ht. (m)	Age Class	Phys. Con.	Structural Condition Other Comments	Preliminary Recommendation	ULE	Cat. Grade	RPA (radius) (m)
				N	S	E	W								
											N-north S-south E-east W- west C-Ht.-crown height, Dia.-diameter Phys.-physiological. branches were cut back to raise up its crown leaving some stubs.	ULE-useful life expectancy Cat.-category, A-average			
0382	<b>Birch cv</b> <i>Betula pendula cv</i>	9	200	2	2	3	2	3	Early Mature	Fair/ Good	Fair It is located in a 1.5m wide grass verge. Its lower branches were pruned/ removed to raise up its crown with some epicormic growth developing on its main trunk at a height of c.1.8m. It has a public light pole located within 3m of its base to the north so it may cause obstruction of this in the long term.	Remove lower epicormic growth.	20+	B1	2.4
	<p><b>The following two trees are located on Carmanhall Road to the west of the junction with Corrig Road.</b> These trees are growing on a 4m wide grass verge with space to grow and develop. Some of them are located within close proximity to public lighting and there are some junction boxes within this grass verge. They have received pruning previously of their lower branches to raise up their crowns but they still have low crowns.</p>

They will require ongoing pruning of their lower branches for clearance.
