SHB5-LDR -RP-CMK-AR-P3-0001-
Aboricultural Assessment
&
Impact Report

Project No.	Project name	Date	Revision
TLOT003 LAM	Lambs Cross	09/07/24	A

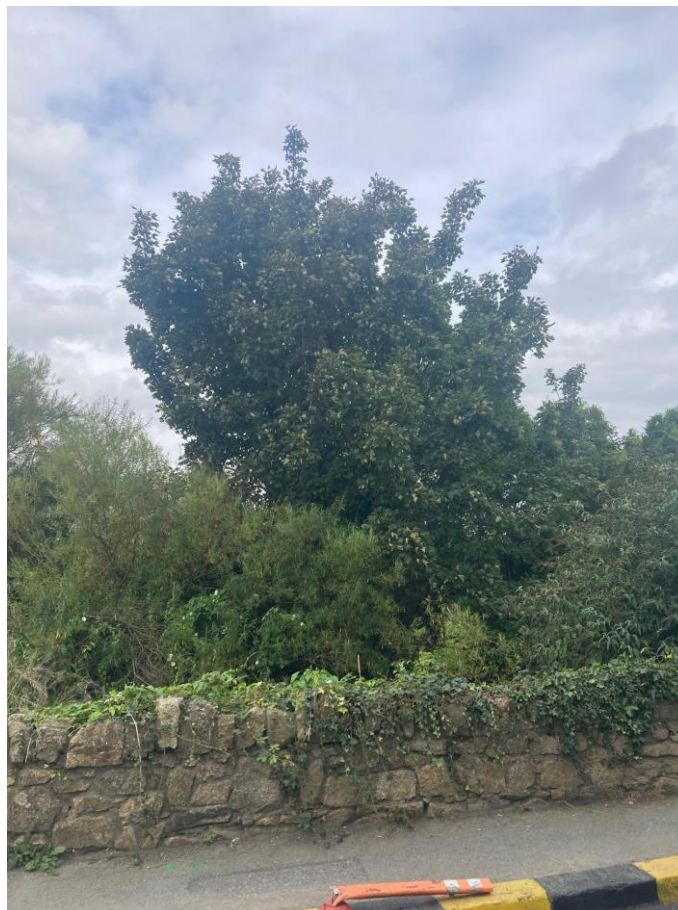
One mature sycamore (*Acer pseudoplatanus*) is located on the eastern boundary on the edge of a stream which is open at this point but culverted along much of its length (image 2). The condition of this tree is good overall and though non-native and considered invasive in certain circumstances provides a degree of screening to and from the subject site. The remaining vegetation on this boundary is scrub crack willow (*Salix fragilis*) of low shrub dimensions.

Image 2. Sycamore #001 on edge of stream on eastern boundary of site. Note shrubby crack willow in foreground.

The mature sycamore #1 on the eastern boundary with the stream will be retained and protected for the duration of the works. The impact of the proposed development and tree protection measures are shown on drawing TLOTLAM01 102 Arboricultural Impact & Tree Protection.

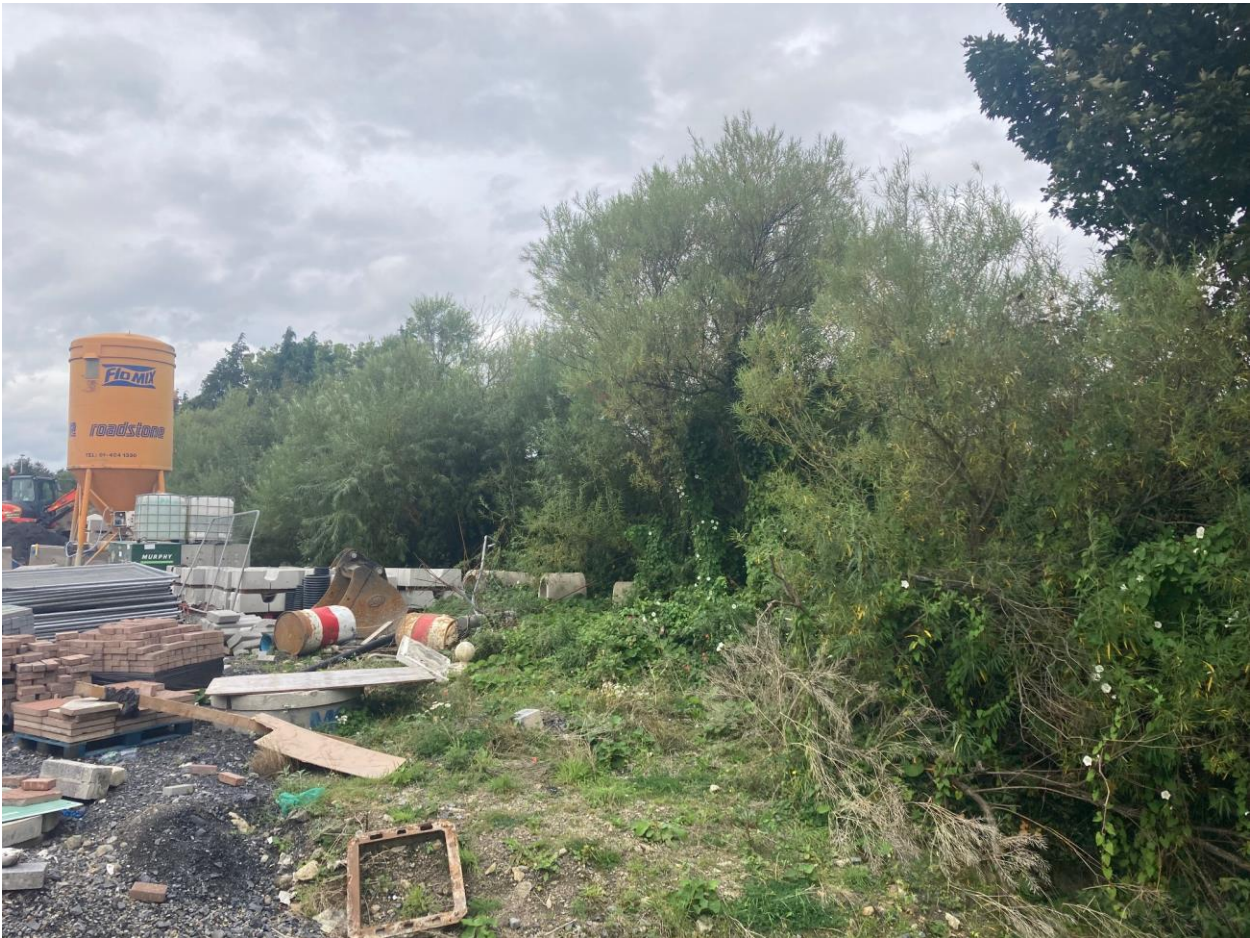
The northern boundary is dominated by crack willow (image 3) which is both scrub-like and more tree-like in size (image 3). The quality of this vegetation is good overall however the nature of this species is for it to be brittle structurally and prone to failure. It has the ability to regenerate from base or when limbs make contact with soil.

Image 3. Crack willow on northern boundary. Note mixed nature of vegetation forming shrubby and more tree-like forms.

This woody vegetation forms a screen to and from the subject site on this section of the northern boundary and is of ecological value due to its status as native species. Its management particularly within the built environment would require periodic coppicing to rejuvenate growth to retain sustainable structurally sound trees / shrubs.

The proposed development will necessitate the removal of all the scrub vegetation on the northern boundary of the site. The Leyland cypress hedge / tree planting which overhangs the site from the Lambs Brook housing development will be cut back to facilitate works and allow light to the residents in this area of the development.

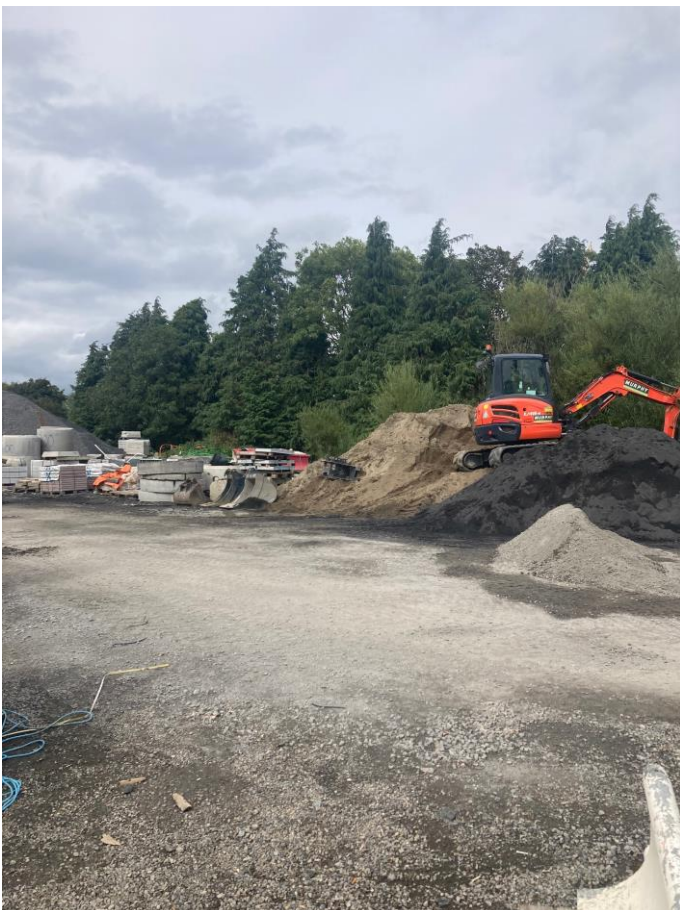
The western section of the northern boundary contains a line of Leyland cypress which appear to be within the open space area of the Lamb's Brook housing development (image 4).

Image 4. View of Leyland cypress on northern boundary from existing site.

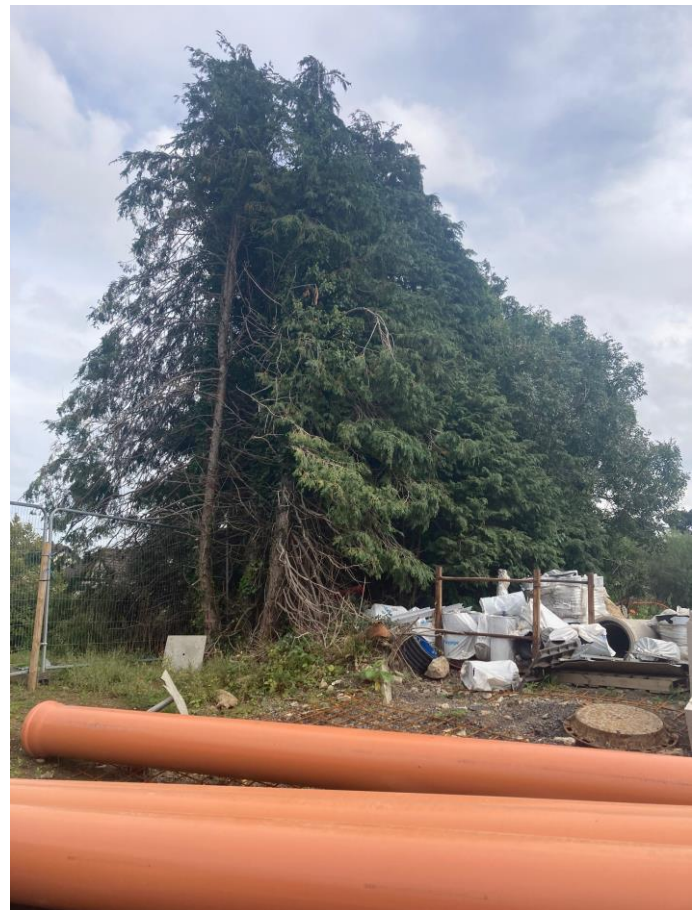
The subject site is a storage area for the construction works and has encroached on the cypress (image 5). There is no evidence of damage to these trees and it was not possible to determine if roots extend into or if they were restricted in any way from entering the subject site.

Image 5. View of Leyland cypress on northern boundary from the western edge of the site.

It is recommended that following the removal of the stored material from this area that a determination is made to establish the potential for roots entering the subject site and if any damage occurred from the storage of materials or other activities in this area.
