Re: An Arboricultural Assessment of the Tree Vegetation within the Site Area for 'Pond 2A' on Lands at Cherrywood, Dublin 18.

An Arboricultural Assessment of the Tree Vegetation within the Site Area for 'Pond 2A' on Lands at Cherrywood, Dublin 18.

Prepared for: Roughan & O'Donovan

Date: 9th December 2020

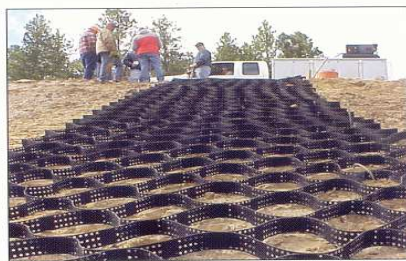
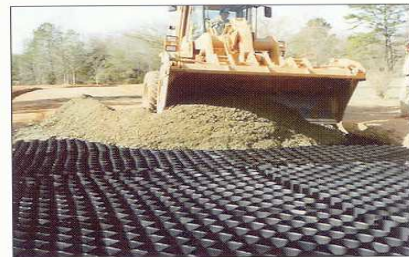
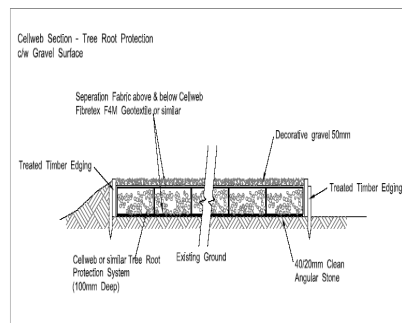
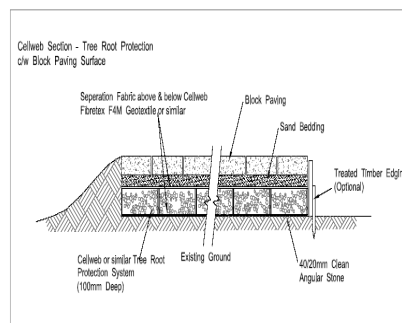
Pictures show the Cell Web being installed on the ground.

The below diagram shows how the Cellular confinement system should be installed.

The service road running along hedge Nos.4 & 5 is to be installed using a 'No-Dig' methodology where this road surfaces will be brought in over the existing ground levels with no excavation for a sub base and a product such as 'CellWeb' or similar is to be incorporated into its build to provide support and protection to the underlying soil and roots. This is to be installed to the recommendations of the project engineers in consultation with the project arboriculturist. See 'Section 6.7' of this report for general guidance on the installation of the 'CellWeb'. It is my understanding that the surface on this service road will be gravel which will allow free movement of air and moisture to the soil and roots below.
