# Renovation and extension of No. 9 George's Place, Kelly's Avenue, Dún Laoghaire

## DEMOLITION JUSTIFICATION STATEMENT

February 2025

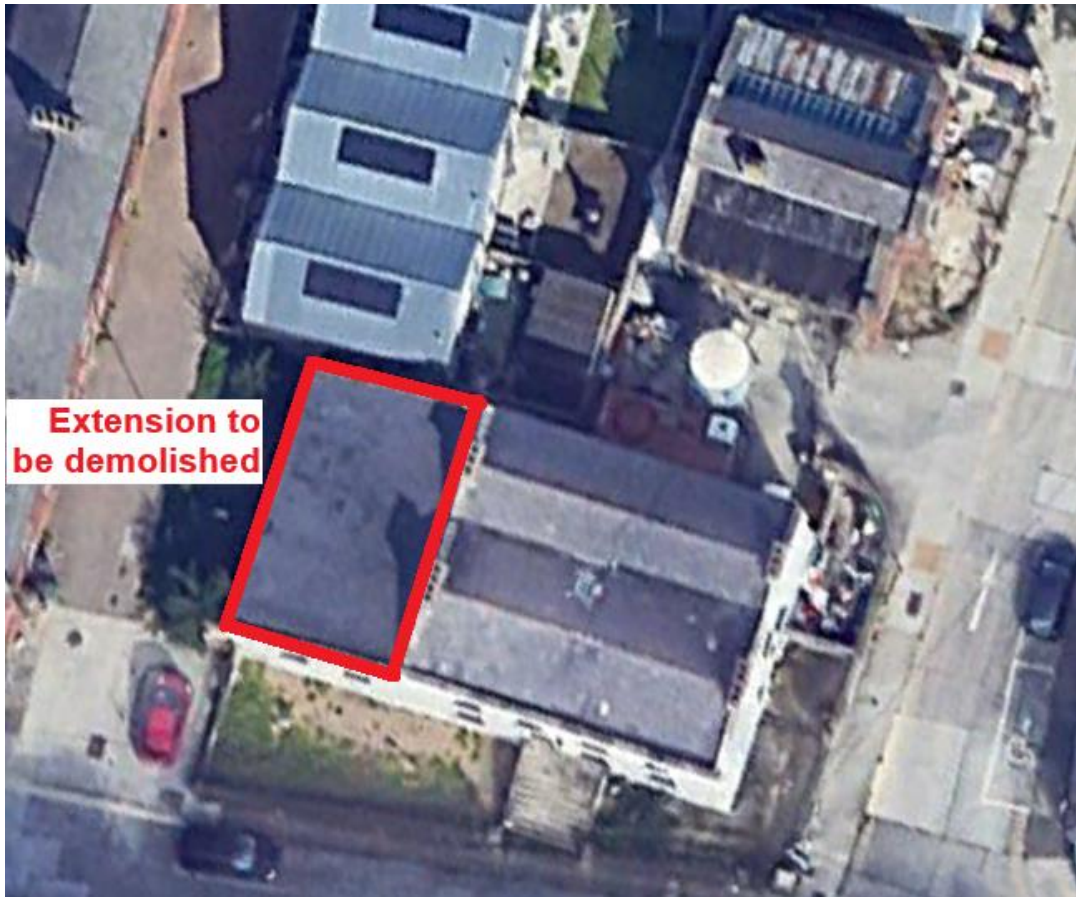
**Figure 3:** Side extension, highlighted, which is proposed to be demolished

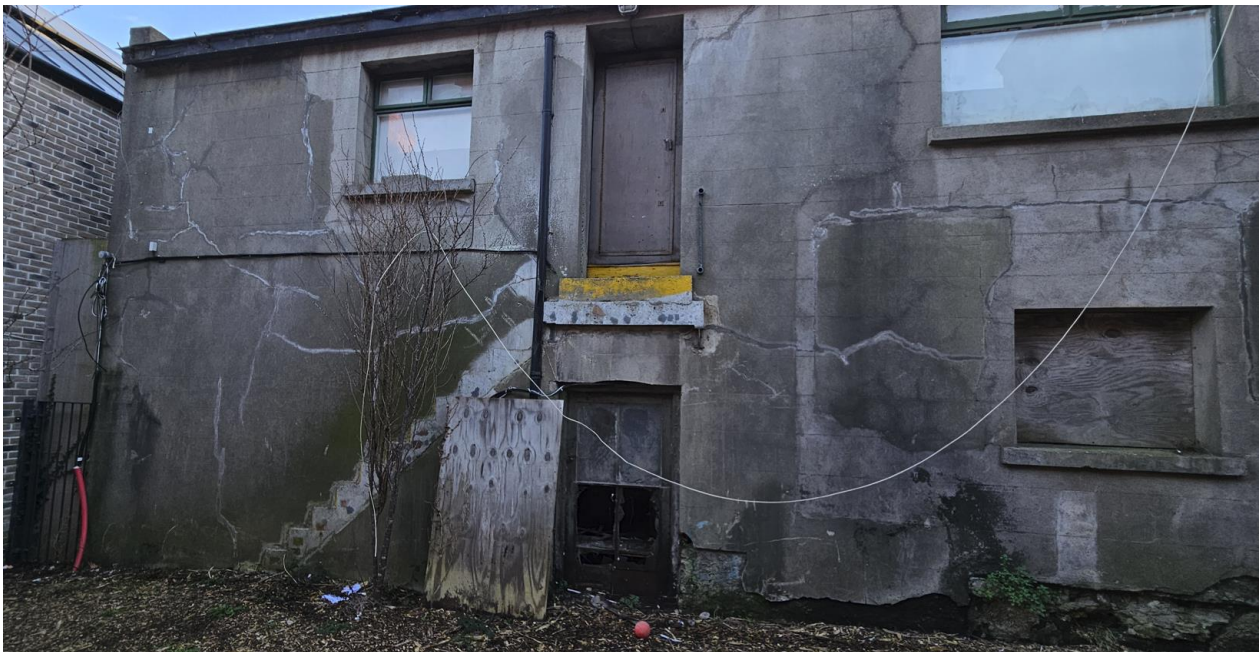
**Photo 4.** External side view of extension with plywood removed

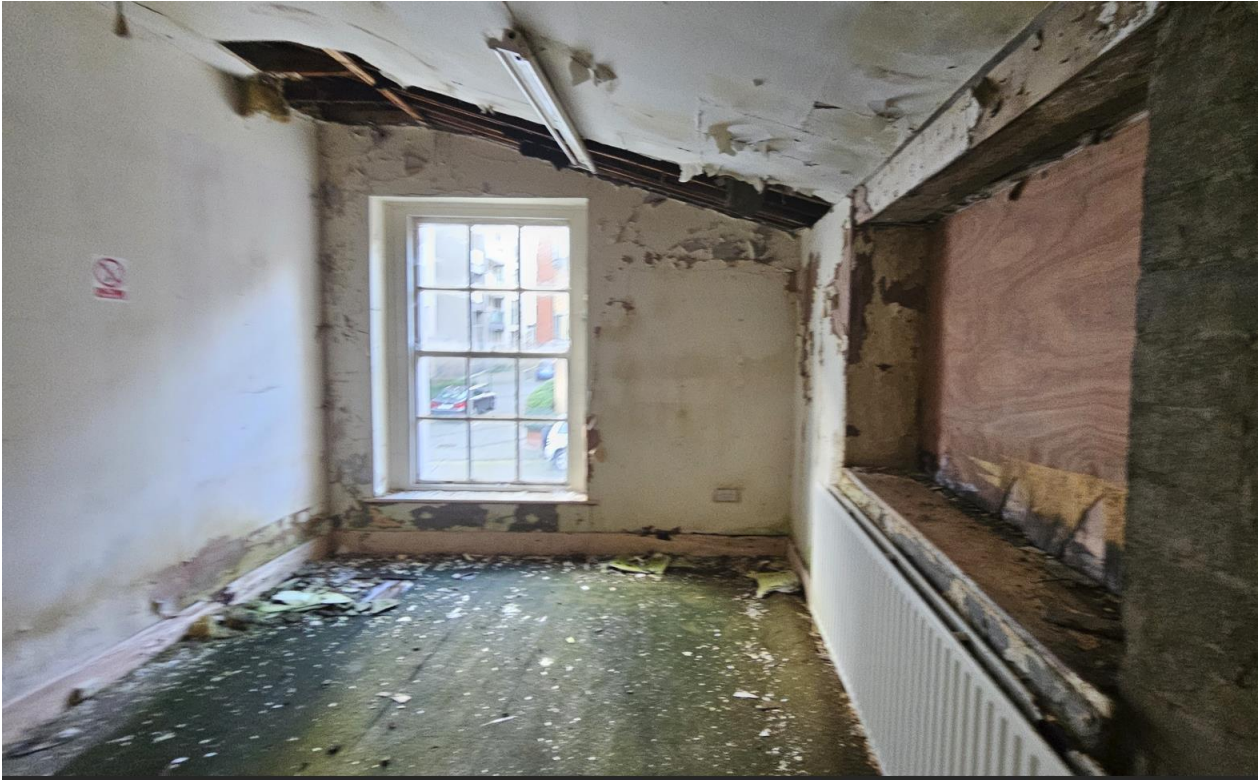
**Photo 5.** Internal floor of extension (First floor – front). Water damage has caused hole in floor

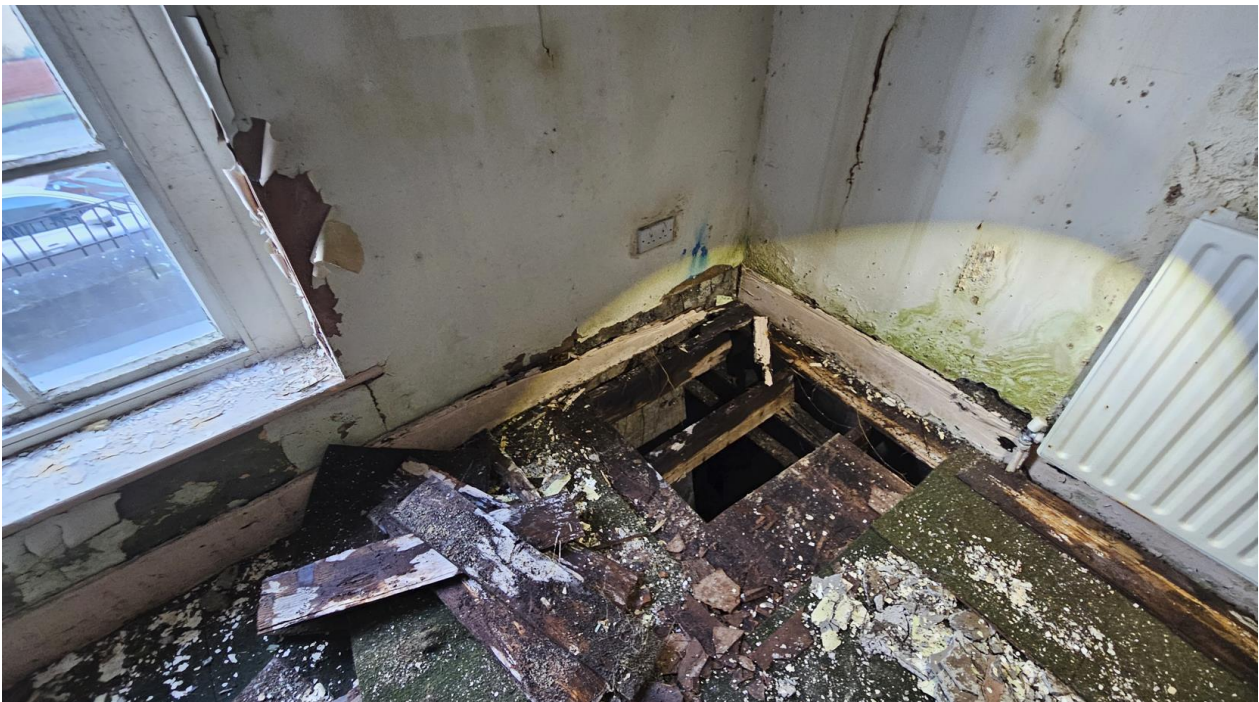
**Photo 6.** Internal floor of extension (First floor – front). Close up of hole in floor

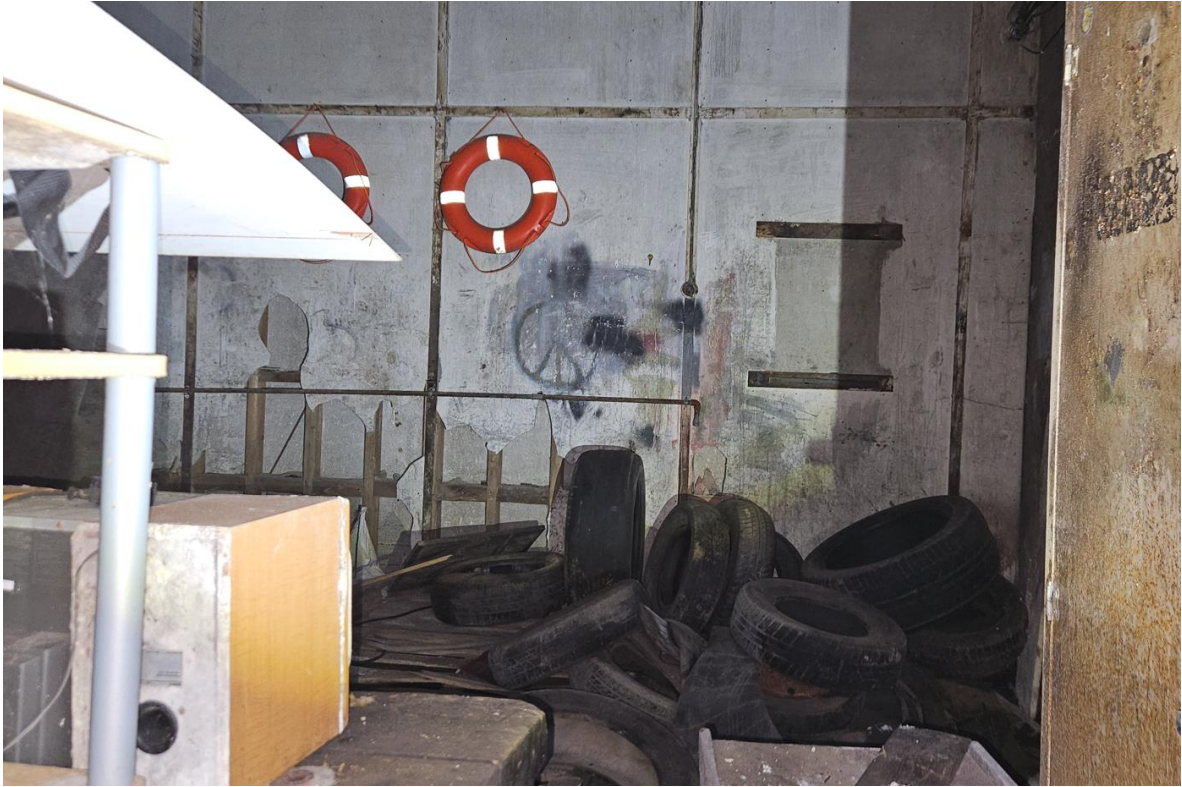
**Photo 7.** Internal floor of extension (Ground floor)

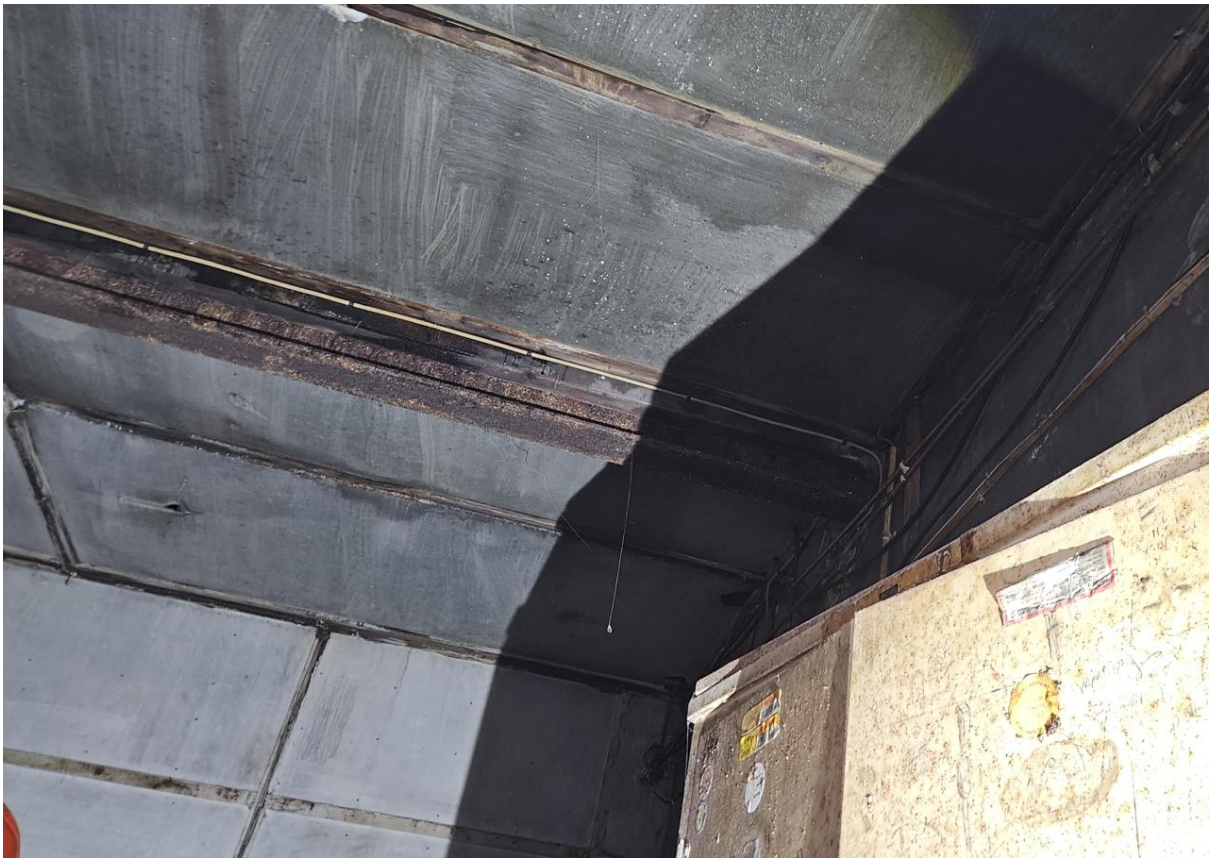
**Photo 8.** Internal ceiling of extension (Ground floor) – Serious corrosion to steel beam evident
