Re: An Arboricultural Assessment of the Site Area for the Sports Facility Project at 'Shanganagh Park', Shankill, Dublin 18.

An Arboricultural Assessment of the Site Area for the Sports Facility Project at 'Shanganagh Park', Shankill, Dublin 18.

Condition Tree Assessment

A Condition Assessment of the Trees within the site area at 'Shanganagh Park', Shankill, Dublin 18.

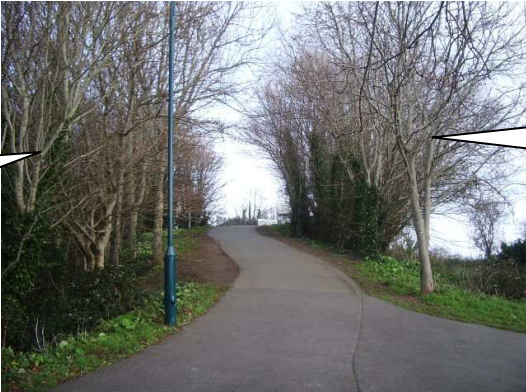
Tree Group No.3	Ash <i>Fraxinus excelsior</i> Sycamore <i>Acer pseudoplatanus</i> Larch <i>Larix decidua</i>	A 8	A 230	A 3	A 3	A 3	A 3	Semi Mature	Fair/ Good	Fair This tree group is growing on the opposite side of the path to Tree Group No.2 and it has also colonized the embankment in this area. It is a prominent group of trees and it has an upper canopy of Ash, Cherry and Sycamore with some Larch in places and Field Maple dominating the lower canopy with Bramble throughout the	Remove any dead/ unstable growth that endangers the public footpath to the north. Continue current maintenance to maintain clearance with the public footpath to the north.	40+	B2
