Ref: SGPP079656677

Re: An Arboricultural Assessment of the Site Area for the Sports Facility Project at 'Shanganagh Park', Shankill, Dublin 18.

An Arboricultural Assessment of the Site Area for the Sports Facility Project at 'Shanganagh Park', Shankill, Dublin 18.

Condition Tree Assessment

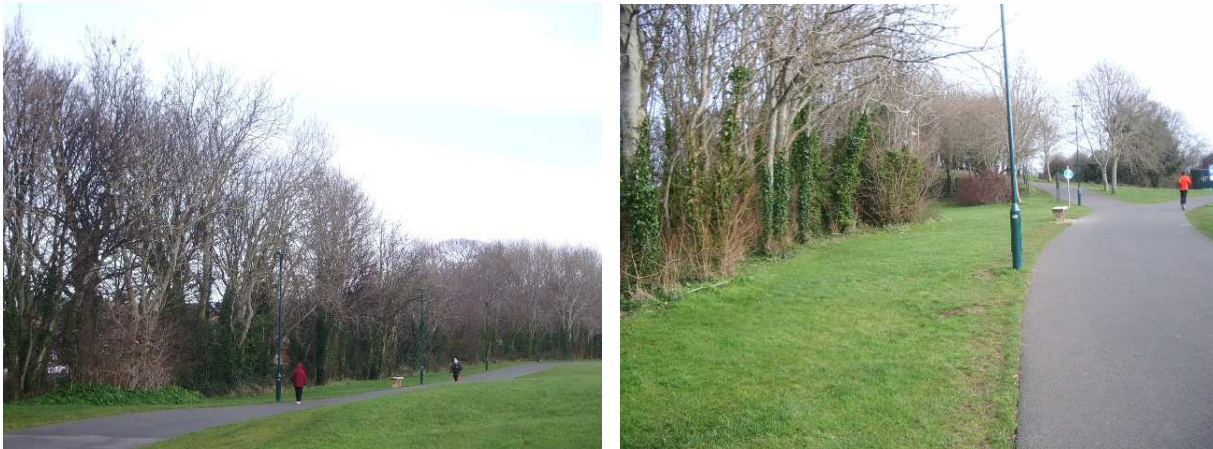
Tree No.	Tree Species	Ht. (m)	Stem Dia. (mm)	Branch Spread (m)				C-Ht. (m)	Age Class	Phys Con.	Structural Condition Other Comments	Preliminary Recommendation	Remaining years	Category Grade
				N	S	E	W							
										N-North S-South E-East W-West Ht.- Height C- Crown Phy Con.- Physiological Condition	A- Average Dia.- Diameter Cat.- Category			
	<i>monogyna</i> Bramble <i>Rubus fruticosus</i>									respectively. They have value as screening in this area. These trees are growing as one coherent group with a combined group canopy formation and they are dependent on each other for support/shelter. Their category grade is based on the merits of the tree belts as a whole and not as individual trees.	Dieback' (<i>Hymenoscyphus fraxineus</i>) disease.			
		Tree Belt No.1

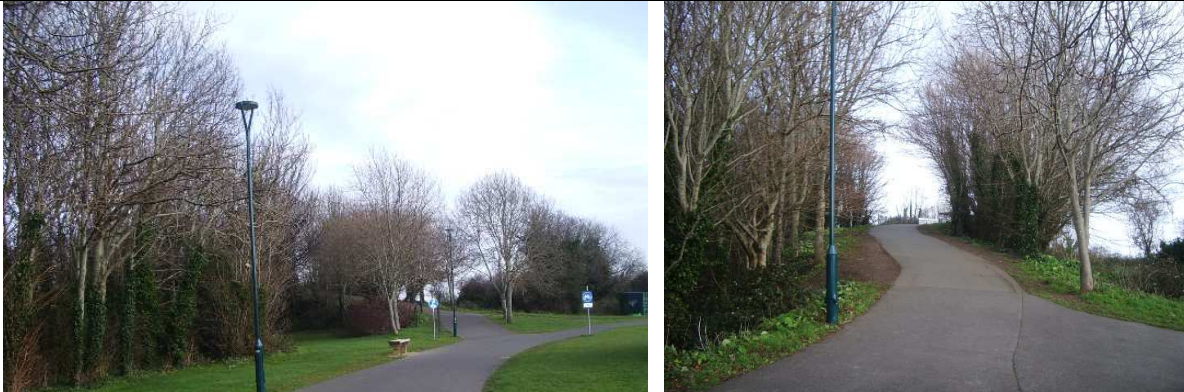
1306	Ash <i>Fraxinus excelsior</i>	10	310	4	4	4	4	2	Early Mature	Fair/ Good	Fair It is growing in the triangular shaped grass area that divides the paths and its crown overhangs the public paths in this area. It is a single-stemmed tree that divides into two stems at a height of c.2m with an acute union formation between stems with included bark present and this may develop into a structural weakness as the tree grows in size. Soil alterations have occurred around its base and its lower branches have been removed in order to raise up its crown with good callous growth around these wounds.	Maintain a larger weed-free area around its base with mulch. It will require formative pruning to address structural issues.	40+	B1

1307	Ash <i>Fraxinus excelsior</i>	10	290	5	5	5	3	2	Early Mature	Fair/ Good	Fair It is growing in the triangular shaped grass area that divides the paths and its crown overhangs the public paths in this area. It is a single-stemmed tree that divides into three stems at a height of c.2m. Soil alterations have occurred around its base and its lower branches have been removed	Maintain a larger weed-free area around its base with mulch. Prune lower branches to improve clearance over paths for high-sided vehicles.	40+	B1

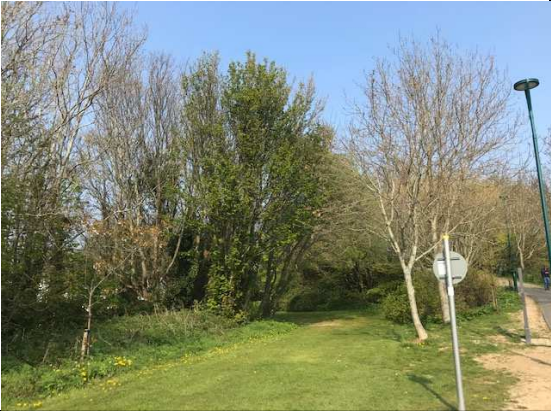
Tree Group No.2	Ash <i>Fraxinus excelsior</i> Sycamore <i>Acer pseudoplatanus</i> Beech <i>fagus sylvatica</i> Field Maple <i>Acer campestre</i> Alder <i>Alnus glutinosa</i> Poplar <i>Populus sp.</i>	A 8	A 220	A 3	A 3	A 3	A 3	A 3	Semi Mature	Fair/ Good	Fair It consists of a group of trees located on the north side of the public footpath that leads to the pedestrian bridge over the railway line and it has colonized the embankment in this area. It is a prominent group of trees in this area and it has an upper-canopy of Ash, Sycamore, and Larch with some Alder, Poplar and Beech in places. The lower-canopy consists of Field Maple predominantly with some Dogwood in places and Bramble throughout the undergrowth. There is a narrow linear strip of grass dividing this tree group from the public footpath and their lower branches have been pruned to provide clearance in this	Remove any dead/unstable growth that endangers the public footpath to the south. Continue current maintenance to maintain clearance with the public footpath to the south. They would benefit from light selective thinning to allow the better quality trees space to develop. It would also benefit from infill planting with additional	40+	B2

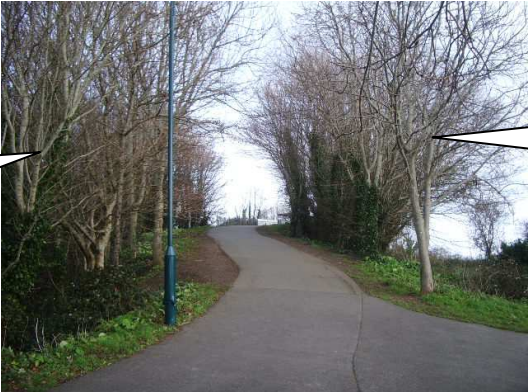
Tree Group No.3	Ash <i>Fraxinus excelsior</i> Sycamore <i>Acer pseudoplatanus</i> Larch <i>Larix decidua</i>	A 8	A 230	A 3	A 3	A 3	A 3	Semi Mature	Fair/ Good	Fair This tree group is growing on the opposite side of the path to Tree Group No.2 and it has also colonized the embankment in this area. It is a prominent group of trees and it has an upper canopy of Ash, Cherry and Sycamore with some Larch in places and Field Maple dominating the lower canopy with Bramble throughout the	Remove any dead/ unstable growth that endangers the public footpath to the north. Continue current maintenance to maintain clearance with the public footpath to the north.	40+	B2

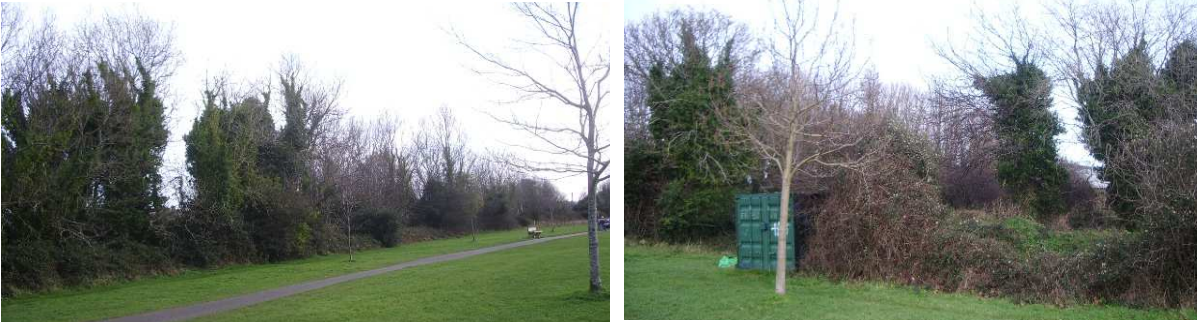
contain the width of the hedge structure and improve the structure of the hedge.		
The following trees are located within Hedge No.1.															
1311	Ash <i>Fraxinus excelsior</i>	11	300/ 280/ 320	6	4	6	5	3	Early Mature	Fair	Fair It is located at the northern end of Hedge No.1 and it is multiple-stemmed from near base. It has suffered storm damage within its crown on its west side. Heavy Ivy cover is extending into its crown and this increasing the windsail of its crown and restricting the visual assessment to some degree.	Cut Ivy at ground level where heavy and remove to a height of 2m to allow for a more detailed assessment of its base and lower trunk.	20-40	B2

Tree Group No.4	Ash <i>Fraxinus excelsior</i>	A 14	A 240 (4 stems)	A 5	A 5	A 5	A 5	A 3	Early Mature	Fair	Fair It is a prominent group of trees within Hedge No.1. They are growing up as a group with a combined group canopy formation and they depend on each other for support/ shelter. Some of their crowns overhang towards the railway line. Heavy Ivy cover is extending into their crowns and this increasing the windsail of their crowns and restricting the visual assessment to some degree. There is some deadwood within their crowns of a	Remove large size dead/ unstable growth. Cut Ivy at ground level where heavy and remove to a height of 2m to allow for a more detailed assessment of their bases and lower trunks. Their crowns may require pruning away from the	20-40	B2

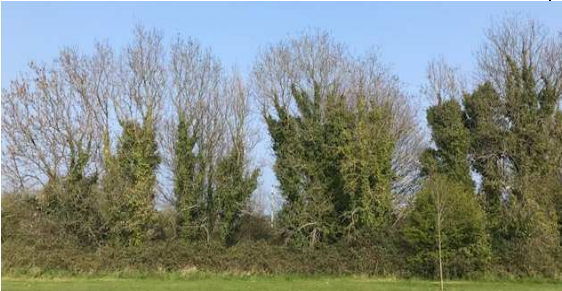
1321	Ash <i>Fraxinus excelsior</i>	10	200 (6 stems)	4	4	5	4	2	Semi Mature	Fair	Fair It is growing at the southern end of Hedge No.1 next to the boundary with the railway line. It is multiple-stemmed from base with light Ivy cover beginning to extend into its crown. Bramble is also growing through its lower crown and it has a small crown overhang toward the railway line.	Cut Ivy at ground level. Its crown may require pruning away from the railway line in the future.	20-40	B1

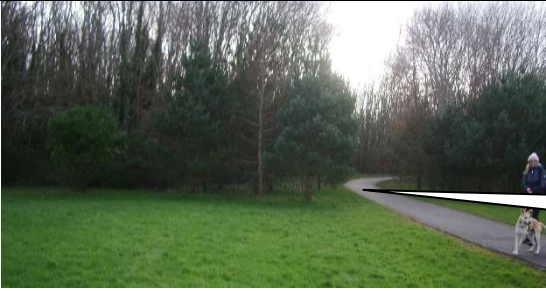
Woodland Block No.1	Ash <i>Fraxinus excelsior</i> Sycamore <i>Acer pseudoplatanus</i> Oak <i>Quercus robur</i> Birch <i>Betula pendula</i> Beech <i>Fagus sylvatica</i> Larch <i>Larix decidua</i> Field Maple <i>Acer campestre</i> Hazel <i>Corylus avellana</i> Horse Chestnut	A 13	A 300	A 4	A 4	A 4	A 4	A 2	Early Mature	Fair/ Good	Fair It is located along the southern boundary of the site area. It is prominent woodland in this area and paths intersect it throughout breaking it up into sub-compartments. Its upper-canopy is made up of predominantly Ash and Sycamore with some Oak, Horse Chestnut, and Larch in places. It has a lower-canopy of Field Maple, Hawthorn and Hazel with some Birch and Beech in places. The understory consists of Bramble and self-seeded trees such as Sycamore and Birch. A lot of these trees have been drawn up for the light due to overcrowding/ competition and this has impacted on their structure. There is some naturally occurring deadwood within their crowns and some trees within have failed due to suppression from the larger neighbouring trees. Their lower branches have been removed to raise up their crowns and provide clearance over the paths and	Remove any dead/ unstable growth that endangers the public footpaths. Continue current maintenance to maintain clearance with the public footpaths. Cut Ivy at ground level where heavy on trees. This woodland block would benefit from ongoing, light, selective thinning to allow the better quality trees space to grow and develop. It would also benefit from infill planting with additional tree species to help further diversify tree	40+	A2

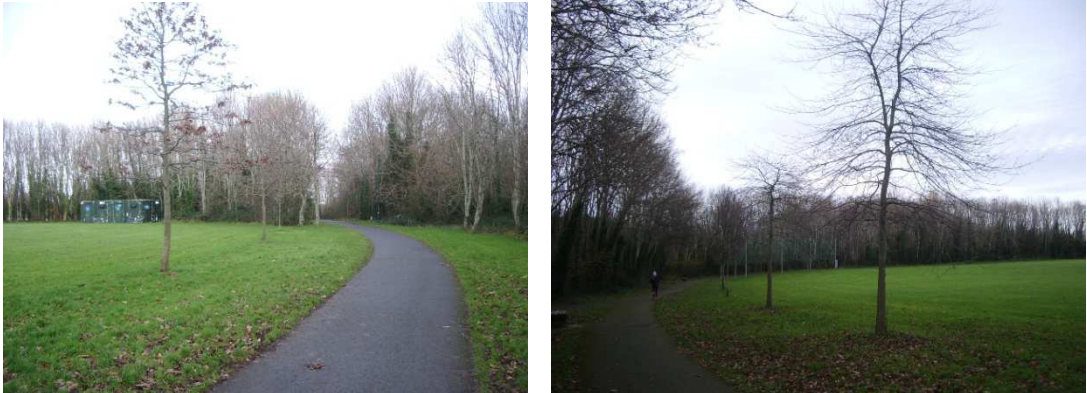
1324	Sycamore <i>Acer</i>	9	270	3	2	4	3	3	Semi Mature	Fair	Fair/ Poor It divides into two stems at a height of c.2m and it	Maintain a larger weed-free area around its base	20+	C1

1326	Scarlet Oak <i>Quercus coccinea</i>	3	60	1	1	1	1	2	Young	Fair/ Poor	Fair/ Poor It moves from base and I suspect it heaved at its root plate before it could properly establish. It has suffered a bark wound on its north side during grass maintenance in this area and decay is developing into the underlying timber at this point.	Maintain a larger weed-free area around its base with mulch. Monitor its stability.	10+	C1
1327	Scarlet Oak <i>Quercus coccinea</i>	5	90	1	1	2	2	2	Young	Fair/ Good	Fair/ Good Its lower branches have been removed in order to raise up its crown and it is establishing well. There are Sycamore seedlings developing at its base.	Maintain a larger weed-free area around its base with mulch. Remove Sycamore seedlings developing at its base.	40+	C1
1328	Scarlet Oak <i>Quercus coccinea</i>	6	100	2	2	2	2	2	Young	Fair	Fair It has suffered a large size bark wound on its west side during grass maintenance in this area and this wounding amounts to c.30% the circumference of the live bark. There is a broken branch within its crown and its lower branches have been removed in order to raise up its crown.	Remove dead/ unstable growth. Maintain a larger weed-free area around its base with mulch.	20+	C1
