Proposed Development of an All-Weather Pitch at Coláiste Eoin/Íosagain PC/PKS/01/18

Appendix 3 – Tree Survey & Report

<u>Re: An Arboricultural Assessment of the Trees on the Site Area for an All Weather</u> <u>Pitch at 'Colàiste Eoin', Stillorgan Road, Booterstown, Blackrock, Co. Dublin.</u>

An Arboricultural Assessment of the Trees on the Site Area for an All Weather Pitch at 'Colàiste Eoin', Stillorgan Road, Booterstown, Blackrock, Co. Dublin.

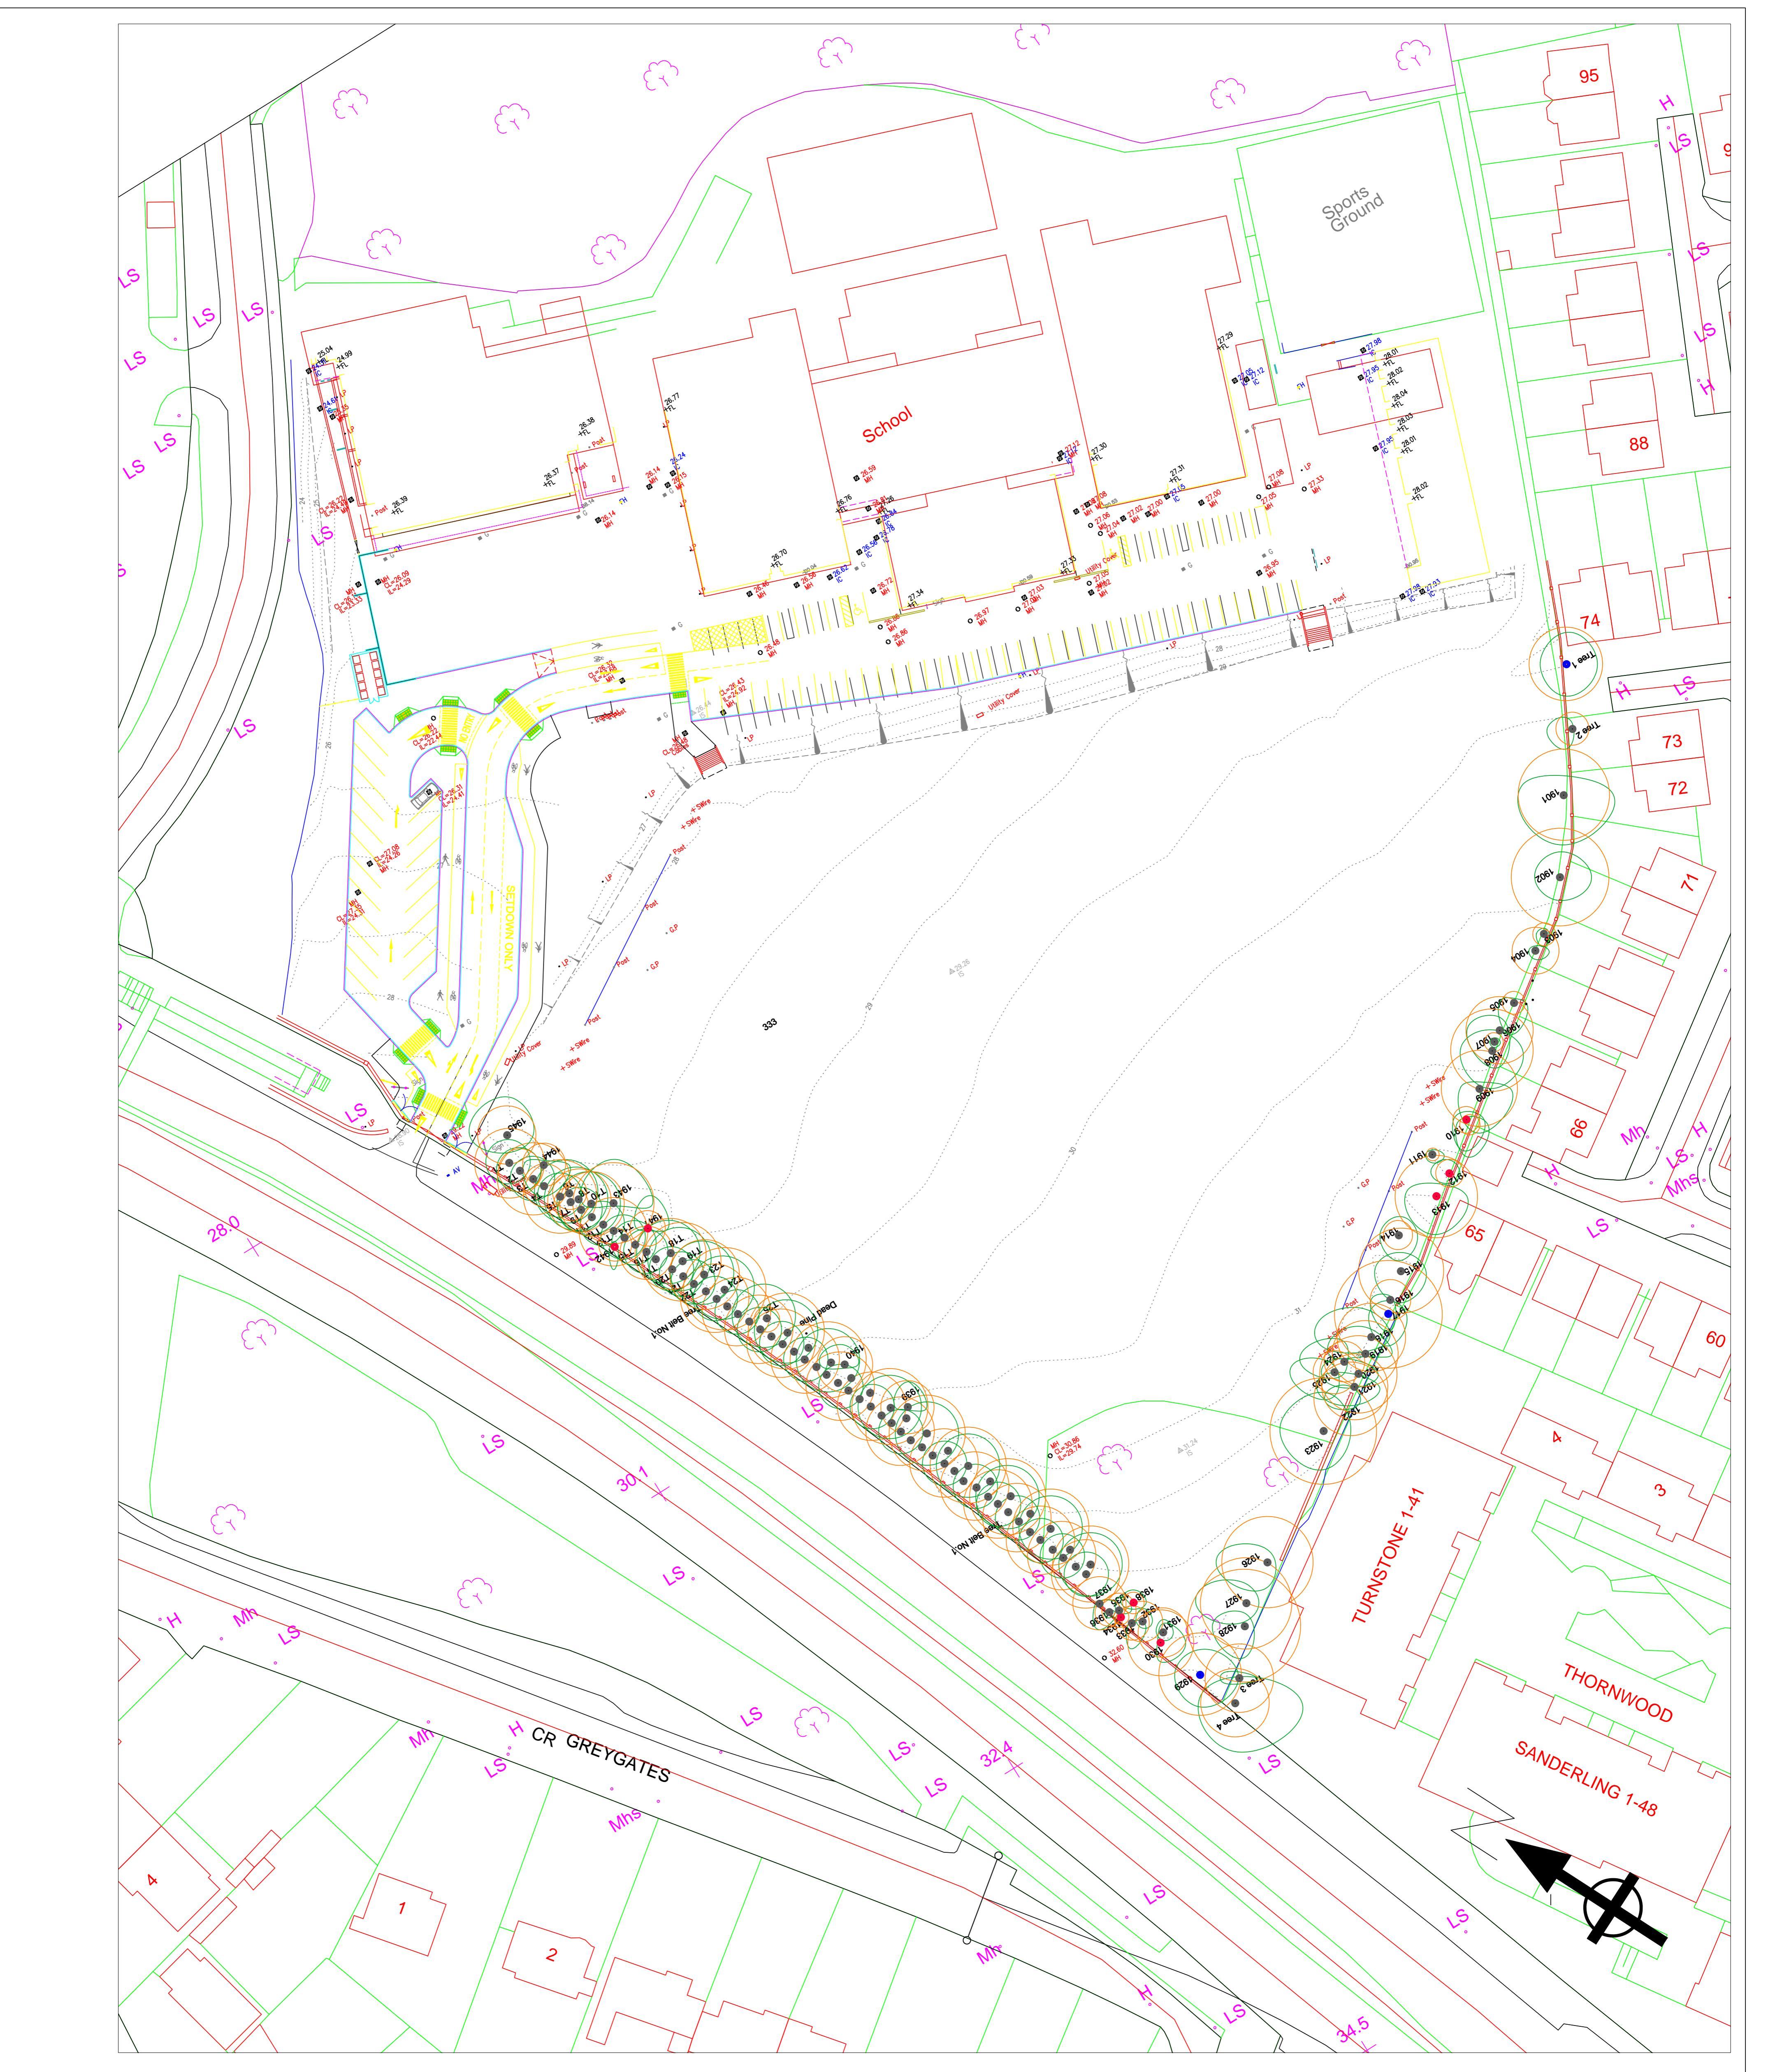
DATE:	Site :	TITLE :	
Dwg No.CES001	All Weather Pitch at Col. Stillorgan, Co. Dublin.	Tree Constraints Plan	EL. 01-27420117007-20230
Scale 1:500 @ A1	aiste Eoin,		ų

- A To assess the present condition of the tree vegetation within this site area. See condition tree assessment schedule within 'Appendix 1' of this report and drawing 'No.CES001' which has been prepared as a constraints drawing for details.

The category 'U' trees have been identified on our drawings (Nos. CES001 & CES002) with a 'Red' donut around their trunk positions. Due to the condition of these trees, they should not be considered a constraint on the design layout of the proposed development of this site area.

The category 'B' trees have been identified on our drawings (Nos. CES001 & CES002) with a 'Blue' donut around their trunk positions.

The category 'C' trees have been identified on our drawings (Nos. CES001 & CES002) with a 'Grey' donut around their trunk positions.

3.5 The trees have been plotted onto the attached drawing (Dwg No.CES001) by a land survey company and their positions are assumed accurate. This drawing has been developed as a constraints drawing to aid the design team in the layout of the development and the tag numbers referred to in the condition tree report have been shown on this drawing along with their crown spreads and their retention category colour coded as recommended by BS 5837 2012. The constraint (Minimum Root Protection Area) for each tree has been shown with an 'Orange Circle' and all proposed development should be planned to be positioned outside those trees proposed for retention allowing for additional space for construction activities.

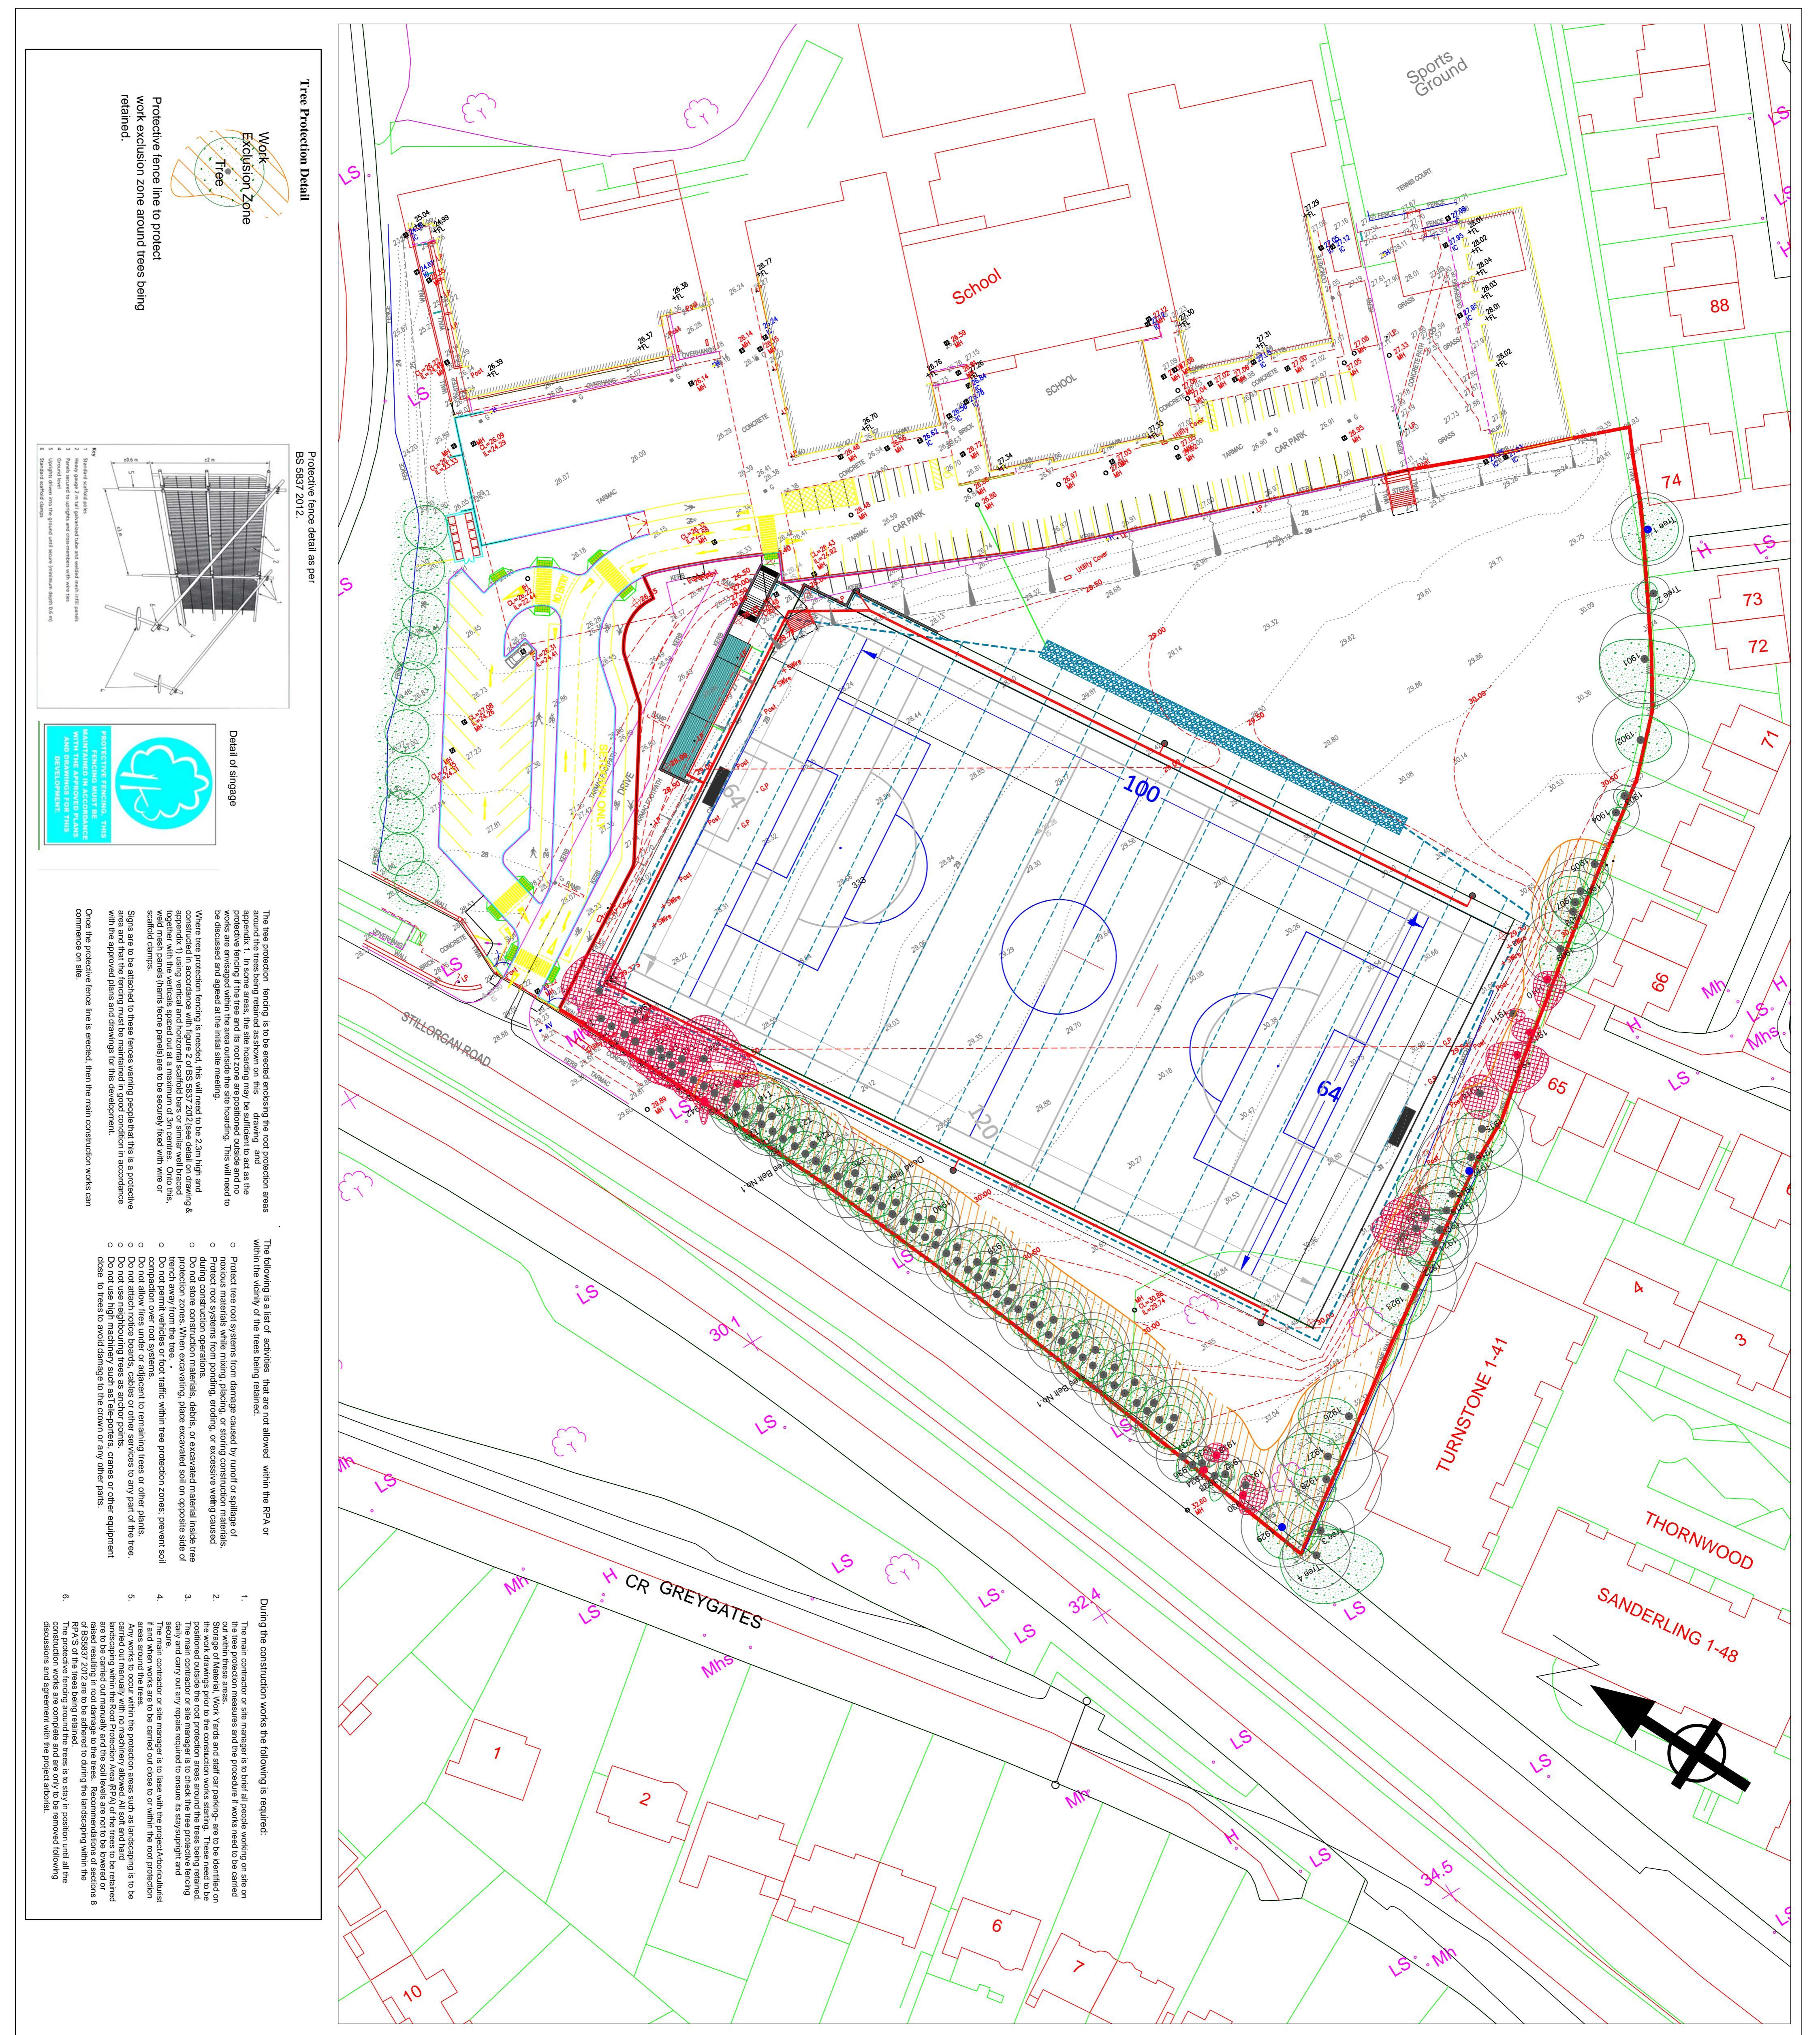
- **B-** To assess the impact of the proposed development layout on the tree vegetation located within and adjoining the site area indicating those for removal and retention. See 'Section 5.0' of this report and 'Drawing No. CES002 for detail.

- **C-** To show on this drawing (No.CES002) the line of protective fencing to be erected around the tree vegetation being retained along with other mitigation measures to aid in their successful retention.
