Re: An Arboricultural Assessment on the Site Area at 'Hyde Park Community Sports Centre', Hyde Road, Dalkey, Co. Dublin.

An Arboricultural Assessment on the Site Area at 'Hyde Park Community Sports Centre', Hyde Road, Dalkey, Co. Dublin.

Prepared for: Dùn- Laoghaire Rathdown County Council

Date: 12th March 2021

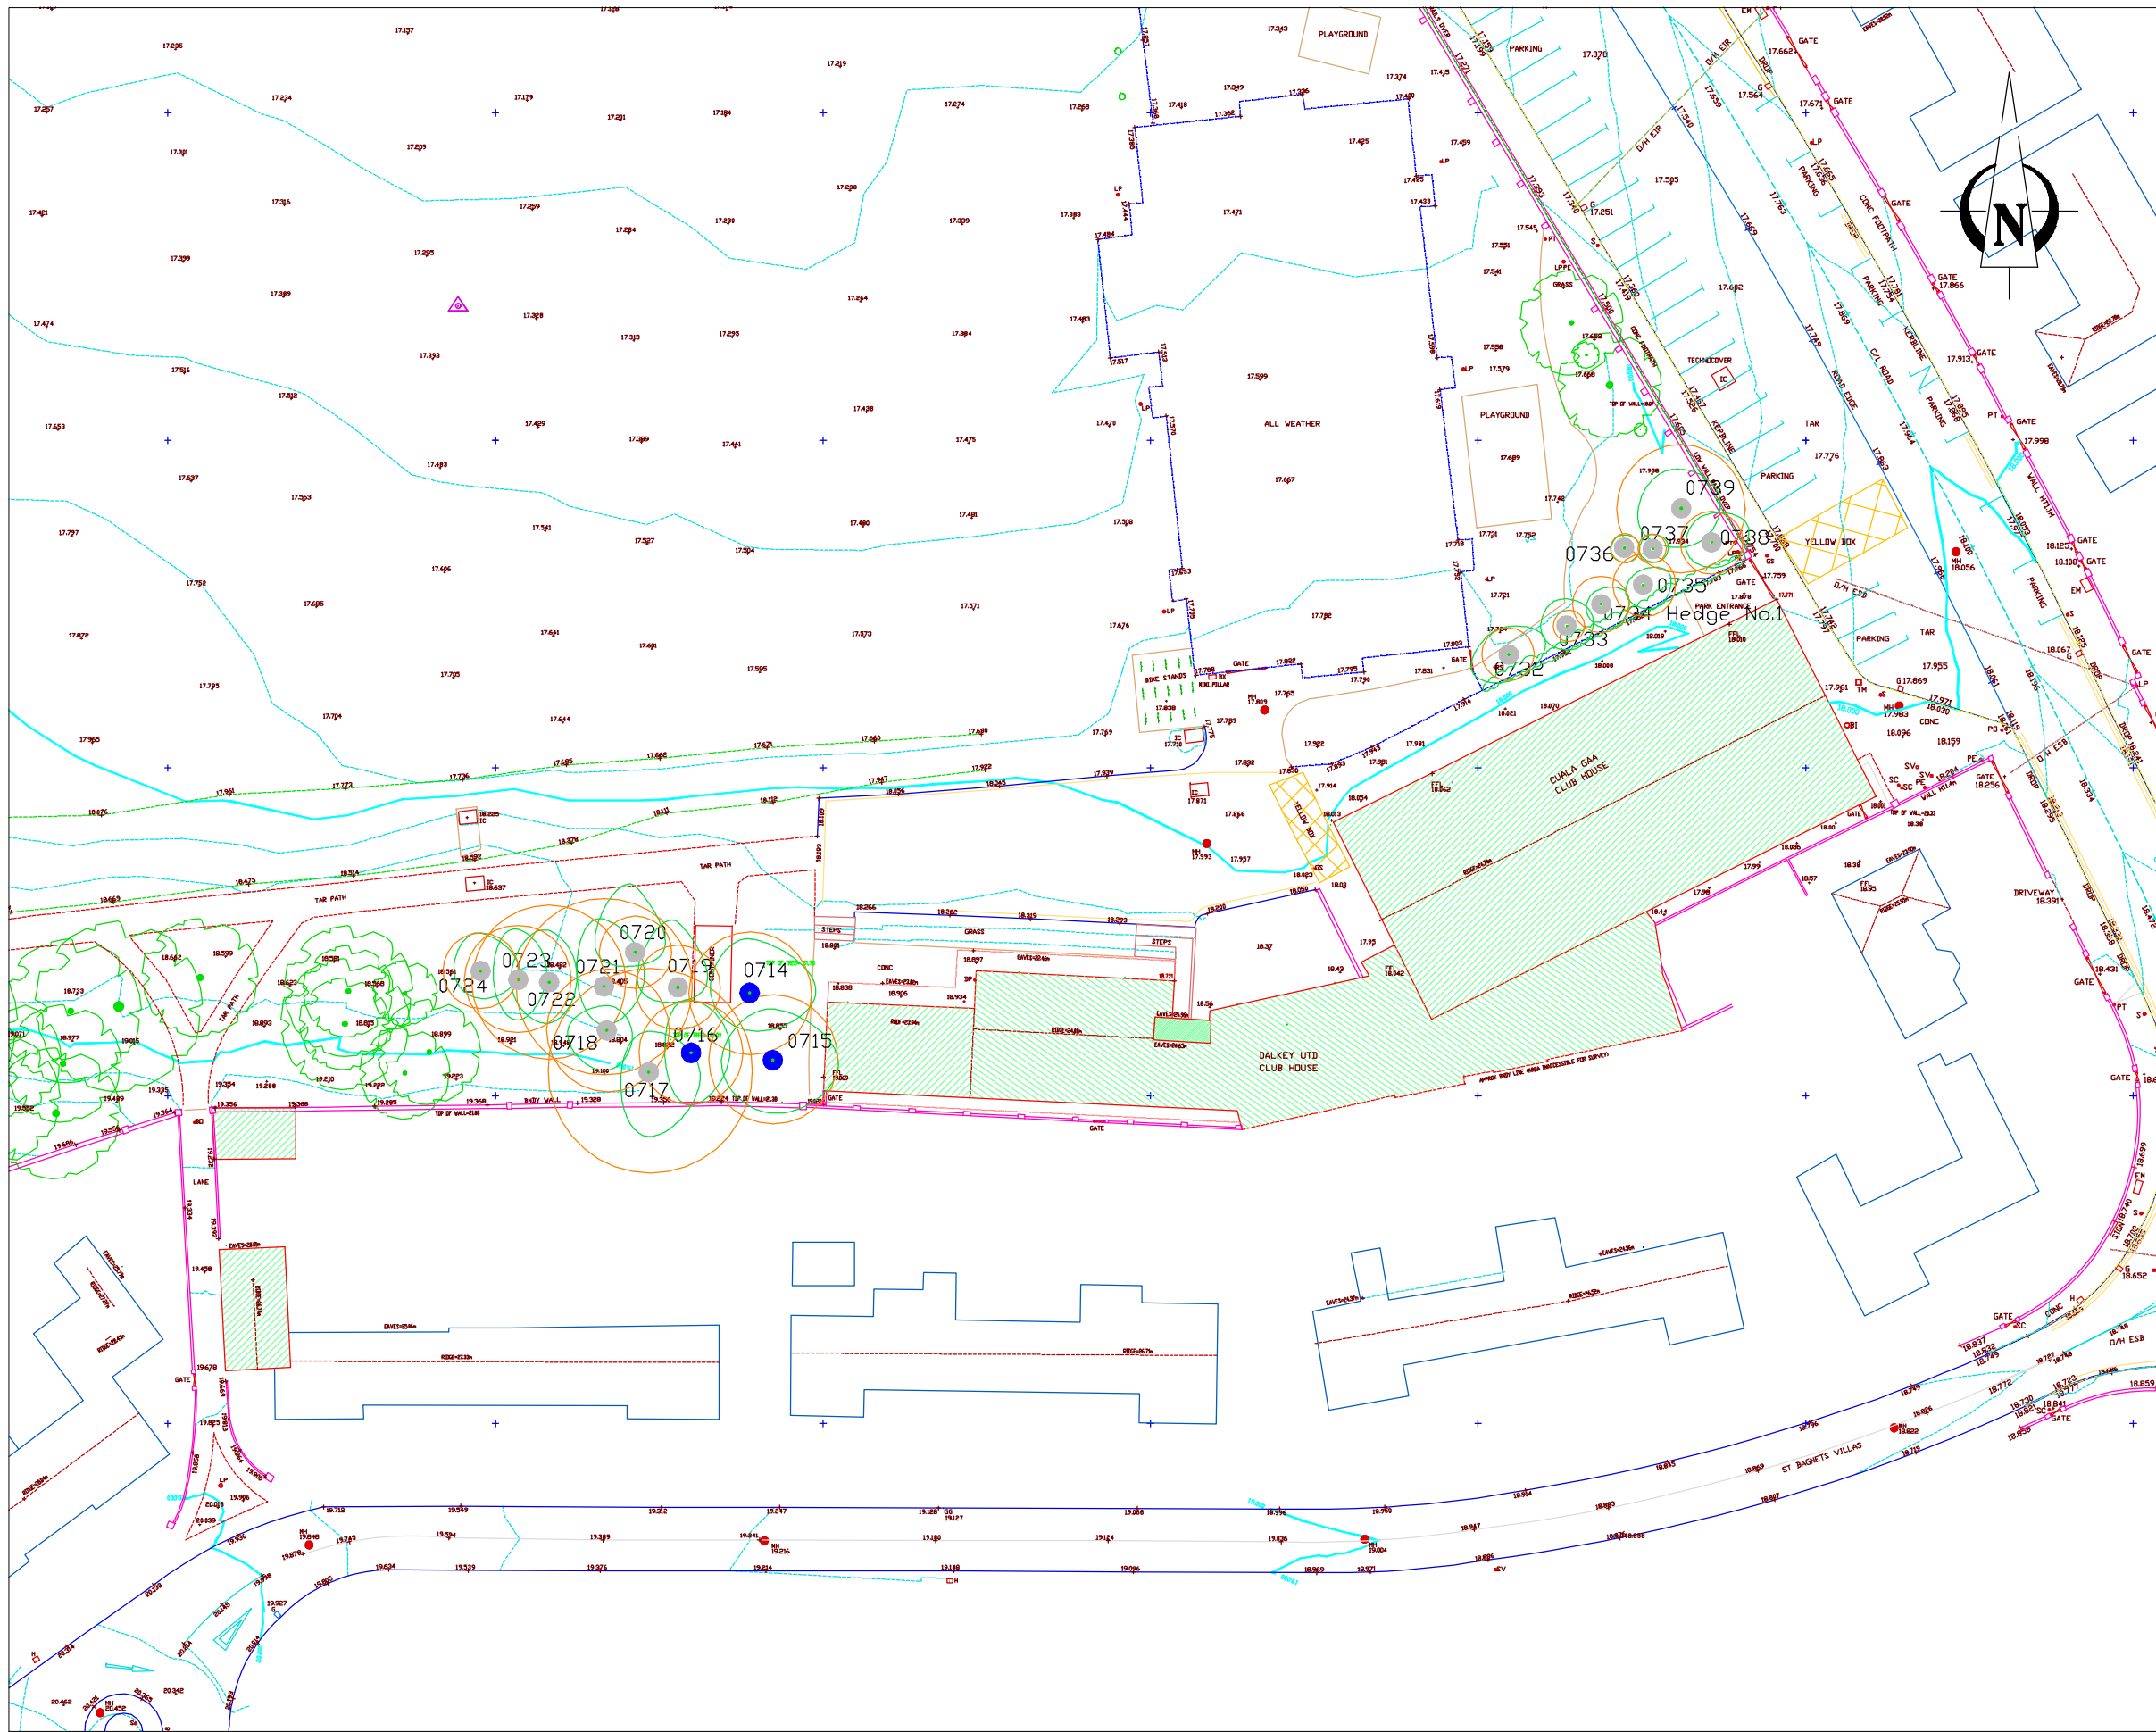
DATE: Dwg No.HPD001 Scale 1:500 @A3

The category 'B' trees within this site area have been identified on our drawings (Nos.HPD001 & HPD002) with a 'Blue' donut around their trunk positions.

The category 'C' trees within this site area have been identified on our drawings (Nos.HPD001 & HPD002) with a 'Grey' donut around their trunk positions.

- 3.5 The trees have been plotted onto the attached drawing (DWG No.HPD001) by a land survey company and their positions are assumed accurate. This drawing has been developed as a constraints drawing to aid the design team in the layout of the development and the tag numbers referred to in the condition tree report have been shown on this drawing along with their crown spreads and their retention category colour coded as recommended by BS 5837 2012. The constraint (Minimum Root Protection Area) for each tree has been shown with an 'Orange Circle' and all proposed development should be planned to be positioned outside those trees proposed for retention allowing for additional space for construction activities.

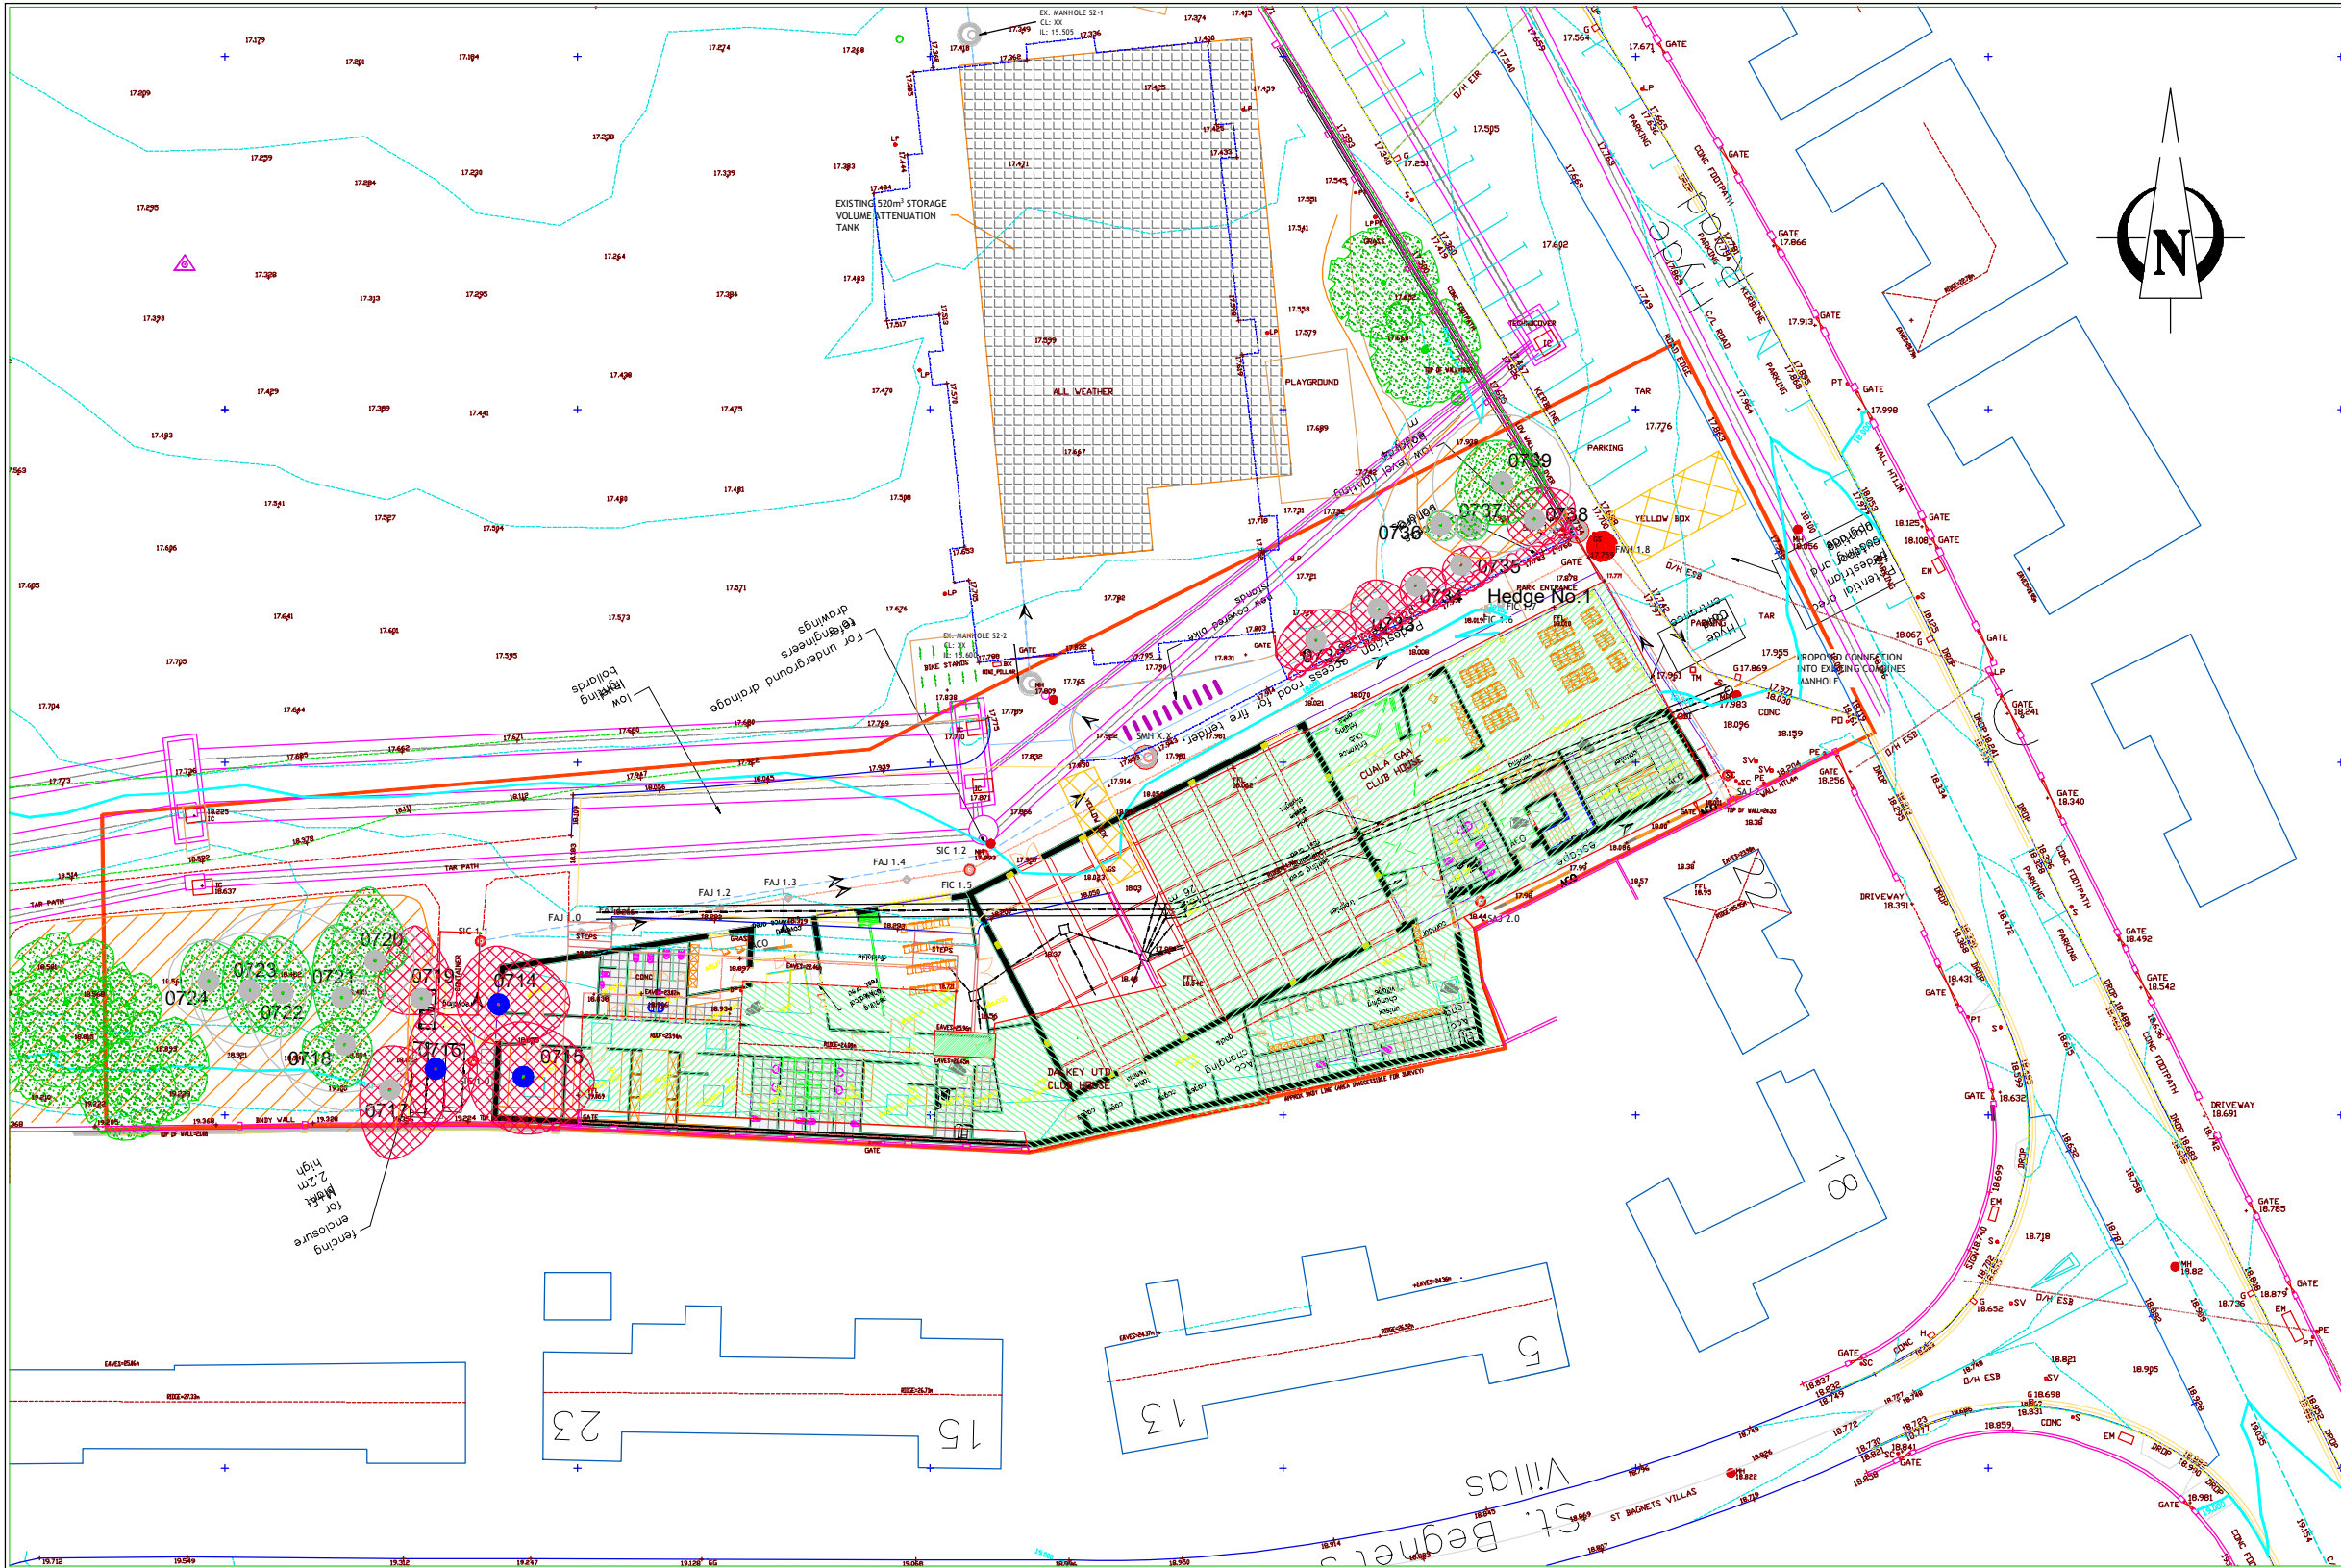
- 5.1.3 On drawing No.HPD002, I have shown the tree vegetation for removal due to the proposed development and condition/management with 'Red Hatched' crown spreads and those to be retained with a 'Green Hatched' crown spread. I have also shown on this drawing the position of any necessary tree protection measures in order to protect the root zone of the tree vegetation being retained within the vicinity of where the construction works will occur. These work exclusion zones are shown on this drawing using 'Orange Hatching' and these areas will need to be cordoned off by the erection of fencing or other means at the start of the works and this will need to be maintained in place until all works are completed. This fencing is to protect the root zone of the trees and to ensure their successful integration into the development of this site area.

5.2.4 The root zone of these trees being retained as shown on the accompanying tree protection plan (No.HPD002) need to be cordoned off from the works by the erection of tree protection fencing for the duration of the construction works as per BS5837 2012. Where work space is required for construction works within the root zone of the trees being retained, then ground protection will need to be put in place to the recommendations of 'Section 6' of BS5837. In areas where manual works need to occur within the root zone of the trees, ground protection could be provided by sheets of heavy duty plywood laid on a bed of woodchip and for heavier loading, this could be achieved by a layer of scaffold planks screwed together by sheets of heavy duty plywood on top of these and all this to be laid on a bed of woodchip to help cushion loading on the soil underneath.

Protective fence line to protect tree exclusion zone around trees being retained. In some areas, the site hoarding may be accepted as sufficient to protect root zones of trees to be retained and protected. This is to be agreed with project arborist on site.
