**Proposed Development of Fernhill Park &
Gardens, Stepside, Co. Dublin with Works
within the Curtilage of the Protected
Structure (Fernhill House)
PC/PKS/01/17**

Appendix 8 – Tree Survey & Report

Ref: FHG078954554

Re: An Arboricultural Assessment on the Tree Vegetation Located Around the Formal Grounds of 'Fernhill Estate', Sandyford, Co. Dublin.

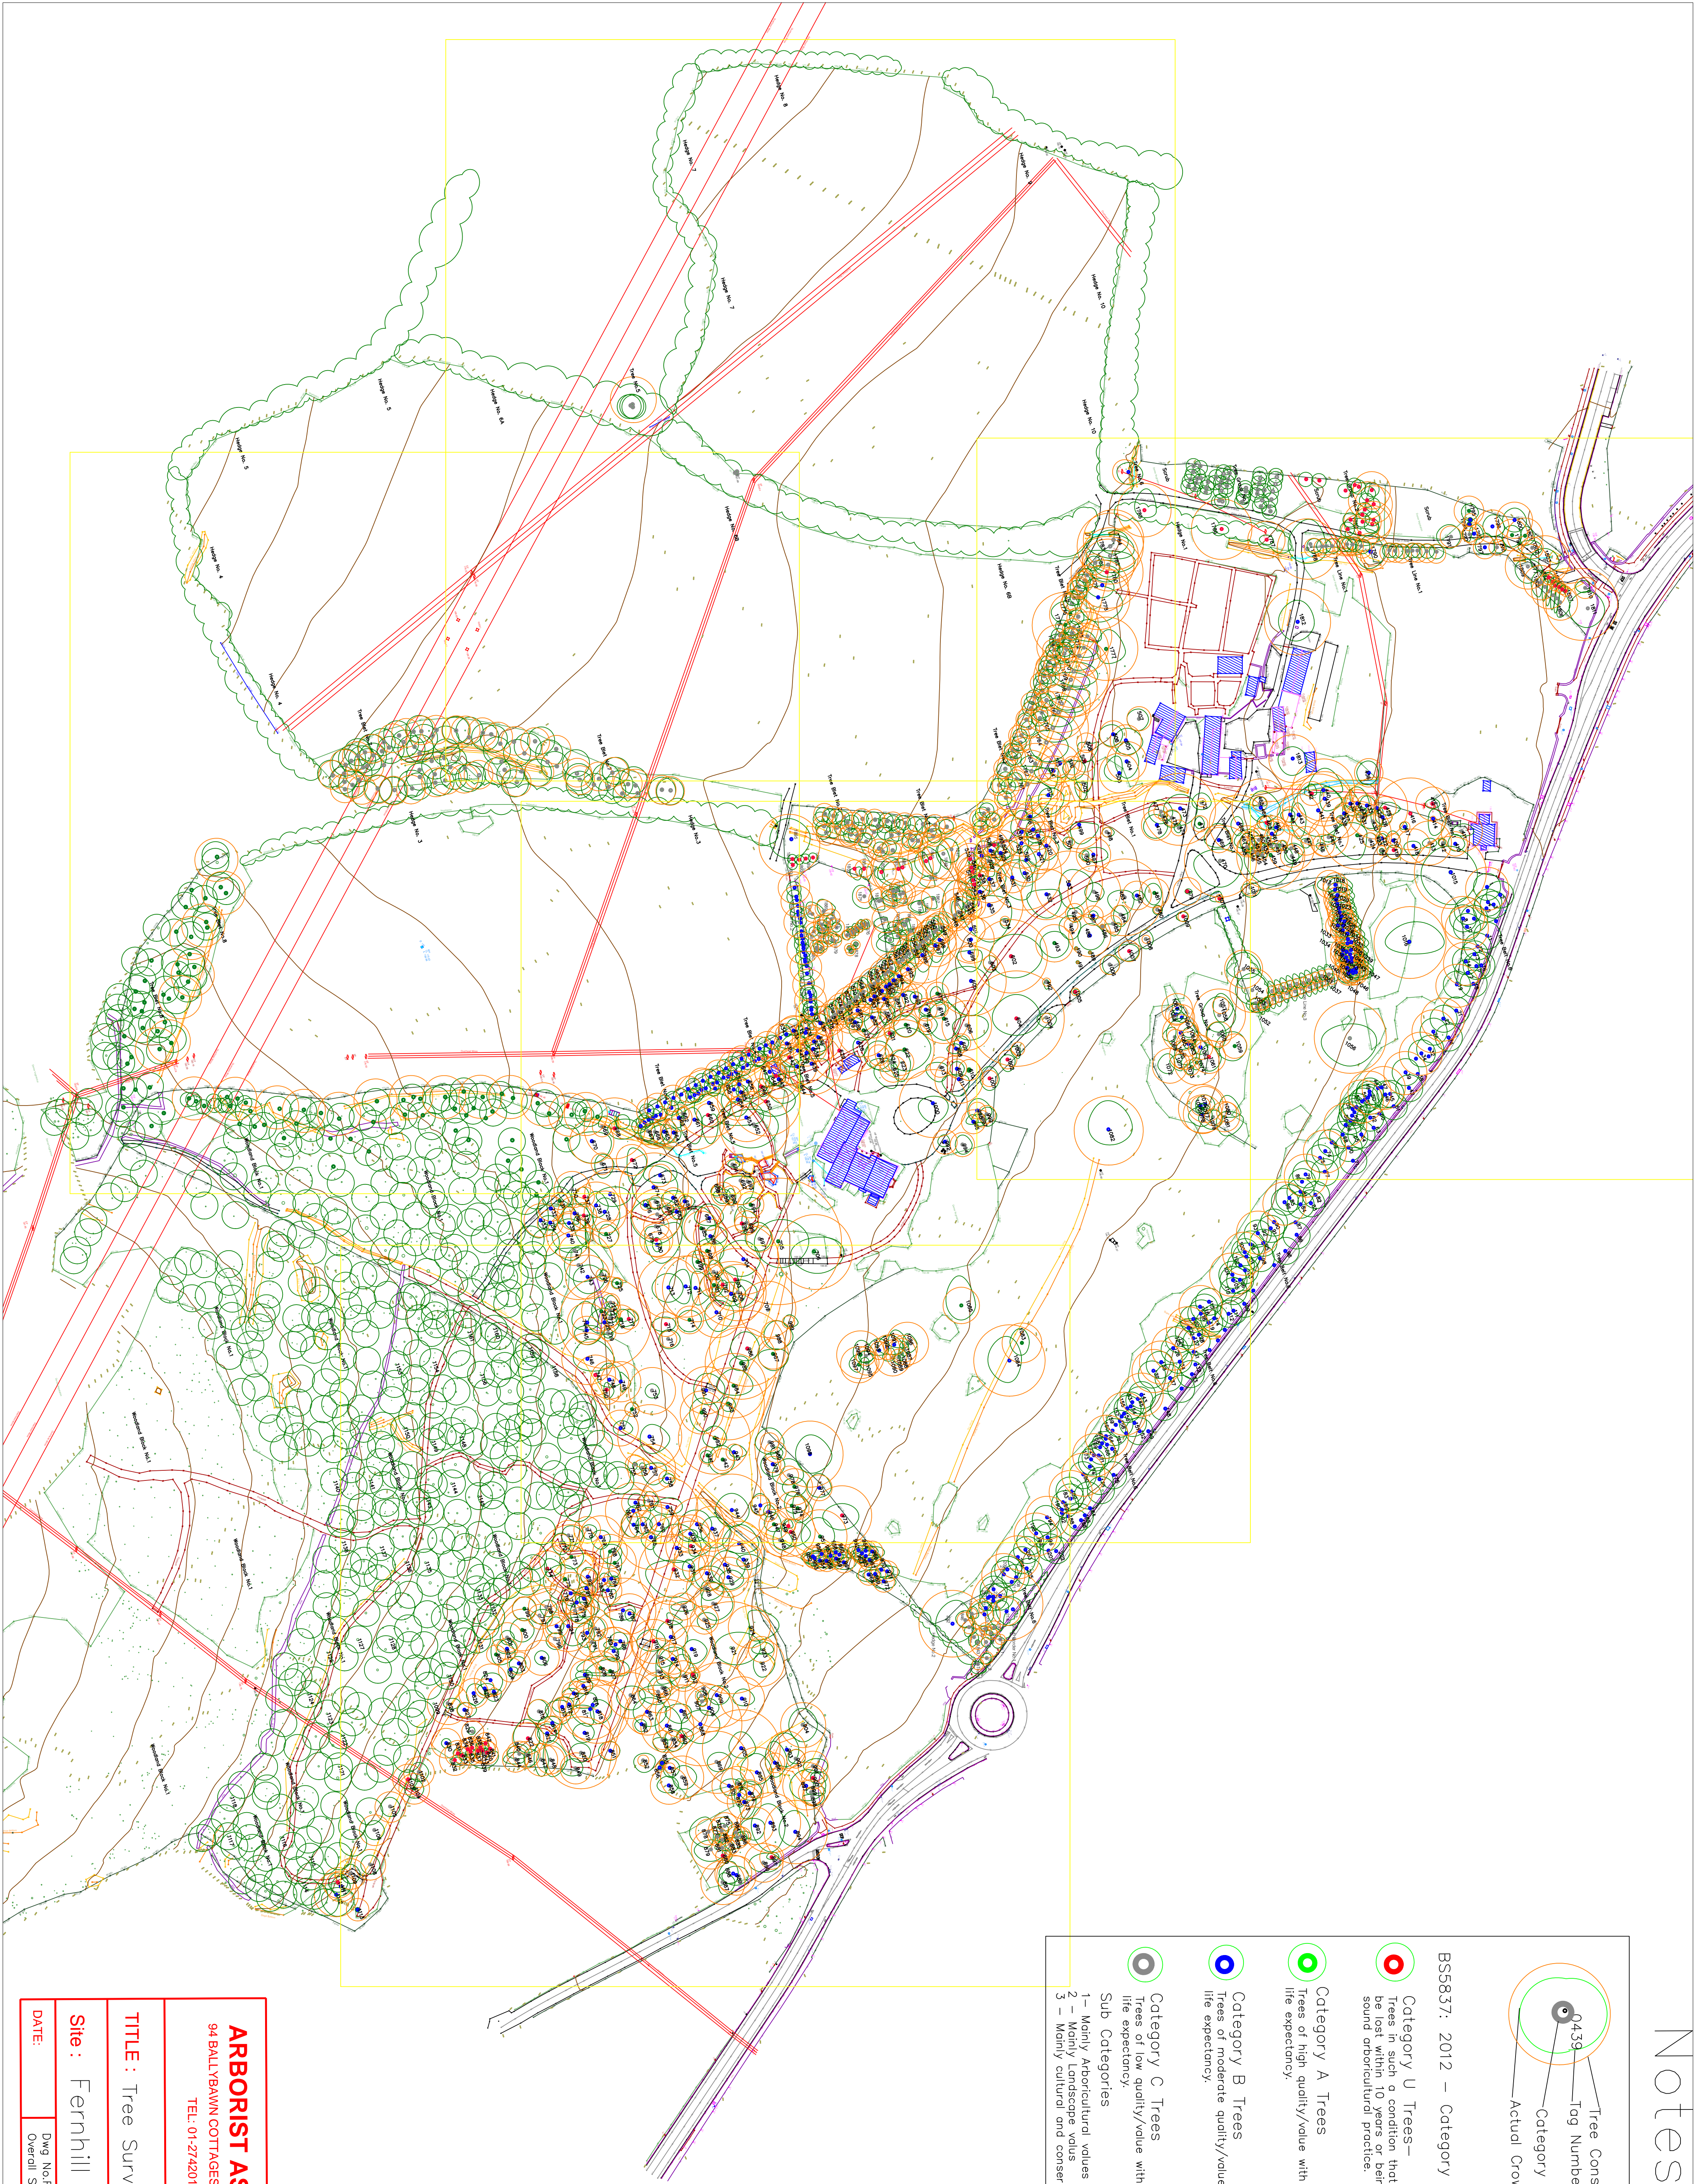
Dwg No: FHG001	Scale 1:1250 © A1
Overall Survey Area

These category 'U' trees have been identified on our drawings (Nos.FHG001 & FHG002) with a 'Red' donut around their trunk positions. Due to the condition of these trees, they should not be considered a constraint for any design layout for these grounds.

- 3.6 The trees have been plotted onto the attached drawing (Dwg. No.FHG001) by a land survey company. The tree reference numbers referred to in the condition tree report have been shown on this drawing along with their crown spreads and their retention category colour coded as detailed above and recommended by BS 5837 2012.
