Ref: CWGW07896566

9<sup>th</sup> December 2021

**Re: An Arboricultural Assessment of the 'Cherrywood Linear Park Greenway',  
Cherrywood, Co. Dublin.**

**Arborist Associates Ltd. Arboriculture Assessment – 'Cherrywood Linear Park Greenway',  
Cherrywood, Co. Dublin - Dec 2021.**

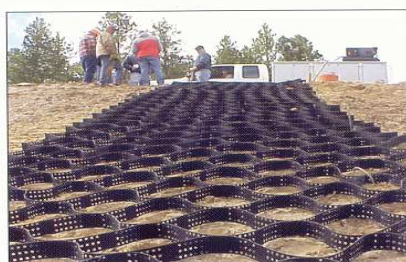
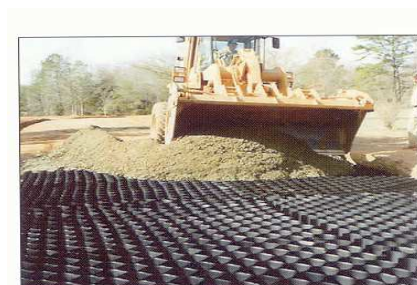
**Pictures show the Cell Web being installed on the ground.**

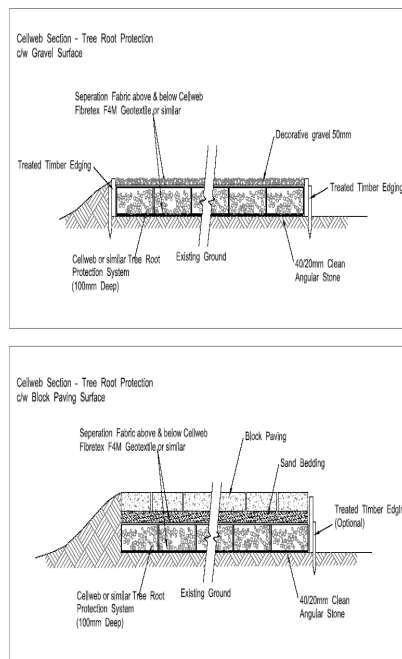
The below diagram shows how the Cellular confinement system should be

installed.
