**APPENDIX B – HYDROGEOLOGICAL RISK ASSESSMENT REPORT**

Lehaunstown Neighbourhood Road

IE01T23A67-REP-GEO0001

## HYDROGEOLOGICAL RISK ASSESSMENT – LEHAUNSTOWN NEIGHBOURHOOD ROAD

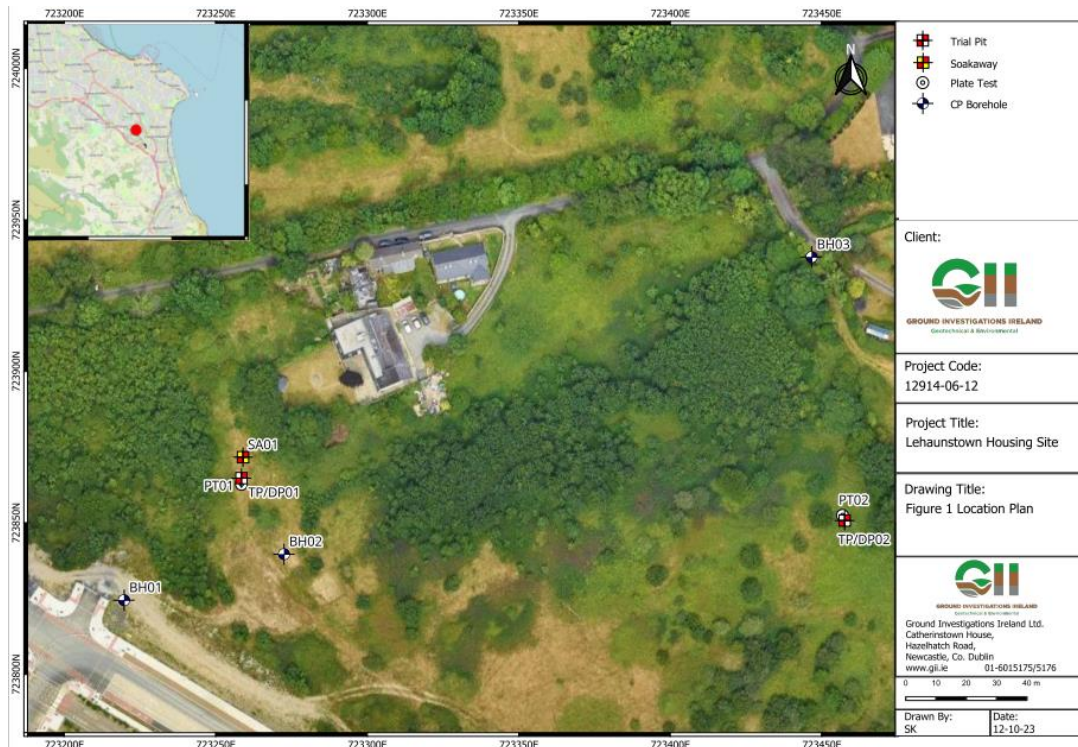
**Figure 6. Exploratory hole location plan for 2023 ground investigation (Source App. A of the GII, Nov 2023 report)**

In November 2023, Ground Investigation Ireland (GII) completed three trial pits (SA01, TP/DP01 and TP/DP02) to 3.6mbgl and three cable percussive boreholes (BH01, BH02 and BH03) to 4mbgl. BH02 was completed as a monitoring well. Figure 6 shows the location of exploratory holes formed during the Ground Investigation Ireland investigation.

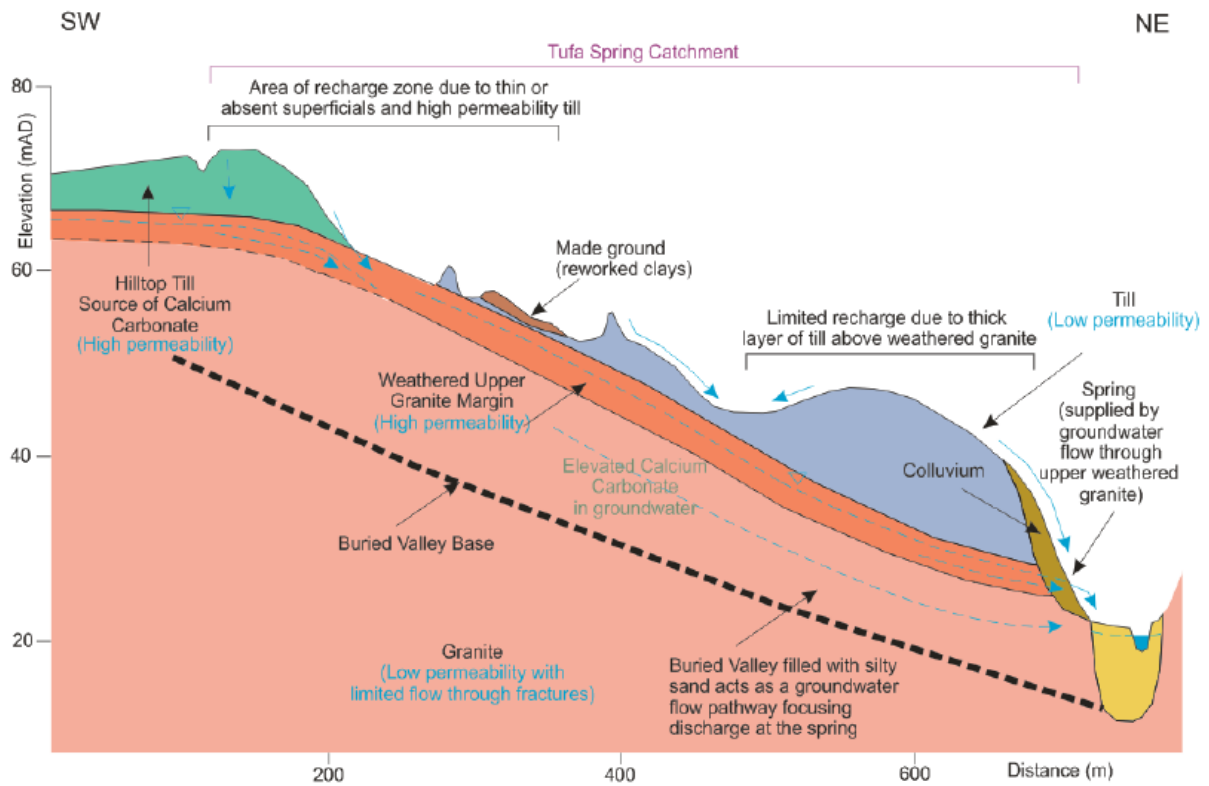
**Figure 7. Conceptual understanding of groundwater movement within the catchment (Source Pg 8 of the JBA, May 2019 report)**

- Precipitation falling within the catchment is more likely to infiltrate through the Hilltop Till and Till/Absent Till recharge areas and migrate easterly along the upper margins of the weathered granite and below more cohesive deposits towards the tuff springs.

The conceptual understanding of groundwater movement is illustrated by Figure 7.

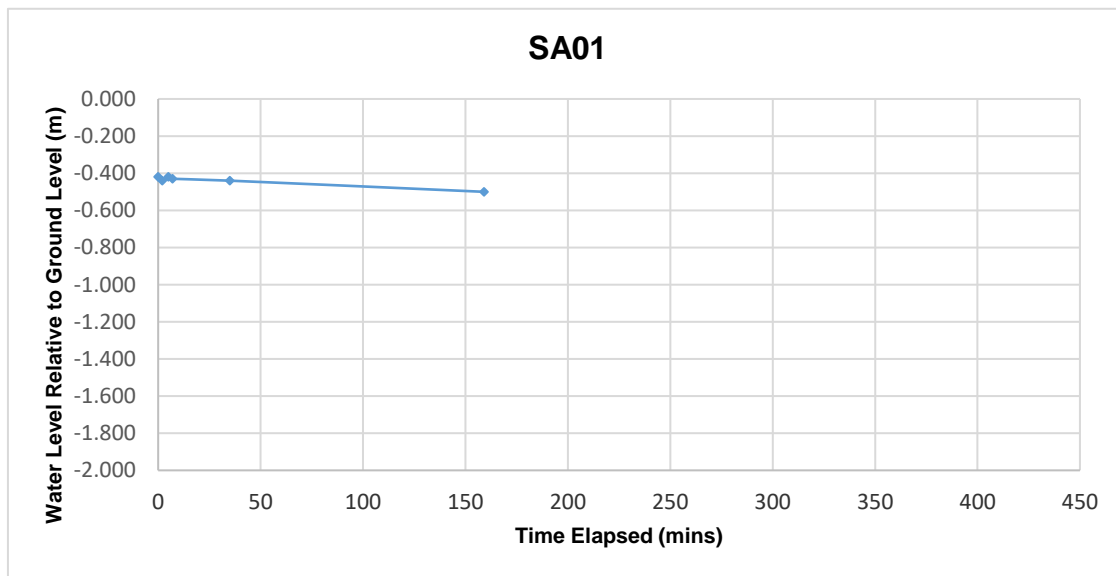
**\*Soakaway failed - Pit backfilled**

Start depth	Depth of Pit	Diff	75% full	25%full
0.42	2.100	1.680	0.84	1.68

A soakaway test completed at SA01 to 2.1m bgl (a trial pit located in approximate west of the LNR) was terminated as the soil infiltration rate (fall in water levels) was too slow, and therefore the location would be unsuitable for the design and installation of system that relied upon relatively high inherent permeability to drain surface waters.

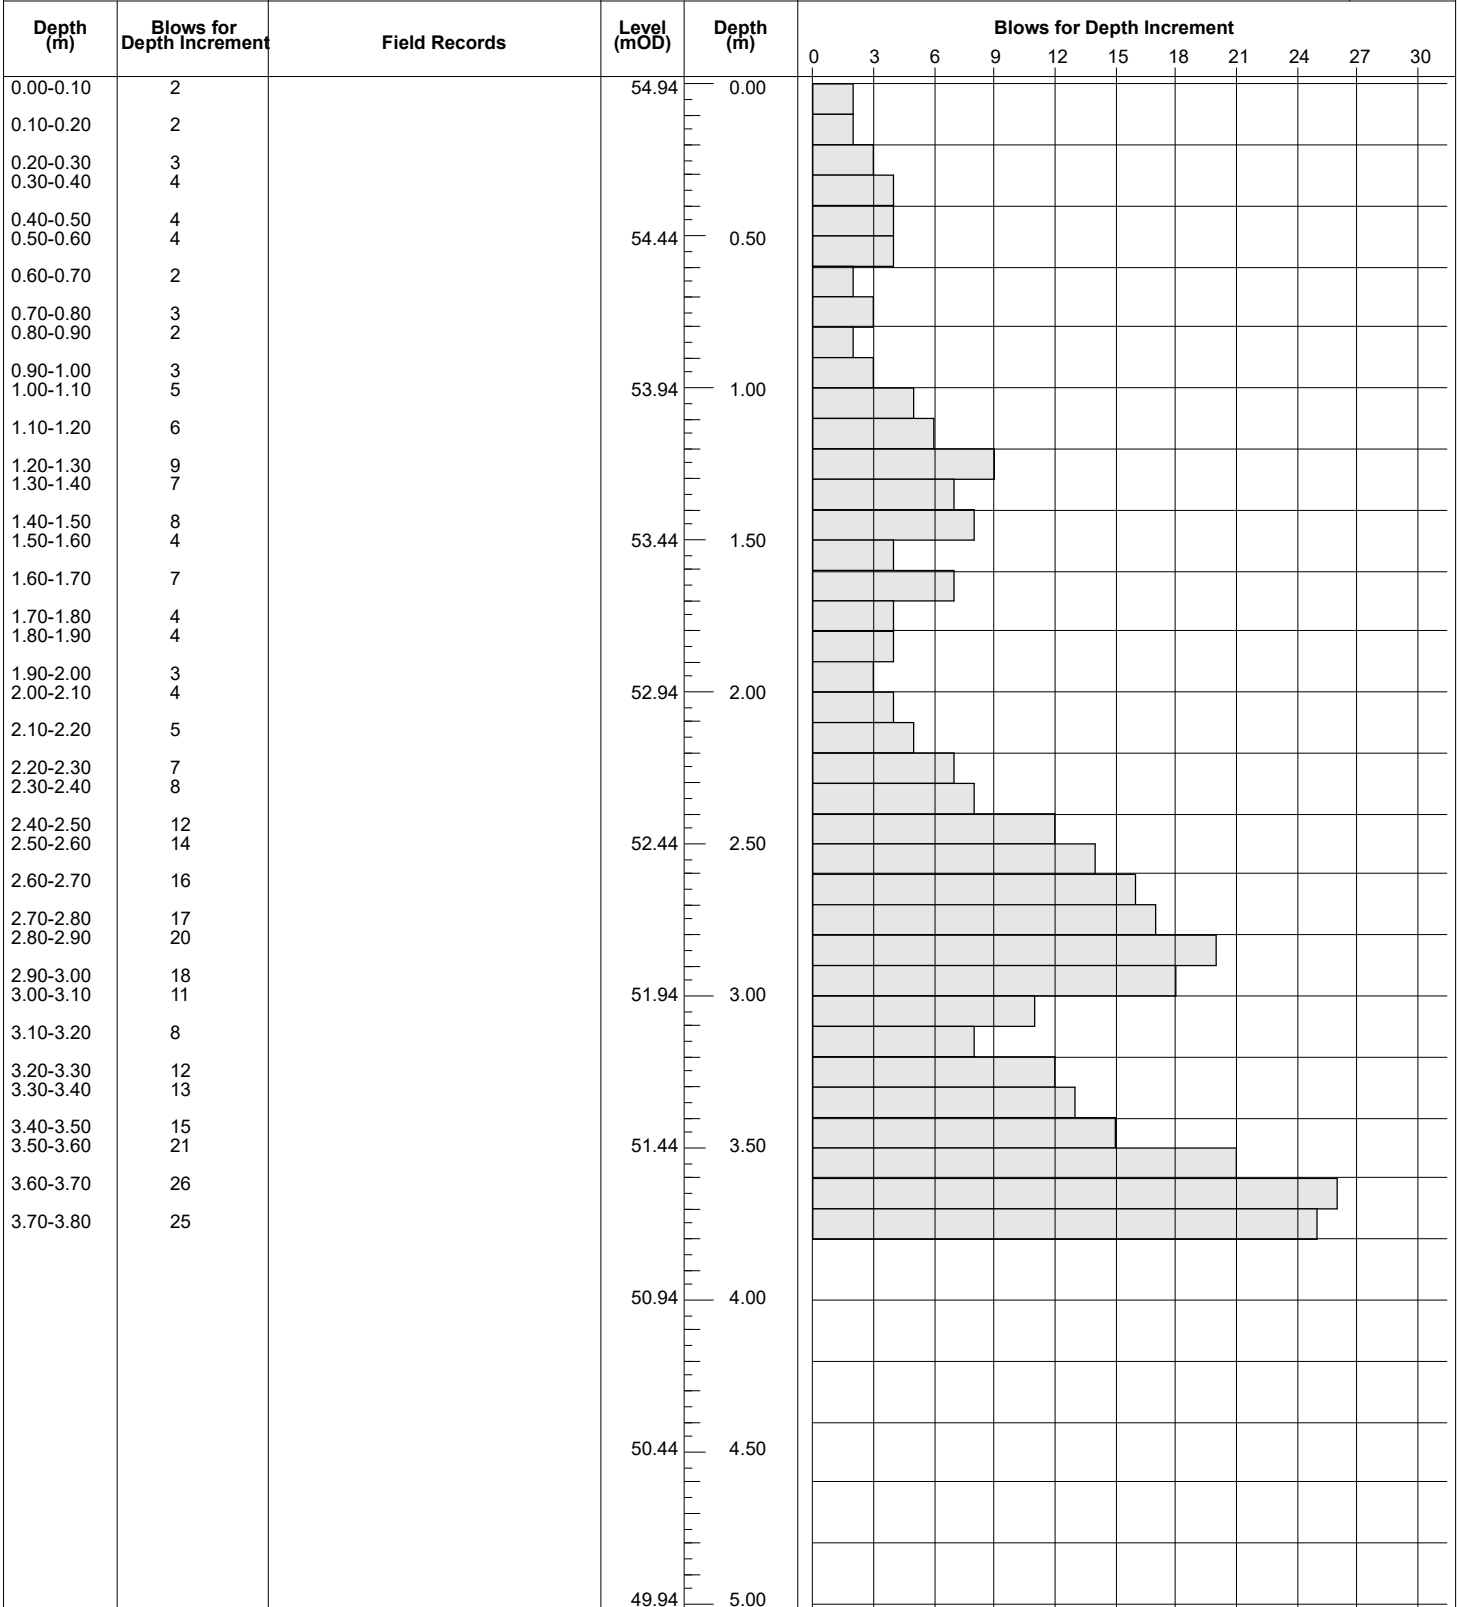
Scale (approx) 1:25  
Logged By S Kealy  
Figure No. 12914-06-23.DP01

Machine : Tecop Tec 10 Method : Dynamic Probe	Cone Dimensions Diameter 47.3mm, Angle 90°	Ground Level (mOD) 54.94	Client DLRD	Job Number 12914-06-23
	Location 723258.4 E 723864.4 N	Dates 14/08/2023	Engineer	Sheet 1/1

Remarks  
Refusal at 3.80m BGL 25 blows

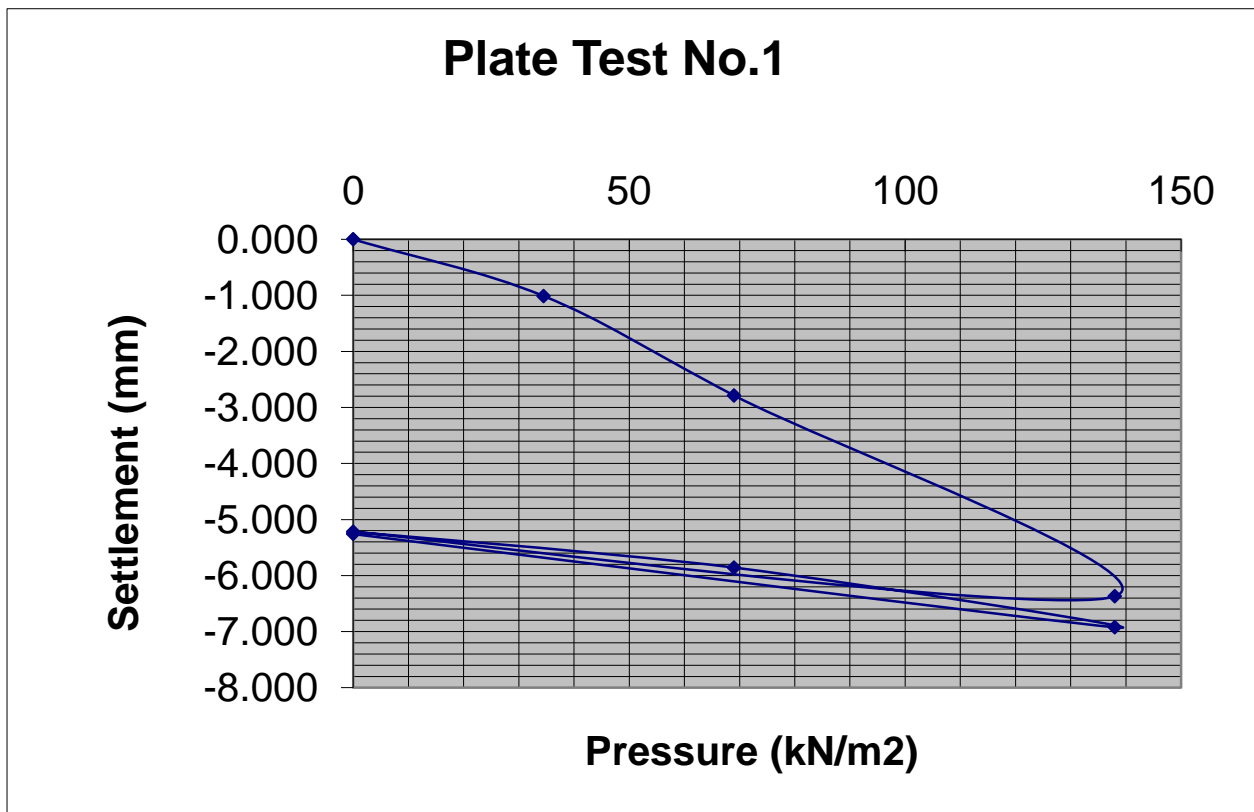
<b>LOCATION</b>	Lehaunstown, Cabinteely	<b>MATERIAL</b>	Brown slightly sandy gravelly CLAY
<b>CONTRACT NO.</b>	12914-06-23	<b>DEPTH</b>	0.50m
<b>DATE</b>	13/07/2023	<b>NOTES</b>	
<b>CLIENT</b>	DLR COCO	<b>SAMPLES</b>	
<b>PLATE DIAMETER</b>	305mm		
<b>TEST NO.</b>	Test 1

Modulus of subgrade reaction, K (Initial) = **11.25 MN/m<sup>2</sup>/m**  
 Modulus of subgrade reaction, K (Reload) = **49.12 MN/m<sup>2</sup>/m**

Equivalent CBR(initial)in accordance with HD25/94 volume7 section2 = **0.64 %**  
 Equivalent CBR(reload)in accordance with HD25/94 volume7 section2 = **8.23 %**

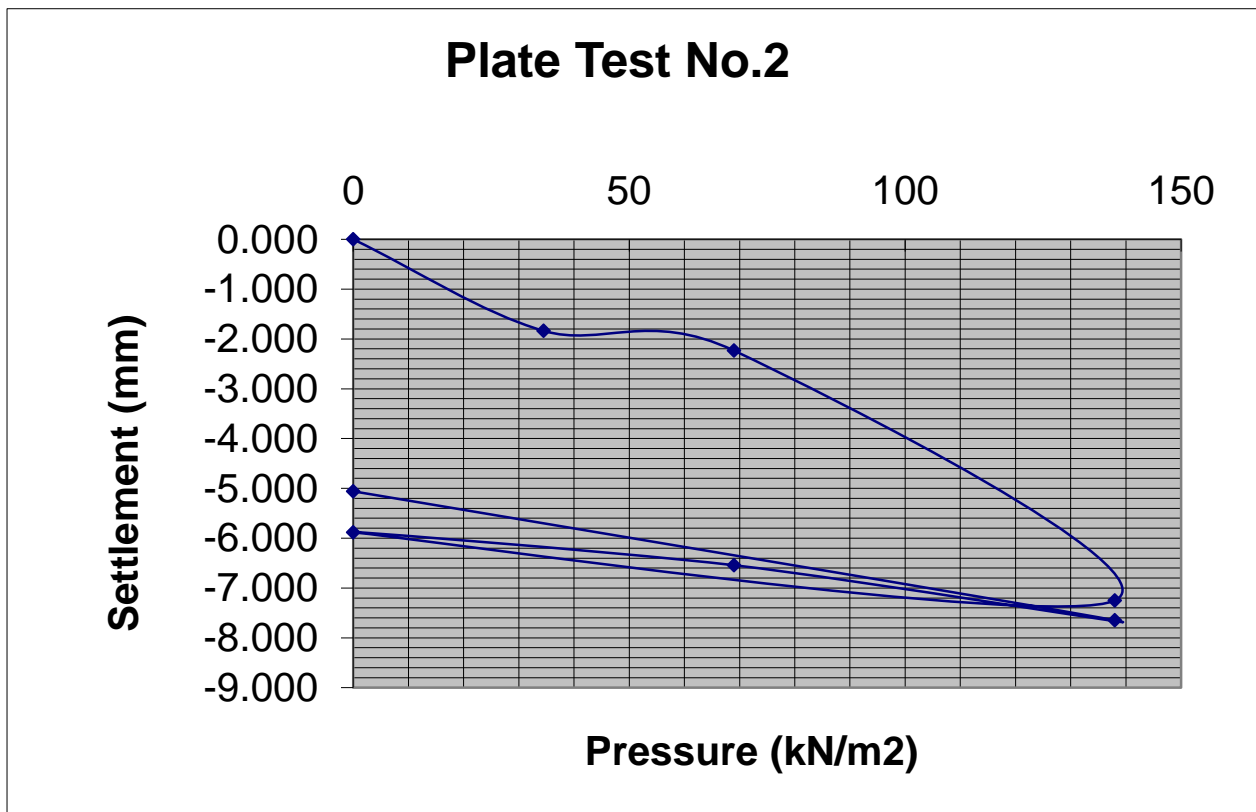
<b>LOCATION</b>	Lehaunstown, Cabinteely	<b>MATERIAL</b>	Brown sandy gravelly CLAY
<b>CONTRACT NO.</b>	12914-06-23	<b>DEPTH</b>	0.60m
<b>DATE</b>	13/07/2023	<b>NOTES</b>	
<b>CLIENT</b>	DLR COCO	<b>SAMPLES</b>	
<b>PLATE DIAMETER</b>	305mm		
<b>TEST NO.</b>	Test 2

Modulus of subgrade reaction, K (Initial) = **14.03 MN/m<sup>2</sup>/m**

Modulus of subgrade reaction, K (Reload) = **47.44 MN/m<sup>2</sup>/m**

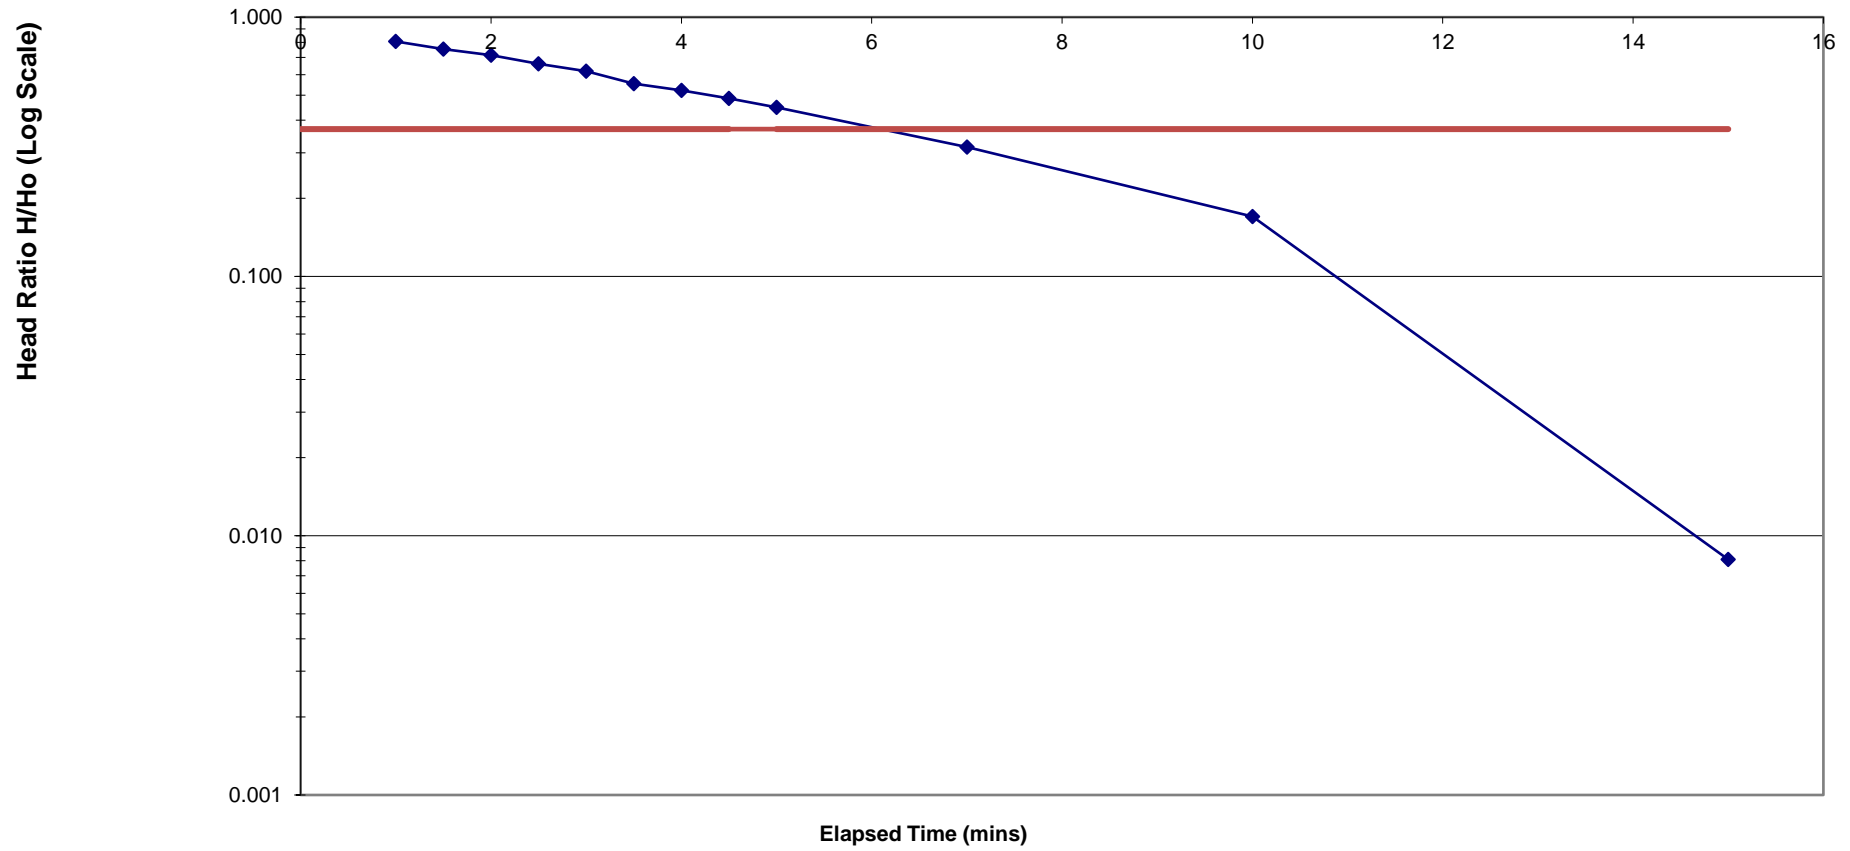
Lehaunstown Cbinteely BH02 Rising Head Test

<b>Intake Factor (F)</b>		<b>Basic Time Factor</b>	
L	2.7	H/Ho	0.37
L/D	1.5	T (mins)	7 at H/Ho = 0.37
F	3.96	T(Seconds)	420
Intake Factor (F): Figure 7 BS5930			
$F = (2.32 \cdot \pi \cdot L/D) / \ln(L/D + \text{SQRT}((1.1(L/D) + \text{SQRT}(1+1.1(L/D)(L/D))))))$			
<b>Permeability</b>			
Note: Diameter of filter zone used in calculation of area in permeability calculation below;			
$k = A / (F \times T)$	<b>1.89E-05 m/secs</b>

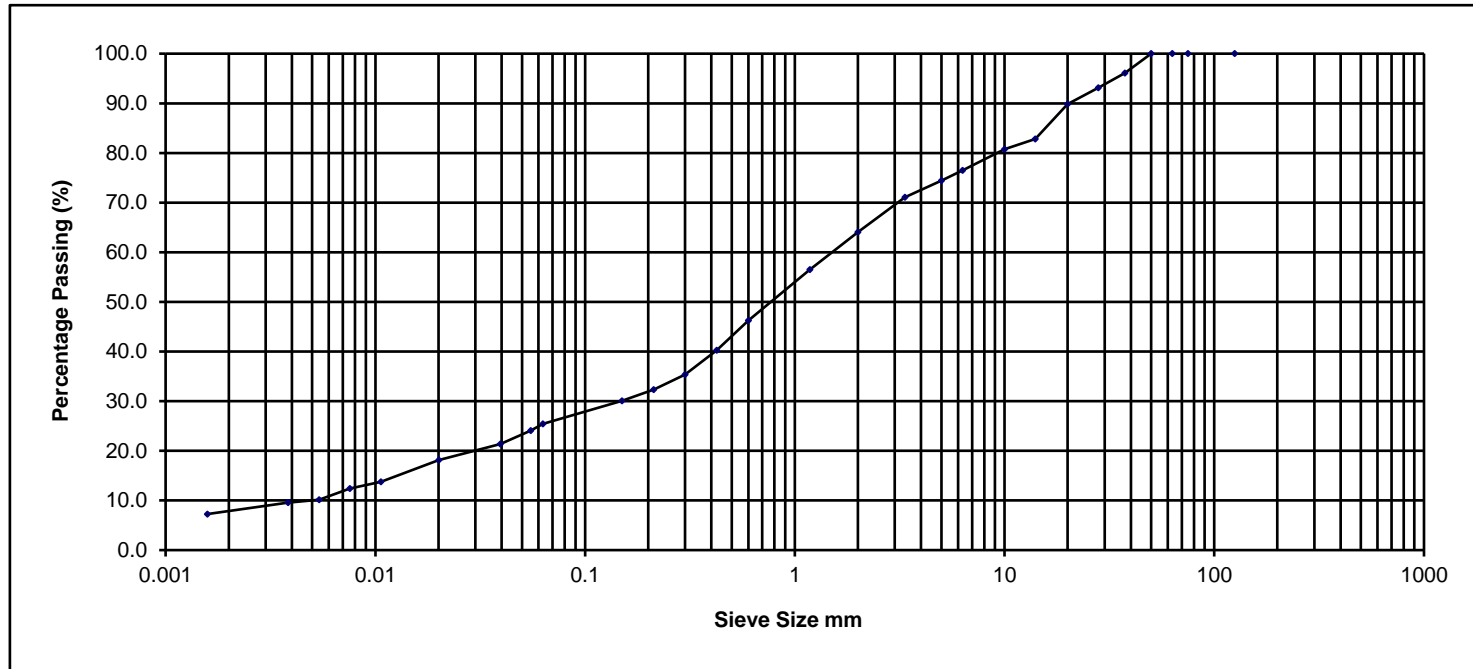
### Determination of Particle Size Distribution BS 1377 : 1990 : Part 2 : Clauses 9.2 & 9.5

Sieve Size mm	% Passing
125.000	100.0
75.000	100.0
63.000	100.0
50.000	100.0
37.500	96.1
28.000	93.1
20.000	89.9
14.000	82.8
10.000	80.7
6.300	76.5
5.000	74.5
3.350	71.1
2.000	64.0
1.180	56.5
0.600	46.3
0.425	40.2
0.300	35.4
0.212	32.4
0.150	30.1
0.063	25.4
0.055	24.1
0.039	21.4
0.020	18.1
0.011	13.8
0.008	12.4
0.005	10.1
0.004	9.5
0.002	7.3

Clay	Fine			Medium			Coarse			Cobbles	Boulder
	Fine	Medium	Coarse	Fine	Medium	Coarse	Fine	Medium	Coarse		
7.3	Silt			Sand			Gravel			0.0	0.0
			18.1			38.6			36.0

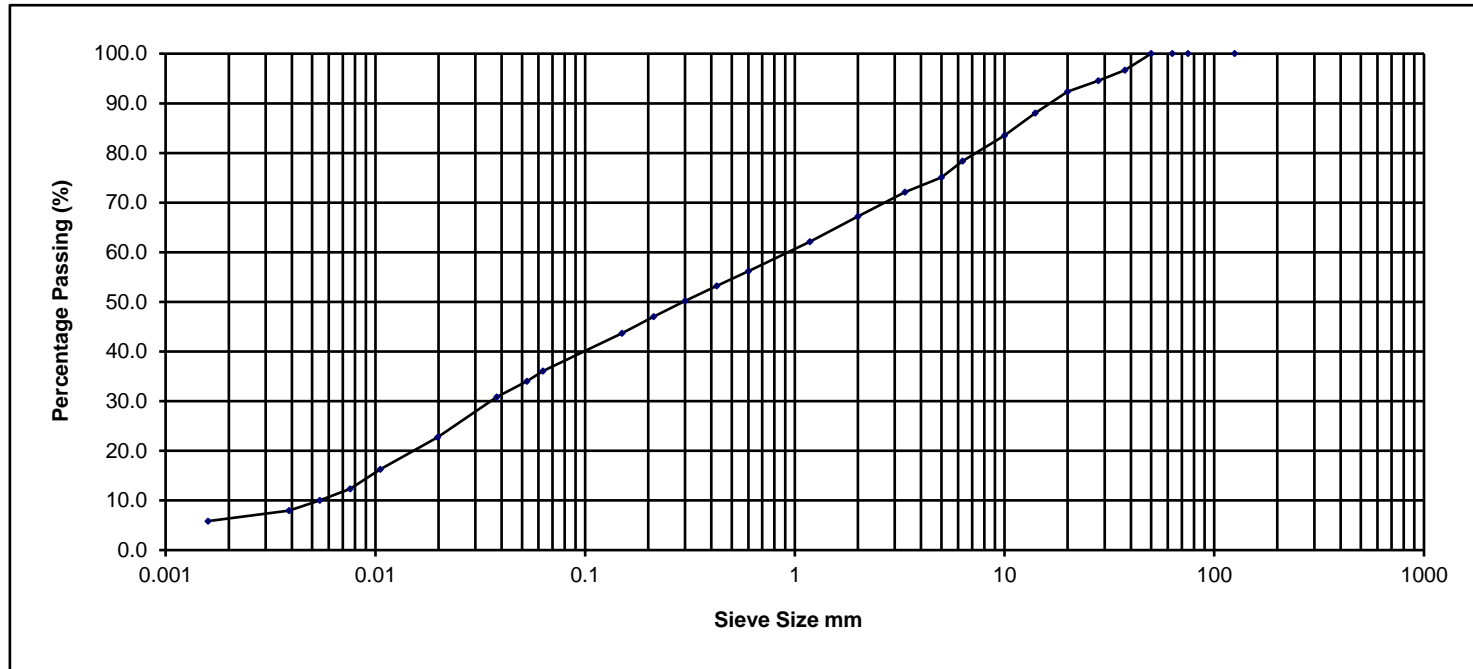
### Determination of Particle Size Distribution BS 1377 : 1990 : Part 2 : Clauses 9.2 & 9.5

Sieve Size mm	% Passing
125.000	100.0
75.000	100.0
63.000	100.0
50.000	100.0
37.500	96.7
28.000	94.6
20.000	92.3
14.000	88.1
10.000	83.5
6.300	78.4
5.000	75.1
3.350	72.1
2.000	67.2
1.180	62.1
0.600	56.2
0.425	53.2
0.300	50.2
0.212	47.0
0.150	43.7
0.063	36.1
0.053	34.0
0.038	30.9
0.020	22.7
0.011	16.3
0.008	12.3
0.005	10.0
0.004	7.9
0.002	5.8

Percentage Particle Size											
Clay	Fine			Medium			Coarse			Cobbles	Boulder
	Fine	Medium	Coarse	Fine	Medium	Coarse	Fine	Medium	Coarse		
5.8	30.2			31.1			32.8			0.0	0.0

Sample Description: Brown slightly sandy slightly gravelly silty CLAY.

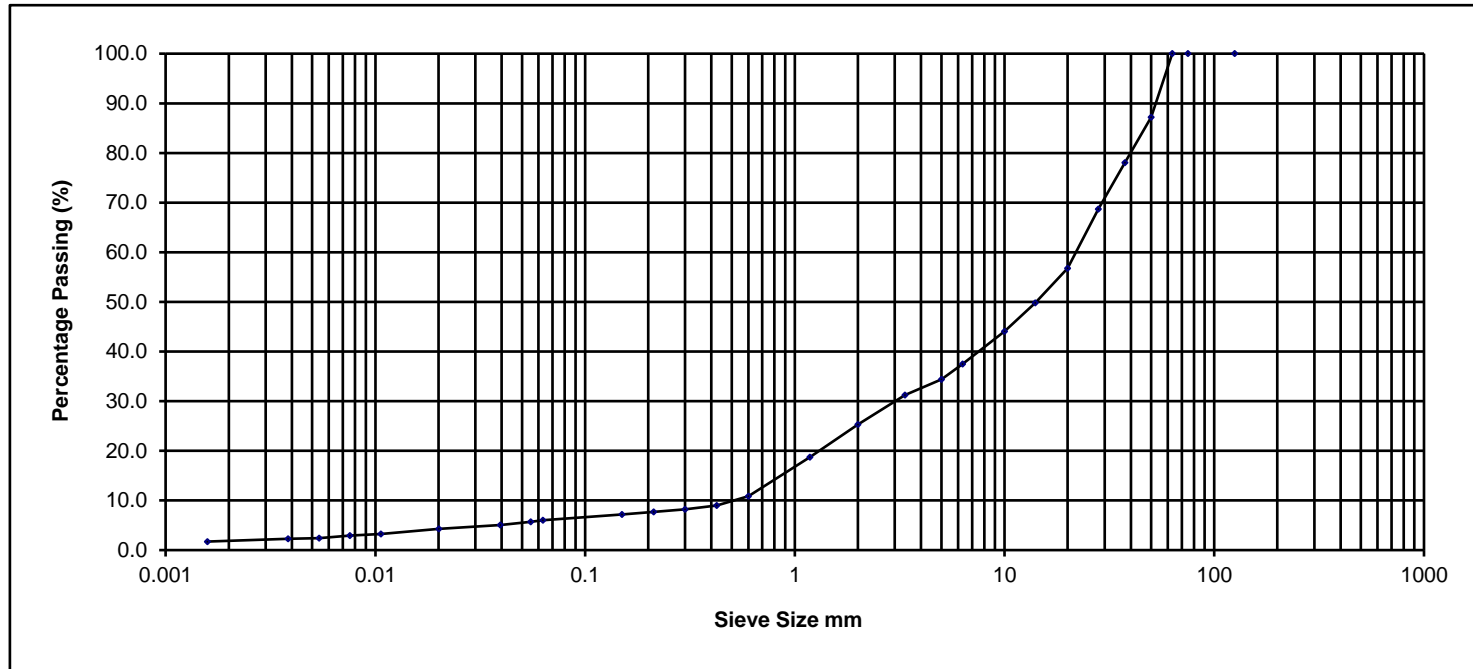
### Determination of Particle Size Distribution BS 1377 : 1990 : Part 2 : Clauses 9.2 & 9.5

Sieve Size mm	% Passing
125.000	100.0
75.000	100.0
63.000	100.0
50.000	87.2
37.500	78.0
28.000	68.7
20.000	56.8
14.000	49.8
10.000	44.1
6.300	37.5
5.000	34.4
3.350	31.2
2.000	25.3
1.180	18.7
0.600	10.9
0.425	9.0
0.300	8.2
0.212	7.7
0.150	7.2
0.063	6.0
0.055	5.7
0.039	5.1
0.020	4.3
0.011	3.3
0.008	2.9
0.005	2.4
0.004	2.3
0.002	1.7

Percentage Particle Size											
Clay	Fine			Medium			Coarse			Cobbles	Boulder
	Fine	Medium	Coarse	Fine	Medium	Coarse	Fine	Medium	Coarse		
1.7	Silt			Sand			Gravel			0.0	0.0

Sample Description: Brown silty sandy fine to coarse GRAVEL.

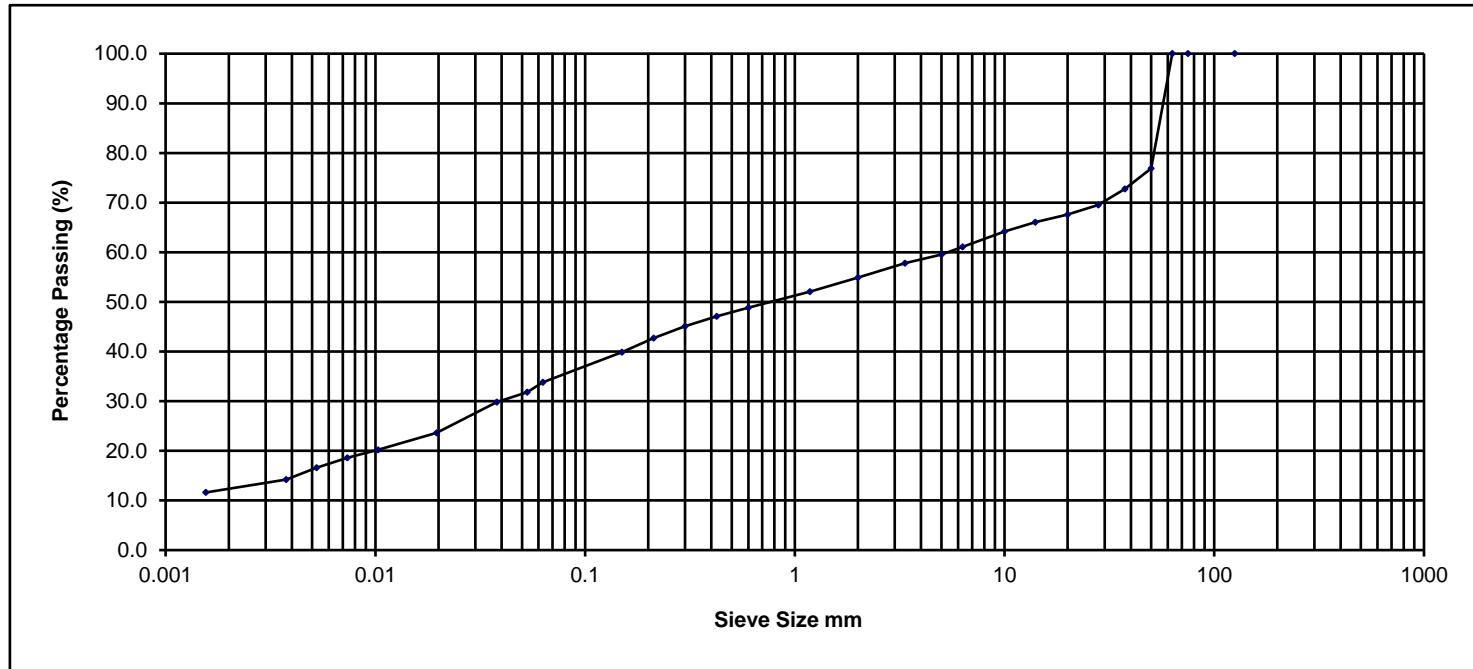
### Determination of Particle Size Distribution BS 1377 : 1990 : Part 2 : Clauses 9.2 & 9.5

Sieve Size mm	% Passing
125.000	100.0
75.000	100.0
63.000	100.0
50.000	76.9
37.500	72.7
28.000	69.5
20.000	67.6
14.000	66.0
10.000	64.2
6.300	61.1
5.000	59.5
3.350	57.8
2.000	54.9
1.180	52.1
0.600	48.8
0.425	47.1
0.300	45.1
0.212	42.7
0.150	39.9
0.063	33.8
0.053	31.8
0.038	29.8
0.020	23.6
0.010	20.2
0.007	18.6
0.005	16.6
0.004	14.2
0.002	11.6

Clay	Percentage Particle Size						Cobbles	Boulder
	Fine	Medium	Coarse	Fine	Medium	Coarse		
	Silt		Sand		Gravel			
11.6	22.2		21.0		45.1		0.0	0.0

Sample Description: Brown slightly sandy gravelly silty CLAY.

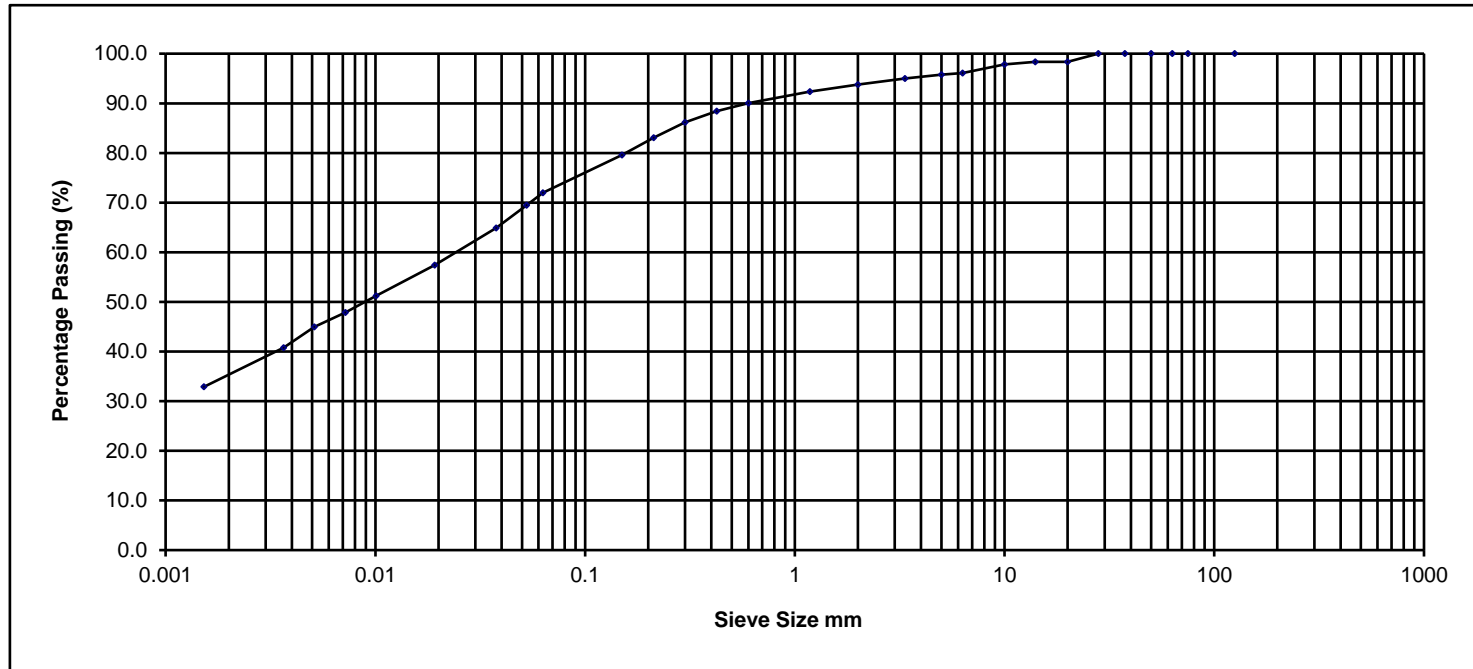
### Determination of Particle Size Distribution BS 1377 : 1990 : Part 2 : Clauses 9.2 & 9.5

Sieve Size mm	% Passing
125.000	100.0
75.000	100.0
63.000	100.0
50.000	100.0
37.500	100.0
28.000	100.0
20.000	98.4
14.000	98.4
10.000	97.8
6.300	96.1
5.000	95.8
3.350	95.0
2.000	93.8
1.180	92.3
0.600	90.0
0.425	88.4
0.300	86.1
0.212	83.0
0.150	79.6
0.063	72.0
0.053	69.5
0.038	64.9
0.019	57.4
0.010	51.2
0.007	47.9
0.005	44.9
0.004	40.8
0.002	32.9

Clay	Percentage Particle Size						Cobbles	Boulder
	Fine	Medium	Coarse	Fine	Medium	Coarse		
	Silt		Sand		Gravel			
32.9	39.1		21.8		6.2		0.0	0.0

Sample Description Red/brown slightly gravelly slightly sandy silty CLAY.

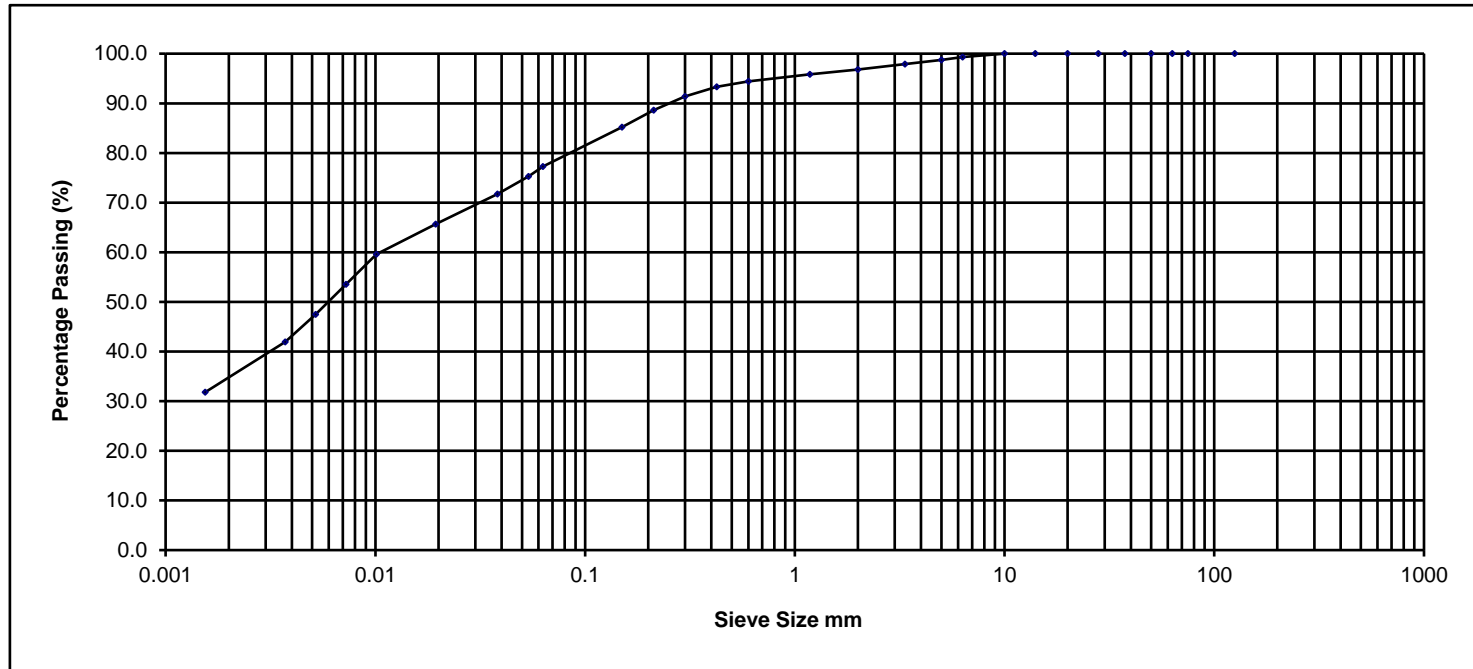
### Determination of Particle Size Distribution BS 1377 : 1990 : Part 2 : Clauses 9.2 & 9.5

Sieve Size mm	% Passing
125.000	100.0
75.000	100.0
63.000	100.0
50.000	100.0
37.500	100.0
28.000	100.0
20.000	100.0
14.000	100.0
10.000	100.0
6.300	99.3
5.000	98.7
3.350	97.9
2.000	96.8
1.180	95.8
0.600	94.4
0.425	93.3
0.300	91.4
0.212	88.6
0.150	85.2
0.063	77.3
0.054	75.2
0.038	71.7
0.019	65.6
0.010	59.6
0.007	53.5
0.005	47.5
0.004	41.9
0.002	31.8

Clay	Percentage Particle Size						Cobbles	Boulder
	Fine	Medium	Coarse	Fine	Medium	Coarse		
	Silt		Sand		Gravel			
31.8	45.4		19.5		3.2		0.0	0.0

Sample Description Brown/grey slightly gravelly slightly sandy silty CLAY.

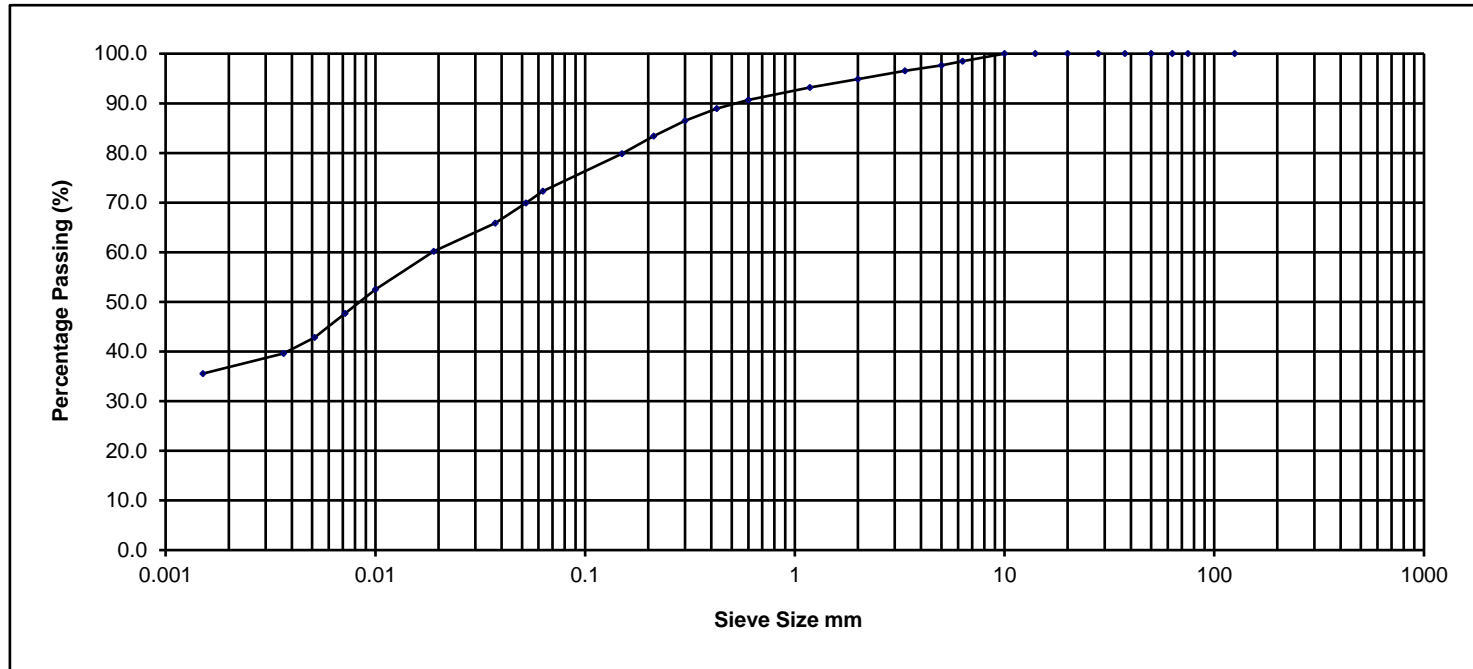
### Determination of Particle Size Distribution BS 1377 : 1990 : Part 2 : Clauses 9.2 & 9.5

Sieve Size mm	% Passing
125.000	100.0
75.000	100.0
63.000	100.0
50.000	100.0
37.500	100.0
28.000	100.0
20.000	100.0
14.000	100.0
10.000	100.0
6.300	98.5
5.000	97.7
3.350	96.6
2.000	94.9
1.180	93.2
0.600	90.7
0.425	88.9
0.300	86.5
0.212	83.4
0.150	79.8
0.063	72.3
0.052	69.9
0.037	65.9
0.019	60.2
0.010	52.5
0.007	47.7
0.005	42.8
0.004	39.6
0.002	35.6

Percentage Particle Size											
Clay	Fine			Medium			Coarse			Cobbles	Boulder
	Fine	Medium	Coarse	Fine	Medium	Coarse	Fine	Medium	Coarse		
35.6	Silt			Sand			Gravel			0.0	0.0

Sample Description Orange/brown slightly gravelly slightly sandy silty CLAY.

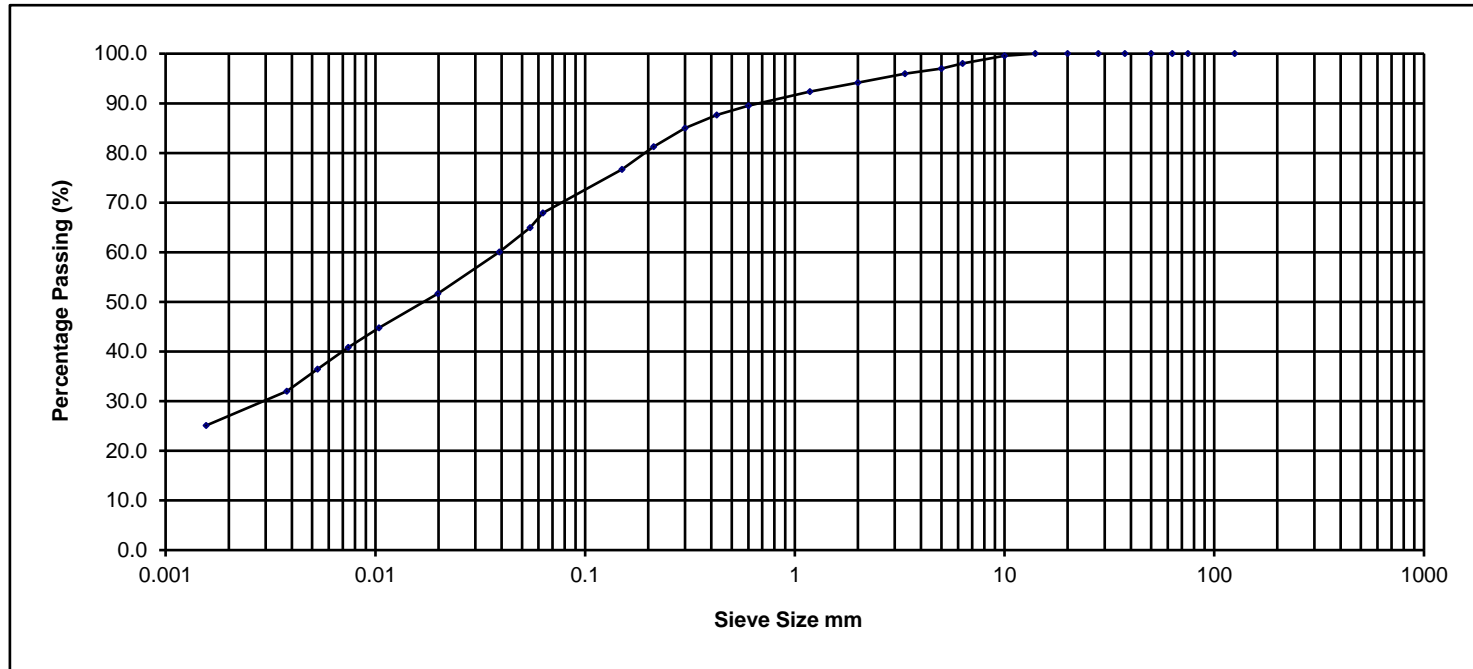
### Determination of Particle Size Distribution BS 1377 : 1990 : Part 2 : Clauses 9.2 & 9.5

Sieve Size mm	% Passing
125.000	100.0
75.000	100.0
63.000	100.0
50.000	100.0
37.500	100.0
28.000	100.0
20.000	100.0
14.000	100.0
10.000	99.6
6.300	98.0
5.000	97.0
3.350	96.0
2.000	94.1
1.180	92.4
0.600	89.5
0.425	87.6
0.300	85.0
0.212	81.2
0.150	76.7
0.063	67.9
0.055	65.0
0.039	60.1
0.020	51.7
0.010	44.8
0.007	40.9
0.005	36.4
0.004	32.0
0.002	25.1

Clay	Percentage Particle Size						Cobbles	Boulder
	Fine	Medium	Coarse	Fine	Medium	Coarse		
	Silt		Sand		Gravel			
25.1	42.8		26.2		5.9		0.0	0.0

Sample Description Red/brown slightly gravelly slightly sandy silty CLAY.

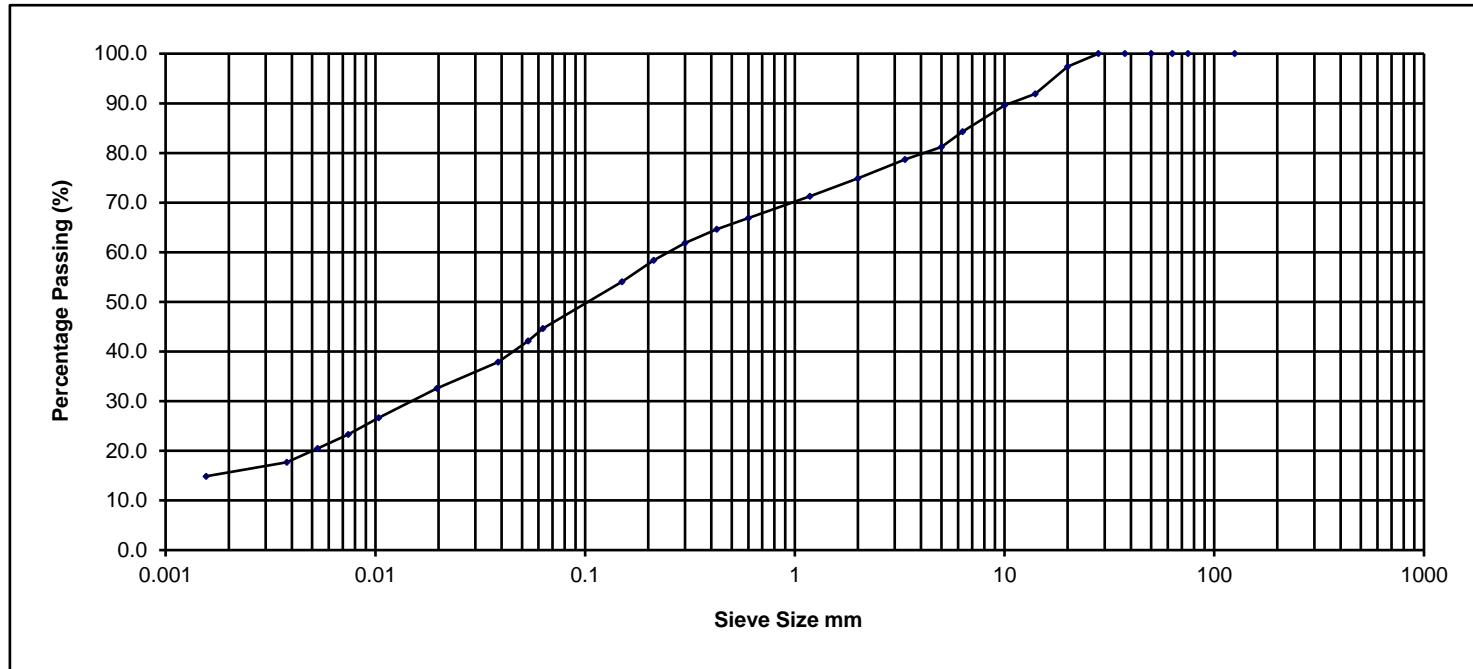
### Determination of Particle Size Distribution BS 1377 : 1990 : Part 2 : Clauses 9.2 & 9.5

Sieve Size mm	% Passing
125.000	100.0
75.000	100.0
63.000	100.0
50.000	100.0
37.500	100.0
28.000	100.0
20.000	97.4
14.000	91.9
10.000	89.6
6.300	84.3
5.000	81.2
3.350	78.7
2.000	74.9
1.180	71.3
0.600	66.9
0.425	64.6
0.300	61.9
0.212	58.3
0.150	54.0
0.063	44.6
0.054	42.1
0.039	37.9
0.020	32.6
0.010	26.7
0.007	23.3
0.005	20.5
0.004	17.7
0.002	14.9

Clay	Silt			Sand			Gravel			Cobbles	Boulder
	Fine	Medium	Coarse	Fine	Medium	Coarse	Fine	Medium	Coarse		
14.9	29.8			30.2			25.1			0.0	0.0

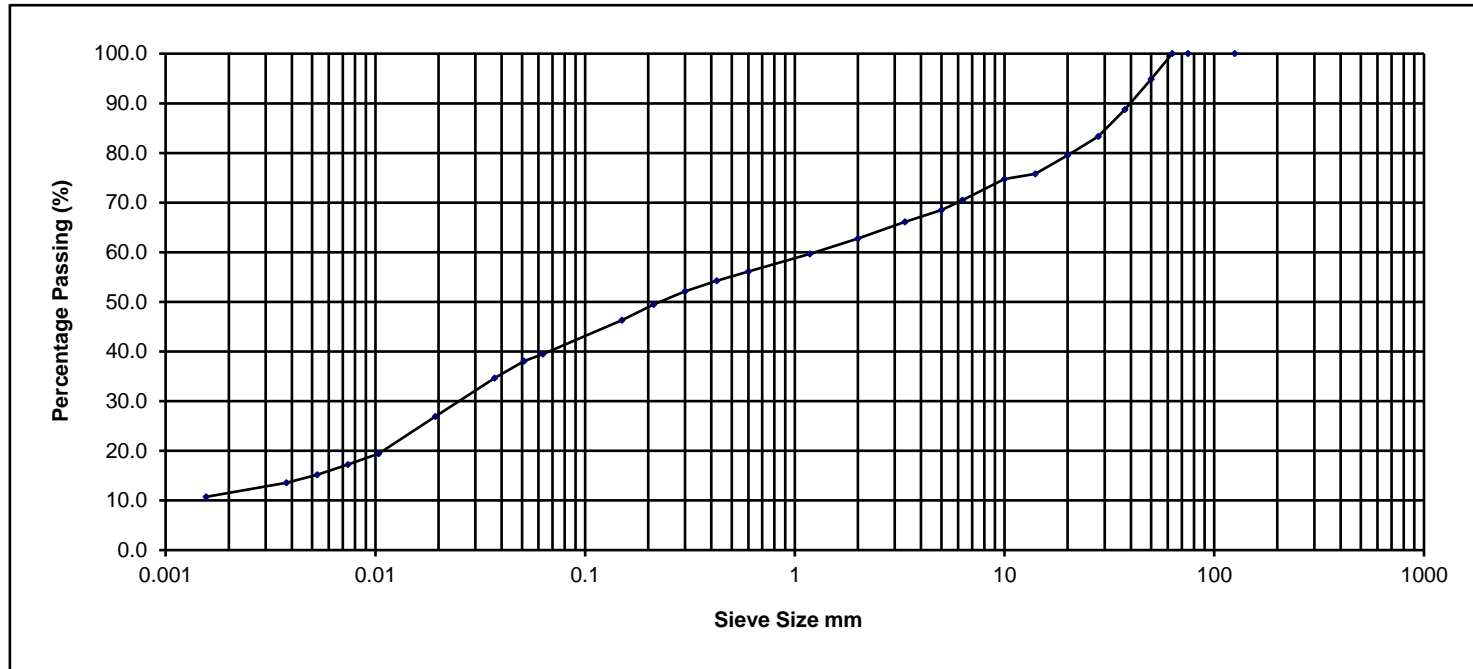
### Determination of Particle Size Distribution BS 1377 : 1990 : Part 2 : Clauses 9.2 & 9.5

Sieve Size mm	% Passing
125.000	100.0
75.000	100.0
63.000	100.0
50.000	94.9
37.500	88.8
28.000	83.3
20.000	79.5
14.000	75.8
10.000	74.7
6.300	70.5
5.000	68.5
3.350	66.1
2.000	62.8
1.180	59.7
0.600	56.1
0.425	54.3
0.300	52.1
0.212	49.5
0.150	46.3
0.063	39.5
0.051	38.1
0.037	34.6
0.019	26.9
0.010	19.4
0.007	17.2
0.005	15.2
0.004	13.6
0.002	10.7

Clay	Percentage Particle Size						Cobbles	Boulder
	Fine	Medium	Coarse	Fine	Medium	Coarse		
	Silt		Sand		Gravel			
10.7	28.8		23.3		37.2		0.0	0.0

Sample Description: Brown slightly sandy gravelly silty CLAY.

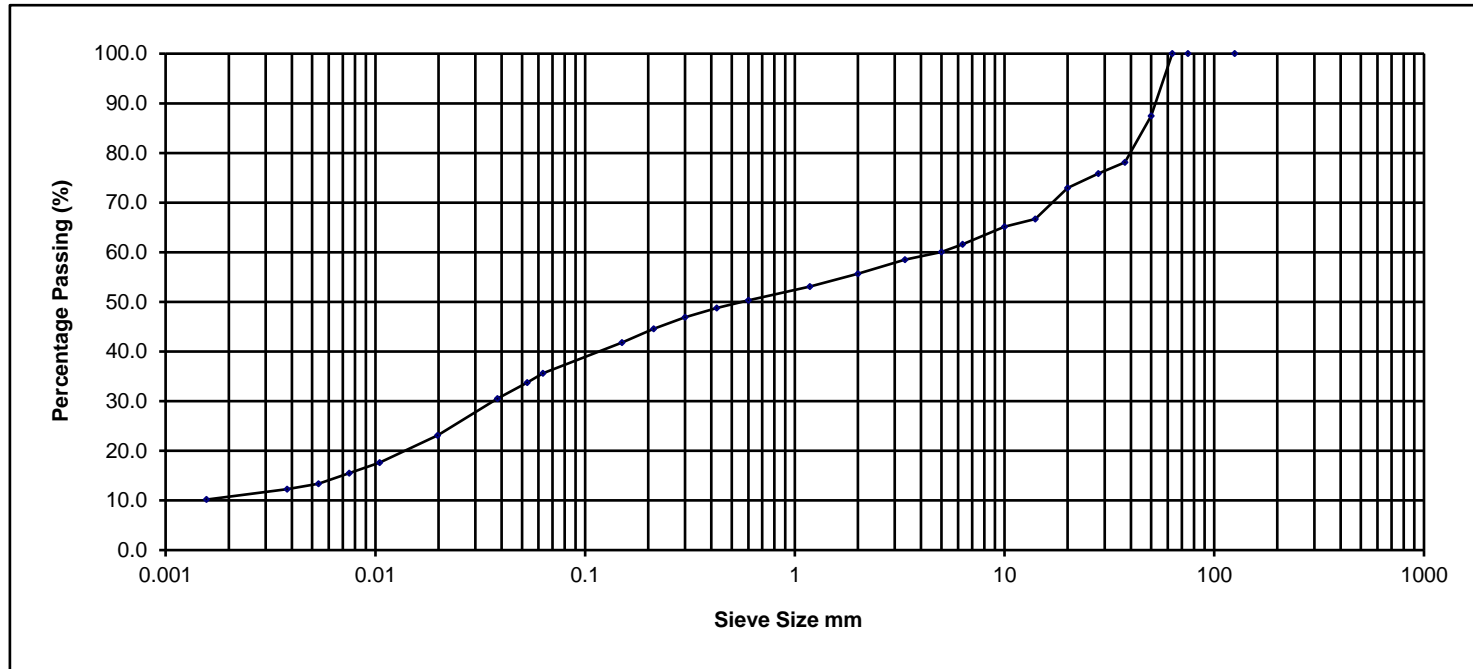
### Determination of Particle Size Distribution BS 1377 : 1990 : Part 2 : Clauses 9.2 & 9.5

Sieve Size mm	% Passing
125.000	100.0
75.000	100.0
63.000	100.0
50.000	87.4
37.500	78.1
28.000	75.9
20.000	73.0
14.000	66.7
10.000	65.1
6.300	61.6
5.000	60.0
3.350	58.5
2.000	55.7
1.180	53.1
0.600	50.3
0.425	48.8
0.300	46.9
0.212	44.6
0.150	41.8
0.063	35.6
0.053	33.7
0.038	30.5
0.020	23.1
0.010	17.6
0.007	15.5
0.005	13.4
0.004	12.3
0.002	10.2

Clay	Percentage Particle Size						Cobbles	Boulder
	Fine	Medium	Coarse	Fine	Medium	Coarse		
	Silt		Sand		Gravel			
10.2	25.4		20.0		44.3		0.0	0.0

Sample Description Brown slightly sandy gravelly silty CLAY.
