## Stillorgan Library

## Ground Investigation Report

Project Title	Stillorgan Library
Engineer	Hayes Higgins
Project No	7289-12-17
Document Title	Ground Investigation Report

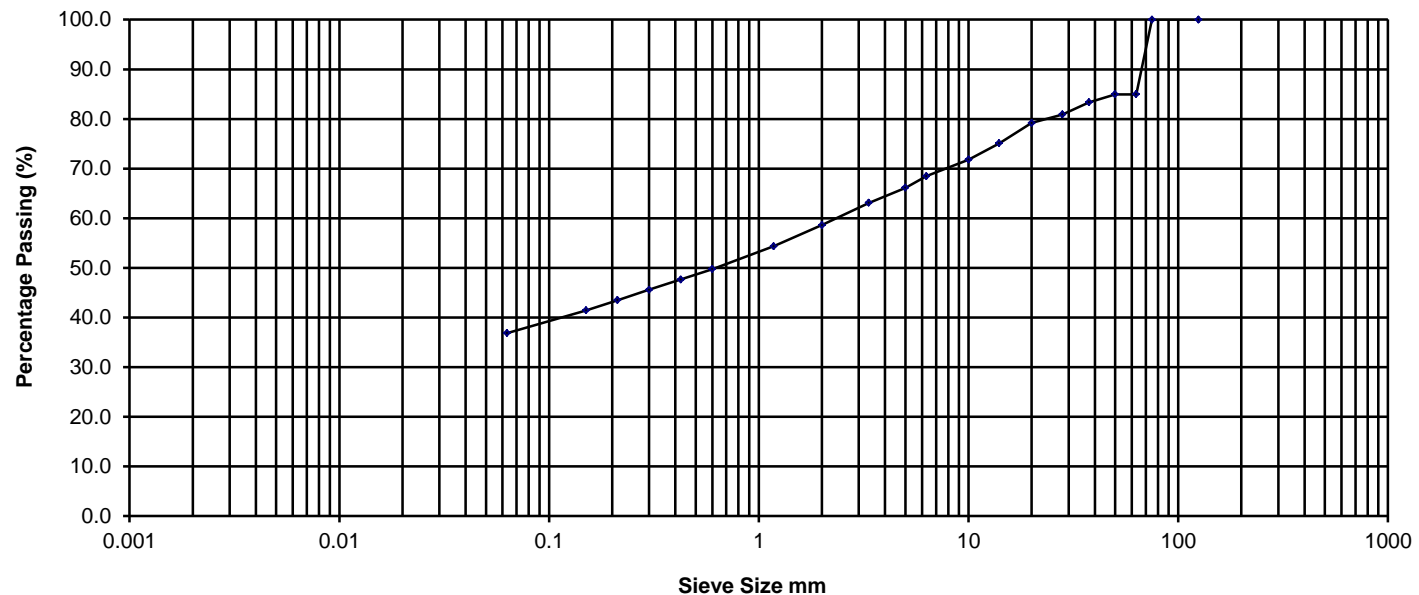
## Determination of Particle Size Distribution

Percentage Particle Size										Cobbles	Boulder
Clay	Fine	Medium	Coarse	Fine	Medium	Coarse	Fine	Medium	Coarse		
silt				Sand			Gravel				
36.8				21.8			26.3			15.0	0.0

Sample Description Brown slightly sandy very gravelly silty CLAY, with some cobbles.

The geotechnical testing carried out on soil samples recovered generally confirm the descriptions on the logs with the primary constituent of the cohesive deposits found to be a CLAY of low to intermediate plasticity. The Particle Size Distribution tests confirm that generally the cohesive deposits are well-graded with percentages of sands and gravels ranging between 21% and 33% generally with fines contents of 37 to 45%.

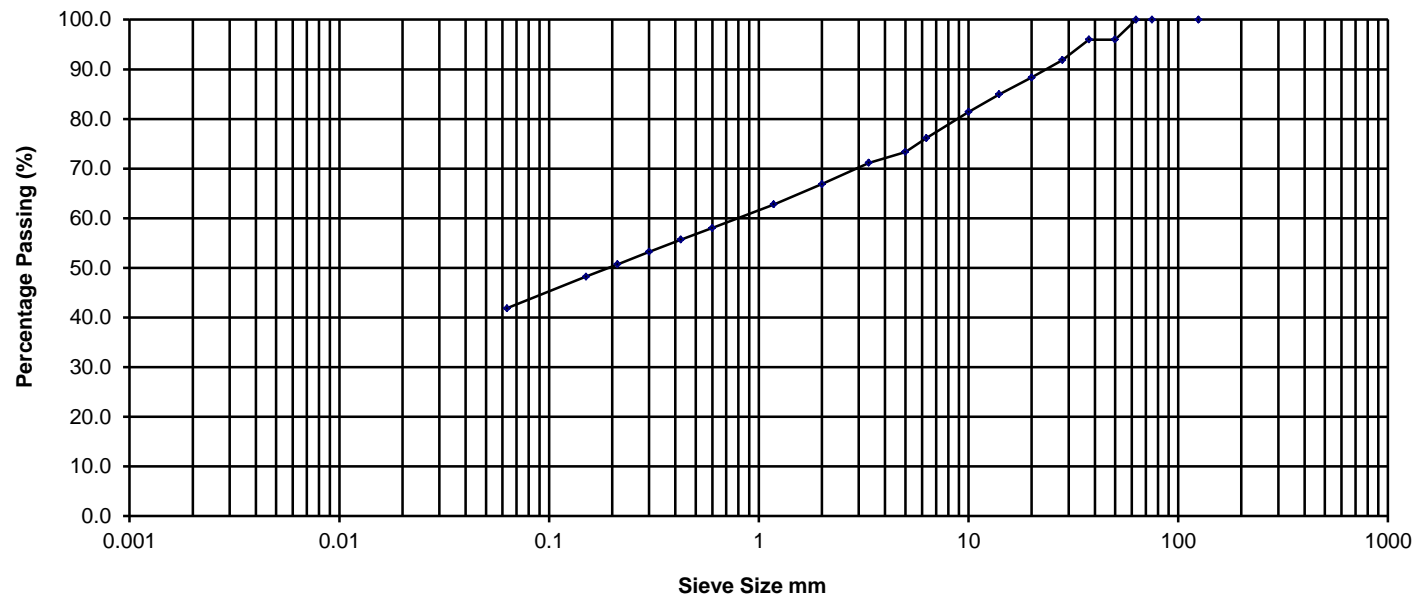
## Determination of Particle Size Distribution

Percentage Particle Size										Cobbles	Boulder
Clay	Fine	Medium	Coarse	Fine	Medium	Coarse	Fine	Medium	Coarse		
silt				Sand			Gravel				
41.9				25.0			33.1			0.0	0.0

Sample Description Brown slightly sandy very gravelly silty CLAY.

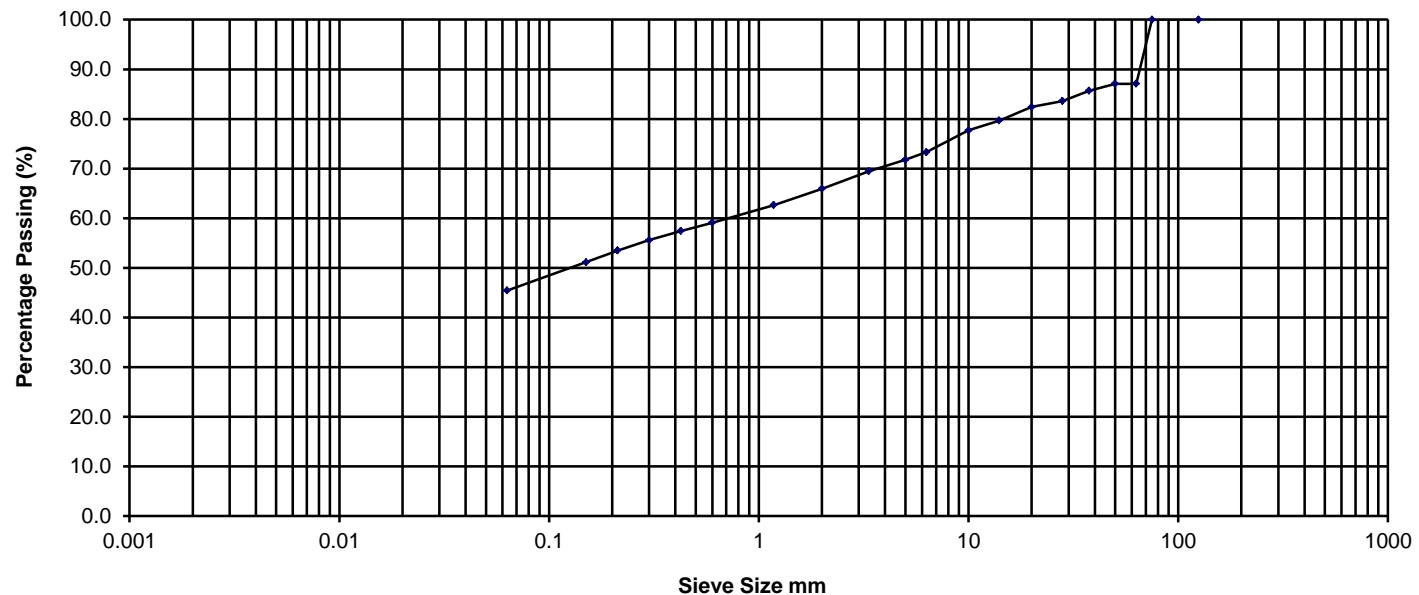
## Determination of Particle Size Distribution

Percentage Particle Size										Cobbles	Boulder
Clay	Fine	Medium	Coarse	Fine	Medium	Coarse	Fine	Medium	Coarse		
silt				Sand			Gravel				
45.4				20.5			21.2			12.9	0.0

Sample Description Dark brown slightly sandy very gravelly silty CLAY, with some cobbles.
