# Cabinteely Greenway

## Stage 1 Road Safety Audit Report

230119-X-90-X-XXX-RP-DBFL-CE-0001

April 2025

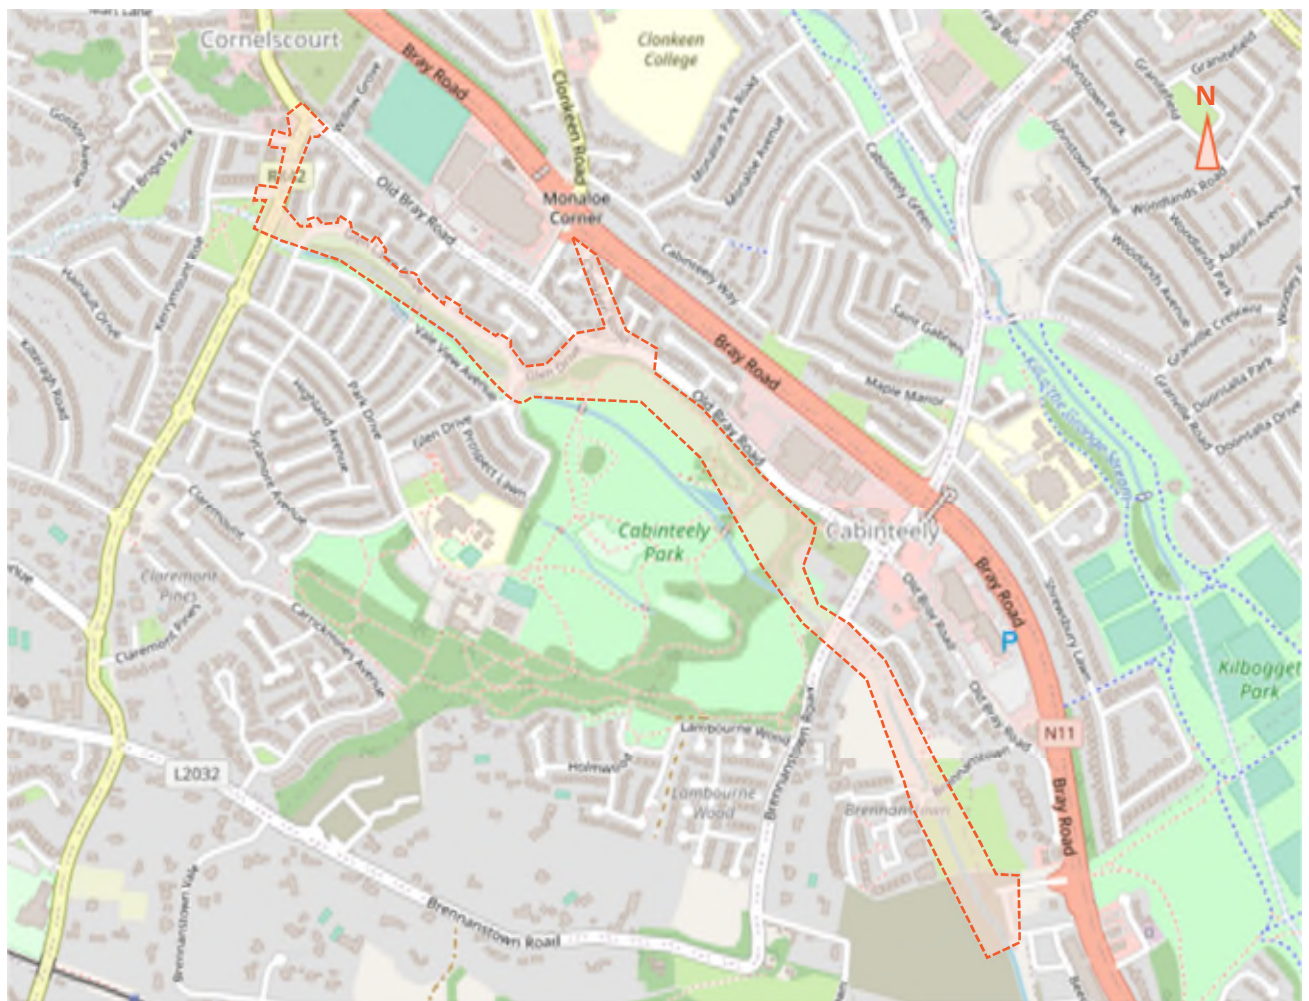
Figure 1 2 Geographical Scope of RSA Audit

The geographical scope of this Stage 1 Road Safety Audit considers the extents of the new pedestrian and cycle facility and its transitions with the wider cycle network including tie-ins at the scheme extents and on side road approaches. The geographical scope of this Road Safety Audit is illustrated in Figure1-2 below.

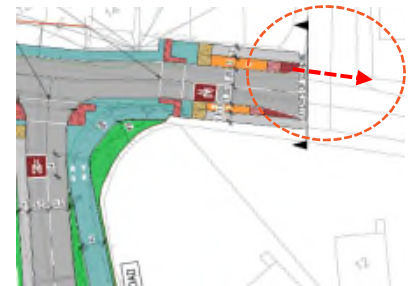
### Location (S1) – Bray Road Southeast tie-in.

The drawings provided for this audit shows that cycle facility along Bray Road terminates to the southeast at the junction with Willow Grove and directs cyclists towards the kerb on the southern side of Willow Grove rather than guiding them on-road in the direction of travel. There is a risk that cyclists may be struck by vehicles entering or exiting Willow Grove or side swipe type collisions with main road traffic as cyclists attempt to redirect their line of travel into the main road.

It is recommended that the cycle facility should be extended across the side road with cyclists guided into their intended direction of travel.

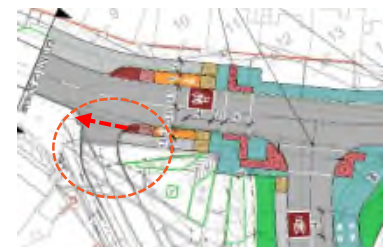
### Location (S2) – Bray Road Northwest tie-in.

The drawings provided for this audit shows that the cycle facility along Bray Road terminates to the northwest at the side access road junction leading to M Roe & Sons. This directs cyclists towards the kerb on the northern side of the side road rather than guiding them on-road in the direction of travel. There is a risk that cyclists may be struck by vehicles entering or exiting the side road or side swipe type collisions with main road traffic as cyclists attempt to redirect their line of travel into the main road.

It is recommended that the cycle facility should be extended across the side road with cyclists guided into their intended direction of travel.

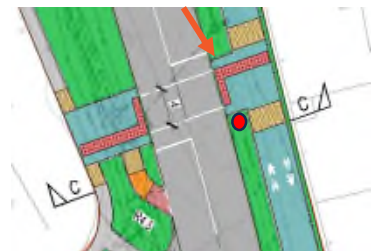
### Location (S4) – Toucan Crossing on Cornelscourt Hill

The auditors note that a toucan crossing is provided on Cornelscourt Hill adjacent to large trees. The auditors are concerned that the large tree may impact visibility of the traffic light for northbound traffic. This may lead to collision between vehicles and crossing pedestrians or cyclists.

It is recommended that the traffic lights should be sufficiently visible to approaching vehicles from both directions.

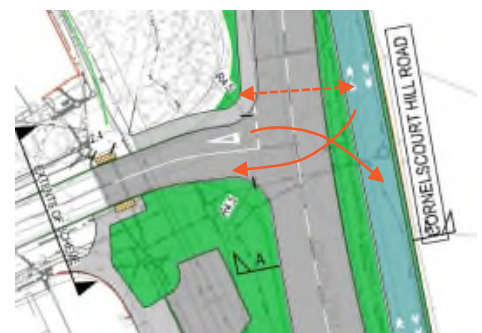
### Location (S5) – Access to/From the Greenway from Gorta Mona Drive

The auditors note that access to/from the Greenway is not provided for users from Gorta Mona Drive. The auditors are concerned that pedestrian or cyclists seeking to access the Greenway via full height kerbs and the grass verge area may result trip/fall type incidents.

It is recommended that safe and convenient access should be provided at this desire line.

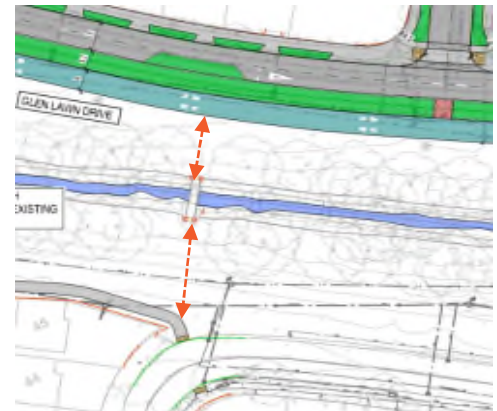
## Location (S6) – Pedestrian Desire Line between Vale View Lawn and the Greenway

The auditors note that no pedestrian facility is provided along the new desire line between Vale View Lawn and the proposed Greenway via the exiting pedestrian footbridge. The auditors are concerned that pedestrians seeking to access the Greenway via the steep grass area may slip/fall as they cross the grass area.

It is recommended that the potential need for the delivery of a formal pedestrian facility along this desire line should be investigated as part of this scheme.

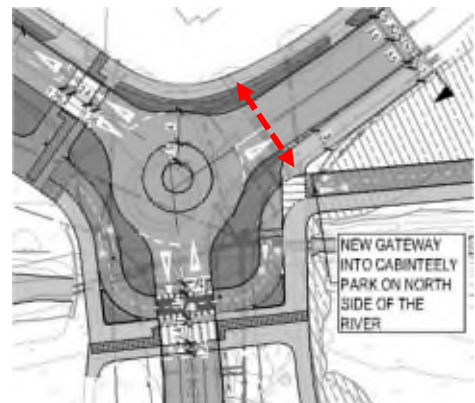
## Location (S7) – Pedestrian Desire Line at Eastern Arm of Glen Drive Roundabout

The auditors note that the existing entrance on Glen Drive will be closed and no pedestrian/ facility is provided at the desire line created at the eastern arm of Glen Drive roundabout to cater for Glen Drive residents. The auditors are concerned that pedestrians travelling from dwellings east of the roundabout and along the eastern side of Glen Lawn Dr. to / from the proposed new access into Cabinteely Park may cross Glen Drive along this much shorter route in the path of moving traffic resulting in collisions between vehicles and pedestrians or the proposed Greenway may not be conveniently accessible to some users (wheelchair/push buggy users and visually impaired).

It is recommended that safe and convenient access should be provided at the pedestrian desire line.

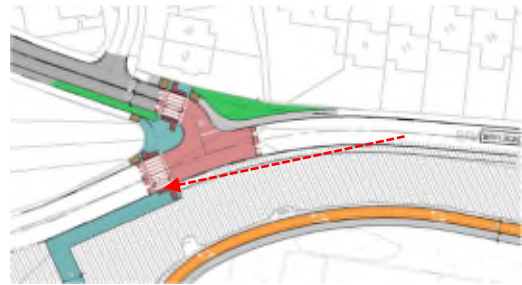
## Location (S8) – Forward Visibility to Pedestrian Crossing

The auditors are unsure if there is sufficient forward visibility provided between westbound drivers and pedestrians at the pedestrian crossing located on Bray Road immediately to the west of Bóthar Chluain Chaoin. Failure to provide sufficient forward visibility between vehicle drivers and pedestrians at the crossing could result in collisions between vehicles/pedestrian/cyclists.

It is recommended that sufficient forward visibility for the desired design speed is provided between drivers and the proposed crossings.

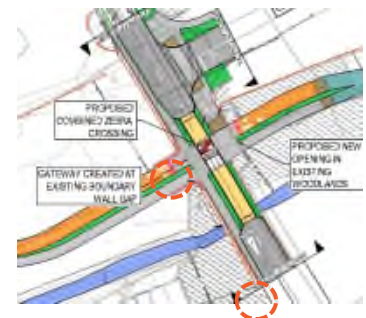
## Location (S9) – Shuttle System on Brennanstown Road.

The drawings submitted for this audit shows proposed Shuttle System on Brennanstown Road. The auditors are unsure if there is sufficient space provided for an opposing vehicle to safely exit the shuttle system when a vehicle is waiting in the opposing lane. Failure to provide sufficient space may lead to side swipe collisions.

It is recommended that sufficient space should be provided for an opposing vehicle to safely exit the shuttle system.

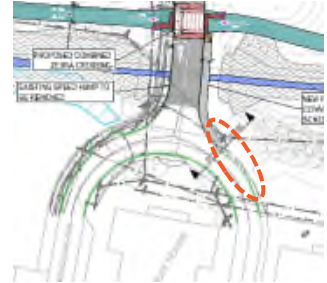
## Location (S10) – Proposed Footpath Tie-in

The drawings submitted for this audit shows proposed new footpath on eastern side of Brennanstown Avenue providing a connection to the proposed Greenway. However, the auditors note that the proposed footpath does not tie-in with the existing footpath. This forces pedestrians seeking to access the Greenway to either walk on the grass resulting in slip/fall incidents or walk on the carriageway with live traffic resulting in vehicle/pedestrian collision.

It is recommended that the proposed footpath should be extended southwards providing tie-in with the existing footpath.

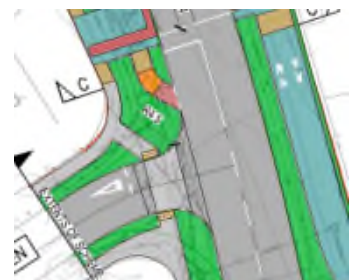
### Comment C2 – Yield Control at Side Road Junctions

The auditors note that Yield Control have been provided at the side road junctions on Cornelscourt Hill. The introduction of the tighter corner radii coupled with the approach to an urban area, 'Stop' road markings and the associated 'Stop' sign should be provided at these side road junctions.
