# No. 9 George's Place & Former Wash House, Kellys Avenue, Dún Laoghaire

High-Level Strategy for Thermal Upgrade of a Heritage Building.

# Jan 2025

# Ref: 024057

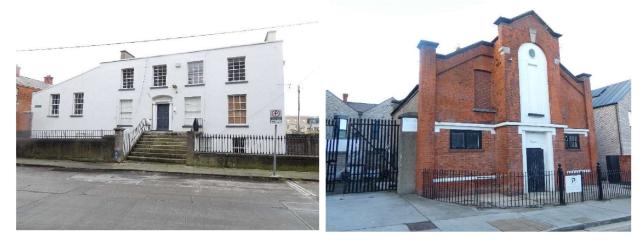
Fig.1: 9 George's Place, Dun Laoghaire

Fig.2: Former Wash House, Kelly's Avenue.
