# Proposed Development of Myrtle Square & Convent Lane, Dun Laoghaire, Co. Dublin PC/PKS/01/20

Appendix 8 - Bat Survey

## Myrtle Square and Convent Lane Greening, Dun Laoghaire, Co. Dublin Bat Survey

10th September 2020

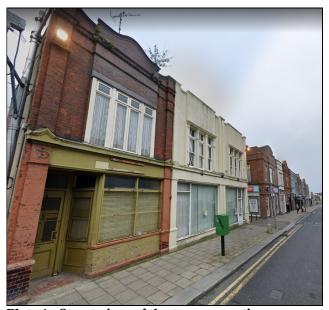
The two properties (No. 35 – 36, which was a former VHI Insurance office building, and No. 37, which was a former cobblers shop and residence) were examined for evidence of roosting bats.

Plate 1. Street view of the two properties.

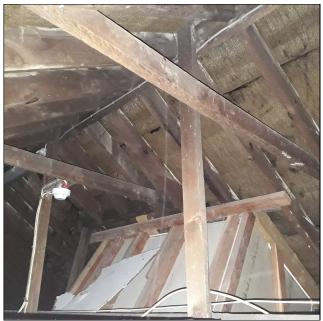
The rear of the VHI Insurance office building is flat roofed with a concrete roof – below this is a modern suspended ceiling. There is a small attic space at the front of the building which could only be partially inspected.

Plate 2. Attic at the front of the VHI building (No. 35 - 36).

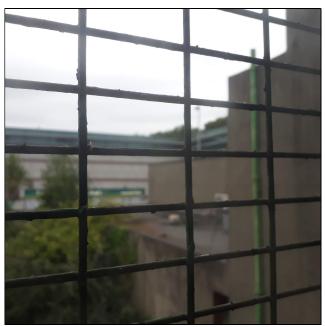
Plate 3. Flat roofed extension at the rear of the VHI building.

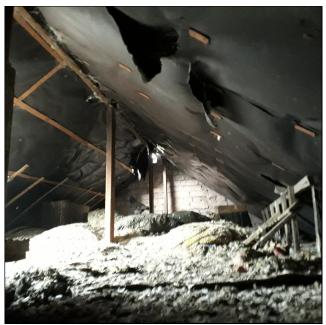
The attic of the old cobbler's shop is in very poor condition with considerable water ingress and roosting feral pigeons.

There was no evidence of bats roosting in any of the buildings on site but there is potential for bats to roost in a number of locations within the buildings such as behind fascia, under slates or around flashings.

Plate 4. Attic of the Cobblers building (No. 37).

The two buildings, which are scheduled for demolition will be resurveyed for bats prior to any proposed demolition works if a significant time (>6 months) has elapsed between the date of the present survey and the demolition works once planning permission is granted.

The results of this bat survey will inform the demolition process. Generally a precautionary approach to the demolition of the building will be taken, whereby the roof will be stripped manually with the expectation that bats may be present. One side of the roof will be removed and then the building left overnight before the other side is removed. This work is best done during the winter months (i.e. October – March) when bat numbers are known to be lower in buildings and will also avoid the bird breeding season.
