**Proposed Development of Fernhill Park &
Gardens, Stepside, Co. Dublin with Works
within the Curtilage of the Protected
Structure (Fernhill House)
PC/PKS/01/17**

Appendix 9 - Conservation Report

Conservation Report

Part 8

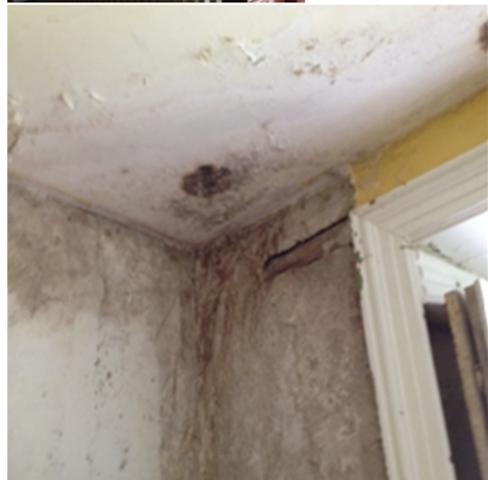
Wet rot Room 8

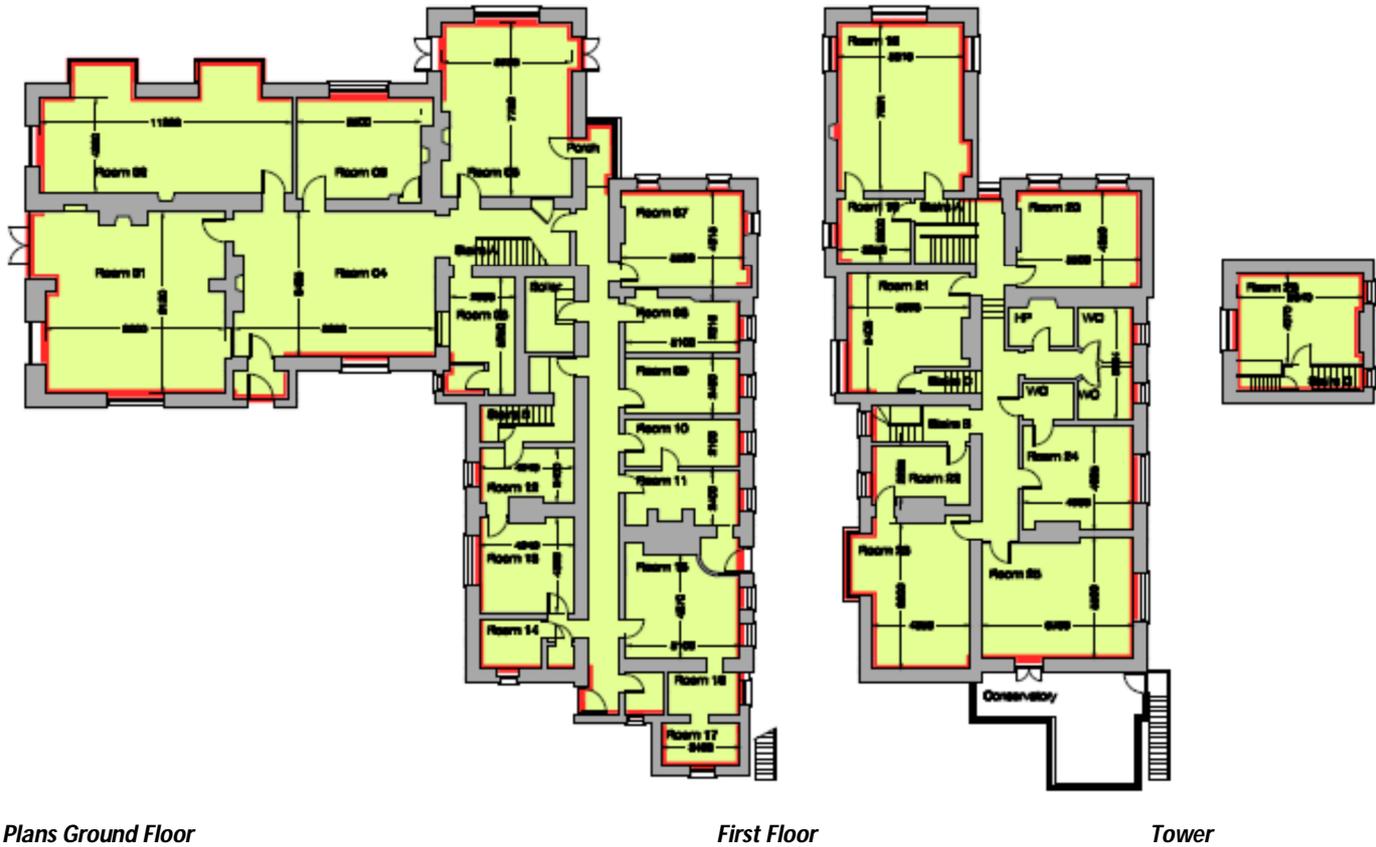
Plans Ground Floor

Fernhill house offers extensive accommodation having a total of 26 various rooms and set out in Table 2 below and shown on the accompanying floor plan.

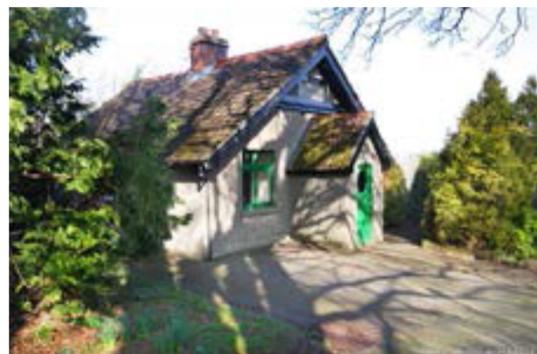
Gate Lodge

This period building is situated at the main entrance. The building is a simple dashed and part timber faced single story building with a single "A" pitched tiled roof.

This was originally a two roomed building which has been extended over the years, including a modern bathroom.

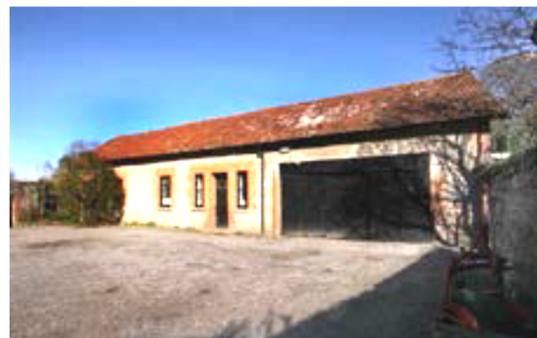
Courtyard Area: Coach house

Two Storey single range building pitched clay tile and timber roof stone construction with brick details to the opes and brick quoin detail.

Carriage/garage with a pit and stables (one stall remains) to the remainder.

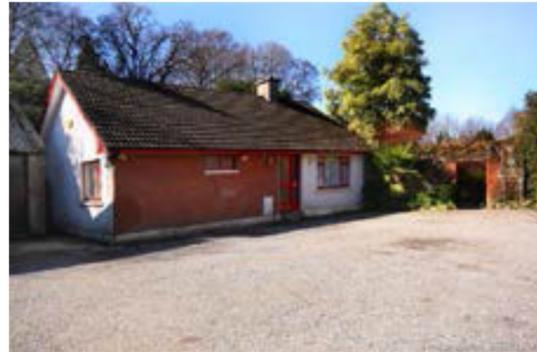
The Garage- Outhouse

The garage is a single story building with metal double doors built onto the Courtyard Wall. It requires remedial works and to be re-roofed.

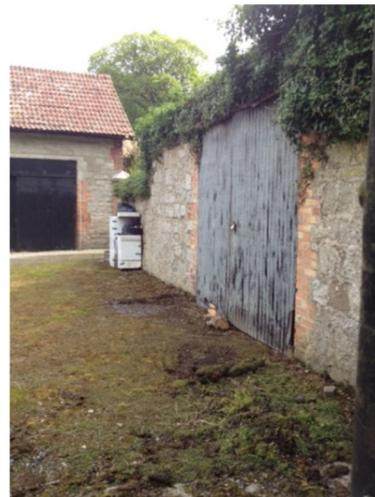
The Shed

This is a small single store building used as a WC and store. The existing metal awning is unusual, reminiscent of a central European design. It requires to be restored and refurbished.

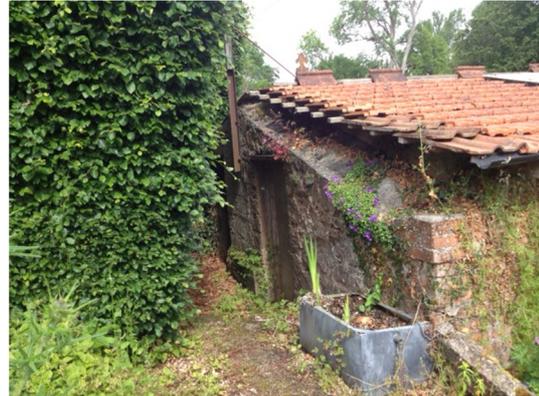
The Peach House

This building is in poor condition. It has had a number of unsuccessful interventions, including plastic panels as sections of roof. The timber rafters are in poor condition. The entire structure requires refurbishment.
