Quality Audit Report Proposed Part 8 Residential Development, Lamb's Cross, Dublin 18

Client:	Malone O'Regan Consulting Engineers
Document No:	231860-ORS-XX-XX-RP-TR-13g-009

This report documents the findings of a Stage 1 Road Safety Audit (RSA) carried out with respect to a Part 8 proposal for the development of 37 no. residential units at Lamb's Cross, Dublin 18 situated at the junction of Sandyford Road and Hillcrest Road.

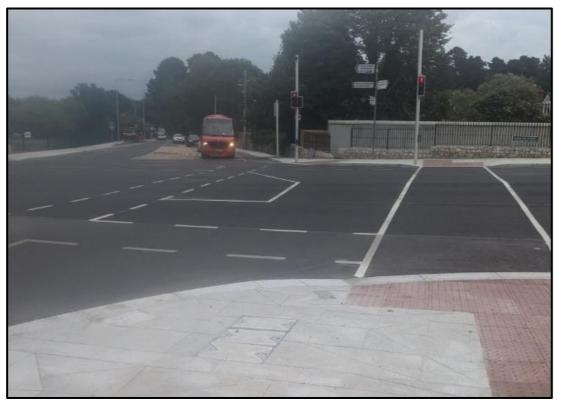
Figure 2.2: Redeveloped Crossroad Junction with Cycle Lanes and Controlled Pedestrian Crossings

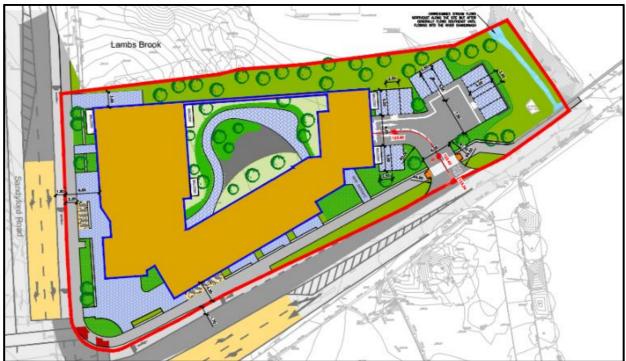
Figure 2.3 shows the site layout provided by Malone O'Regan Consulting Engineers.

Figure 2.3: Site Layout (Source: Malone O'Regan Consulting Engineers)

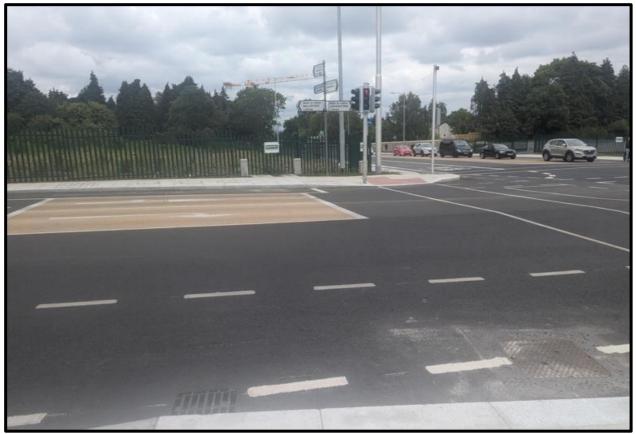
The existing road network around the site is equipped new road markings and signage, while the pavement is in good condition, as shown in **Figure 2.4**.

Figure 2.4: Site location along Hillcrest Road and Lambs Cross

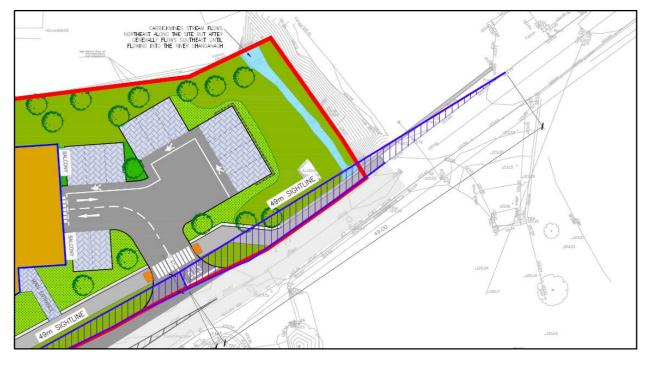
Problem No.1: Sightlines Encroaching Neighbouring Property Wall Location: Main Access

The audit team note from the drawings provided that the sightlines at the main access appear to encroach over the neighbouring boundary wall which could restrict visibility for exiting vehicles. This could potentially result in potential collisions with vehicles on the mainline due to unsafe exits.

Recommendation:

The design team should ensure that the sightlines from the development are not restricted by existing boundary walls.

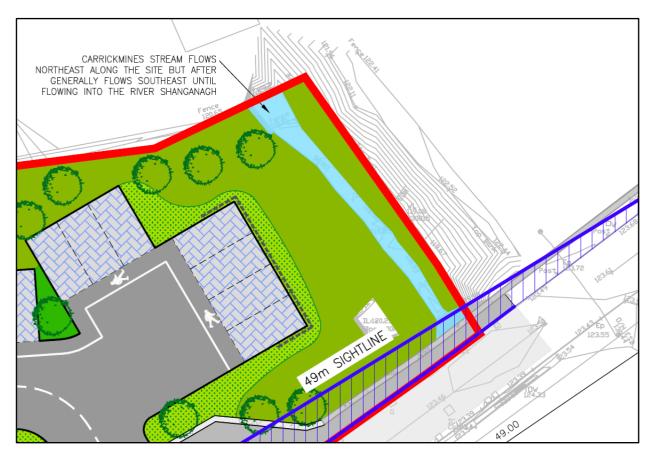
Problem No.2: Protection at Existing Stream Location: Eastern Side of Scheme

The audit team note from the drawings and site visit that there is an existing stream along the eastern boundary to the site which is unprotected. The audit team is concerned that if a vulnerable user fell into the stream that it would result in potential injuries to the vulnerable user.

Recommendation:

The design team should ensure that protective measures are provided along the top of the bank to mitigate the potential for vulnerable users to fall down the bank into the stream.

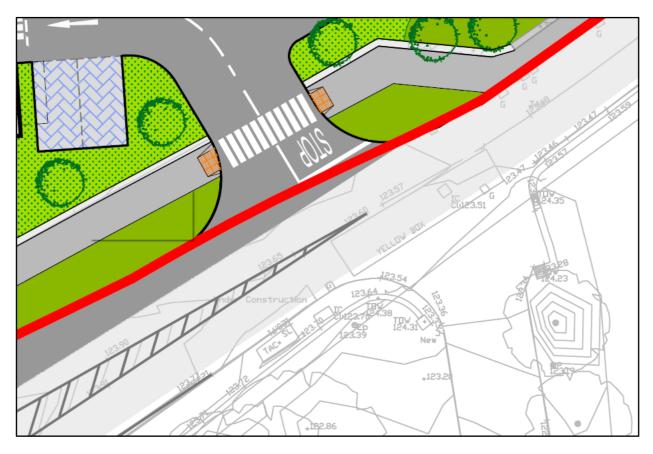
Problem No.3: Solid Centreline Location: Entrance at Hillcrest Road

The audit team note from the site visit that there is an existing solid centreline on Hillcrest Road which would indicate that vehicles approaching from the east are not permitted to cross the road/centreline to gain access to the development. This could result in potential confusion among motorists which could lead to unsafe manoeuvres.

Recommendation:

The design team should ensure that the centreline is dashed or has a break at the access point to allow vehicles to cross.

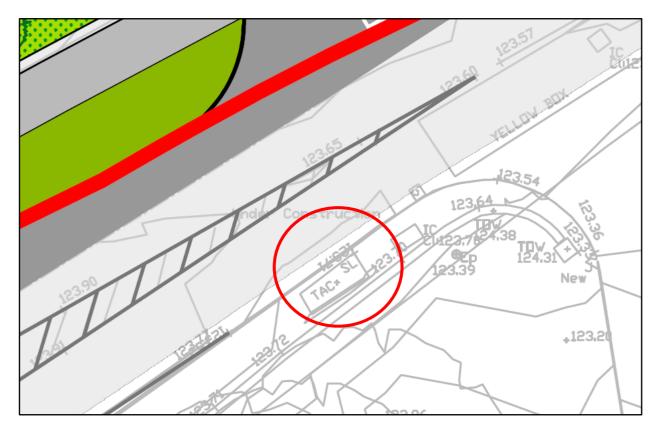
Problem No.4: Existing Pedestrian Crossing Location: Entrance at Hillcrest Road

The audit team note from the site visit that there is an existing pedestrian crossing and tactile paving in the vicinity of the carpark access into the development. The design allows for the northern crossing to be removed, however there is not detail on how the southern crossing is to the dealt with. There is a risk that visually impaired users approaching from the south will use the existing crossing and become disoriented when they do not meet a corresponding crossing facility on the opposite side of the road.

Recommendation:

The design team should ensure the existing crossing is removed on both sides.

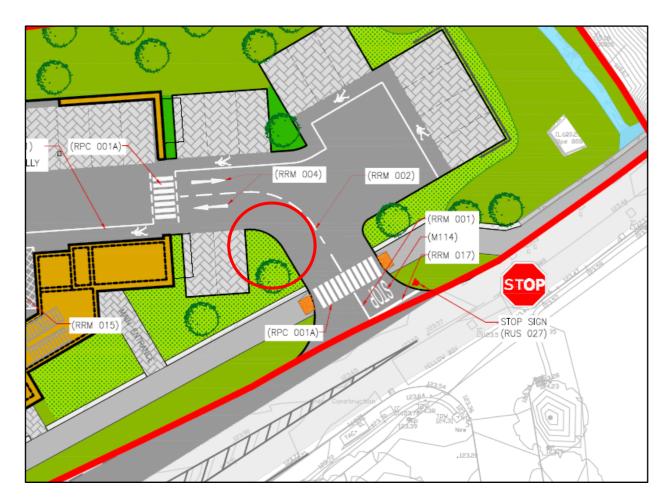
Problem No.5: Advanced Signage for Crossing Location: Entrance at Hillcrest Road

The audit team note from the drawings that there is no advanced warning for motorists in advance of the pedestrian crossing within the carpark. This could lead to an increased risk of vehicle conflicts with vulnerable users due to the lack of awareness of the impeding hazard.

Recommendation:

The design team should ensure that an advanced warning side is provided in advance of the crossing to alert motorists of the impeding hazard.

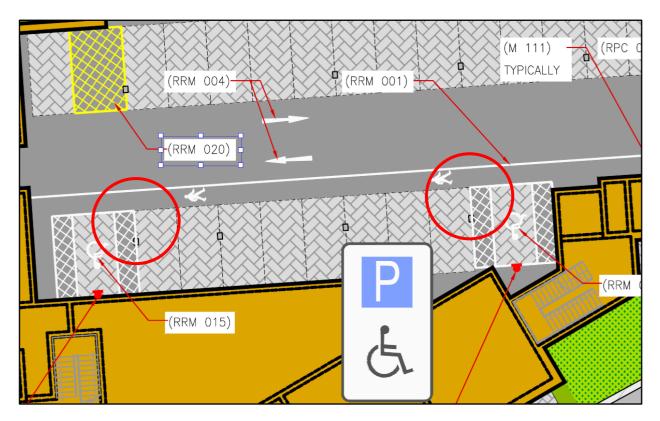
Problem No.6: Restricted Accessible Spaces Location: Under Croft Carpark Area

The audit team note from the drawings that there are columns proposed next to the accessible spaces which could potentially restrict the movement for vulnerable users.

Recommendation:

The design team should ensure that the columns do not restrict the movement of vulnerable users.
