# **Appendix E:** Phase 1 Hydrogeology Assessment of the Cherrywood SDZ

# Cherrywood Hydrogeology

## Phase I Hydrogeology Assessment of the Cherrywood SDZ

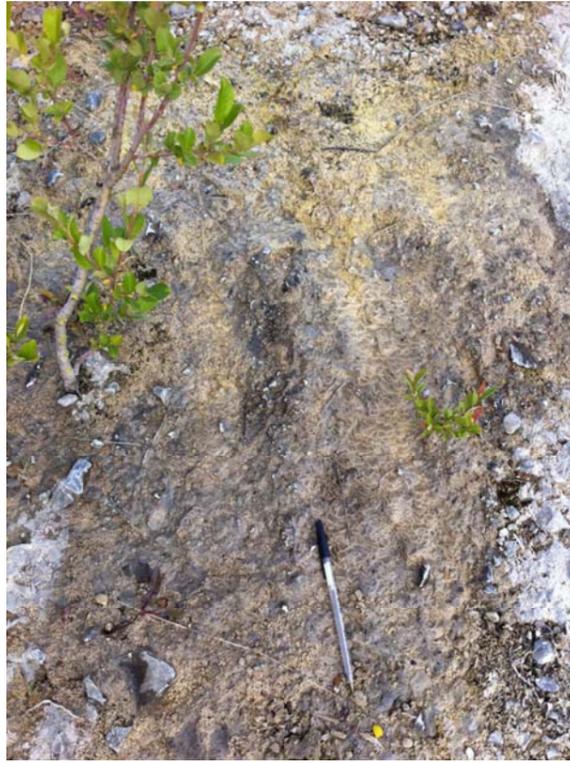
Immature recently formed tuffa as the result of recent earthworks exposing shallow perched groundwater tables and spring/seepage along new embankments. Several examples were evident along the northeast - southwest trending embankment to the northwest of the Wyatville Link Road (location 1 on **Figure 3**). Photographs 1 and 2 (**Appendix A**) illustrate this in close up and from a distance.

Photograph 1 – Close up view of new tuffa formation observed along slope break (ref Location 1 on Figure 3).

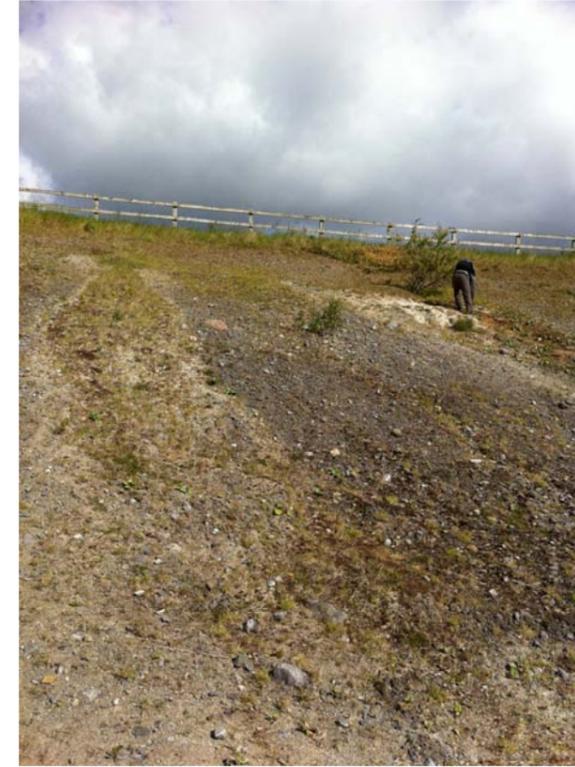
Photograph 2 – View of new tuffa formation (where person is standing) observed from a distance along slope break (ref Location 1 on Figure 3).

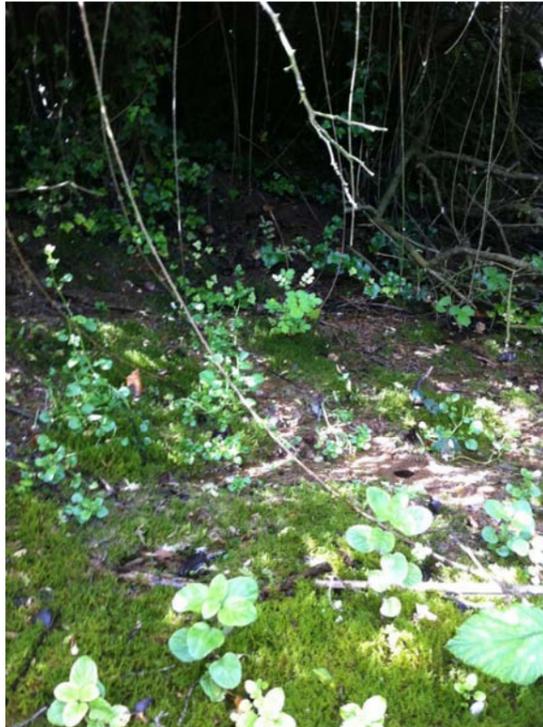
Mature, high quality tuffa springs with active groundwater flow and calcareous carbonate precipitation with associated plant communities. Two large examples were present on the southwestern flank of the river valley to the southwest of the N11 (location 5 on **Figure 3**) and illustrated in Photographs 3 and 4 (**Appendix A**).

The mature tuffa spring formations observed at location 5 (**Figure 3**) are the only maturely developed tuffa formations within the limits of the SDZ. RPS also understands from Scott Cawley that the tuffa spring formations at location 5 correspond to an EC Habitats Directive Annex I habitat. These factors combined ensure that location 5 will be most important for the proposed SDZ in terms of the impacts of the development on the hydrogeology - ecology interaction of the area.

Photograph 3 – Close up of tuffa (orange material surrounded by moss) and spring located along southwest bank of valley at location 5 (refer to Figure 3).

1. A Sustainable Urban Drainage Systems (SUDS) design philosophy should be employed for the SDZ;
2. The construction of hard standing areas should be minimised in the catchments immediately up gradient of the high quality tuffa springs (e.g. location 5) in order to minimise the potential for disruption to recharge in these areas.;
3. Artificial recharge systems should be considered where possible in sensitive areas, specifically up gradient from high quality tuffa spring (e.g. location 5) discharges in order to maintain the overall hydrological balance if development cannot be avoided in these areas; and
4. Landscape proposals should be considered in relation to the position of the groundwater table below the site so as to avoid possible interference with natural groundwater flow directions to sensitive receptors such as the high quality tuffa springs (e.g. location 5).

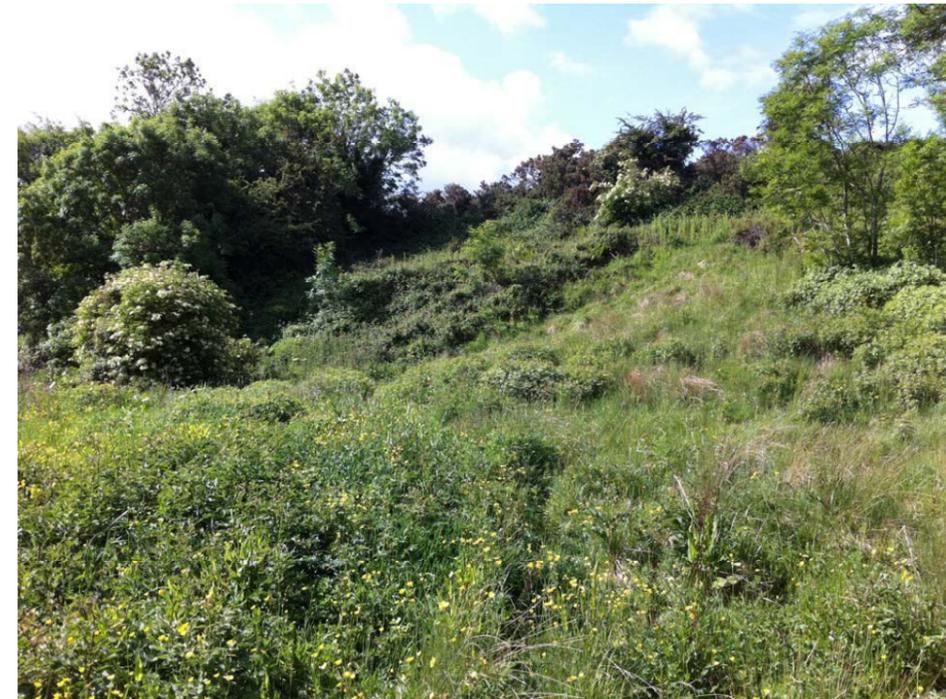
Photograph 4 – Distant view of tuffa spring (heavily overgrown area to the left of trees) located along southwest bank of valley at location 5 (refer to Figure 3).

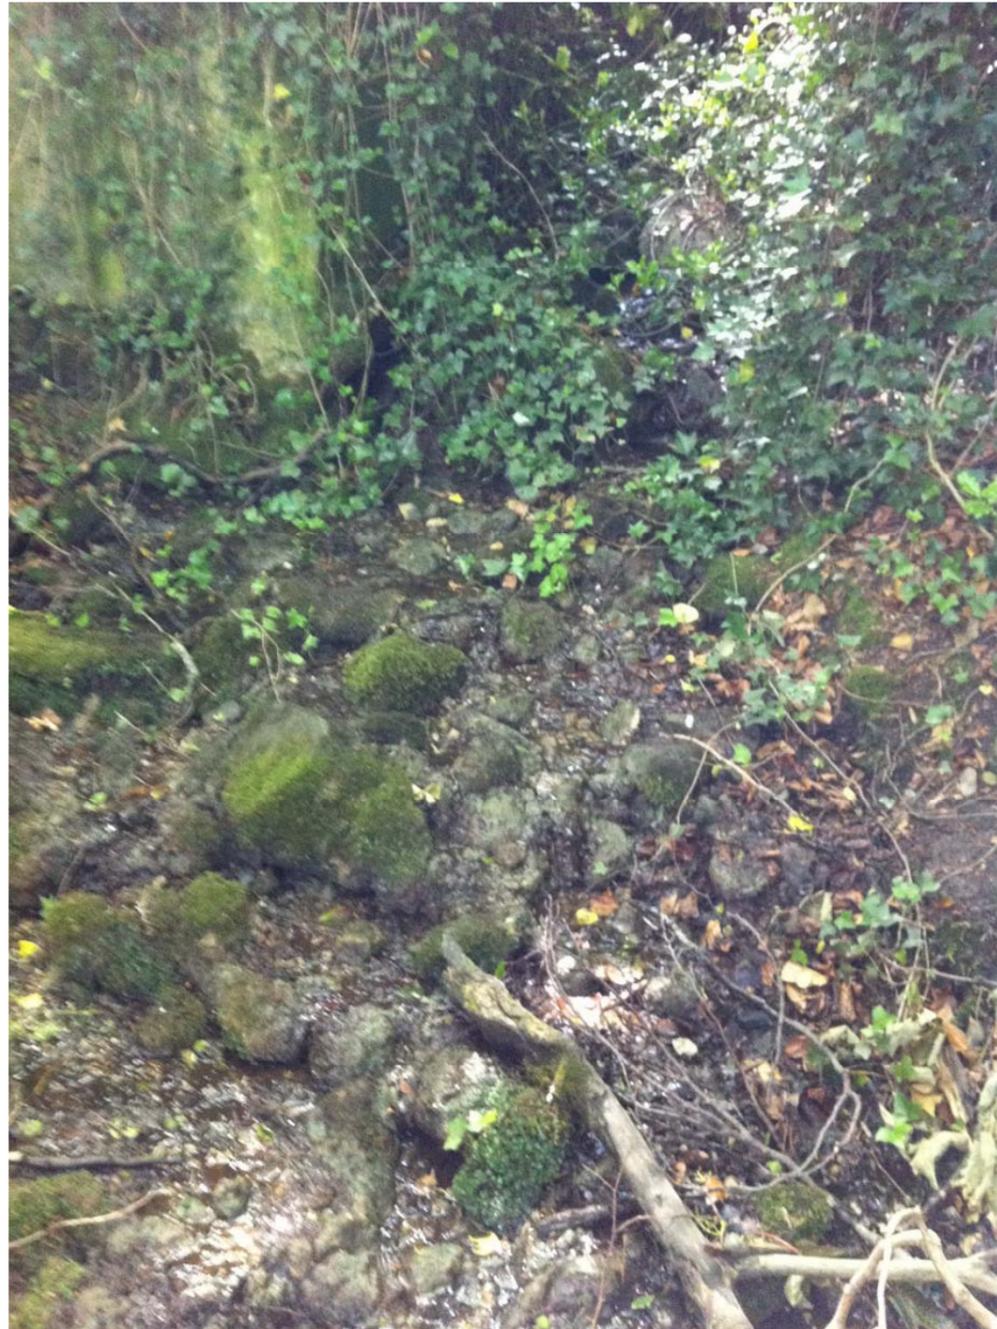
Lower quality tuffa spring formations were located along small drainage channels (with the associated plant communities less dominant). An example occurs at spring seepage to the south of Brennanstown Road on the southern slope of the river valley (location 11 on **Figure 3**) and illustrated in Photograph 5 (**Appendix A**). A rare species of mollusc was also identified by Scott Cawley at location 11.

The more immature tuffa formations identified around the site are insufficiently developed at this time to be considered an issue of high hydrogeological protection, with the exception of location 11. Location 11 has been identified by Scott Cawley as an ecologically sensitive area within the SDZ and as such the hydrogeological impacts of the SDZ development on this site will also be important to consider.

**Photograph 5 –Tuffa formation along drainage stream from spring emergence at location 11. Concrete water holding tank visible at top left corner of image.**

The protection zone (**Figure 4**) relevant to location 11 coincides largely with the 50m buffer zone recommended by Scott Cawley. The protection zone has been extended 50m past the recommended buffer zone to the west of the tuffa spring formation, giving a 100m protection zone in this direction to allow for a conservative estimate in the length of the flow path to the tuffa spring. Topographic contours suggest that flows from the east are unlikely to be contributing to the tuffa spring at location 11.

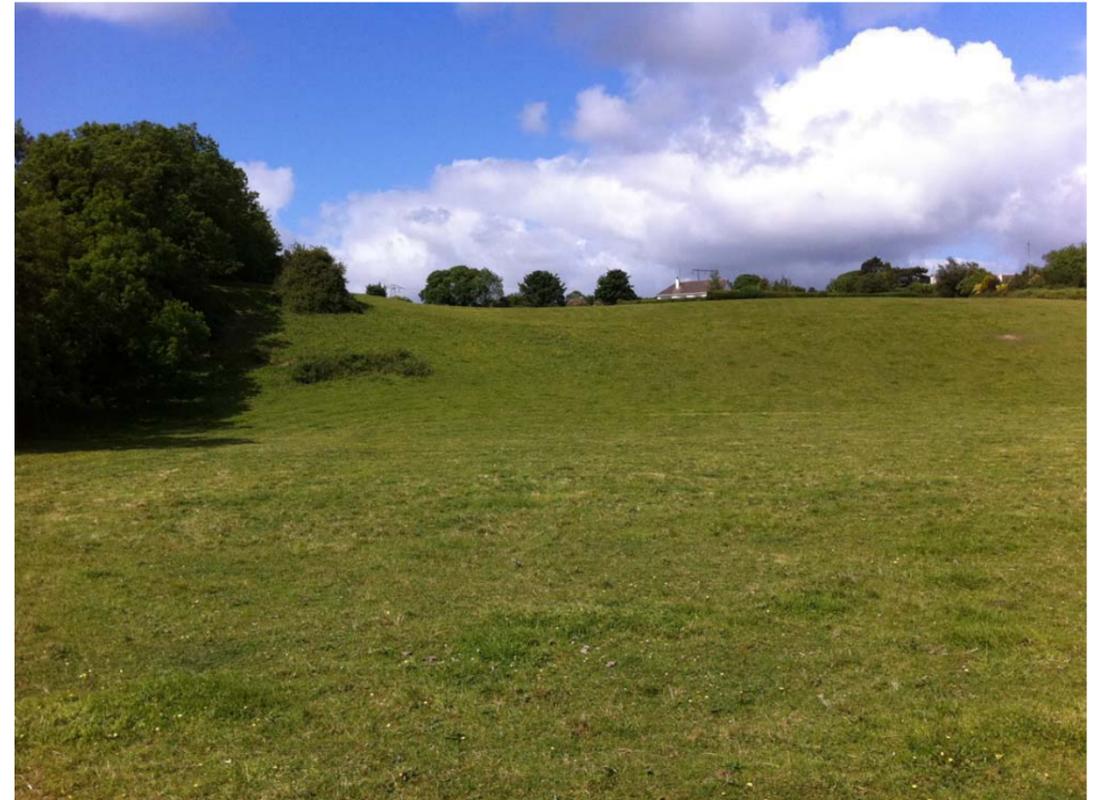
The absence of extensive tuffa spring formations along the southwest side of the river valley indicates that the groundwater flow systems supporting these formations are relatively limited in aerial extent. Photograph 6 (Appendix A) illustrates the nature of a well drained slope without any spring emergence 100m to the northwest of the large tuffa springs observed at location 5.

**Photograph 6 – Dry well drained land without spring or tuffa emergence along western bank of River valley, refer to location 6 on Figure 3.**
