**10 EBLANA AVENUE
DÚN LAOGHAIRE**

**ARCHITECTURAL HERITAGE
IMPACT ASSESSMENT**

4th April 2024

**Historic Building Consultants
Old Bawn
Old Connaught
Bray**

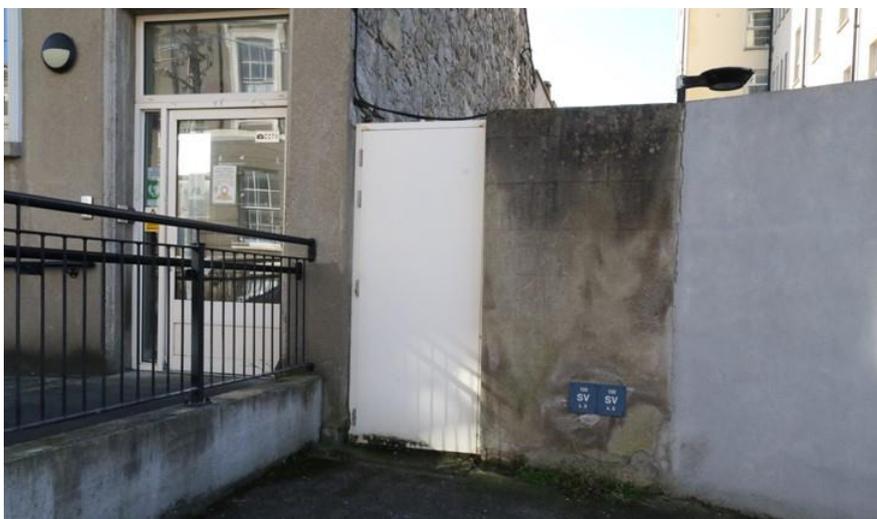
Plate 2: Doorway at western end of building

Evidence from a photograph taken in 2013 prior to works being carried out to the building suggests that the Roman cement moulding surrounding the doorways was based on a timber substrate. It is uncertain how much of the original moulding was removed and replaced during those relatively recent works.

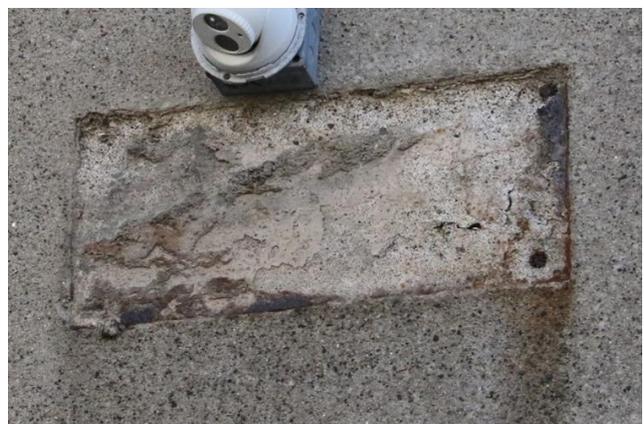
Plate 7: Site of street name plaque on facade

At the western end of the frontage is a rectangular disruption to the sand and cement facing of the building. This was formerly the location of a cast-iron street nameplate bearing the name Eblana Avenue without an equivalent in the Irish language. The erection of the plaque predated the provision of a skim of sand and cement on the façade and the earlier render of harling is visible in the absence of the plaque.

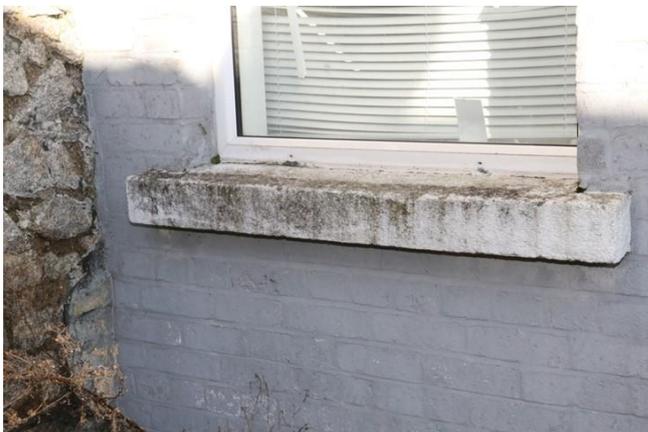
Plate 15: Granite sill

The two windows are of uPVC with one large pane topped by a smaller top-hung casement. The windows are set in openings spanned by a deep precast concrete lintel. The sills are of granite and are painted. A shallow concrete ramp approaches the doorway.

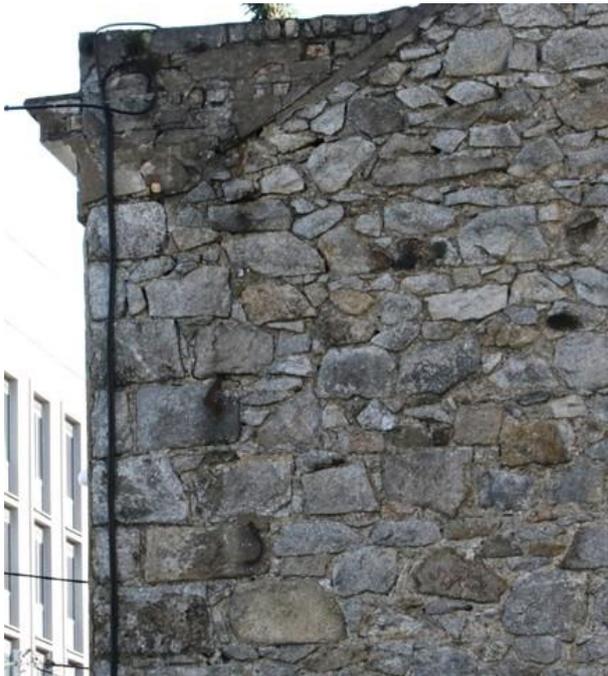
Plate 27: Top of gable at northern end

The western gable of the building is of rubble granite without coursing and is not rendered. The gable at the southern slope has a capping of brick, while the gable at the northern slope has no coping, the slates being cemented to the top of the wall.

The original line of the northern slope continued to the eaves and an additional section of masonry has been added to bring the wall up to the top of the parapet.

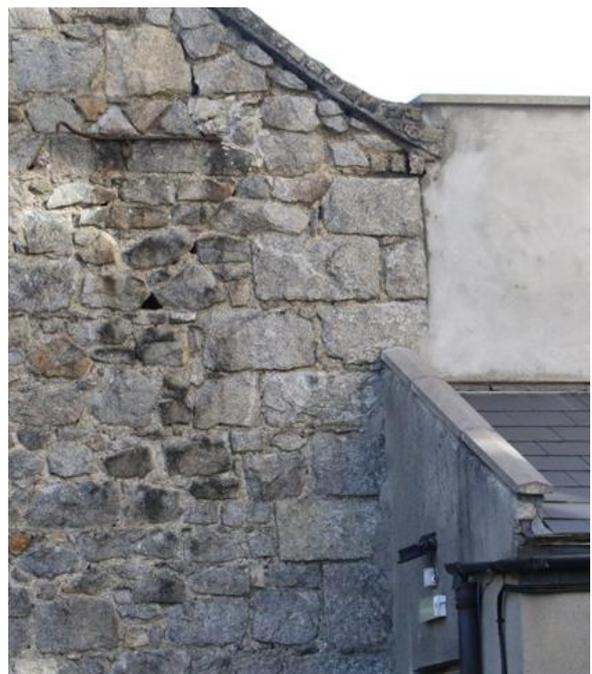
Plate 28: Top of gable at southern end

At both the northern and the southern sides of the gable wall squared granite is incorporated as quoins to strengthen the corners of the building.

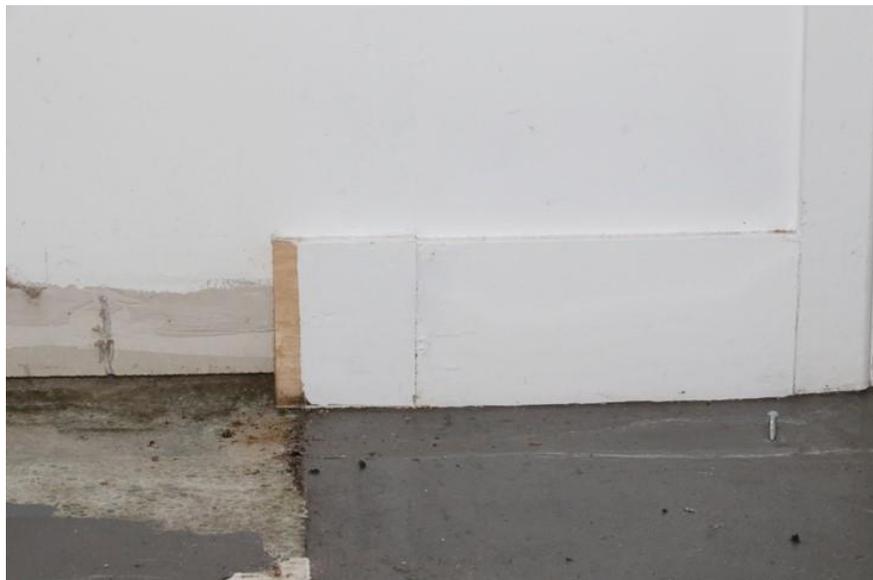
Plate 95: Skirting in store

The skirtings in the store are plain and are of timber. They do not run around the entire perimeter of the room, apparently due to the prior existence of fitted cupboards that have now been removed.

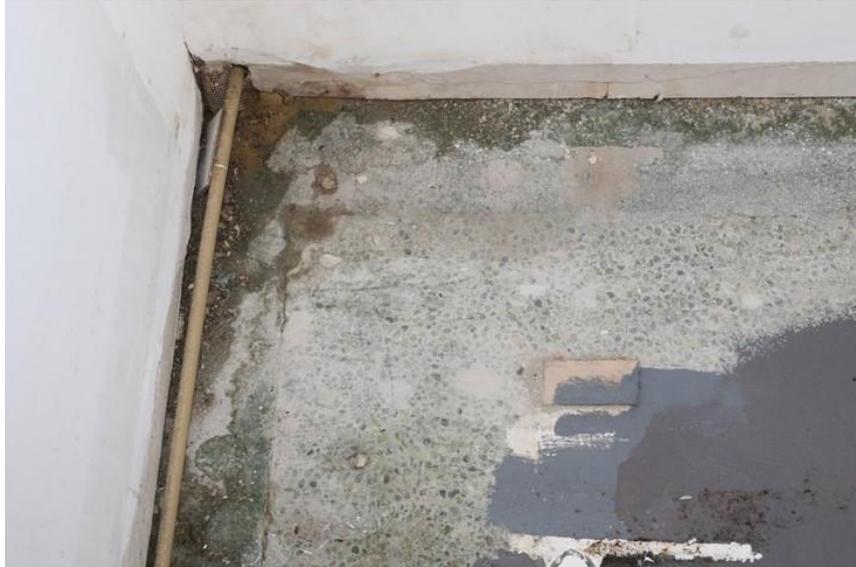
Plate 96: Floor in store

The floor in the store has a concrete base with a finish of terrazzo. The greater part of the floor has been coated with grey floor paint, though the terrazzo is visible where cupboard units have been removed.

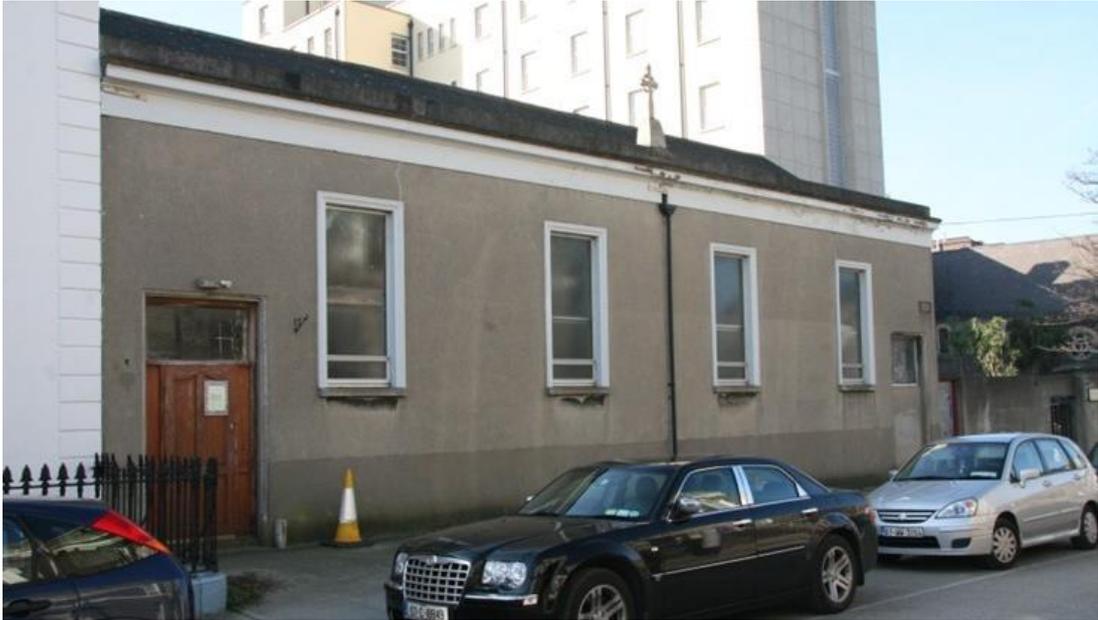
Plate 105: Number 10 Eblana Avenue in February 2013

Firstly, it is noted that the main entrance, at the left-hand end of the building, is a timber door of a type common in the 1960s and 1970s, flanked by narrow timber panels and with a rectangular glazed panel above. At the right-hand end of the building the other doorway is expressed as a recessed area in the façade, though it is blocked up with masonry, except for a glazed panel above. The present ramp to provide disability access was not present. The four windows along the frontage are of uPVC, with large upper panes with obscured glazing, while a small area at the base is a top-hung casement. The floor at first-floor level may be seen crossing the left-hand window.

Clearly there have been significant changes to the exterior of the building since 2013. There have also been significant changes to the interior, and these arise from works that were the subject of a planning permission that was granted in 2015 under planning reference number D15A/0578. The existing floor plan that was submitted with that application is shown in the copy reproduced below.

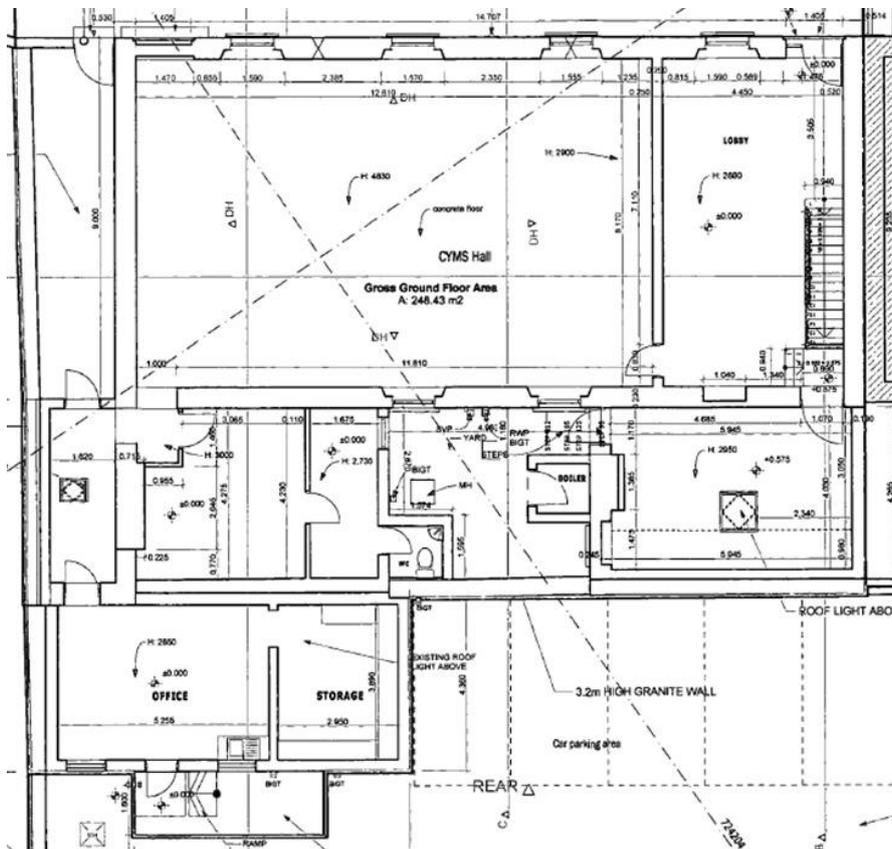
Figure 10: Plan of ground floor as it existed in 2015

The plan as it was in 2015 shows that the main hall was much as it was today except that the servery did not then exist. The eastern end of the ground floor of the main building was a single open space with one door leading into the main hall at the southern end. The present division between the entrance hall and the kitchen did not then exist and there was no doorway into the main hall where the present entry leads in from the entrance hall. The staircase was not enclosed at that time and the elevations show a balustrade alongside the stairway.
