# **Arborist Associates Ltd.**

## **A Condition Assessment of the Trees within 'Clarinda Park', Dún-Laoghaire, Co. Dublin.**

**Prepared for: JB Barry & Partners Limited.**

**Date: 8<sup>th</sup> September 2023**

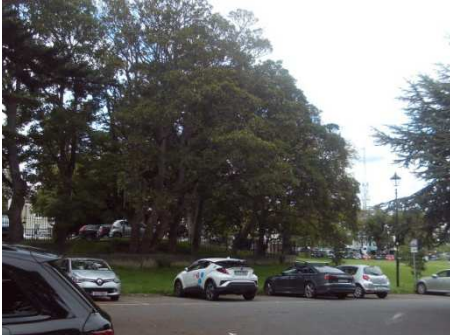
<b>Tree Line No. 1</b>	<b>Sycamore</b> <i>Acer pseudoplatanus</i> <b>Monterey Cypress</b> <i>Cupressus macrocarpa</i>	Mature	17	400	7	7	7	7	2	They are located along the southern boundary of the park on the adjoining property and they are cordoned off from the park by a low wall and railing. They are of prominence within the treescape as a tree line within this area and add to the sylvan character. Their crowns overhang the boundary into the park.

The management of this tree line is located outside the control of this site area.	20+	B2	
The following trees are located within the park.

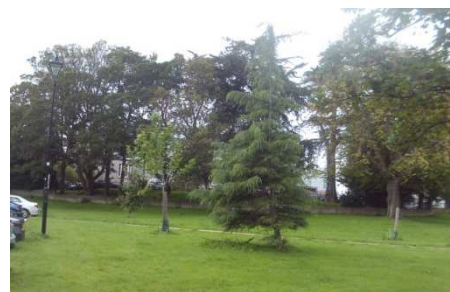
<b>Oak</b>	Young	-	-	-	-	-	-	-	Fair	Fair	Mulch the area around its base.	40+	C1

Tree No	Tree Species	Age	Ht (m)	TD (mm)	Crown Spread (m)				C. Ht (m)	Phys. Condition	Structural Condition/Comments	Works Required	Remaining Years	Category
					N	S	E	W						
	<i>Quercus robur</i>										Located between Tree Nos. 0230 & 0231. It has been recently planted into this area and is beginning to establish. There are weeds growing up around its base.			
0231	<b>Cherry</b> <i>Prunus kanzan</i>	Mature	8	450	7	5	5	5	2	Fair	Fair The lower branches have been pruned/ removed in order to raise up its crown, however it still has a low crown formation. It has a relatively full crown, however some thinning is evident.	It will require further pruning to maintain clearance over the surrounding surfaces and to take back from the public lighting to the north-west. There are some surface roots present.	10-20	C1
0232	<b>Horse Chestnut</b> <i>Aesculus hippocastanum</i>	Mature	20	1100	8	6	7	8	2	Fair/ Poor	Poor It is a large, prominent visual tree located within the open park. It is in declining health with a lot of stress/ decline evident throughout. It is infected by 'Bacteria Canker of Horse Chestnut '(Pseudomonas syringae pv. aesculi ) with 'Horse Chestnut Leaf Blight ' (Guignardia aesculi). also present. There are large areas of dead bark present on the main trunk and scaffold limbs, in particular on the main trunk from ground level up to a height of 2m with extensive decay developing at this point which is likely to impact on its stability as a result. This tree is of low vigour and is unlikely to respond well to pruning.	<b>Two Management Options:</b>  <b>1:</b> To retain for the present time reduce crown in order to reduce height in particular by 3m and prune the remaining crown to reshape/ balance.  <b>2:</b> To remove completely.	<10	U
