A Condition Assessment of the Trees along 'Georges Street', Dún-Laoghaire, Co. Dublin.

Prepared for: JB Barry & Partners Limited.

Date: 8th September 2023

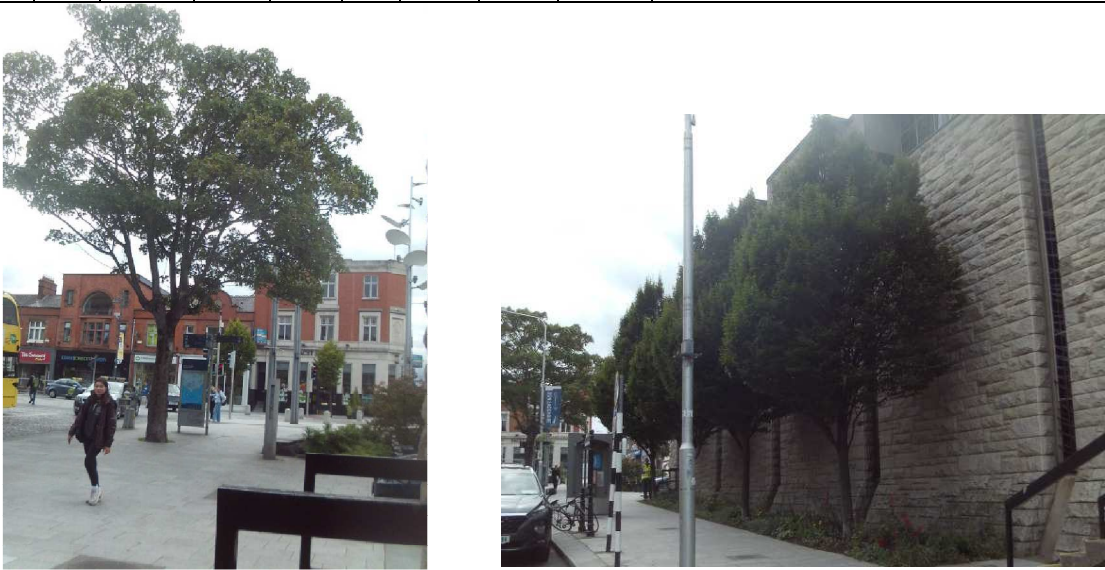
0250	Sycamore <i>Acer pseudoplatanus</i>	Mature	12	500	5	6	6	6	4	Fair	Fair It is a large, prominent visual tree and it has been incorporated into the paved area around its base. The lower limbs/ branches have been removed in order to raise up its crown and some pruning wounds have been created as a result. Its crown is slightly thin, an indication of stress related issues, possibly due to its growing environment and impacts from past construction works. Lighting has been attached to its crown and the ties and wires may cause structural damage.	Remove the electoral wires and the lighting within its crown along with dead/ unstable growth.	20+	B2
0251 - 0254	Hornbeam <i>Carpinus Betulus</i> (4 in total)	Early Mature	11	210	2	2	2	2	2	Fair/ Good	Fair They are located within a linear shrub bed along the east façade of the church building and their crowns are beginning to grow in onto the building. The area around their bases is in soft landscape with paving to the east outside this area. The lower branches	It will require further pruning to maintain clearance with the building. They may eventually	20+	C2

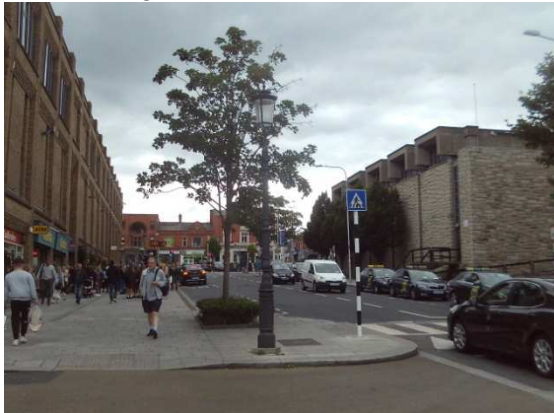
0258	Sycamore <i>Acer pseudoplatanus</i>	Semi Mature	12	210	3	3	3	3	2	Good	Good It is establishing well and is located within a 5m X 2m planter within the paved streetscape. It is establishing well and is a good quality tree. The lower branches have been pruned/ removed in order to raise up its crown.	Requires no work at the present time.	40+	A1
0259	Sycamore <i>Acer pseudoplatanus</i>	Semi Mature	10	160	3	3	3	2	2	Fair	Fair It is located within a linear planter 4m north/south x 2m east/west and has been under planted with shrubs which are being maintained. It is establishing well, although it is showing some signs of stress. The lower branches have been pruned/ removed in the past in order to raise up its crown. It has space to develop.	Requires no work at the present time.	20-40	B1

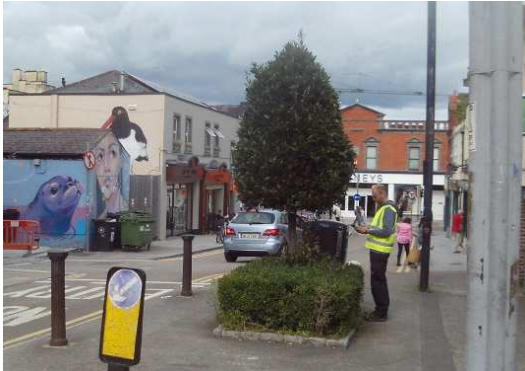
0263	Bay Laurel <i>Laurus nobilis</i>	Semi Mature	4	90	-	-	-	-	1	Fair/ Good	Fair It is located in a planter 3m north/south x 2m east/west on Convent Rd. It has a clear stem to a height of c.1.5m with suckers developing from its base. It has been maintained as a formal shape.	Maintain basal suckers.	20+	C1
