**BUILT HERITAGE INVENTORY
OF PARKS
IN DUN LAOGHAIRE-RATHDOWN**

MARLAY PARK

**REPORT PREPARED FOR
DUN LAOGHAIRE-RATHDOWN COUNTY COUNCIL**

August 2018

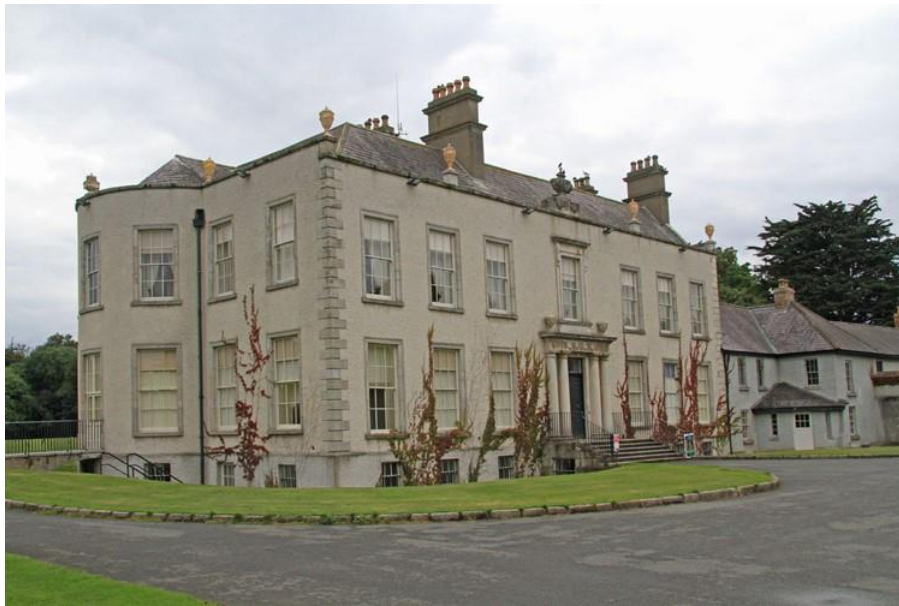
*Plate 1: Marlay House***Description:**

Two-storey over basement, seven-bay house; rendered façade with parapets and granite quoins. Slate roof.

Period of construction:	18 th Century
Materials:	Stone and other materials
NIAH reference:	60220011
Heritage significance:	Regional
NIAH rating:	Regional

Full details of this building are not required for this survey.

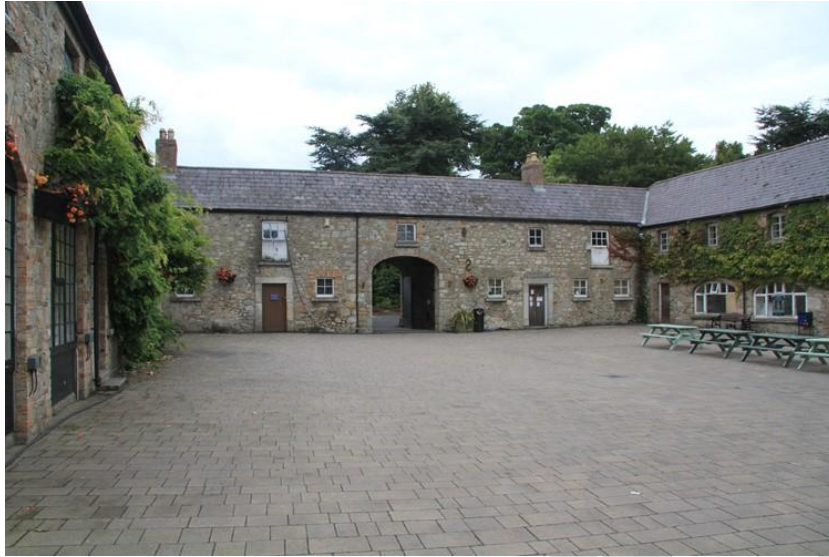
Plate 2: Western side of courtyard

Two-storey stable yard associated with Marlay House. The buildings range around four sides of a rectangular yard with entrances on the eastern, western and southern sides.

Period of construction:	18 th Century
Materials:	Stone and other materials
NIAH reference:	60220012
Heritage significance:	Regional
NIAH rating:	Not rated

Full details of the courtyard are not required for this survey.

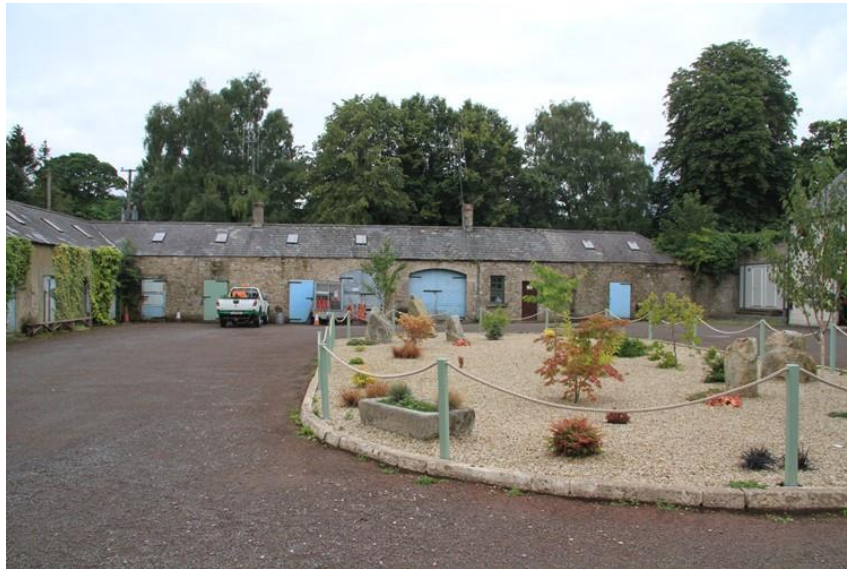
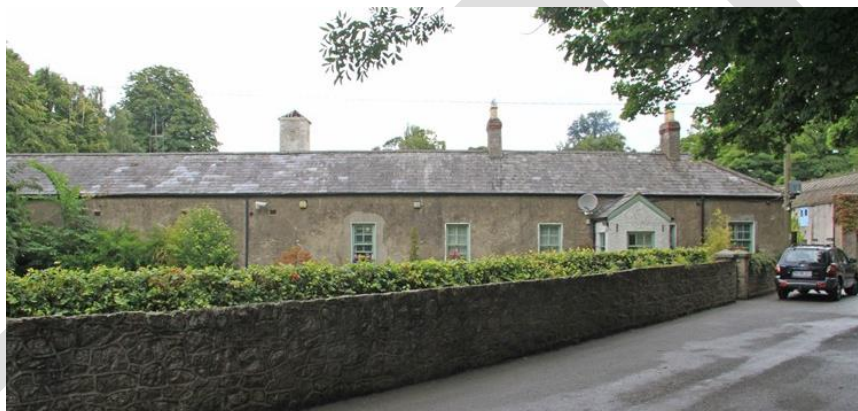
Plate 3: Southern side of farm yard

Plate 4: Eastern side of farm yard from outside yard

Part single-storey and part two-storey farm complex ranged around two yards. Buildings date from a range of periods and some have been altered significantly.

Period of construction:	18 th century and later
Materials:	Stone, slate and other materials
NIAH reference:	60220016
Heritage significance:	Regional
NIAH rating:	Regional

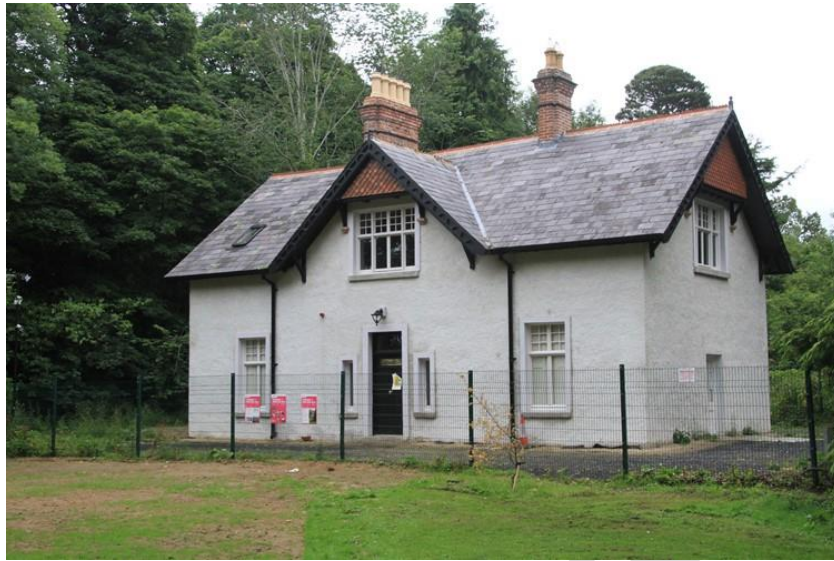
Plate 5: Laurelmere Cottage

Three-bay house with ground floor and attic storey in the Arts & Crafts style, though based on an earlier *cottage ornée* of 18th century date.

Period of construction:	18 th century and later
Materials:	Stone, slate and other materials
NIAH reference:	60220015
Heritage significance:	Regional
NIAH rating:	Regional

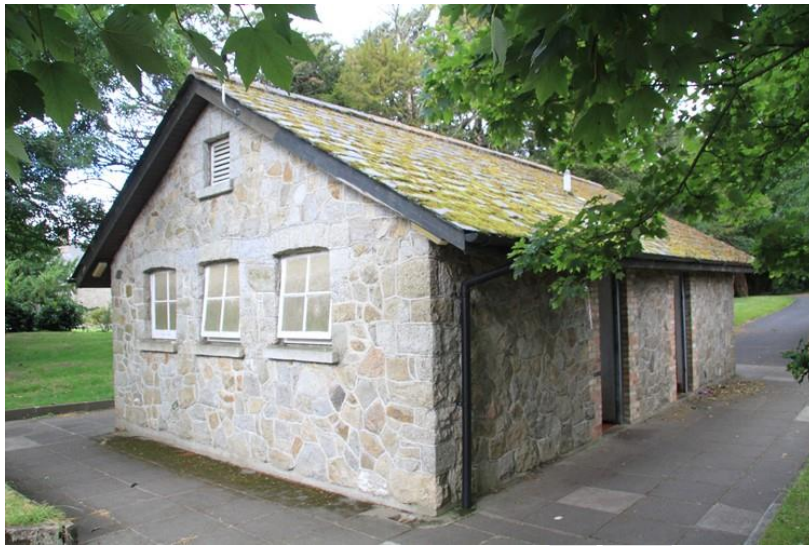
Plate 10: Toilet block near northern boundary

Single-storey stone-clad building with gabled roof.

Period of construction:	Later 20 th century
Materials:	Stone, slate and other materials
NIAH reference:	Not included
Heritage significance:	None
NIAH rating:	n/a

The building is of late date, probably built after the land was acquired by the county council in the early 1970s.

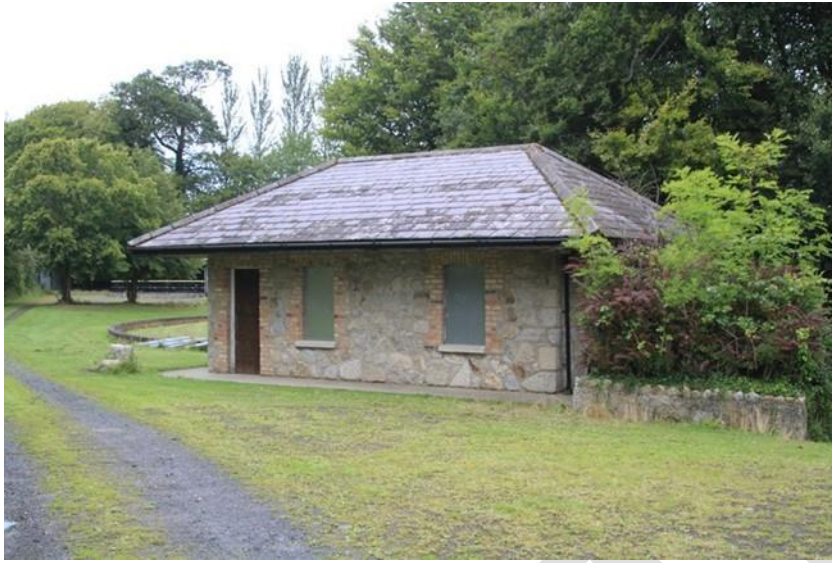
Plate 11: Building associated with miniature railway

Single-storey stone-clad building with slate roof and wide eaves.

Period of construction:	c.1981
Materials:	Stone, slate and other materials
NIAH reference:	Not included
Heritage significance:	None
NIAH rating:	n/a

The building is of late date and would appear to have been built as part of the construction of the infrastructure for the Dublin Society of Model and Experimental Engineers when the society moved to Marlay Park in 1981.

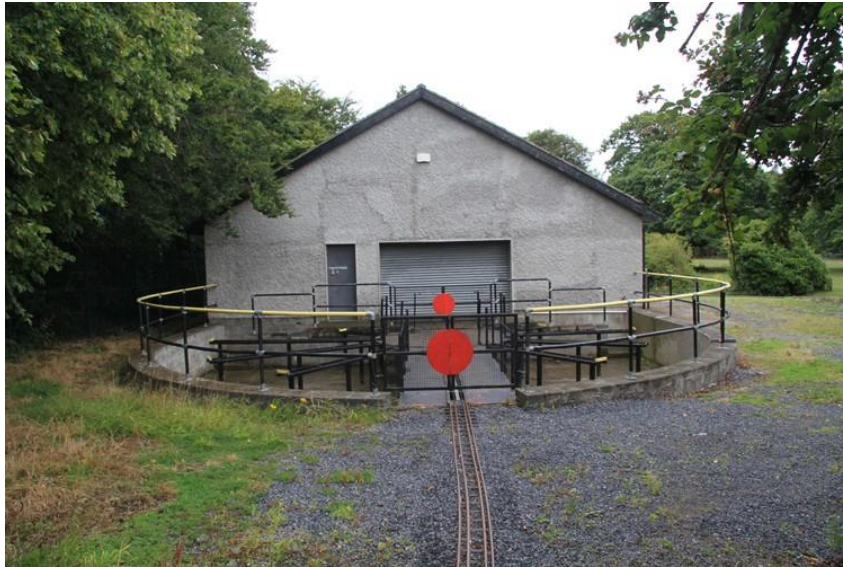
Plate 12: Shed associated with miniature railway

Single-storey concrete shed.

Period of construction:	c.1981
Materials:	Concrete
NIAH reference:	Not included
Heritage significance:	None
NIAH rating:	n/a

The building is of late date and was been built as part of the construction of the infrastructure for the Dublin Society of Model and Experimental Engineers when the society moved to Marlay Park in 1981.

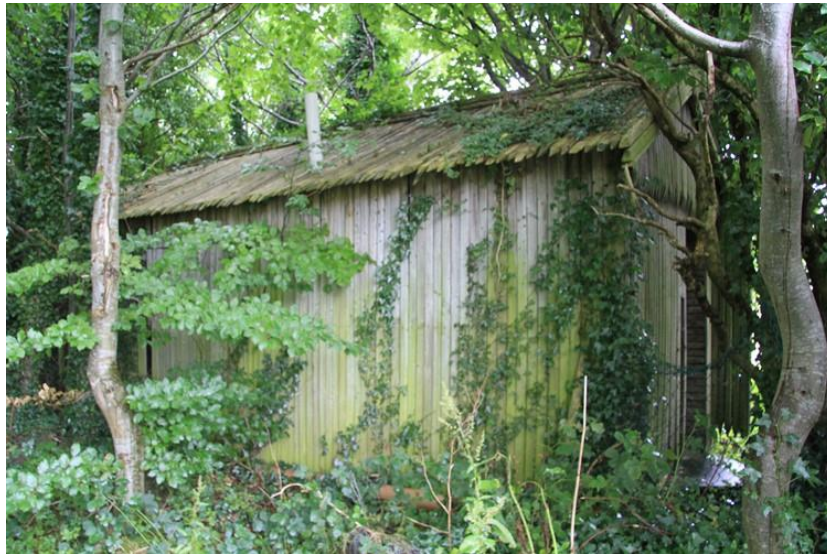
Plate 13: Timber shed

Single-storey timber-built shed.

The building is of a purely utilitarian nature.

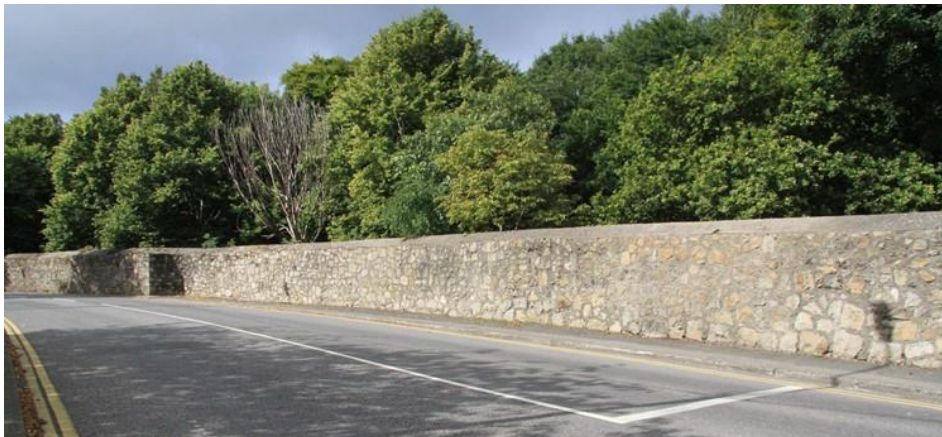
Plate 14: Part of perimeter wall of Marlay Park

Demesne wall approximately 2½ to 3 metres in height and running around the northern and eastern sides of the demesne. The southern side is bounded by a stone-faced wall of early 21st-century date.

Period of construction:	18 th century
Materials:	Granite and lime
NIAH reference:	Not included
Heritage significance:	Regional
NIAH rating:	n/a

The demesne of Marlay House would have been surrounded by a high stone wall. However, the demesne varied in extent with the initial acquisition of lands and, in the twentieth century, the disposal of lands. The heritage significance given above relates only to the eighteenth-century walls and not the wall on the southern boundary.

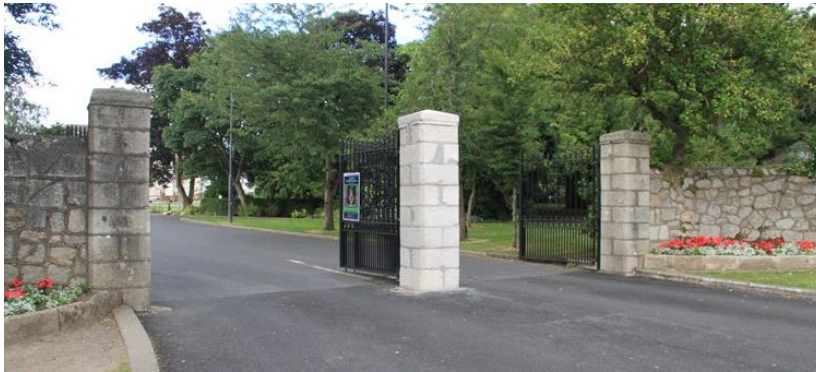
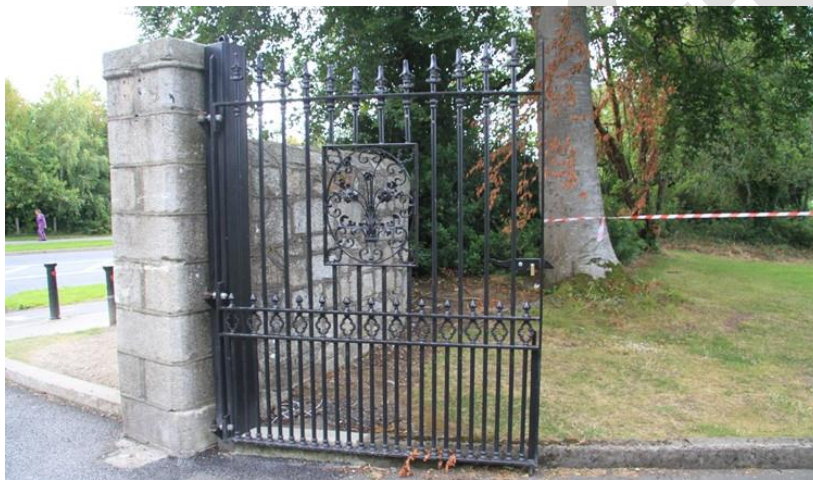
Plate 15: Gate to the public car park, off Grange Road

Plate 16: Gate at entrance to car park

Gateway with two openings – an entrance and an exit – and three piers of dressed granite. Wing walls of granite rubble splay out to the sides and are terminated by piers of rubble granite. The two pairs of gates are ornate and are of mild steel.

Period of construction:	Later 20 th century
Materials:	Granite piers and walls, steel gates
NIAH reference:	Not included
Heritage significance:	None
NIAH rating:	n/a

The gateway and gates are sympathetic to the style of the demesne; however, they are nonetheless of late date.

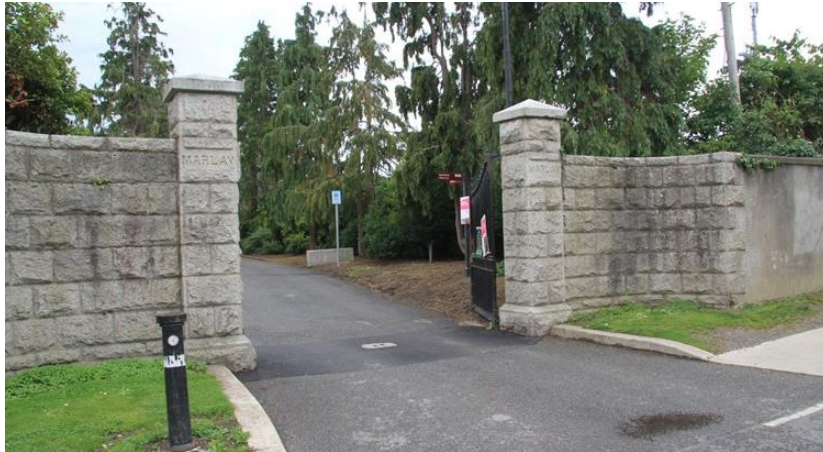
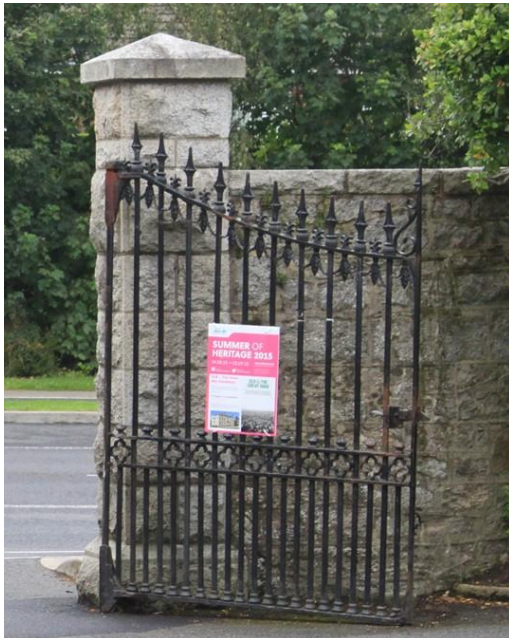
The gate piers are constructed with rock-faced granite ashlar and have pyramidal granite cap stones. The wing walls are short and shallow and are also constructed of rock-faced granite ashlar. The gates are ornate and are of wrought iron with cast iron bosses and spears.

Period of construction:	Later 19 th century
Materials:	Granite piers and walls, wrought iron gates
NIAH reference:	60220019
Heritage significance:	Regional
NIAH rating:	Regional

The gateway and gates are of later nineteenth century date, when this gateway was opened up.

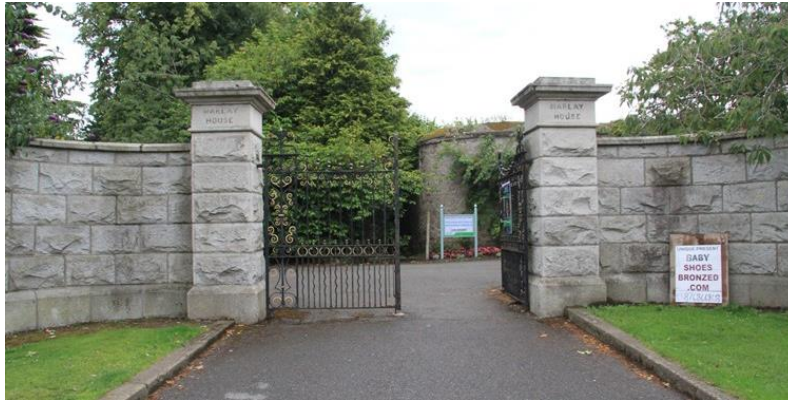
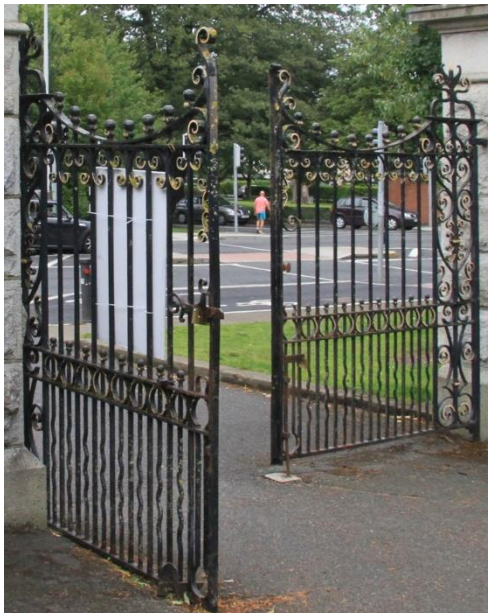
Gateway with piers of rock-faced granite ashlar. Wing walls of rock-faced granite ashlar splay out to the sides and are terminated by more substantial piers, also of rock-faced granite ashlar. The two pairs of gates are ornate and are of wrought iron.

Period of construction:	Early 20 th century
Materials:	Granite piers and walls, wrought iron gates
NIAH reference:	60220017
Heritage significance:	Regional
NIAH rating:	Regional

There was a gateway in this location earlier in the nineteenth century and this is shown on the first edition Ordnance Survey map of 1843. There is no gateway shown in this location on the 1907 Ordnance Survey map. The style of the stonework is similar to that on the adjacent gateway to the west, suggesting that they were built at around the same time. It is likely that this gateway was moved from another location during the disposal of land in the late 19th or early 20th century.

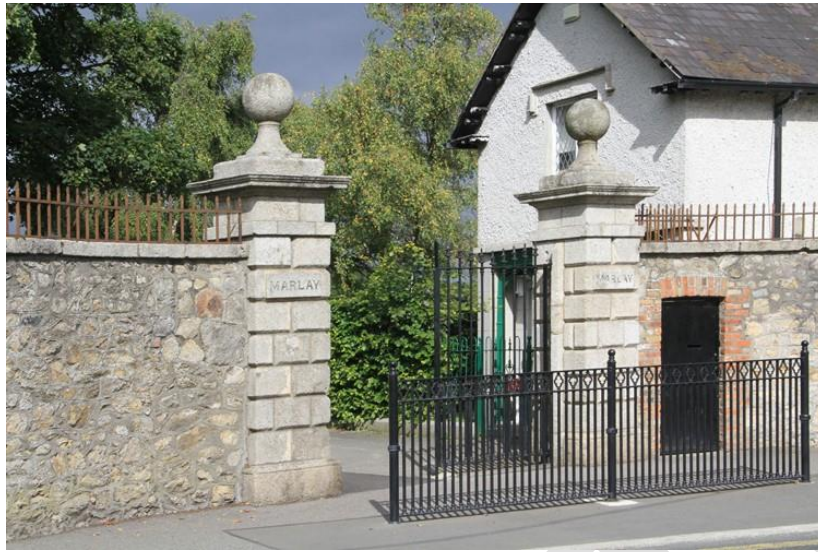
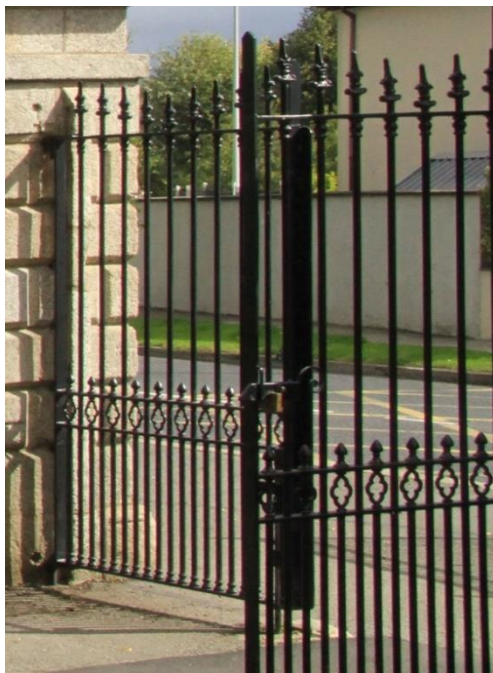
Plate 21: Gate near Ballinteer Avenue

Gateway flanked by substantial gate piers of chamfered granite ashlar topped with a string course, frieze and cornice carrying a ball finial on a pedestal. The gates are of more recent date and are of mild steel.

Period of construction:	Piers: late 18 th or early 19 th century, gates: 20 th century
Materials:	Granite piers, steel gates
NIAH reference:	60220021
Heritage significance:	Regional (piers only)
NIAH rating:	Regional

Comment: The gate piers are very fine and the earliest of any at Marlay. This gate faced the junction with Ballinteer Avenue until that road was realigned.

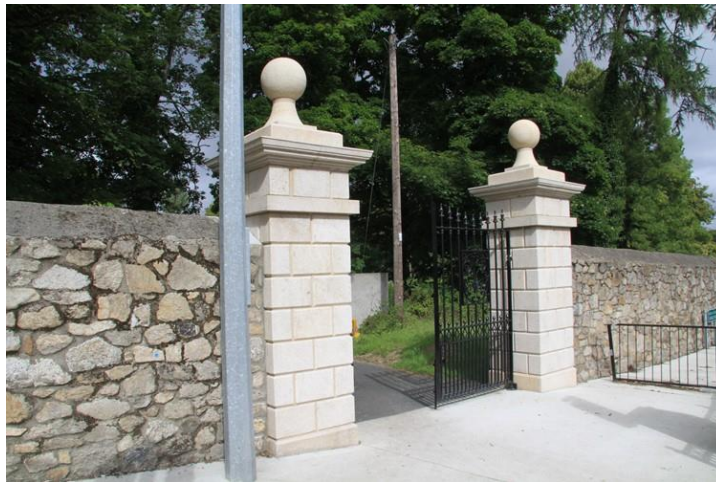
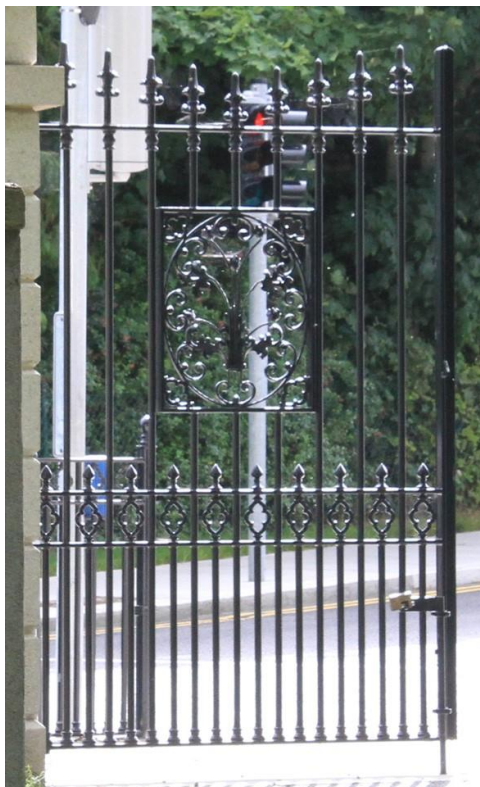
Gateway flanked by substantial gate piers of chamfered granite ashlar topped with a string course, frieze and cornice carrying a ball finial on a pedestal. This gateway is of late date and is a well-executed replica of the Ballinteer gateway. The gates are also of recent date and are relatively ornate.

Period of construction:	Piers and gates: 20 th century
Materials:	Reconstituted granite piers, steel gates
NIAH reference:	Not included
Heritage significance:	None
NIAH rating:	n/a

Comment: This gateway is a replica of high quality, though not of heritage value.

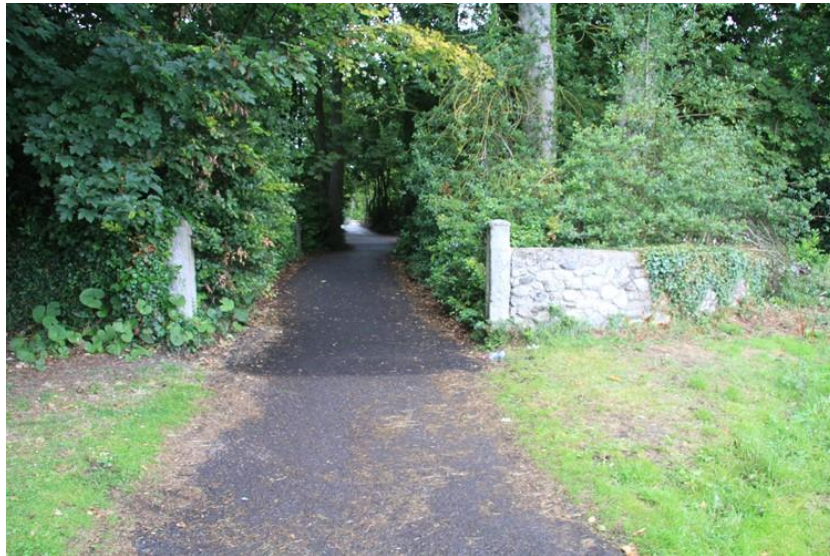
Plate 25: Gateway 6

Gateway now consists of no more than a gap in a wall, flanked by gate piers, each of which is cut from a single piece of granite.

Comment: The gate piers are similar to farm gateways, though using local granite-working skills to good effect.

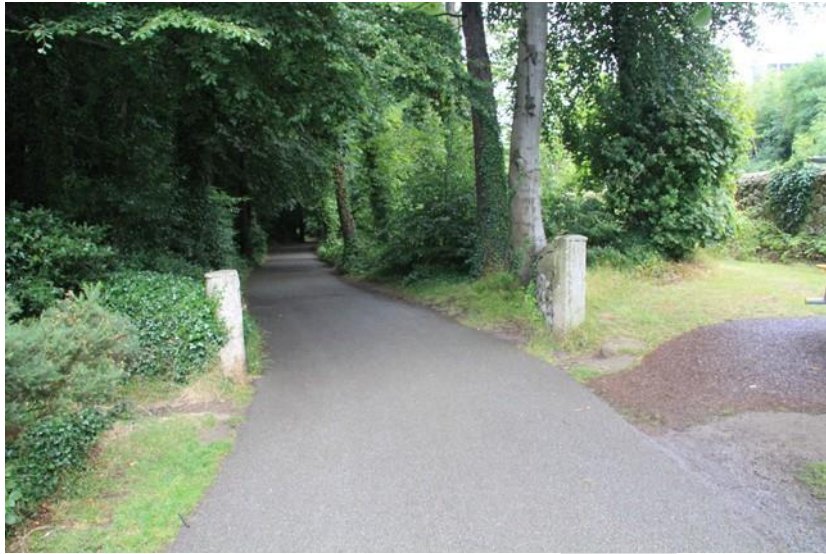
Plate 26: Gateway 7

Comment: The gate piers are similar to farm gateways, though using local granite-working skills to good effect.

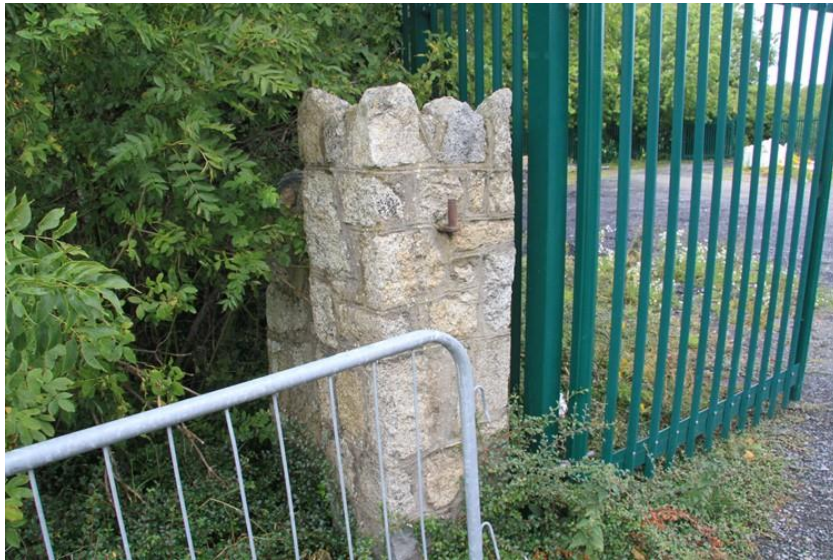
Plate 27: Gateway 8

Comment: The gate pier uses local granite rubble but is not of heritage value.

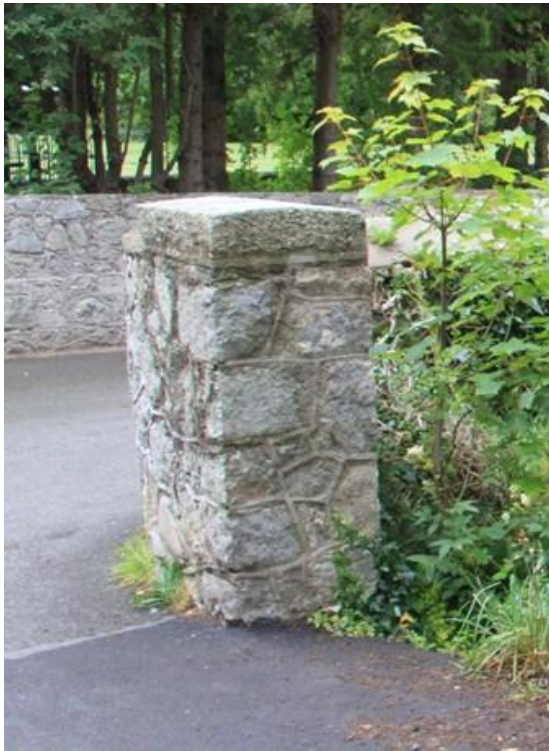
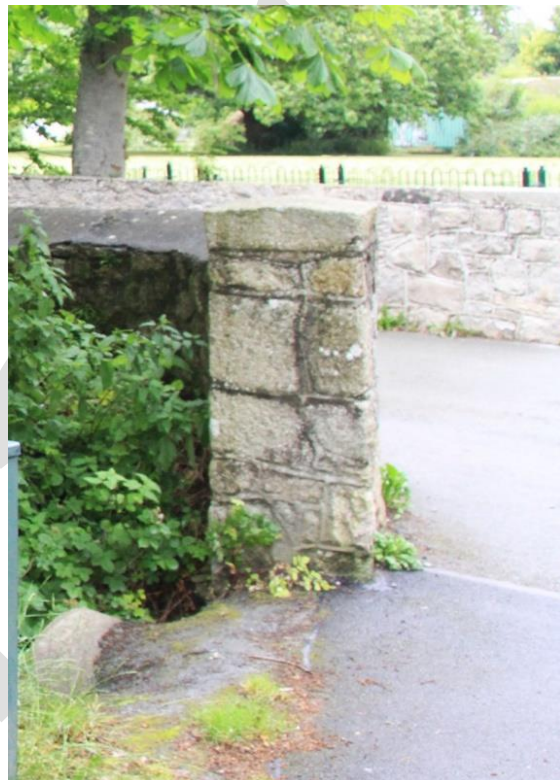
Plate 28: Eastern pier of gate 9

Plate 29: Western pier of gate 9

Comment: The gate piers are of local granite but are not of heritage significance.

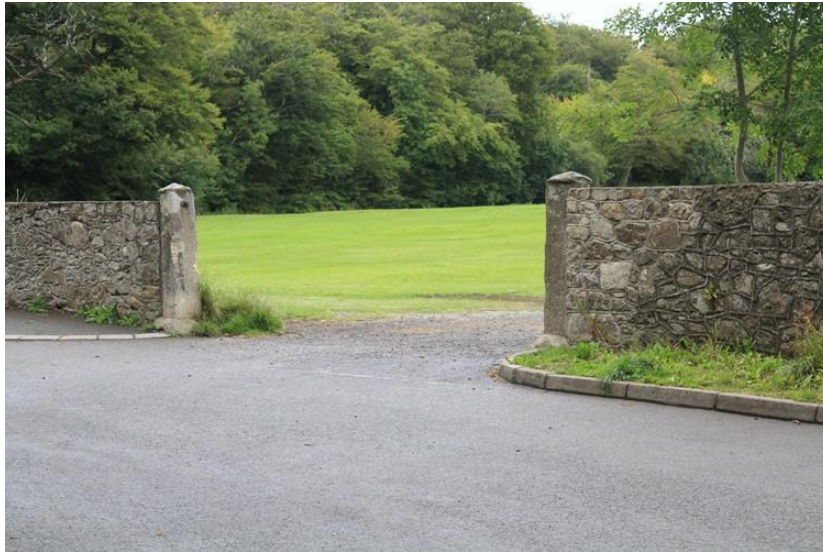
Plate 30: Gateway 10

Comment: The gate piers are similar to farm gateways, though using local granite-working skills; good way of reusing earlier granite piers.

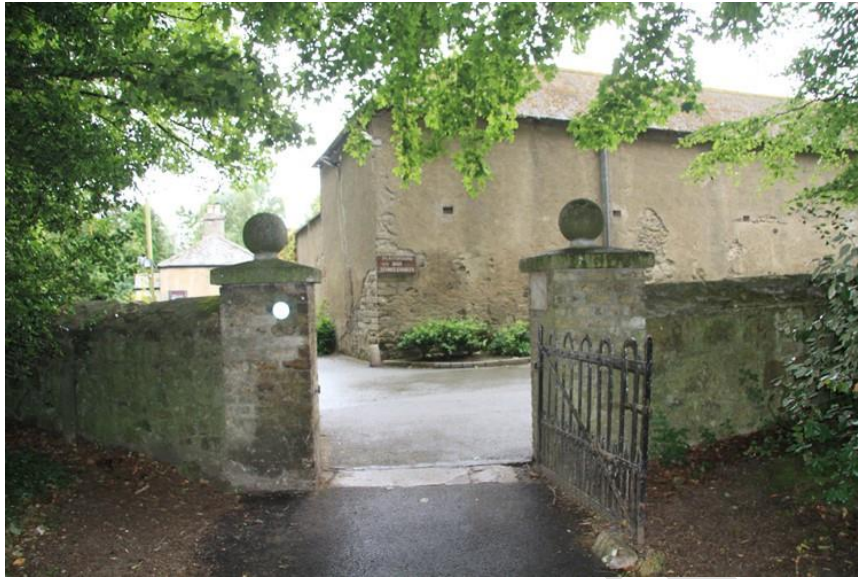
Plate 31: Gateway 11

Comment: Simple gate piers and gate, enlivened with addition of ball finials. Gateway provides access between Laurelmere and the farmyard. The gateway is not shown in the same location on the 1843 and 1864 Ordnance Survey maps.

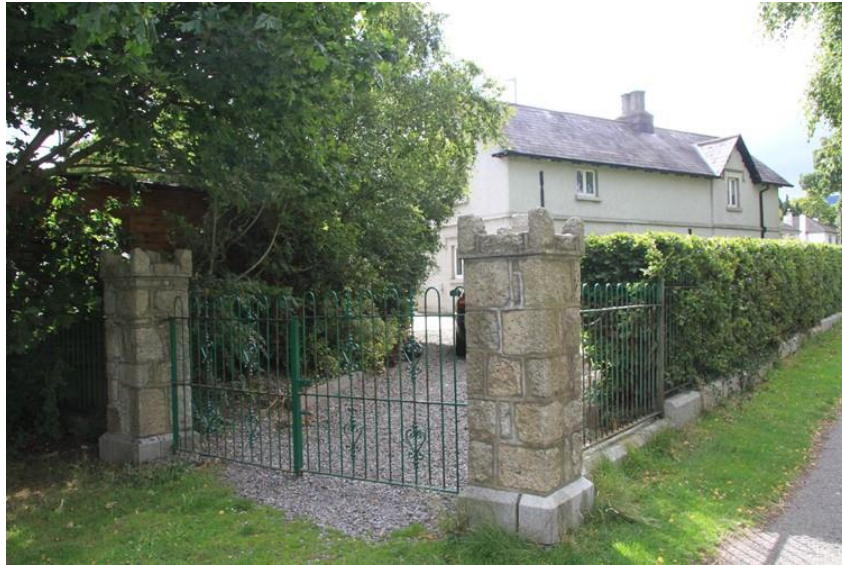
*Plate 32: Gateway 12***Description:**

Gateway flanked by piers of granite, partly rubble and partly squared blocks. The gateway is of late date, reusing granite from elsewhere, probably within the demesne. The gates are of traditional form, though are also of late twentieth century origin. The adjacent railings are set into granite plinth walls, again of late twentieth century date.

Comment: The gate piers have been made with recycled granite and are well suited to the demesne, though not of heritage significance.

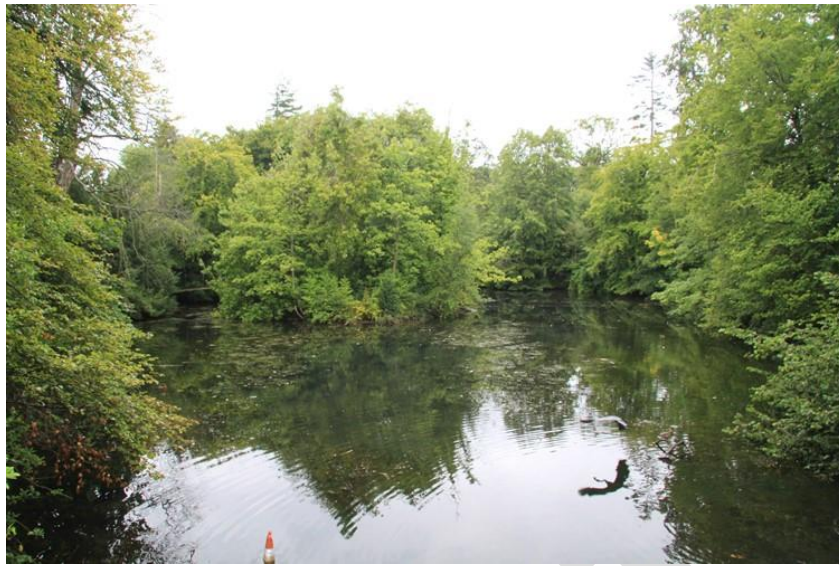
Plate 33: Smaller lake

Comment: The lakes are rare survivors within the county of eighteenth century demesne lakes.

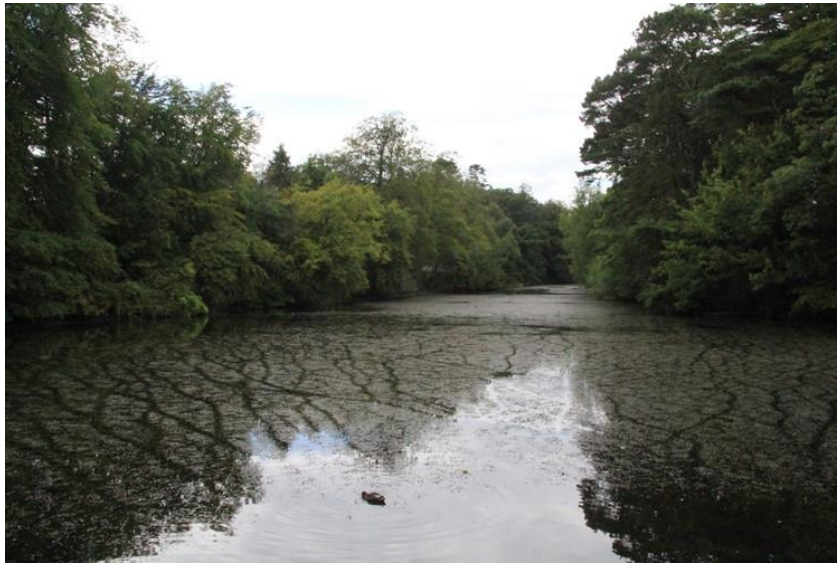
Plate 34: Larger lake

Comment: The lakes are rare survivors within the county of eighteenth century demesne lakes.

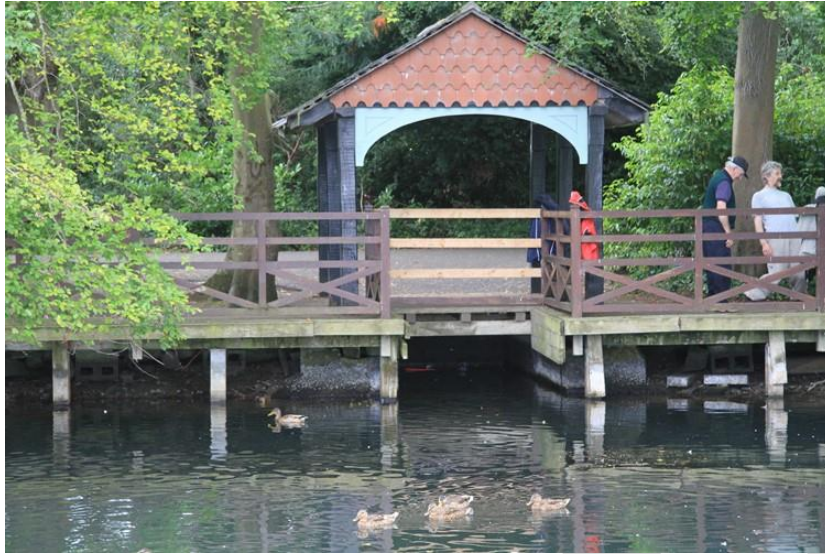
Plate 35: Shelter, with remnants of boat house beneath

Comment: Only the base of the boat house now survives, so it is of limited significance.

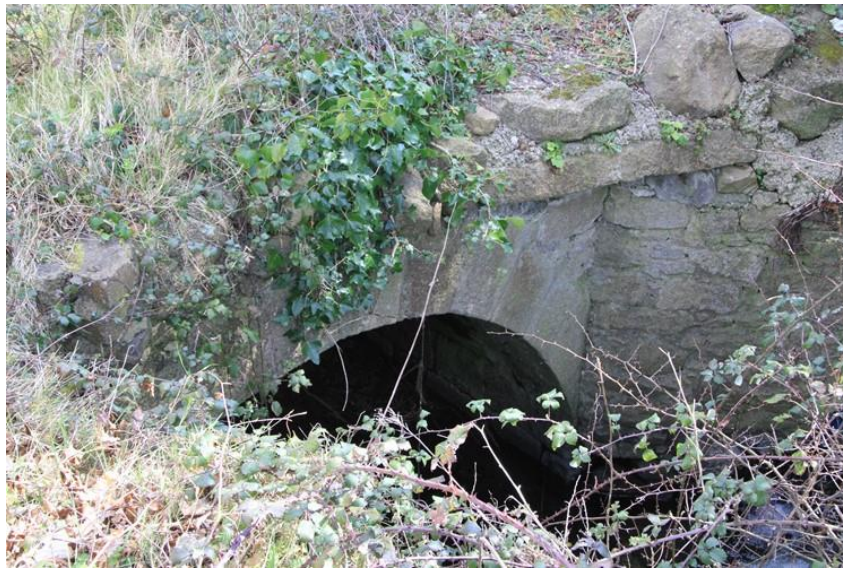
Plate 36: Bridge 1, at Grange Road

Comment: The visible part of the bridge is well made and attractive.

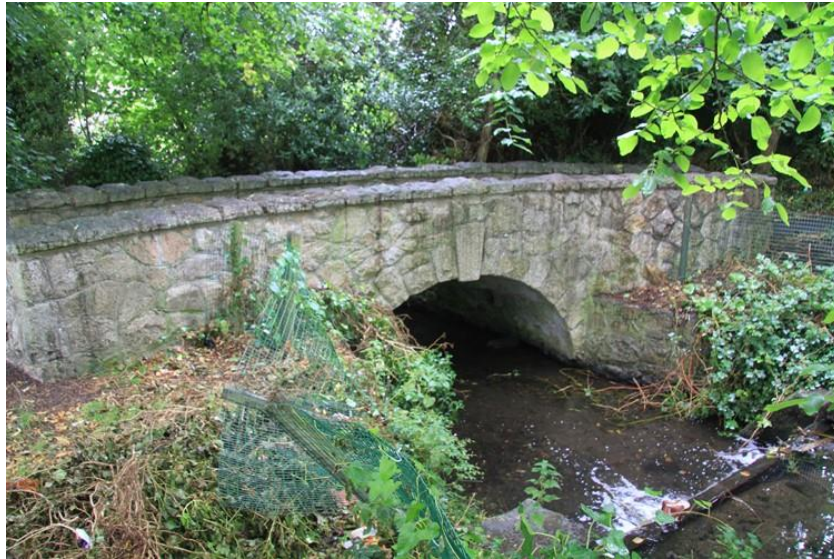
Plate 37: Bridge 2

Single-arched bridge with voussoirs of rock-faced granite and prominent keystone. Spandrels and walls of causeway are continuous and of uncoursed granite rubble. The coping stones are of square blocks of rock-faced granite.

Comment: No bridge is shown on this site on the 1907 Ordnance Survey map. The bridge is well executed and an enhancement to the park.

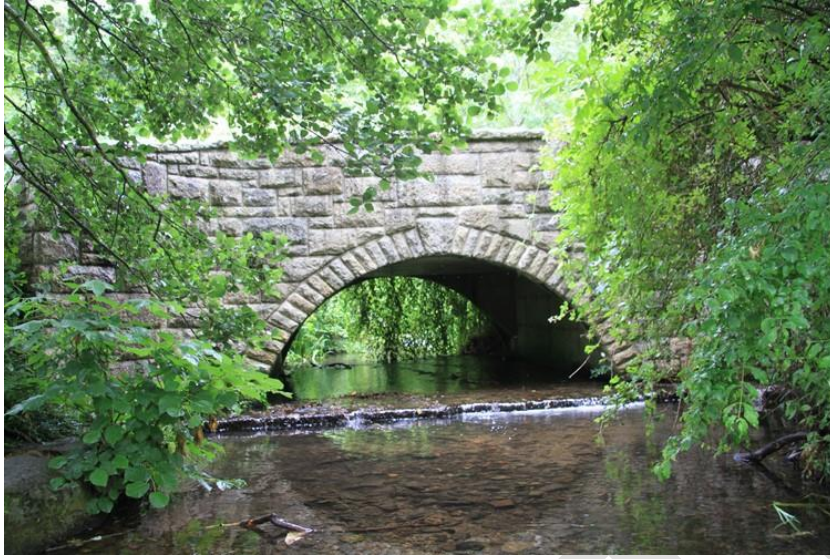
*Plate 38: Bridge 3***Description:**

Single-arched bridge of mass concrete faced with granite. Voussoirs are of rock-faced granite with prominent keystone. Spandrels and walls of causeway are continuous and faced with squared granite rubble. The coping stones are of square blocks of rock-faced granite.

Comment: While made of mass concrete, the granite facing of the bridge is well executed and an enhancement to the park. Whatever its aesthetic appeal, it does not have heritage significance.

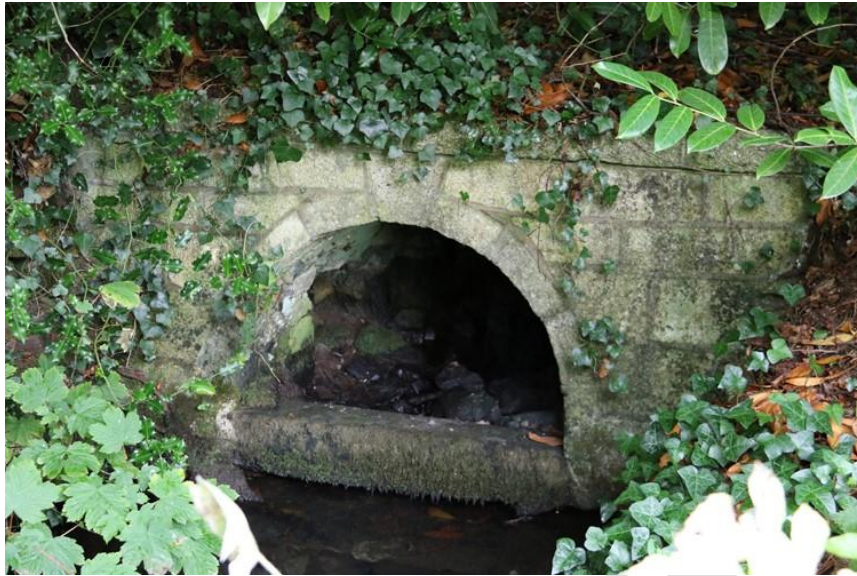
*Plate 39: Bridge 4***Description:**

Single-arched bridge faced with granite. Voussoirs are slender and of cut granite with large keystone. Spandrels are faced with squared granite rubble. The coping stones are of squared blocks of rock-faced granite.

Comment: The granite facing of the bridge is well executed and an enhancement to the park. Whatever its aesthetic appeal, it does not have heritage significance.

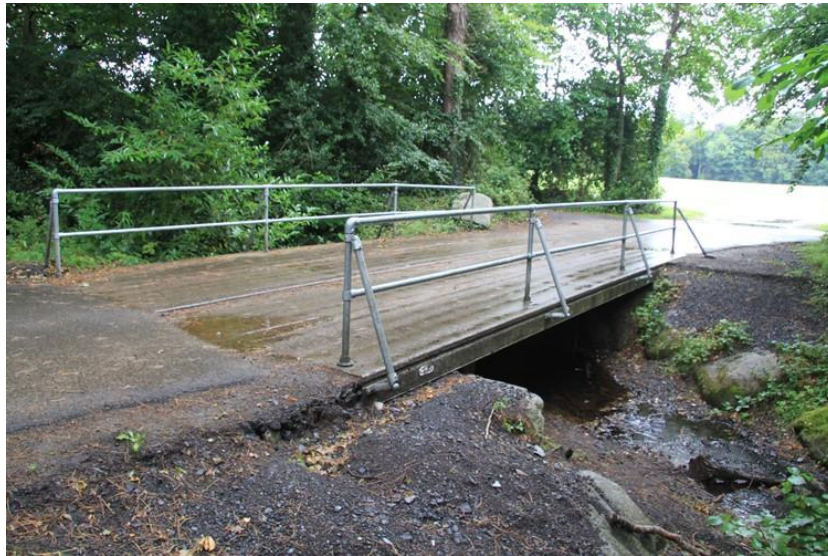
Plate 41: Bridge 6

Comment: No heritage significance.

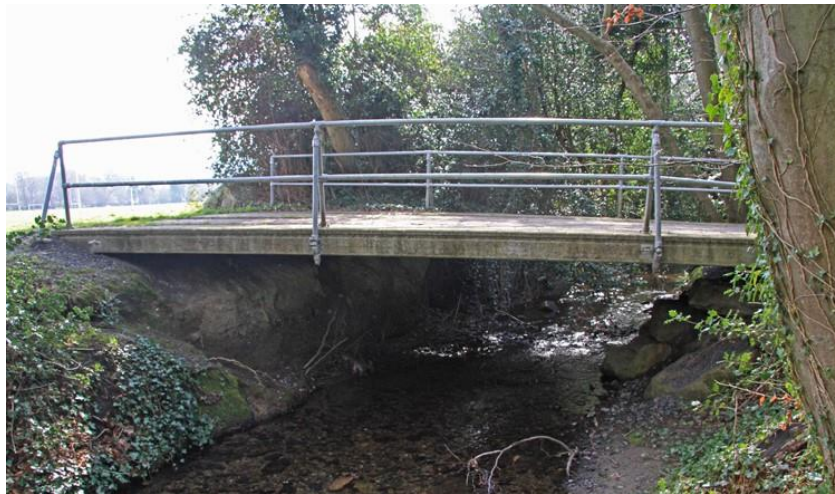
*Plate 42: Bridge 7***Description:**

Beam bridge of concrete and timber with tubular-steel balustrades.

Comment: No heritage significance.

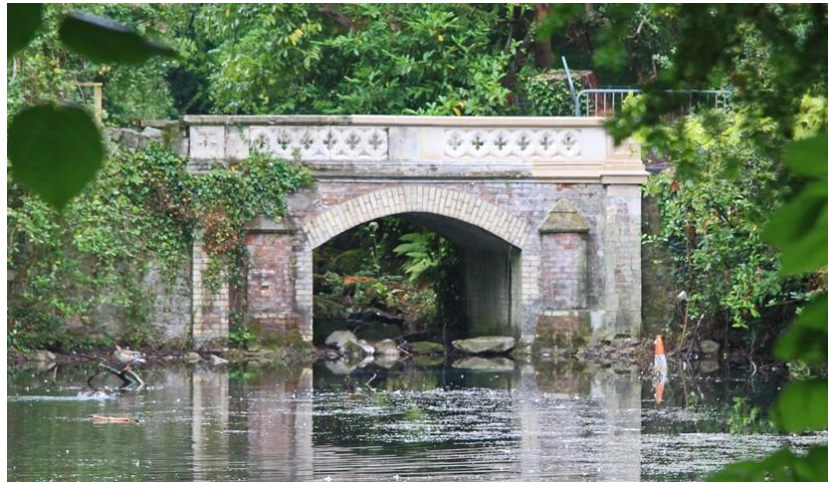
*Plate 44: Bridge 9***Description:**

Single-segmental-arched bridge of red and buff-coloured brick. Parapet is of pierced Portland stone with Portland stone copings. Rectangular niches set into the abutments have hoods of Portland stone.

Period of construction:	19 th century
Materials:	Brick and Portland stone
NIAH reference:	Not included
Heritage significance:	Regional
NIAH rating:	n/a

Comment: High-quality bridge that has had some well-executed restoration work carried out recently.

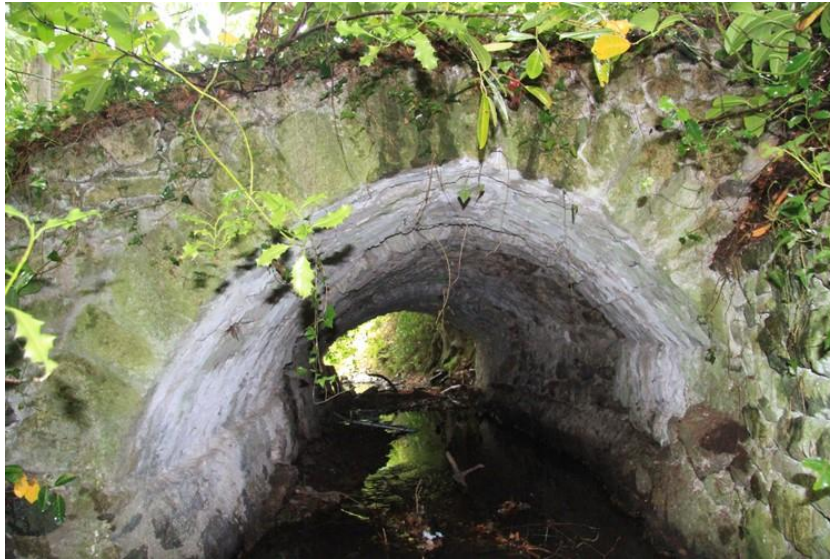
Plate 45: Bridge 10

Single-arched bridge of granite; arch ring is of roughly-squared granite, while spandrels, abutments and the barrel of the arch are of rubble granite. The arch is crudely formed, and its geometry varies from parabolic to three-centred. The length of the bridge is significantly greater than the span and the bridge may be more correctly referred to as a tunnel.

Period of construction:	19 th century
Materials:	Granite
NIAH reference:	Not included
Heritage significance:	Local
NIAH rating:	n/a

Comment: While not of high-quality construction, the bridge has a certain charm. It is not readily visible.

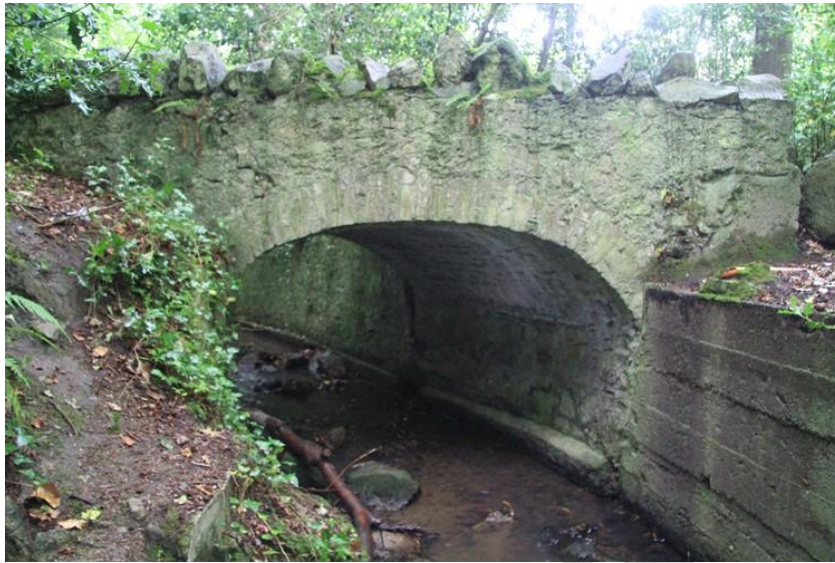
Plate 46: Bridge 11

Single-arched bridge with elliptical brick arch. Abutments, spandrels and parapets are of rubble granite with large granite stones as capping.

Heritage significance: Local

Comment: Bridge appears modest from above, though it is well-made and of pleasant appearance when seen from the stream.

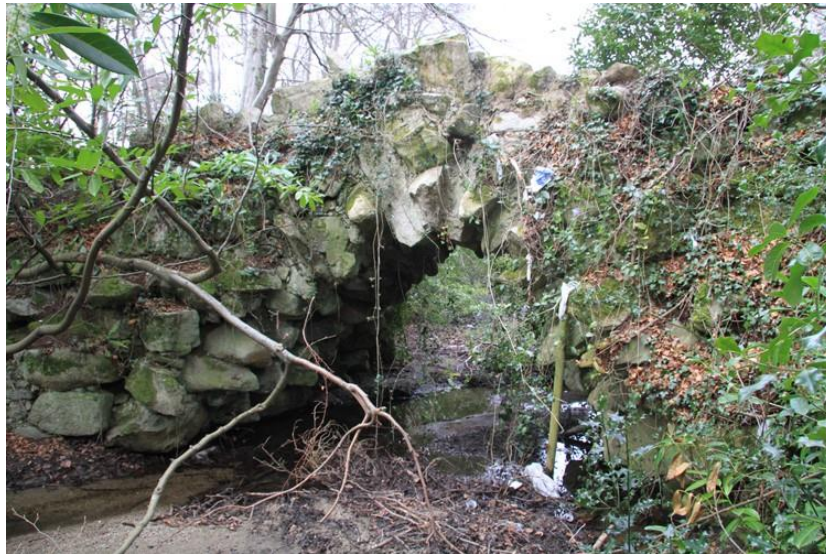
*Plate 47: Bridge 12***Description:**

Single-arched rustic bridge with irregular arch of large granite stones and similarly large irregular stones in spandrels and abutments.

Heritage significance: Local

Comment: Bridge has been built with a deliberately informal, irregular style and as a result has a certain charm.

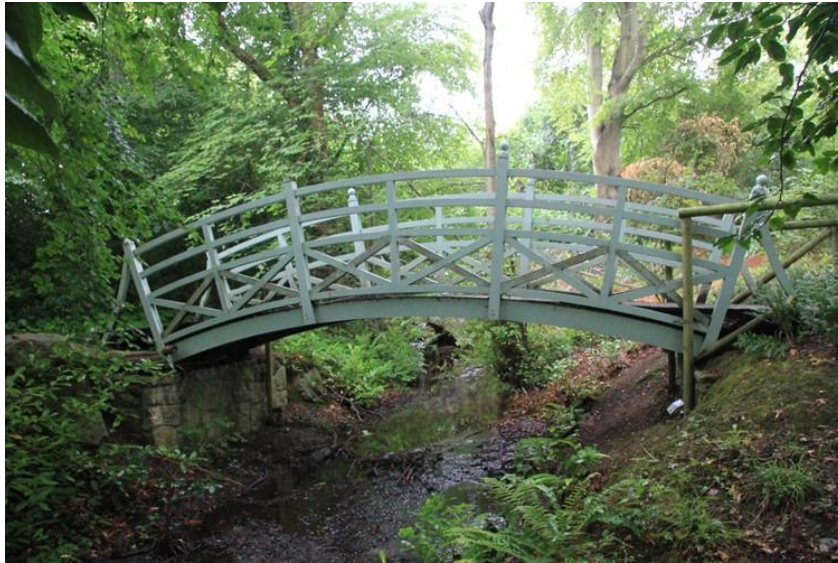
Plate 48: Bridge 13

Single-arched bridge with shallow segmental arch. Abutments are of granite rubble, span is of steel and parapets are timber railings.

Period of construction:	20 th century
Materials:	Timber, steel and granite
NIAH reference:	Not included
Heritage significance:	None
NIAH rating:	n/a

Comment: The bridge is very picturesque and fits well into the character of the demesne but is not of heritage value.

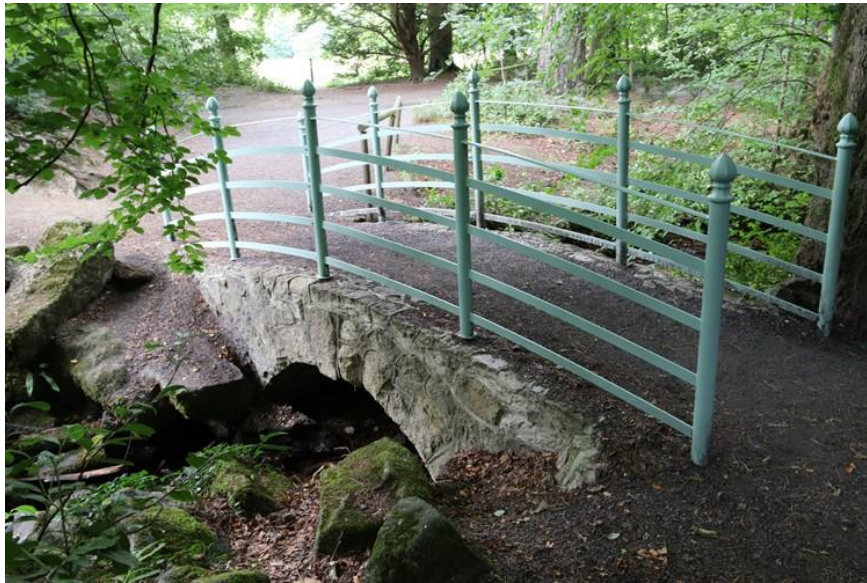
*Plate 49: Bridge 14***Description:**

Single-arched bridge with segmental arch of roughly-squared granite voussoirs and with dropped keystone. Abutments and spandrels are of rubble granite. The steel railings are a later addition.

Period of construction:	20 th century
Materials:	Granite
NIAH reference:	Not included
Heritage significance:	Local
NIAH rating:	n/a

Comment: A relatively modest bridge, though well-made and in keeping with the demesne. It is of local value.
