**BUILT HERITAGE INVENTORY
OF PARKS
IN DUN LAOGHAIRE-RATHDOWN**

MARLAY PARK

**REPORT PREPARED FOR
DUN LAOGHAIRE-RATHDOWN COUNTY COUNCIL**

August 2018

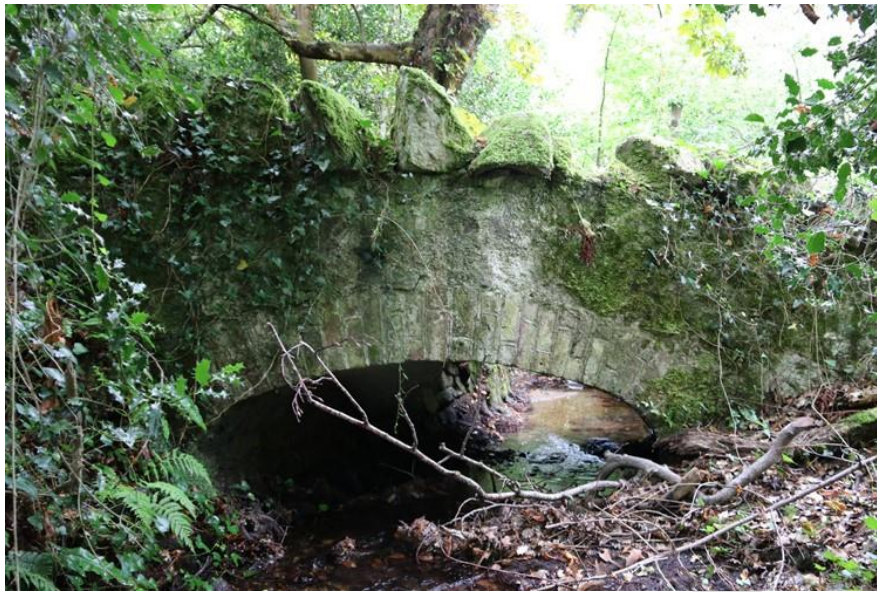
Plate 50: Bridge 15

Single-arched bridge on eastern river channel. Brick vaulting with three-centred shallow brick arch. Abutments, spandrels and parapets are of rubble granite with large granite stones as capping.

Period of construction:	19 th century
Materials:	Granite
NIAH reference:	Not included
Heritage significance:	Local
NIAH rating:	n/a

Comment: Bridge appears modest from above, though it has a well-made and attractive brick arch when seen from the stream.

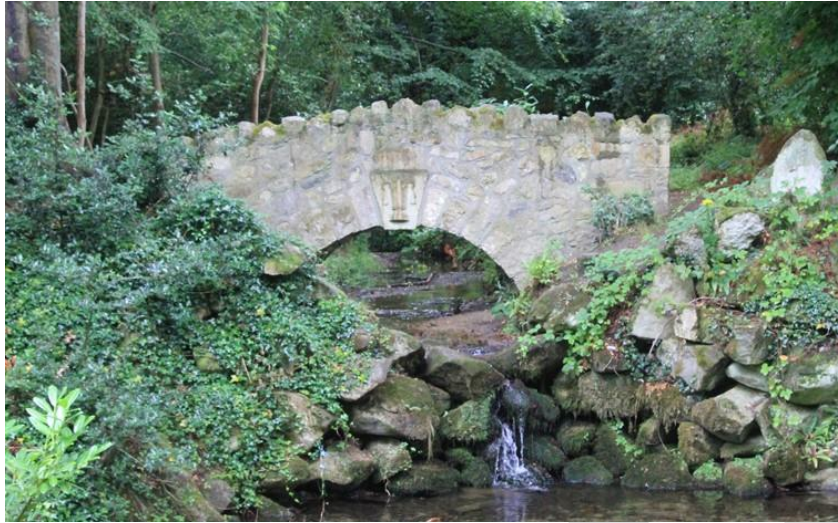
*Plate 51: Bridge 16***Description:**

Single-arched bridge with segmental granite arches on either face, with prominent granite keystone with carved motif. Abutments, spandrels and parapets are of rubble granite with large granite stones as capping. Deck is mass concrete.

Period of construction:	20 th century
Materials:	Granite and concrete
NIAH reference:	Not included
Heritage significance:	None
NIAH rating:	n/a

Comment: Well-designed granite-faced bridge with carved keystone. Fits well into character of demesne, but is not of heritage value

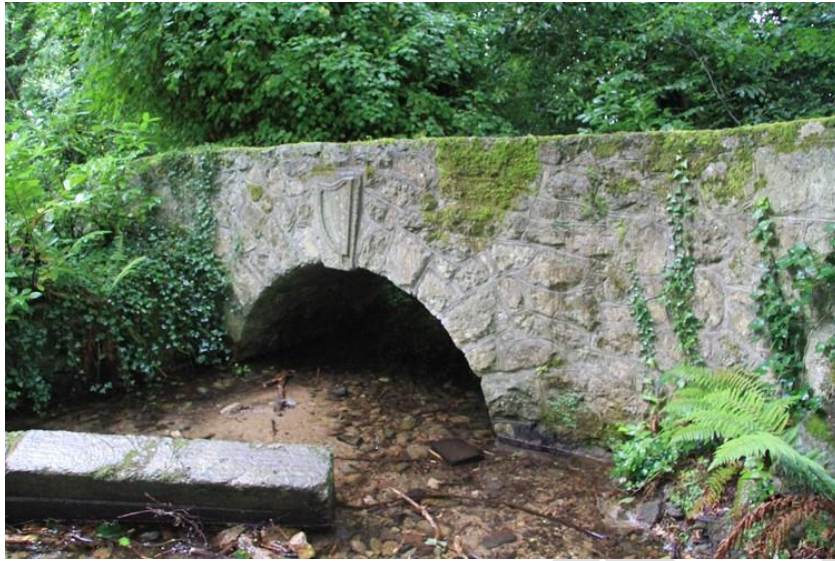
*Plate 52: Bridge 17***Description:**

Single-arched bridge with segmental granite arches on faces and prominent carved granite keystone. Deck is of arched mass concrete. Abutments, spandrels and parapets are of rubble granite with large granite stones as capping.

Period of construction:	20 th century
Materials:	Granite and concrete
NIAH reference:	Not included
Heritage significance:	None
NIAH rating:	n/a

Comment: Bridge is well designed and blends well with the character of the park but is not of heritage value.

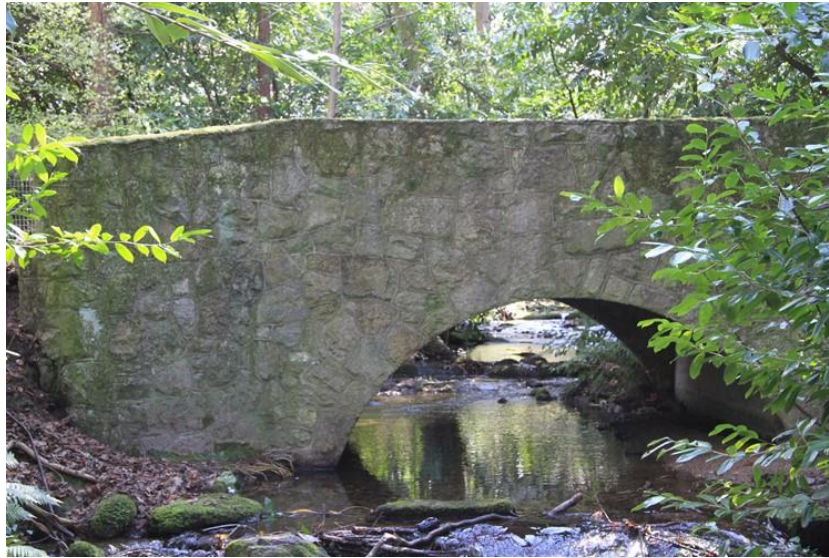
Plate 53: Bridge 18

Single-arched bridge of mass concrete and faced with rubble granite. There is no distinct arch ring on either side, and no coping.

Period of construction:	20 th century
Materials:	Granite and concrete
NIAH reference:	Not included
Heritage significance:	None
NIAH rating:	n/a

Comment: Well-designed granite-faced bridge that fits into character of demesne, but is not of heritage value

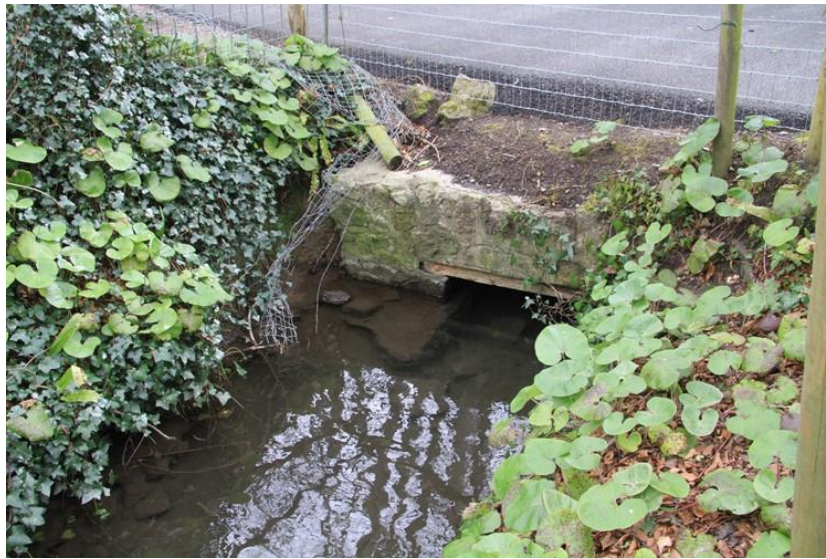
Plate 55: Bridge 20

Flat-headed bridge or culvert of rubble granite with timber beam on visible face. Footings appear to be of mass concrete.

Period of construction:	20 th century
Materials:	Granite and concrete
NIAH reference:	Not included
Heritage significance:	None
NIAH rating:	n/a

Comment: Modest culvert opening and not of heritage value

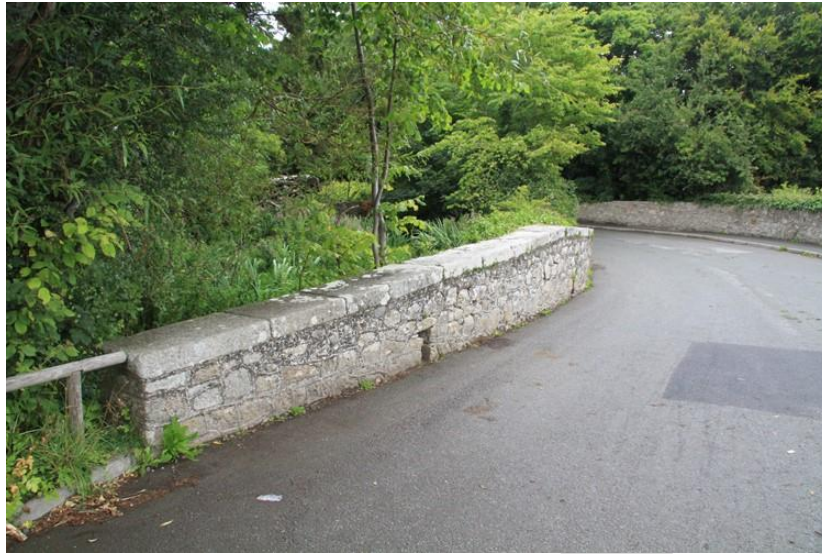
Plate 56: Bridge 21

Bridge is concealed and is inaccessible other than the deck and parapets. Nature of the construction is uncertain. Parapet walls are of rubble granite. On the western side of the bridge there is a fen, which was formerly a pond and may have been a duck pond associated with the farmyard. The bridge carries a small watercourse from this pond towards the lake. The bridge may be so small as to be referred to more correctly as a culvert.

Period of construction:	Uncertain, but probably 19 th century
Materials:	Unknown
NIAH reference:	Not included
Heritage significance:	Unknown
NIAH rating:	n/a

Comment: Without better access to examine the bridge its nature and character cannot be assessed.

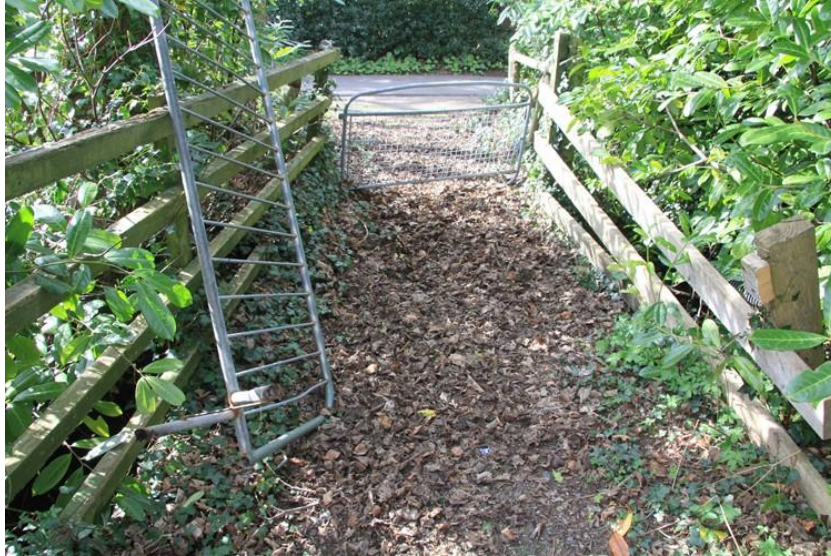
Plate 57: Bridge 22

Single-span bridge of steel and/or concrete. Parapets are timber fences.

Period of construction:	20 th century
Materials:	Timber and steel
NIAH reference:	Not included
Heritage significance:	None
NIAH rating:	n/a

Comment: Not of heritage interest.

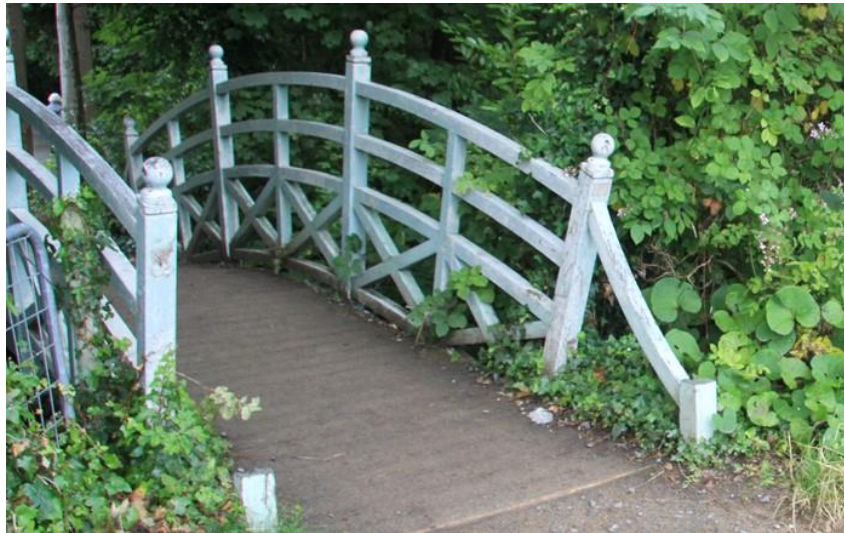
*Plate 58: Bridge 23***Description:**

Single-span bridge with segmental steel arch. Parapets are timber fences.

Period of construction:	20 th century
Materials:	Timber and steel
NIAH reference:	Not included
Heritage significance:	None
NIAH rating:	n/a

Comment: Attractive bridge, but not of heritage interest.

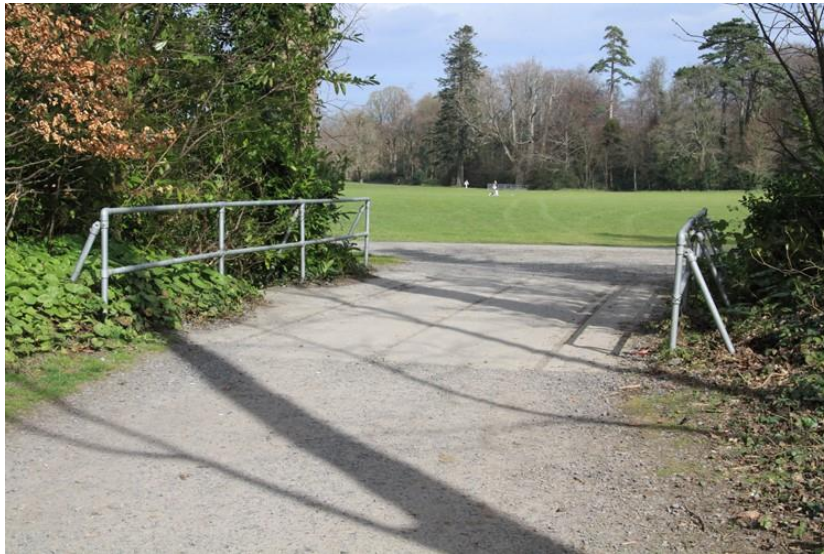
Plate 59: Bridge 24

Concrete beam bridge with tubular steel rails.

Period of construction:	20 th century
Materials:	Concrete and steel
NIAH reference:	Not included
Heritage significance:	None
NIAH rating:	n/a

Comment: Utilitarian bridge and not of heritage value.

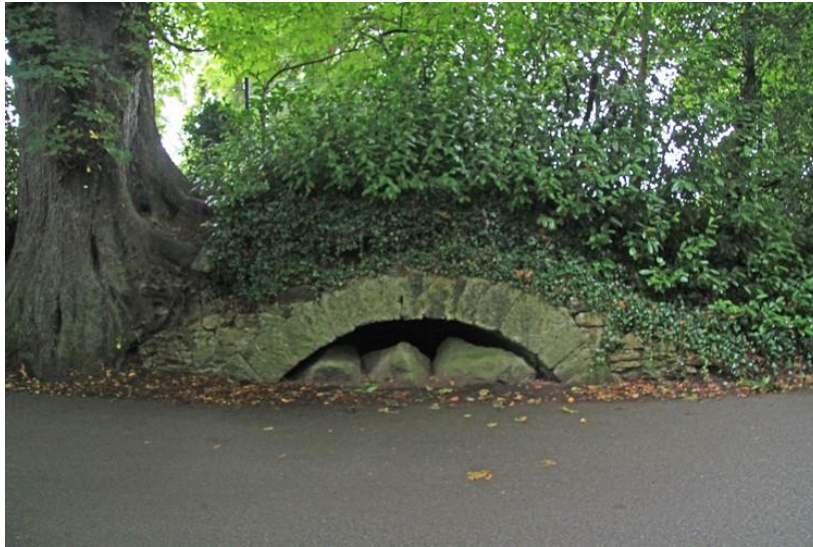
*Plate 60: Bridge 25*

Externally, this bridge appears to have no function and to consist of a segmental granite arch, without spandrels. It is, however, a tunnel that has been buried due to the raising up of the ground to the front to provide for the roadway between the farm yard and the gates. This is a buried tunnel with a roughly semi-circular vault of rubble granite. It runs to the western boundary of the park, a distance of about six metres

Period of construction: 18th century

Heritage significance: Regional

Comment: The Ordnance Survey map of 1864 shows that this tunnel brought a walkway underneath the former line of the road between the farm yard and the gates of the demesne, allowing the gentry to continue their walks without having to cross the farm road. This may also be seen on the first-edition Ordnance Survey six-inch map of 1843.

Pedestrian underpasses such as these are not common in demesnes, or elsewhere, from the eighteenth or early nineteenth centuries.

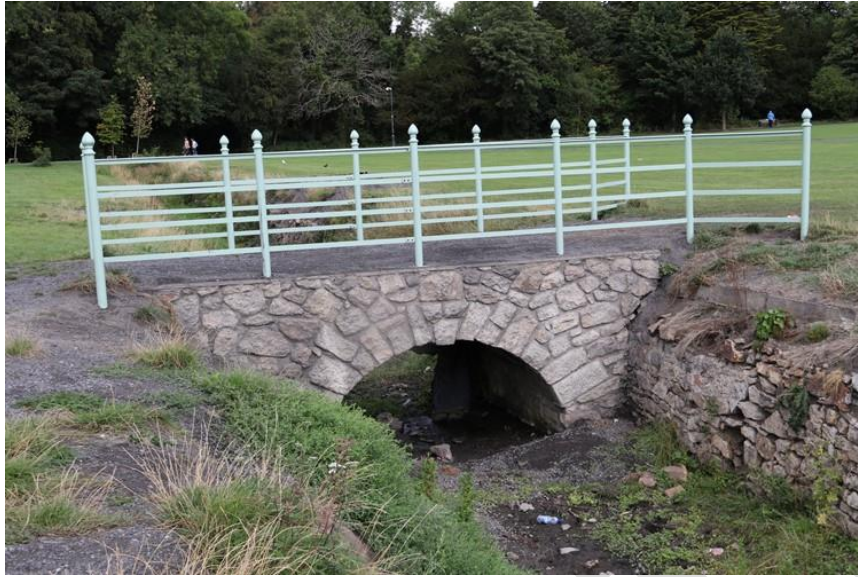
*Plate 62: Bridge 26***Description:**

Granite bridge crossing the ha-ha in the parkland to the south of the main house. The bridge vault is of rubble granite and mass concrete and the arch ring consists of squared granite blocks and with granite rubble spandrels. The railings are of steel.

Period of construction:	20 th century
Materials:	Granite, concrete and steel
NIAH reference:	Not included
Heritage significance:	None
NIAH rating:	n/a

Comment: No bridges are shown crossing the ha-ha on the 1865, 1907 or 1936 Ordnance Survey maps, suggesting that this bridge is of later twentieth century date; this is confirmed in the use of mass concrete.

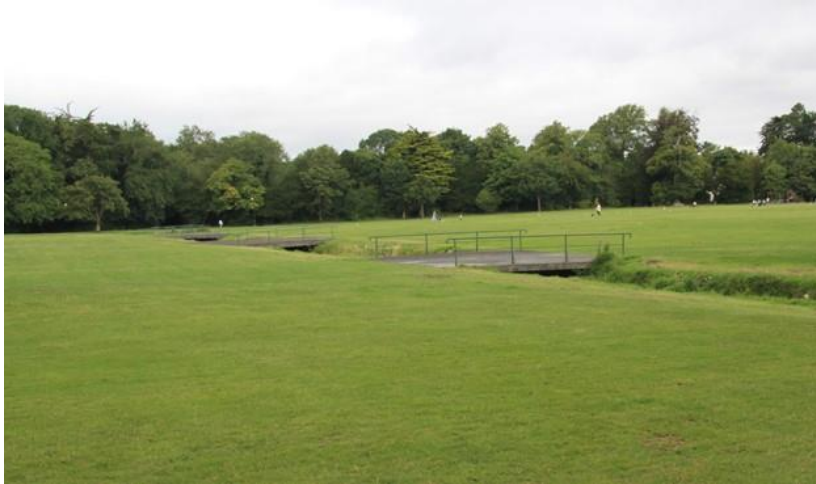
Plate 63: Bridges 27 to 29

Three steel beam bridges with timber decks and tubular steel rails. The bridges crossed the ha-ha in the parkland to the south of the main house.

Period of construction:	20 th century
Materials:	Steel and timber
NIAH reference:	Not included
Heritage significance:	None
NIAH rating:	n/a

Comment: Utilitarian bridges and were not of heritage value. They have now been removed.

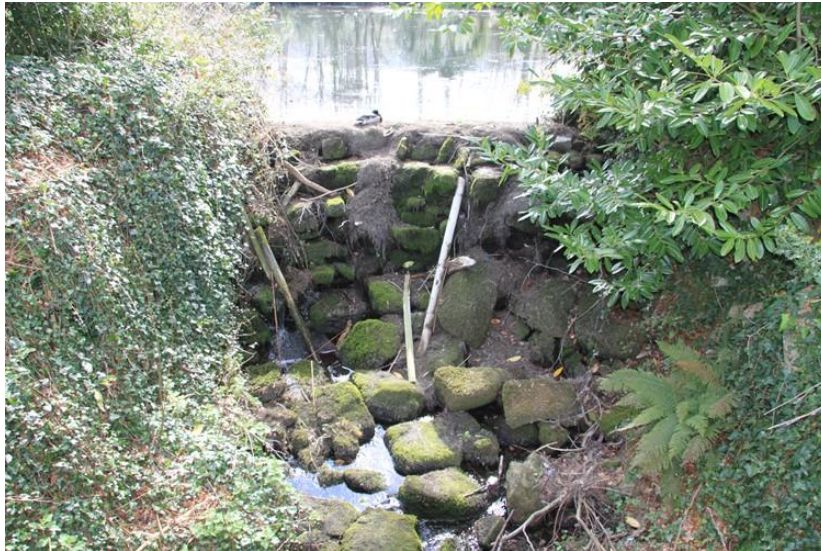
Plate 66: Weir number 3

Description: Weir number 3 is constructed with granite rubble, probably to appear as a picturesque waterfall, as seen from the adjacent footbridge. The top is level, built carefully so as determine the water level in the upper lake.

Period of construction:	18 th century
Materials:	Granite
NIAH reference:	Not included
Heritage significance:	Regional
NIAH rating:	n/a

Comment: The regional significance attribution arises from the weir being an integral and necessary part of the upper lake rather than from its own inherent qualities.

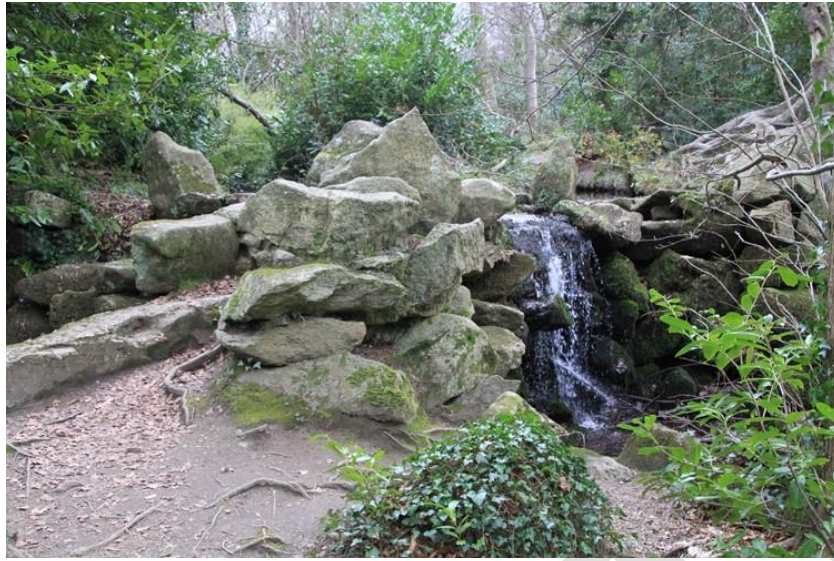
Plate 67: Weir number 4

Description: Weir constructed with granite rubble, providing a cascade of water. A branch of the river leads off towards the east to join the other channel a short distance away.

Heritage significance: Local

Comment: This would have held back the small pond or lake seen on the 1864 Ordnance Survey map, though according to the map evidence it is not in the same location as the weir that would have provided the longer lake seen on the 1843 map.

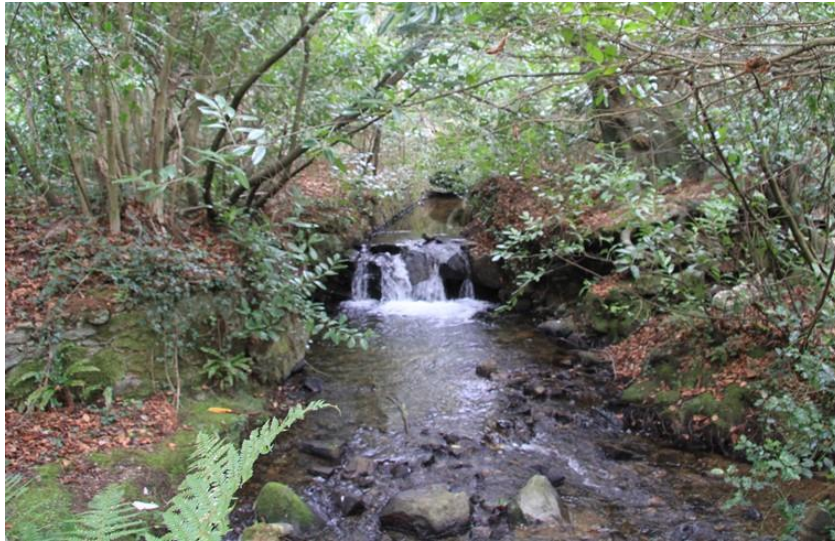
Plate 68: Weir number 5

Description: Artificial waterfall, or weir, probably designed to provide the sound of falling water and to create a visual effect.

Heritage significance: Local

Comment: Modest-sized weir.

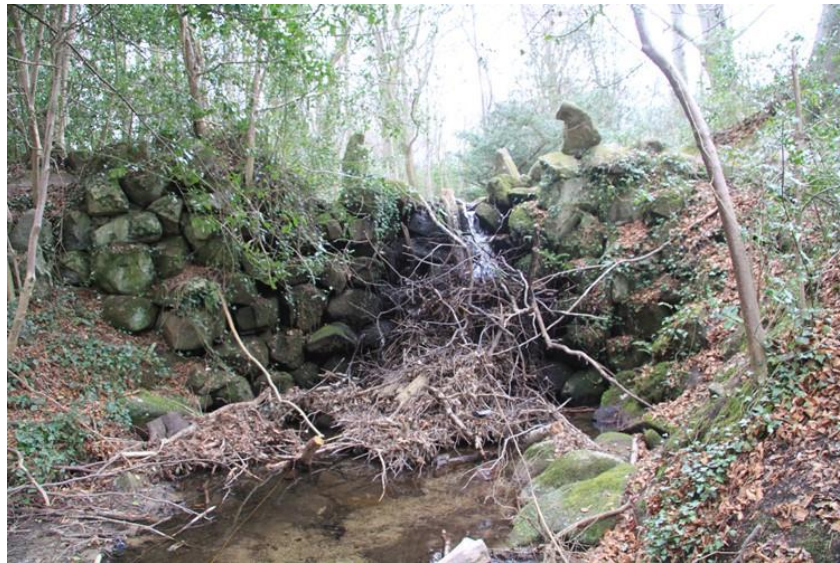
Plate 69: Weir number 6

Description: Substantial U-shaped weir constructed with rubble stone.

Heritage significance: Local

Comment: It is possible that this weir originally held back part of the now-disappeared upper lake, which may have descended in stages, due to the gradient along the valley.

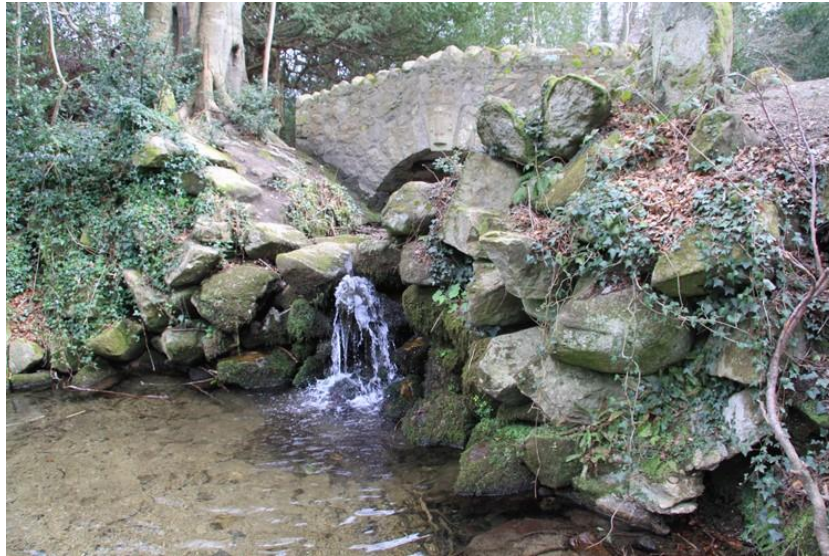
Plate 70: Weir number 7

Description: Rubble-stone weir.

Comment: Simple weir of rocks.

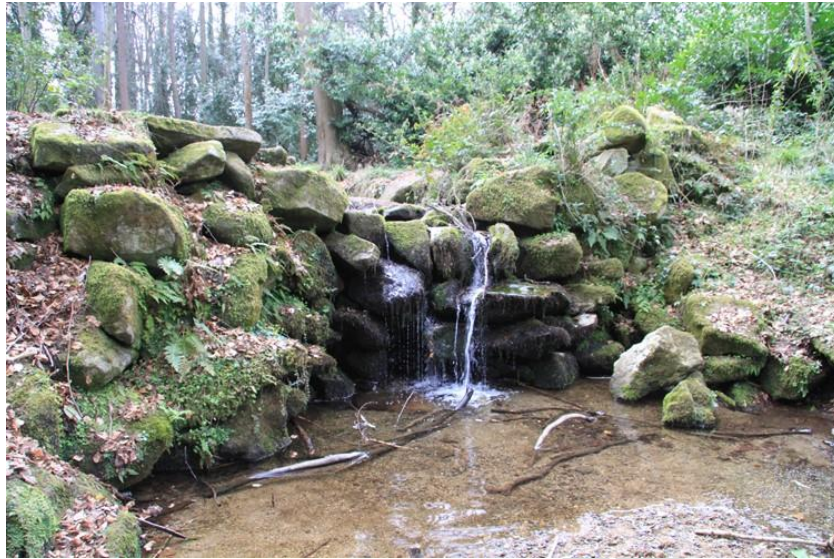
Plate 71: Weir number 8

Description: Weir of granite rocks, raising the water level.

Period of construction:	Probably mid-nineteenth century
Materials:	Granite
NIAH reference:	Not included
Heritage significance:	Local
NIAH rating:	n/a

Comment: Simple granite weir

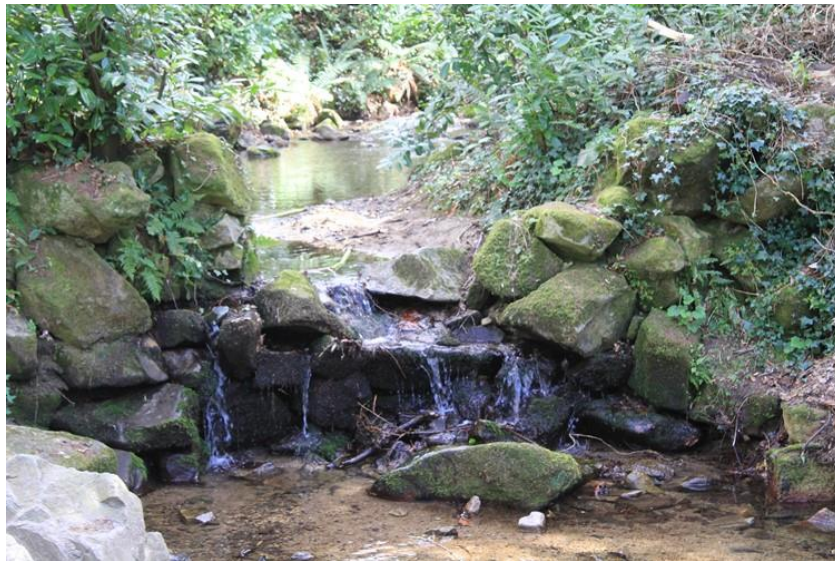
Plate 72: Weir number 9

Description: Weir of granite rocks

Comment: Simple granite weir

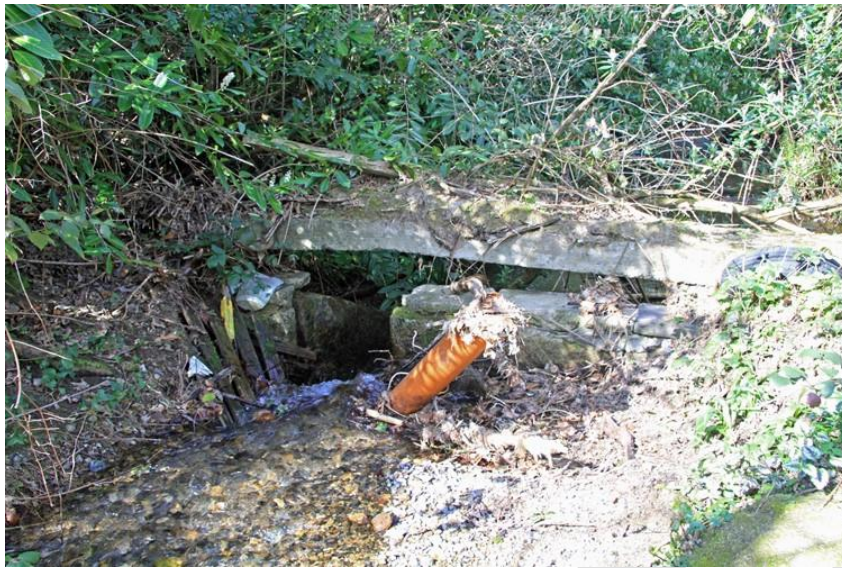
Plate 73: Weir number 10

Description: Granite weir with vertical rectangular gap with slots for boards to regulate the height of the water upstream.

Comment: The weir is not shown on the 1843 or 1864 Ordnance Survey maps.

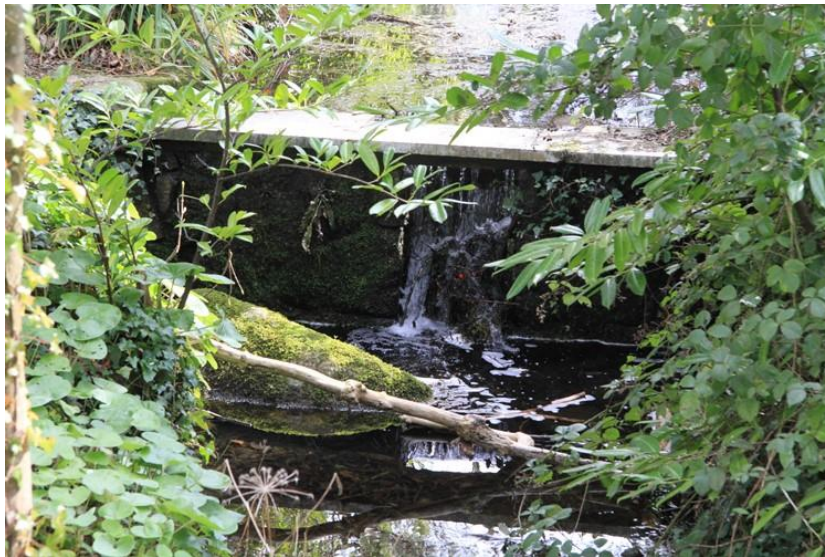
Plate 74: Weir number 11

Description: Granite weir with concrete platform spanning the top. The weir serves to hold back the water in the longer lake.

Heritage significance: Regional

Comment: The concrete beam is not part of the original weir and hence is not considered to be part of the Regional designation. This designation has been assigned as the weir is an integral part of the lake and hence should be assigned the same rating.

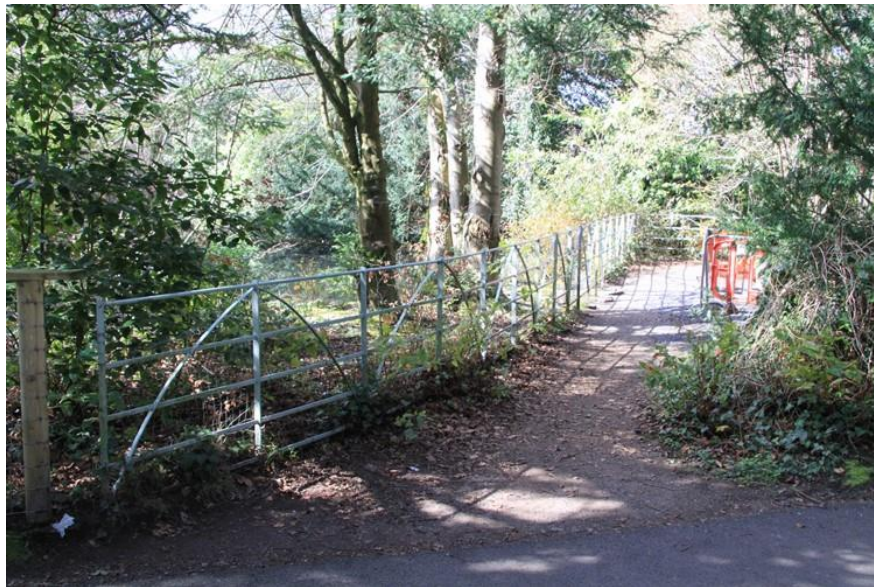
Plate 75: Railing number 1

Description: Galvanised-steel railing with posts and five rails and with curved opposing diagonals.

Heritage significance: None

Comment: Attractive iron railing alongside the smaller lake. Despite the late date the railings are in a traditional style that adds to the character of the park.

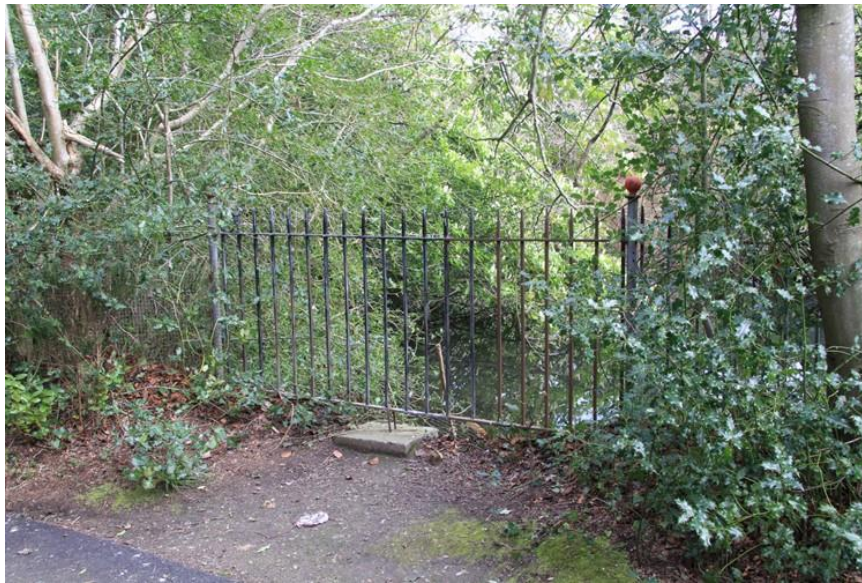
Plate 76: Railing number 2

Description: Simple galvanised-steel railing with spiked vertical bars held between horizontal flat bars.

Heritage significance: None

Comment: The railing is in the vicinity of the bridge to the island in the smaller lake. Despite the late date the railings are of traditional design and add to the character of the park.

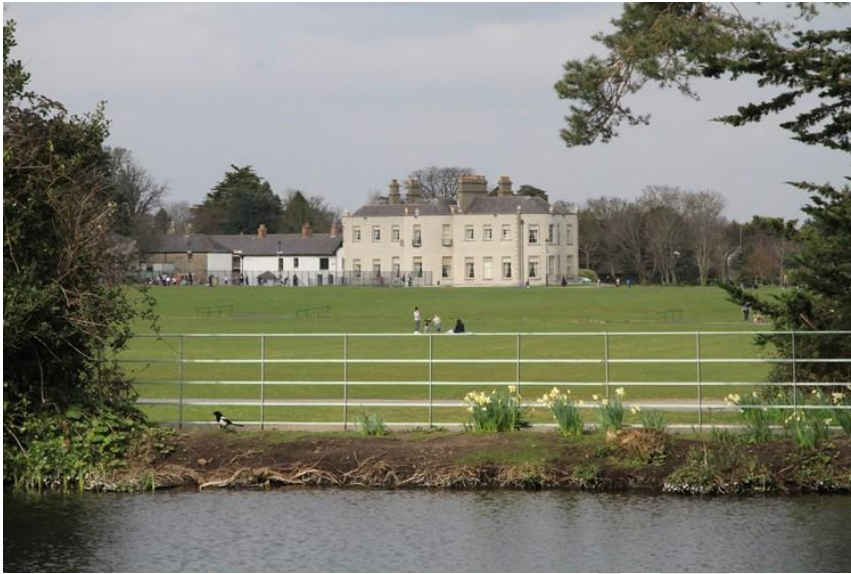
Plate 77: Railing 3

Description: Traditional simple steel railings of a type frequently found alongside the driveways to country houses. Railing consists of five horizontal bars supported at intervals with simple vertical bars.

Heritage significance: None

Comment: Attractive traditional-style wrought-iron railing, though of a later date.

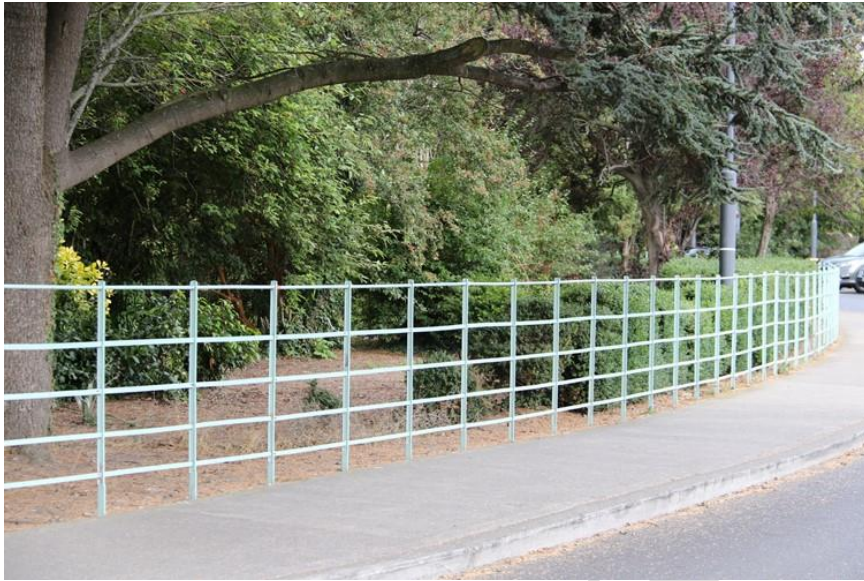
Plate 78: Railing 4

Description: Traditional simple galvanised-steel railings consisting of four flat horizontal bars and one round-section horizontal bar supported at intervals with I-section vertical bars.

Heritage significance: None

Comment: Attractive traditional-style wrought-iron railing, though of a later date.

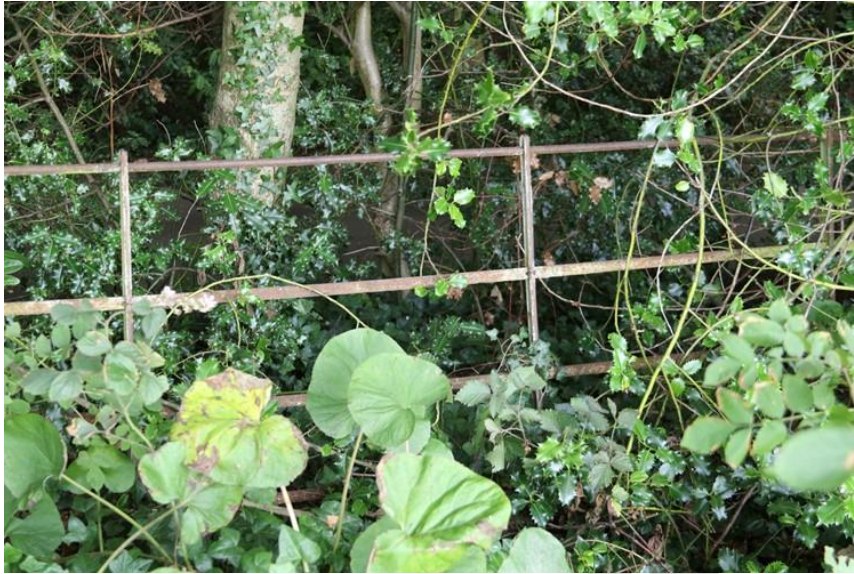
Plate 79: Railing 5

Description: Wrought-iron railing with round-section top bar and three horizontal flat bars, supported on vertical wrought-iron I-section bars.

Comment: Located on the eastern side of the parkland to the south of the main house and along the margin of the woodland alongside the river. This railing would have prevented livestock from straying out of the parkland and into the pleasure grounds along the river valley.

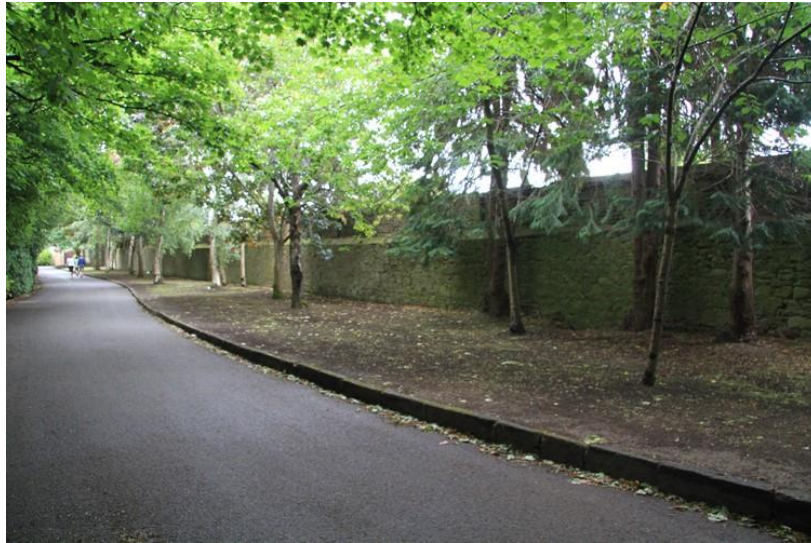
Plate 80: Western side of wall of walled garden

Comment: Substantial perimeter wall enclosing the walled gardens. This would have been built around the time that the main house was built.

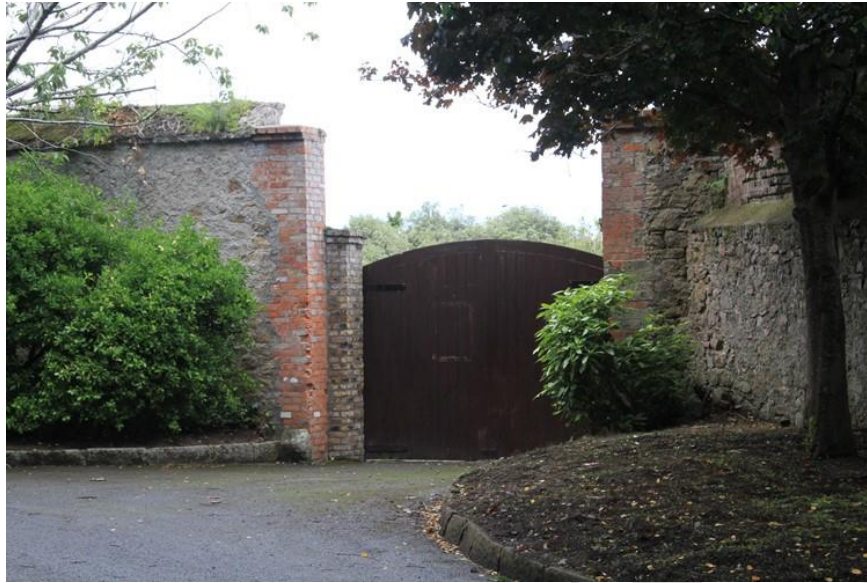
Plate 81: Western gateway to walled garden

Comment: The gateway is a late insertion into the western wall of the walled garden and is not of heritage value.

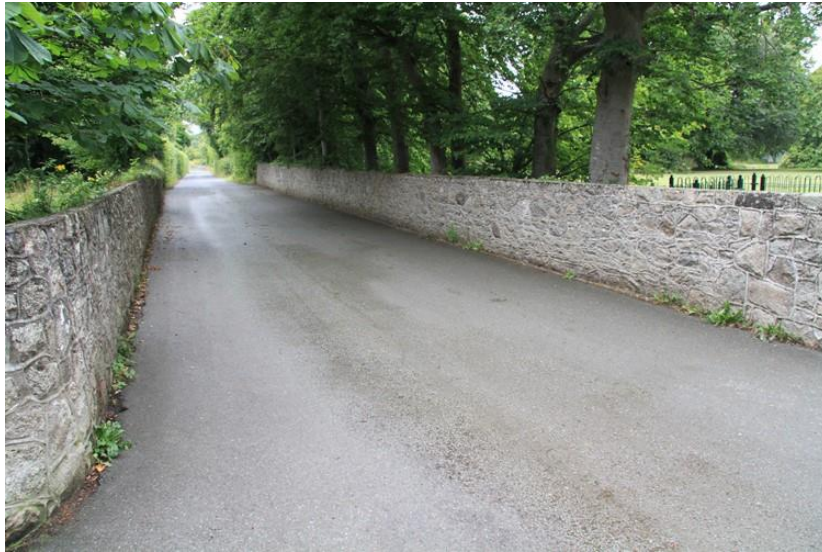
Plate 82: Walls flanking farm roadway

Comment: The walls would be part of the original demesne, though of low heritage value other than their association with the Marlay demesne.

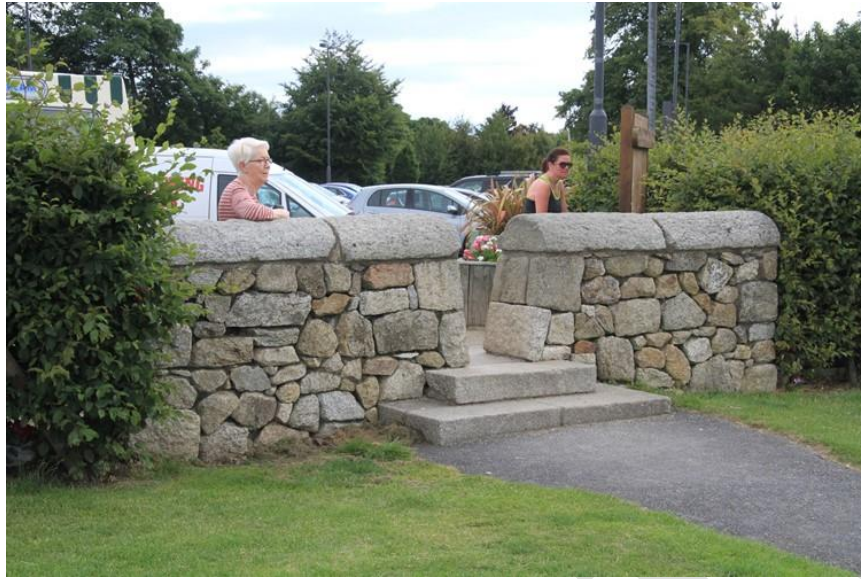
Plate 83: Wall at car park

Comment: This is a well-designed and well-built stretch of wall with imaginative use of salvage granite elements, however it is not of heritage value.

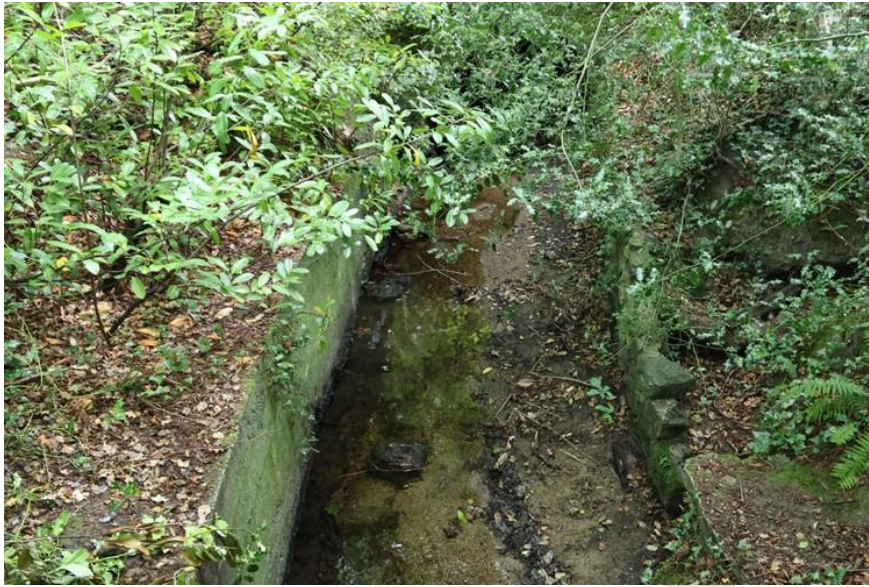
Plate 84: Wall at car park

Comment: The walls are necessary for keeping the channel open.

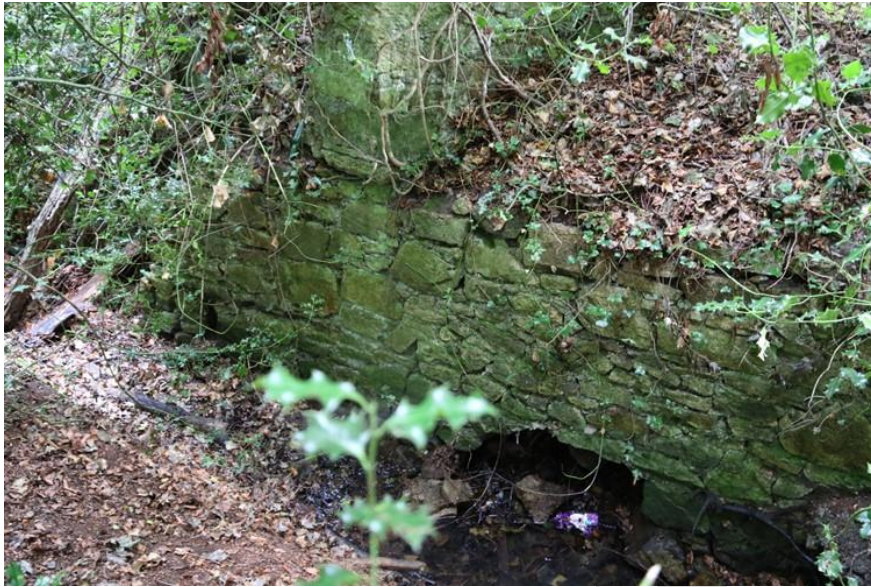
Plate 85: Wall at old ditch

Comment: No ditch or walls are shown on any Ordnance Survey maps at this location.

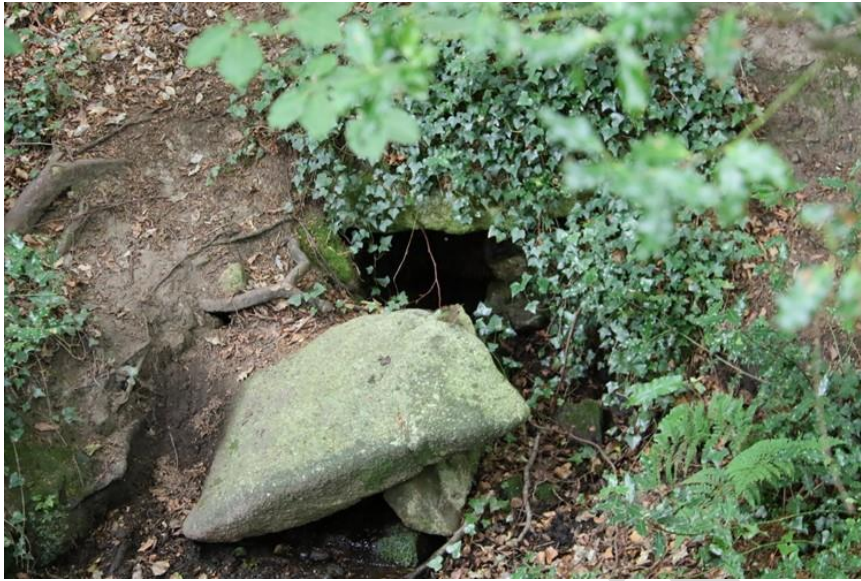
BH-79 – Box culvert beside western river channel

Plate 87: Box culvert alongside river channel
