Re: An Arboricultural Assessment of the Site Area for the Sports Facility Project at 'Shanganagh Park', Shankill, Dublin 18.

An Arboricultural Assessment of the Site Area for the Sports Facility Project at 'Shanganagh Park', Shankill, Dublin 18.

Condition Tree Assessment

A Condition Assessment of the Trees within the site area at 'Shanganagh Park', Shankill, Dublin 18.

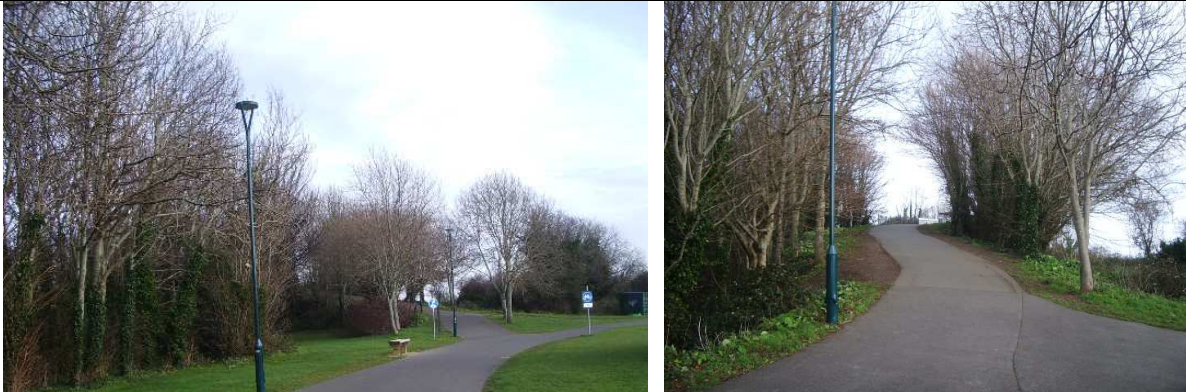
1306	Ash <i>Fraxinus excelsior</i>	10	310	4	4	4	4	2	Early Mature	Fair/ Good	Fair It is growing in the triangular shaped grass area that divides the paths and its crown overhangs the public paths in this area. It is a single-stemmed tree that divides into two stems at a height of c.2m with an acute union formation between stems with included bark present and this may develop into a structural weakness as the tree grows in size. Soil alterations have occurred around its base and its lower branches have been removed in order to raise up its crown with good callous growth around these wounds.	Maintain a larger weed-free area around its base with mulch. It will require formative pruning to address structural issues.	40+	B1

1307	Ash <i>Fraxinus excelsior</i>	10	290	5	5	5	3	2	Early Mature	Fair/ Good	Fair It is growing in the triangular shaped grass area that divides the paths and its crown overhangs the public paths in this area. It is a single-stemmed tree that divides into three stems at a height of c.2m. Soil alterations have occurred around its base and its lower branches have been removed	Maintain a larger weed-free area around its base with mulch. Prune lower branches to improve clearance over paths for high-sided vehicles.	40+	B1

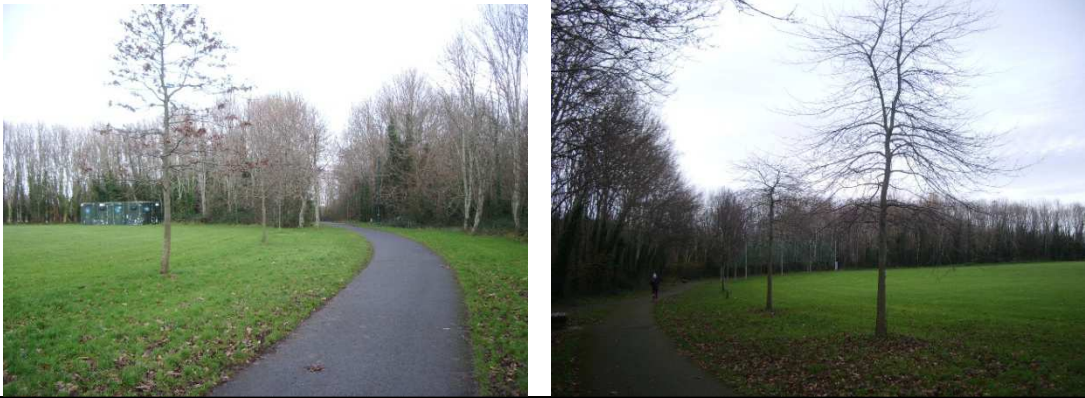
1324	Sycamore <i>Acer</i>	9	270	3	2	4	3	3	Semi Mature	Fair	Fair/ Poor It divides into two stems at a height of c.2m and it	Maintain a larger weed-free area around its base	20+	C1
