Ref: SGPP079656677

Re: An Arboricultural Assessment of the Site Area for the Sports Facility Project at 'Shanganagh Park', Shankill, Dublin 18.

An Arboricultural Assessment of the Site Area for the Sports Facility Project at 'Shanganagh Park', Shankill, Dublin 18.

Condition Tree Assessment

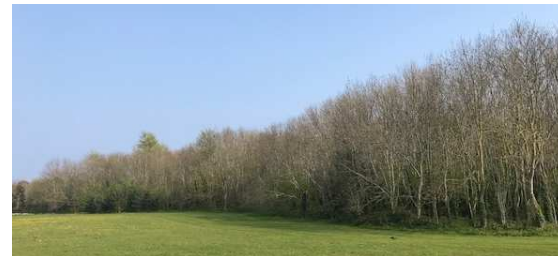
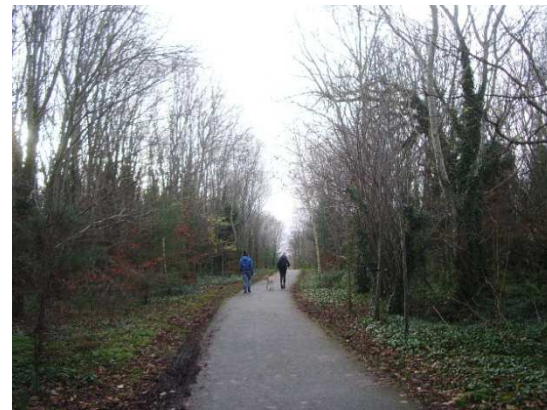
Woodland Block No.1	Ash <i>Fraxinus excelsior</i> Sycamore <i>Acer pseudoplatanus</i> Oak <i>Quercus robur</i> Birch <i>Betula pendula</i> Beech <i>Fagus sylvatica</i> Larch <i>Larix decidua</i> Field Maple <i>Acer campestre</i> Hazel <i>Corylus avellana</i> Horse Chestnut	A 13	A 300	A 4	A 4	A 4	A 4	A 2	Early Mature	Fair/ Good	Fair It is located along the southern boundary of the site area. It is prominent woodland in this area and paths intersect it throughout breaking it up into sub-compartments. Its upper-canopy is made up of predominantly Ash and Sycamore with some Oak, Horse Chestnut, and Larch in places. It has a lower-canopy of Field Maple, Hawthorn and Hazel with some Birch and Beech in places. The understory consists of Bramble and self-seeded trees such as Sycamore and Birch. A lot of these trees have been drawn up for the light due to overcrowding/ competition and this has impacted on their structure. There is some naturally occurring deadwood within their crowns and some trees within have failed due to suppression from the larger neighbouring trees. Their lower branches have been removed to raise up their crowns and provide clearance over the paths and	Remove any dead/ unstable growth that endangers the public footpaths. Continue current maintenance to maintain clearance with the public footpaths. Cut Ivy at ground level where heavy on trees. This woodland block would benefit from ongoing, light, selective thinning to allow the better quality trees space to grow and develop. It would also benefit from infill planting with additional tree species to help further diversify tree	40+	A2

Tree No.	Tree Species	Ht. (m)	Stem Dia. (mm)	Branch Spread (m)				C-Ht. (m)	Age Class	Phys Con.	Structural Condition Other Comments	Preliminary Recommendation	Remaining years	Category Grade
				N	S	E	W							
										N-North S-South E-East W-West Ht.- Height C- Crown Phy Con.- Physiological Condition	A- Average Dia.- Diameter Cat.- Category			
	<i>Aesculus hippocastanum</i> Hawthorn <i>Crataegus monogyna</i> Bramble <i>Rubus fruticosus</i>									they have suffered some branch breakages from high-sided vehicles passing through this area. Ivy cover is beginning to extend into some of their crowns. These trees are growing as one coherent group with a combined group canopy formation and they depend on each other for support/ shelter. Their category grade is based on their merits as a woodland block and not as individual trees.	species and to future proof the tree belt, and in particular to help compensate for the loss of Ash trees due to 'Ash Dieback' (<i>Hymenoscyphus fraxineus</i>) disease.

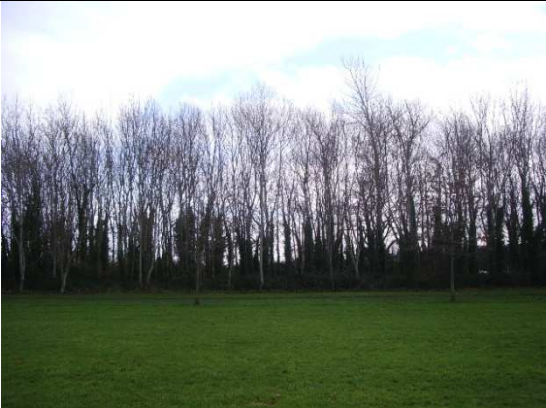
Tree No.	Tree Species	Ht. (m)	Stem Dia. (mm)	Branch Spread (m)				C-Ht. (m)	Age Class	Phys Con.	Structural Condition Other Comments	Preliminary Recommendation	Remaining years	Category Grade
				N	S	E	W							
											N-North S-South E-East W-West Ht.- Height C- Crown Phy Con.- Physiological Condition	A- Average Dia.- Diameter Cat.- Category		
Tree Belt No.2	Ash <i>Fraxinus excelsior</i> Sycamore <i>Acer pseudoplatanus</i> Oak <i>Quercus robur</i> Beech <i>Fagus sylvatica</i> Larch <i>Larix decidua</i> Field Maple <i>Acer campestre</i> Hazel <i>Corylus avellana</i> Horse Chestnut <i>Aesculus hippocastanum</i> Hawthorn <i>Crataegus monogyna</i> Bramble <i>Rubus fruticosus</i>	A 13	A 300	A 4	A 4	A 4	A 4	A 2	Early Mature	Fair/ Good	Fair It is located along the southern boundary of the site area extending east to west. It is a prominent tree belt in this area. Its upper-canopy is made up of predominantly Ash and Sycamore with some Oak, Horse Chestnut, and Larch in places. It has a lower-canopy of Field Maple, Hawthorn and Hazel with some Beech in places. The understory consists of Bramble and self-seeded trees such as Sycamore. A lot of these trees have been drawn up for the light due to overcrowding/ competition, affecting their structure. There is some naturally occurring deadwood within their crowns and some trees within have failed due to suppression from the larger neighbouring trees. Their lower branches have been removed to raise up their crowns and provide clearance over the path to the north. Ivy cover is beginning to extend into some of their crowns. These trees are growing as one coherent group with a combined group canopy formation and they depend on each other for support/ shelter. Their category grade is based on their merits as a tree belt and not as individual trees.	Remove any dead/ unstable growth that endangers the public footpath. Continue current maintenance to maintain clearance with the public footpaths. Cut Ivy at ground level where heavy on trees. It would benefit from ongoing, light, selective thinning to allow the better quality trees space to grow and develop. It would also benefit from infill planting with additional tree species to help further diversify tree species and to future proof the tree belt, and in particular to help compensate for the loss of Ash trees due to 'Ash Dieback' (<i>Hymenoscyphus fraxineus</i>) disease.	40+	A2

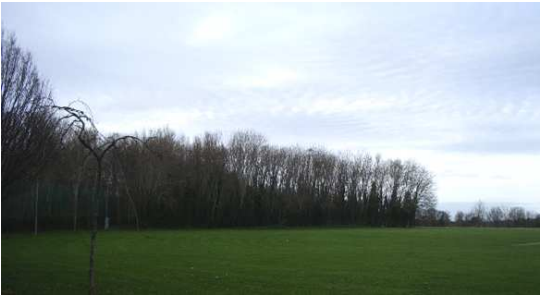
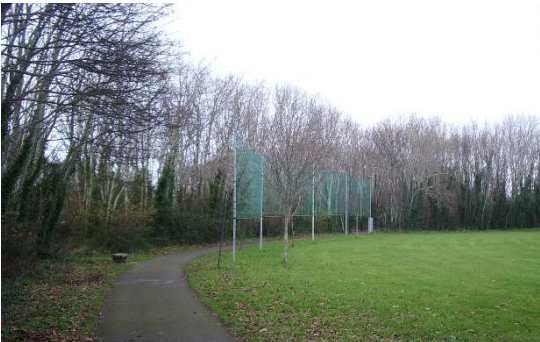
1337	Serviceberry <i>Amelanchier lamarckii</i>	4	70	1	1	1	1	2	Young	Fair/ Good	Fair/ Good Its lower branches have been removed in order to raise up its crown and it is establishing well.	Maintain a larger weed-free area around its base with mulch.	20+	C1
Tree Belt No.3	Ash <i>Fraxinus excelsior</i> Sycamore <i>Acer pseudoplatanus</i> Oak <i>Quercus robur</i> Beech <i>Fagus sylvatica</i> Rowan <i>Sorbus aucuparia</i> Cherry <i>Prunus avium</i> Norway Maple <i>Acer</i>	A 13	A 280	A 4	A 4	A 4	A 4	A 3	Early Mature	Fair/ Good	Fair It is located north of Tree Belt No.2 and it protrudes out into the open grass area. It has an upper-canopy of predominantly Ash and Sycamore with some Horse Chestnut, Oak and Norway Maple in places. It has a lower canopy of Cherry, Hazel, Willow and Field Maple with some Rowan and Beech in places. There is Bramble throughout its understory and there are self-seeded trees developing such as Ash, Sycamore and Rowan. Their lower branches have been removed to raise up their crowns resulting in pruning wounds. Ivy cover is beginning to extend into some of their crowns. These trees are growing as one coherent group with a combined group canopy formation and they depend on each other for support/ shelter. Their category grade is	Remove any dead/ unstable growth that endangers the public footpath to the south and west. Continue current maintenance to maintain clearance with the public footpaths. Cut Ivy at ground level where heavy on trees. They would benefit from ongoing, light, selective thinning to allow the better quality trees space to grow and develop. It would also benefit from infill planting	40+	B2

Tree No.	Tree Species	Ht. (m)	Stem Dia. (mm)	Branch Spread (m)				C-Ht. (m)	Age Class	Phys Con.	Structural Condition Other Comments	Preliminary Recommendation	Remaining years	Category Grade
				N	S	E	W							
										N-North S-South E-East W-West Ht.- Height C- Crown Phy Con.- Physiological Condition	A- Average Dia.- Diameter Cat.- Category			
	<i>platanoides</i> Field Maple <i>Acer campestre</i> Hazel <i>Corylus avellana</i> Horse Chestnut <i>Aesculus hippocastanum</i> Willow <i>Salix sp.</i> Bramble <i>Rubus fruticosus</i>									based on their merits as a tree belt and not as individual trees.

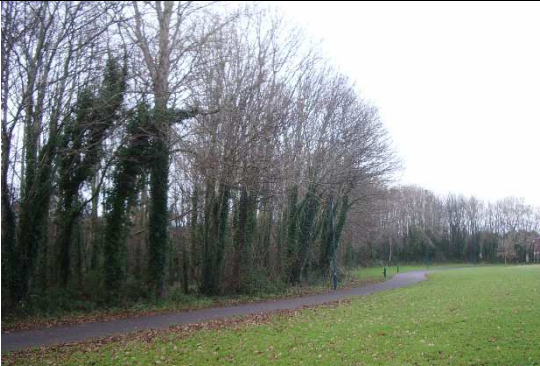
with additional tree species to help further diversify tree species and to future proof the tree belt, and in particular to help compensate for the loss of Ash trees due to 'Ash Dieback' (<i>Hymenoscyphus fraxineus</i>) disease.			
Tree Belt No.4	Ash <i>Fraxinus excelsior</i> Sycamore <i>Acer pseudoplatanus</i> Oak <i>Quercus robur</i>	A 16	A 380	A 5	A 5	A 5	A 5	A 4	Early Mature	Fair	Fair It extends north to south along the western boundary of this open grass area along the boundary with 'Shanganagh Castle'. It is cordoned off from the open grass area by a pathway which has been widened recently towards the trees which may have resulted in some soil and root damage that may impact on	Remove large size dead/unstable growth that endangers the public footpath to the south and east. Continue current maintenance to maintain clearance with the public	40+	A2

Tree No.	Tree Species	Ht. (m)	Stem Dia. (mm)	Branch Spread (m)				C-Ht. (m)	Age Class	Phys Con.	Structural Condition Other Comments	Preliminary Recommendation	Remaining years	Category Grade
				N	S	E	W							
										N-North S-South E-East W-West Ht.- Height C- Crown Phy Con.- Physiological Condition	A- Average Dia.- Diameter Cat.- Category			
	Beech <i>Fagus sylvatica</i> Alder <i>Alnus glutinosa</i> Rowan <i>Sorbus aucuparia</i> Cherry <i>Prunus avium</i> Poplar <i>Populus sp.</i> Norway Maple <i>Acer platanoides</i> Field Maple <i>Acer campestre</i> Hazel <i>Corylus avellana</i> Horse Chestnut <i>Aesculus hippocastanum</i> Willow <i>Salix sp.</i> Hawthorn <i>Crataegus monogyna</i> Bramble <i>Rubus fruticosus</i>									<p>the trees. The upper canopy consists of predominantly Ash and Sycamore with some Oak, Cherry and Poplar in places and these Poplars tower over the rest of the upper-canopy. The lower canopy consists of mainly Field Maple, Hazel, and Horse Chestnut with some Beech, Norway Maple, Willow, Rowan and Alder in places. Bramble is dominating the understory and there is also some Hawthorn present along with self-seeded trees such as Ash, Sycamore and Field Maple. Their crowns overhang the public footpath to the east at the southern end of this tree belt and their lower branches have been removed to provide clearance in this area. Some larger trees have failed within but don't pose any threat the public path and there is some deadwood throughout their crowns. Ivy cover is beginning to extend into some of their crowns increasing wind-loading in some trees. These trees are growing as one coherent group with a combined group canopy formation and they depend on each other for support/ shelter. Their category grade is based on their merits as a tree belt and not as individual trees.</p>	<p>footpaths. Cut Ivy at ground level where heavy on trees. They would benefit from ongoing, light, selective thinning to allow the better quality trees space to grow and develop. It would also benefit from infill planting with additional tree species to help further diversify tree species and to future proof the tree belt, and in particular to help compensate for the loss of Ash trees due to 'Ash Dieback' (<i>Hymenoscyphus fraxineus</i>) disease.</p>

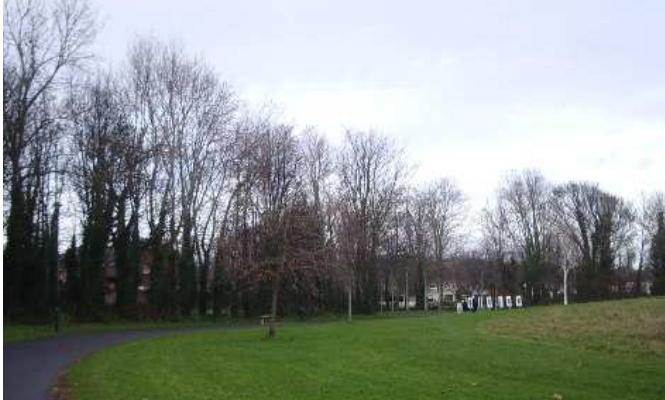
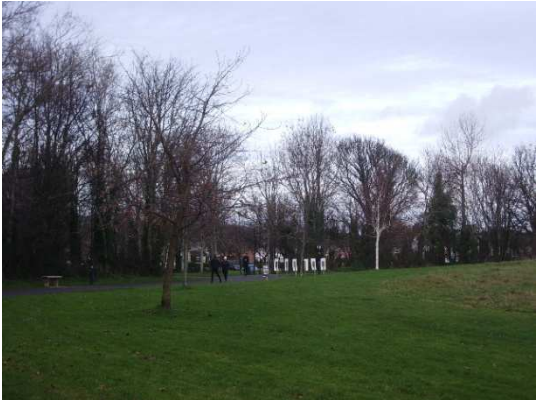
The following trees are growing on the west side of the open grass area to the east of the public footpath and Tree Belt No.4.									They would benefit from formative pruning to encourage good form/ structure.	-	-

1338	Oak <i>Quercus sp.</i>	6	140	2	2	3	3	2	Young	Fair/ Good	Fair/ Good Its lower branches have been removed in order to raise up its crown and it is establishing well.	Maintain a larger weed-free area around its base with mulch.	40+	C1
