# **Arborist Associates Ltd.**

## **An Arboricultural Assessment on the Site Area for the 'Kilbogget Park Sports Pavillion Project', Churchview Road, Cabinteely, Dublin 18.**

**Prepared for: Dun Laoghaire Rathdown County Council**

**Date: 28<sup>th</sup> April 2026**

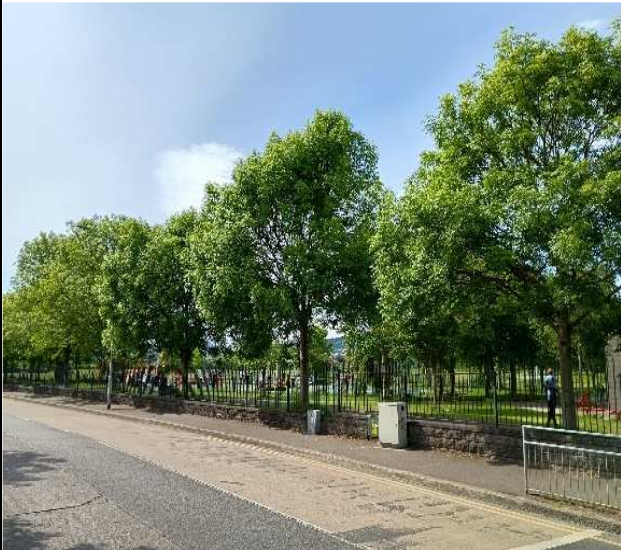
<p><b>Photograph 1 shows the above line of Ash trees along boundary. Photograph shows Tree No.1293.</b></p>									
1293	<b>Oak</b> <i>Quercus sp.</i>	17	1200	6	7	6	8	2	Mature	Fair	Fair A single stem tree growing close to the site boundary with a slight lean to the east towards the road. The crown contains some minor deadwood and heavy Ivy growth extends high into the crown, increasing the windsail and limiting the visual assessment. There is a decay area on the buttress root at the base on the west side.	Cut Ivy at ground level. Remove dead / unstable growth.	20+	B2	14.4

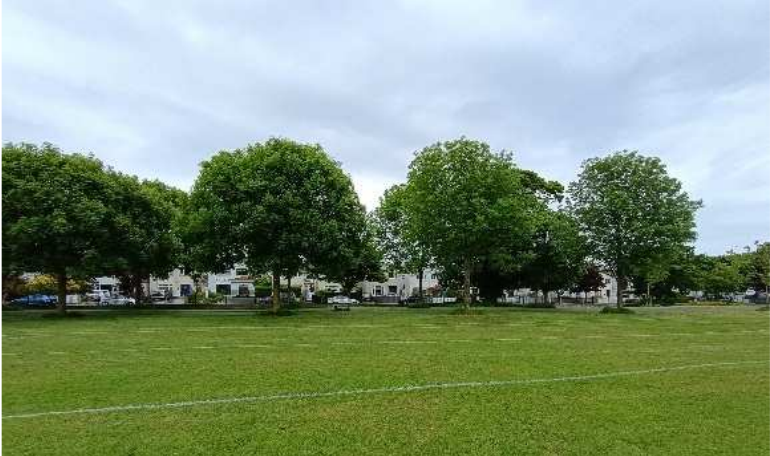
Tree No.	Tree Species	Ht. (m)	Stem Dia. (mm)	Branch Spread (m)				C-Ht. (m)	Age Class	Phys. Con.	Structural Condition Other Comments	Preliminary Recommendation	ULE	Cat. Grade	RPA (radius) (m)
				N	S	E	W								
				N	S	E	W				N-north S-south E-east W- west C-Ht.-crown height, Dia.-diameter Phys.-physiological.	ULE-useful life expectancy Cat.-category, A-average			
Tree Line 0901 – 0904 & 1294	<b>Ash cv</b> <i>Fraxinus excelsior cv</i>	A.10	A.330	5	5	4	5	2	Early Mature	Fair	Fair A short line of five single stem trees growing to the west of the perimeter path and which form an avenue with the tree on the east side of the path. They extend southwards from the playground and they form part of a longer tree line, the southern part of which is a much more recent planting. Lower branches have been pruned in the past to improve ground clearance. They show little signs of infection by 'Ash Dieback Disease' ( <i>Hymenoscyphus fraxineus</i> ) at present.	No works required at present.  They will require further pruning in the short term of their lower branches for clearance over the surrounding surfaces.  Monitor for infection with 'Ash Dieback Disease'	10 – 20	C2	4.0

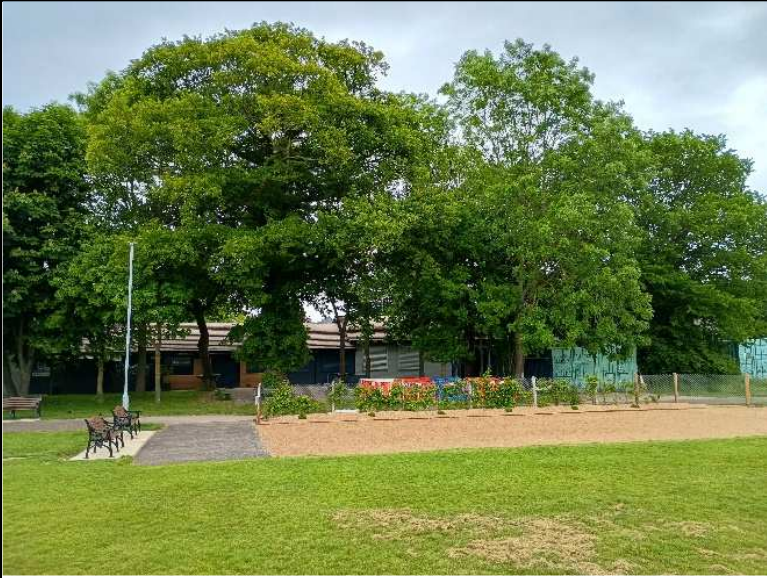
<b>Tree Group</b> 0961 – 0974 (14 trees)	<b>Elm</b> <i>Ulmus glabra</i> <b>Oak</b> <i>Quercus petraea</i> <b>Ash</b> <i>Fraxinus excelsior</i> <b>Horse Chestnut</b> <i>Aesculus hippocastanum</i>	<p><b>This tree group is located to the west of the Seapoint RFC Clubhouse and to the north of the Cabinteely Boys FC clubhouse.</b></p> <p>It consists of mixed age class and species of trees in varying condition. They are located in a wide grass area, part of which has been developed as an outdoor seating area with paving and part of which has been used for the placement of steel shipping containers for use as storage areas. It is likely that some soil damage and root disturbance may have occurred during these developments, in particular around the larger trees. The Ash trees are vulnerable to 'Ash Dieback Disease' (<i>Hymenoscyphus fraxineus</i>) and some of the trees are showing signs of infection and early decline at present. The Elm are vulnerable to infection with 'Dutch Elm Disease' (<i>Ophiostoma ulmi</i>) and will require ongoing monitoring. The group forms a significant feature in the local tree scape and has been graded as such.</p>									Monitor the Ash and Elm trees for advancing disease infection.		C2

<p><b>It includes the following trees:</b></p>															
0961	<b>Elm</b> <i>Ulmus glabra</i>	17	310/ 400/ 320	6	6	3	7	3	Mature	Fair	Fair A multi-stem tree from near ground level, there is some minor storm damage present in the crown. It is growing up with a shared canopy with Tree No. 0962. Heavy Ivy cover extends high into the crown, increasing the windsail. It is vulnerable to infection with 'Dutch Elm Disease' ( <i>Ophiostoma ulmi</i> ) and will require monitoring. There is a Cordyline developing at the base.	Prune storm damaged branches back to target pruning points and tidy up undergrowth.  Cut Ivy at ground level at present.  Monitor for infection with 'Dutch Elm Disease'	10 - 20	C2	7.2

0962	<b>Elm</b> <i>Ulmus glabra</i>	13	260/ 360	3	6	6	0	3	Mature	Fair	Fair / A pair of stems from near ground level growing up with a shared canopy with Tree No. 0961. It	Tidy up undergrowth and cut Ivy at ground level.	10-20	C2	5.3
