# Arborist Associates Ltd.

## A Condition Assessment of the Trees Within the Site Area for the 'Sandyford Civic Park Project'.

Prepared for: Dun Laoghaire Rathdown County Council

Date: 20<sup>th</sup> November 2025

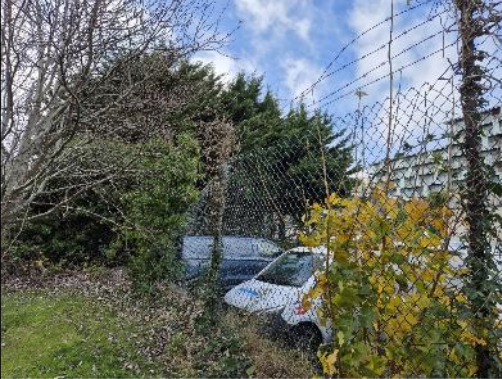
<p>The following trees are located on a wide grass verge running between the roadside kerb and the public footpath on the south side along Carmanhall Road. They have space to develop and they have some value to the treescape of the area.</p>									<p>Mulch area around the base of the trees to protect them from damage during grass maintenance. These trees will require pruning from time to time to maintain clearance over the surrounding surfaces.</p>
