Civil Engineering Services Report

Residential Housing Development at Blackglen Road

Client	Dun Laoghaire, Rathdown County Council							
	Project Title	Residential Housing Development at Blackglen Road							
	Project Ref.	23D059							
	Document Title	Planning Report							
	Document No.	23D059-PR 01							
	This Document Comprises	DCS	PD	TOC	Text	-	-	-	Appendices
		1	-	1	5				9
Check

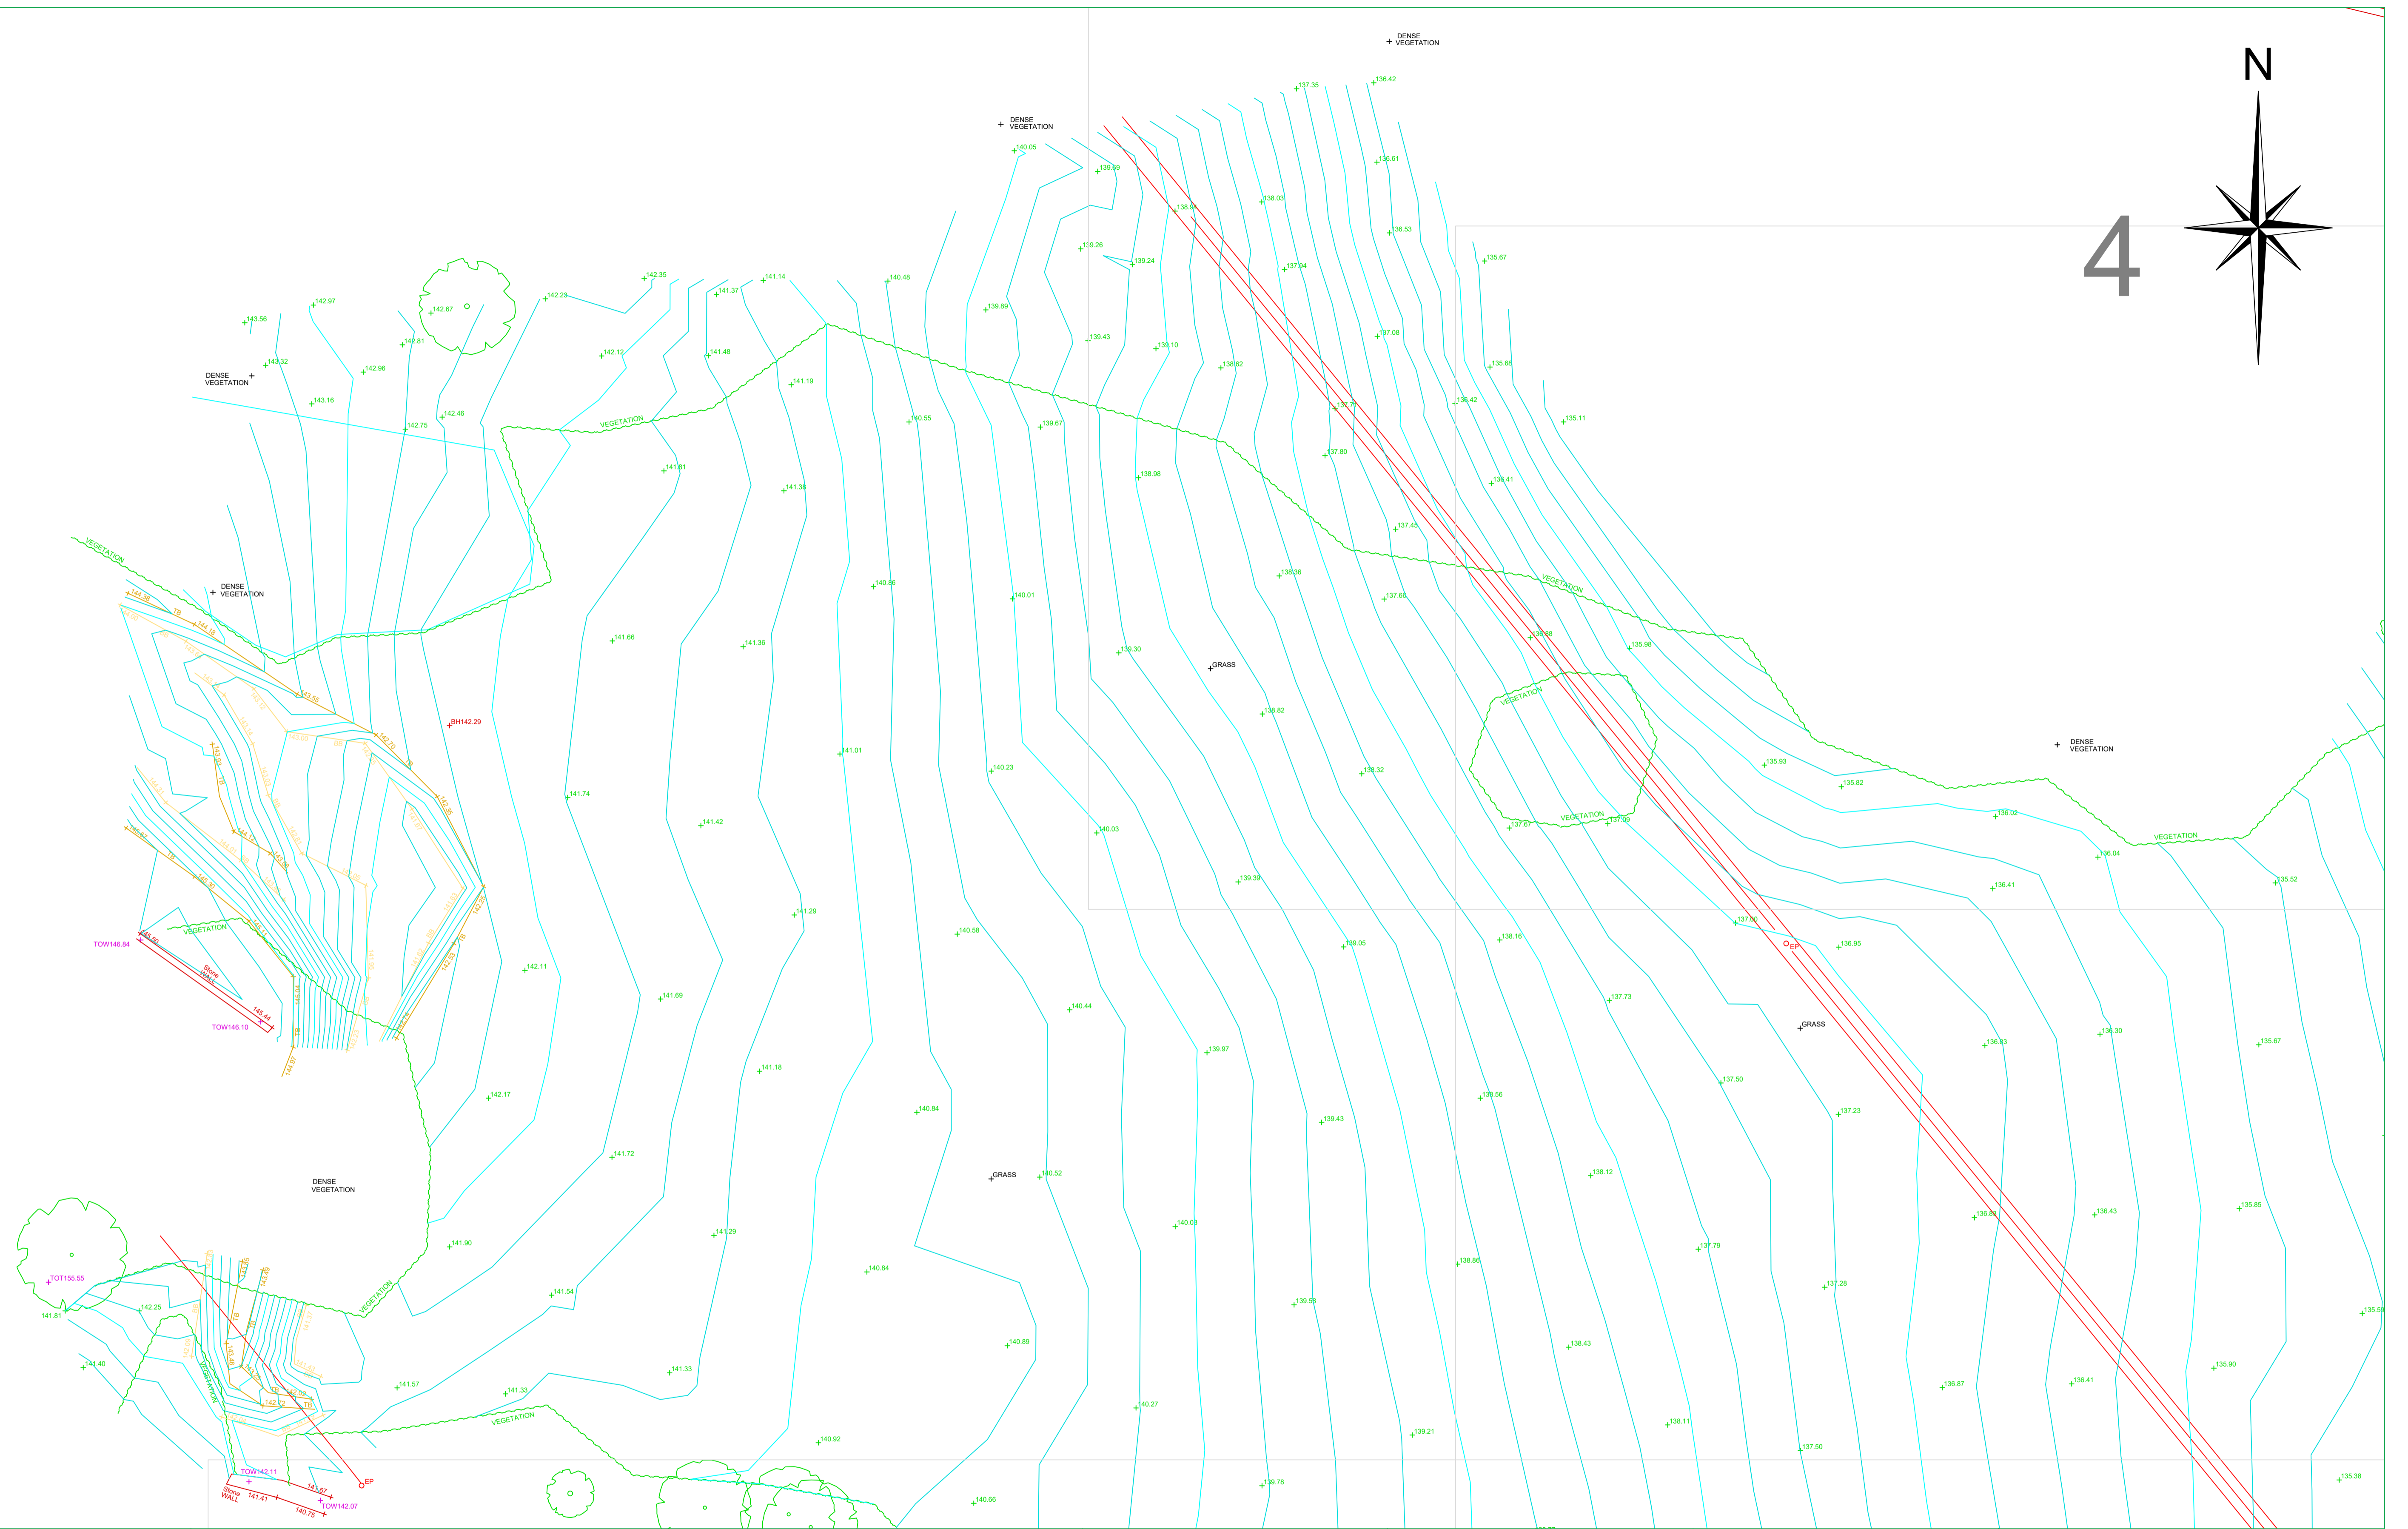
SCALE :	1/200 A1	DATE :	23/05/2024
DRG No:	6337	DESCRIPTION :	3D Topographical
SHEET:	4 of 5	SURVEYED BY :	R.D. & S.E.
		PROCESSED BY :	F.S.
		CHECKED BY :	A.B.

BED LEVEL	
EAVE LEVEL	
FLOOR LEVEL	
INVERT LEVEL	
ROAD LEVEL	
RIDGE LEVEL	
SOFFIT LEVEL	
SPOT LEVEL	
TOP OF FENCE LEVEL	
TOP OF WALL LEVEL	
WATER LEVEL	
SURVEY CONTROL STATION

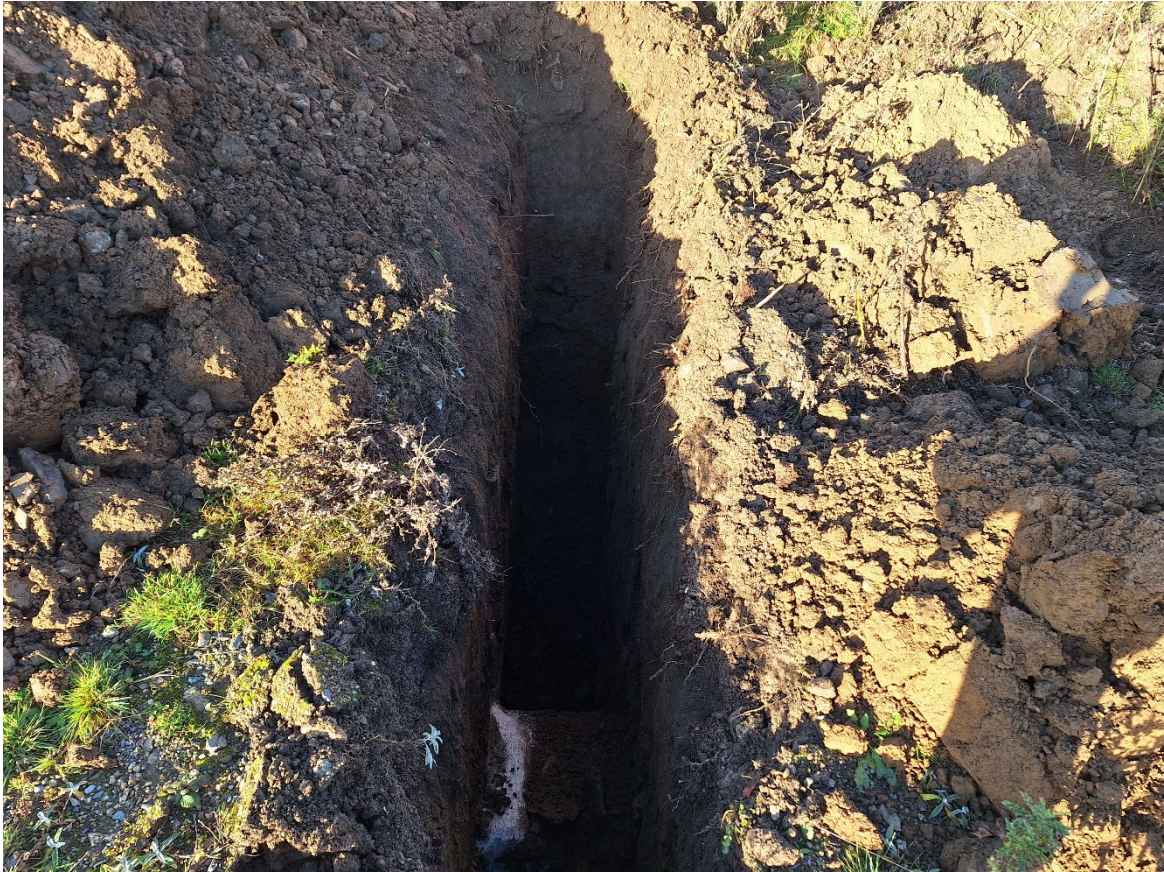
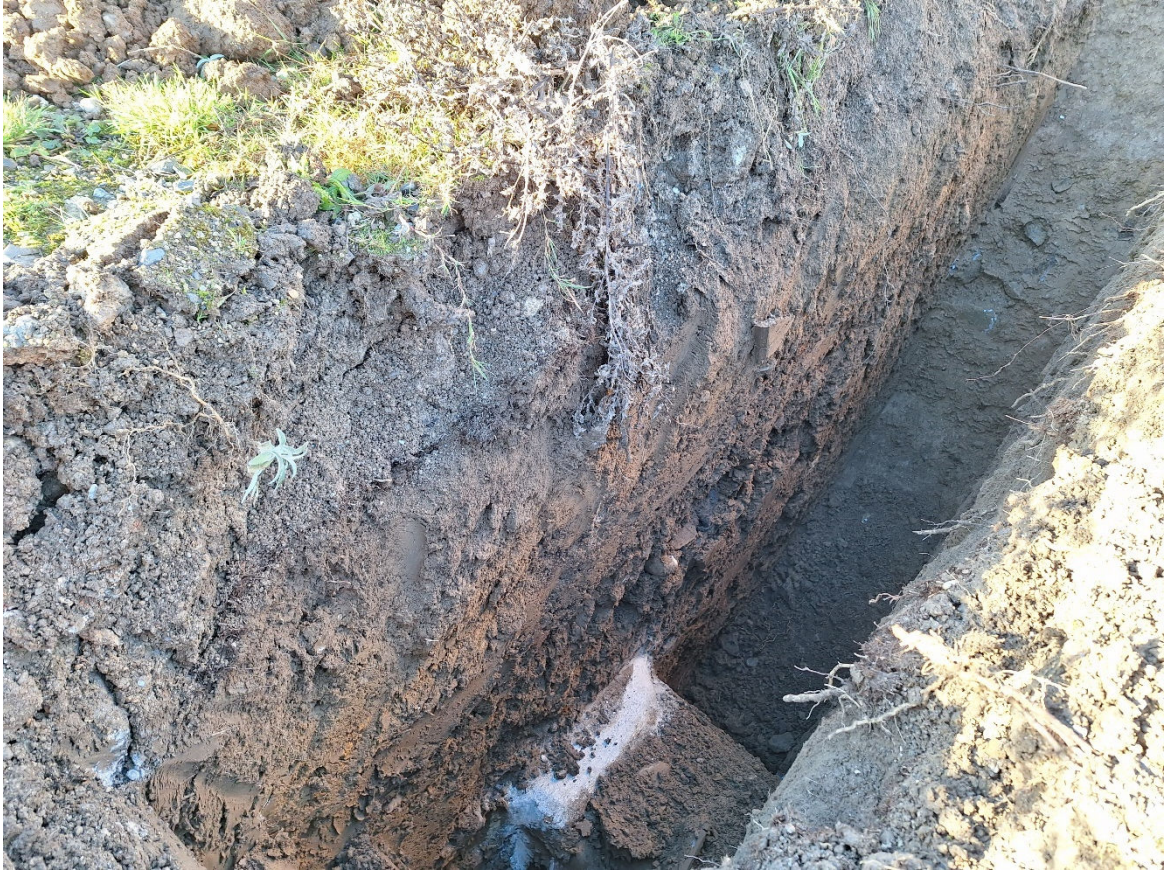
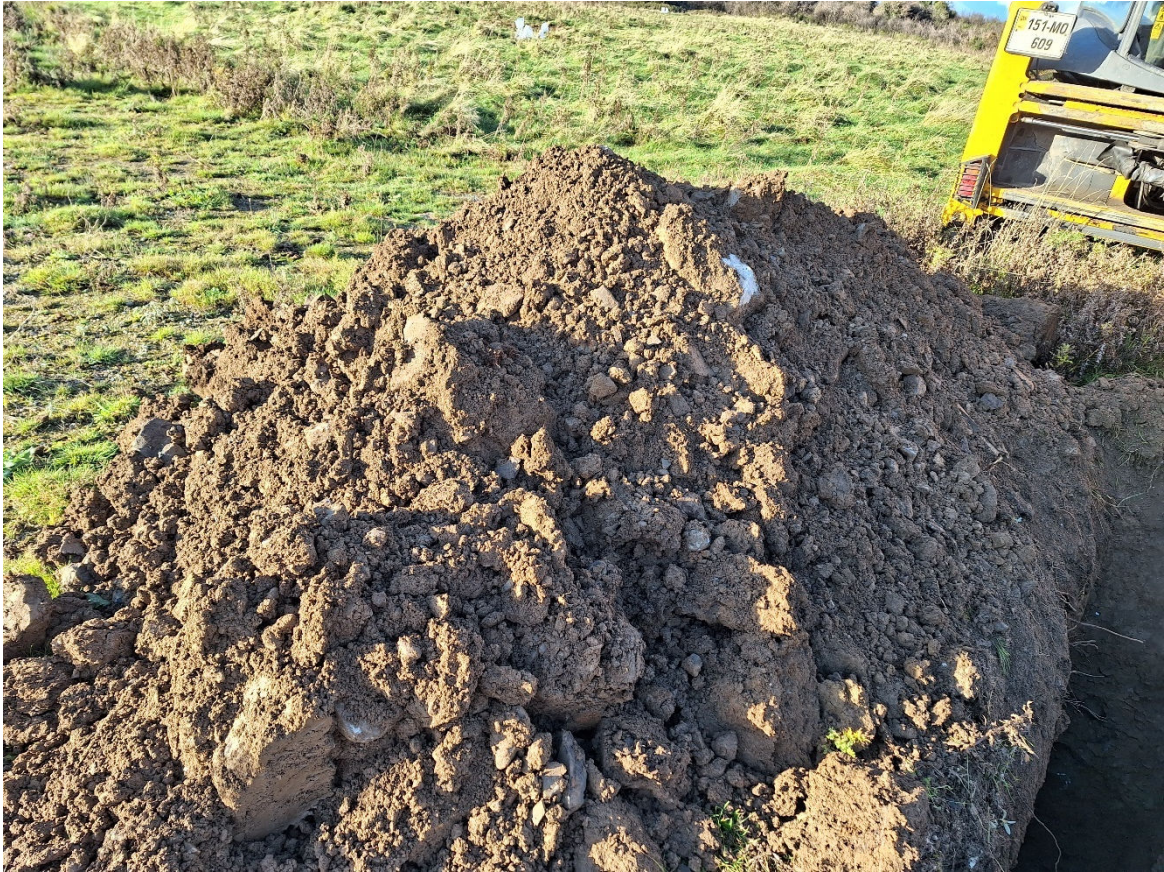
TP04

Plan	Remarks
	No groundwater encountered. Trial pit stable. Trial pit terminated at 2.80m BGL due to encountering competent bedrock. Trial pit backfilled upon completion.
	Scale (approx) 1:25
	Logged By AM
	Figure No. 12844-05-23.TP04

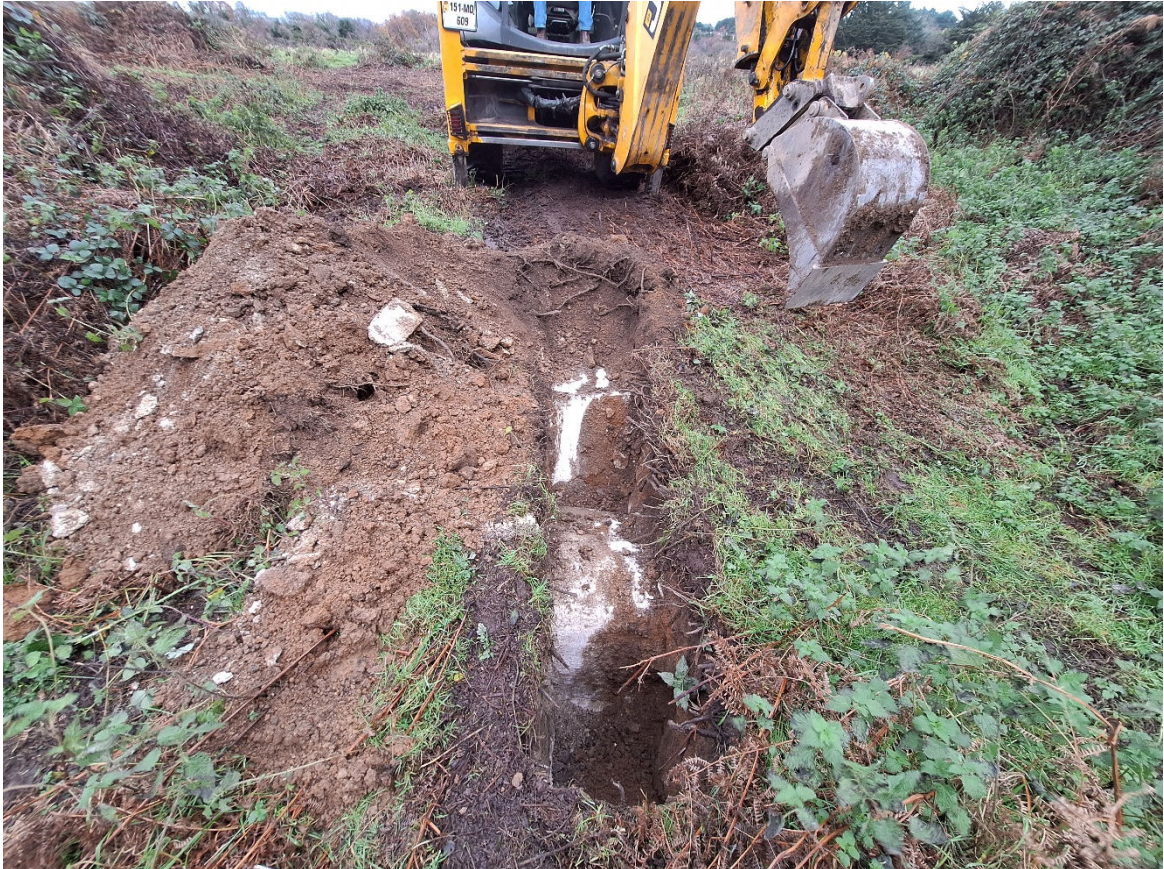
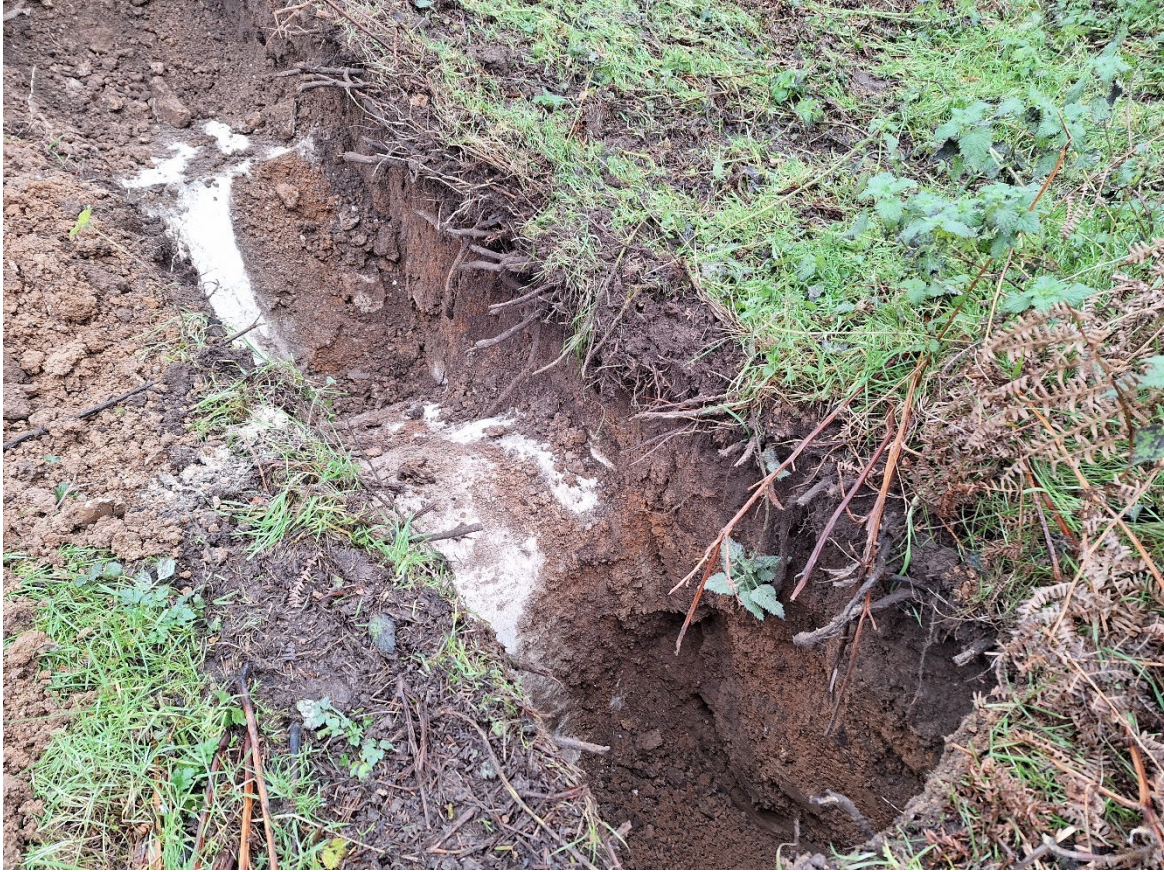
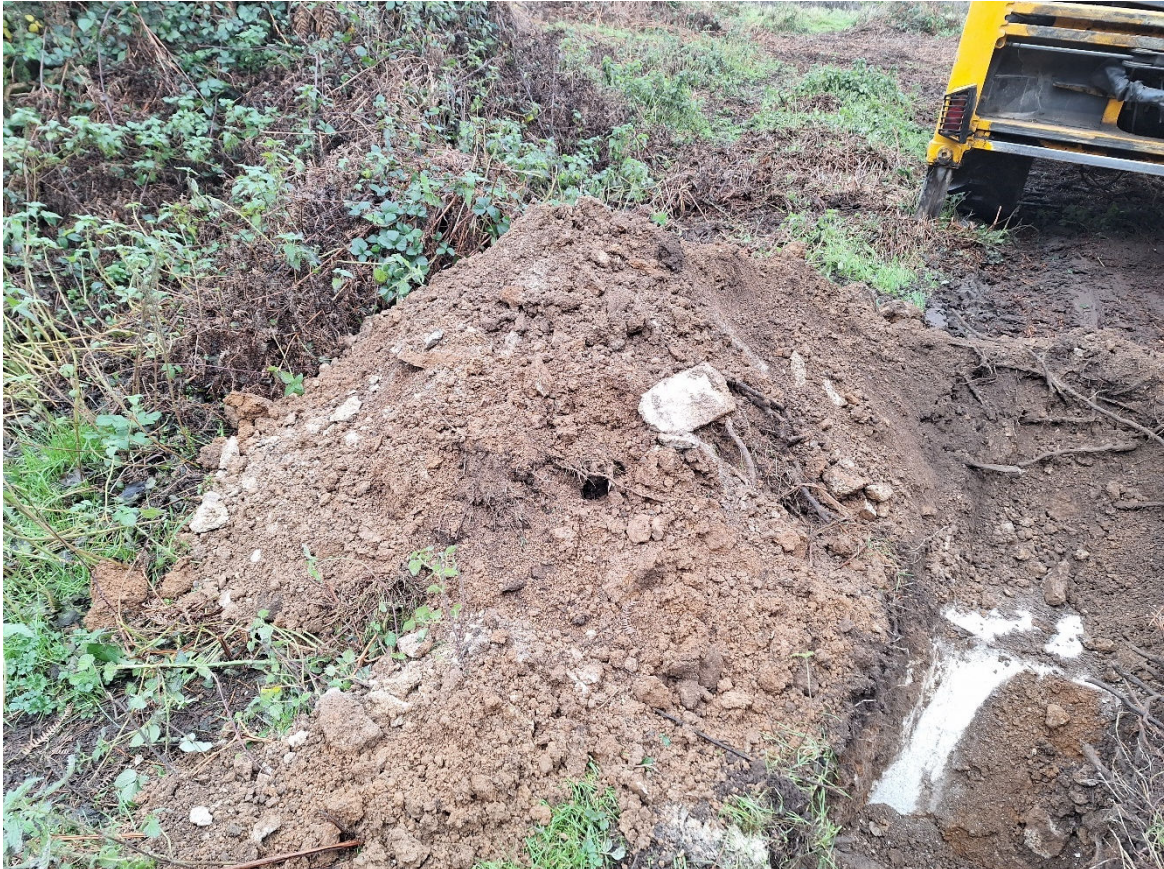
TP06

Plan .	Remarks No groundwater encountered. Trial pit stable. Trial pit terminated at 1.25m BGL due to encountering competent bedrock. Trial pit backfilled upon completion.		
	<table border="1"> <tr> <td>Scale (approx) 1:25</td> <td>Logged By AM</td> <td>Figure No. 12844-05-23.TP06</td> </tr> </table>	Scale (approx) 1:25	Logged By AM
Scale (approx) 1:25	Logged By AM	Figure No. 12844-05-23.TP06

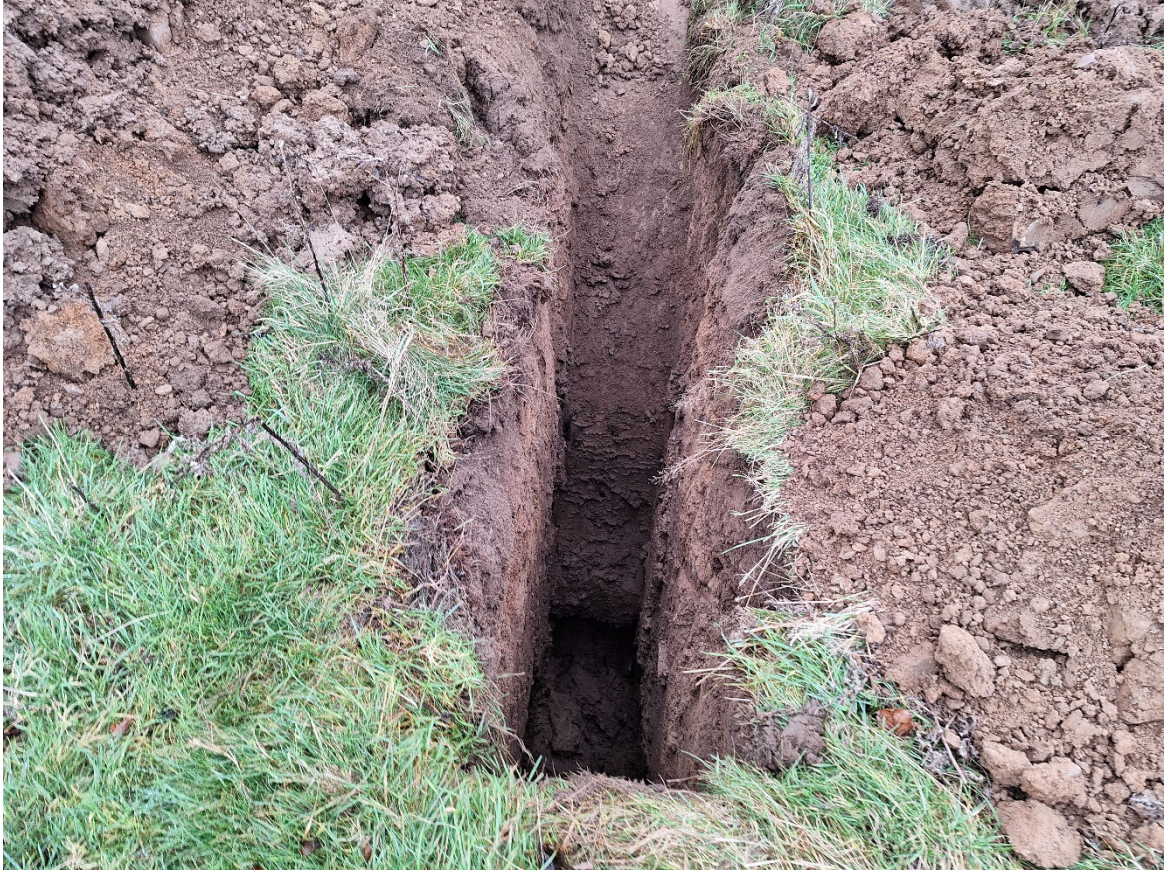
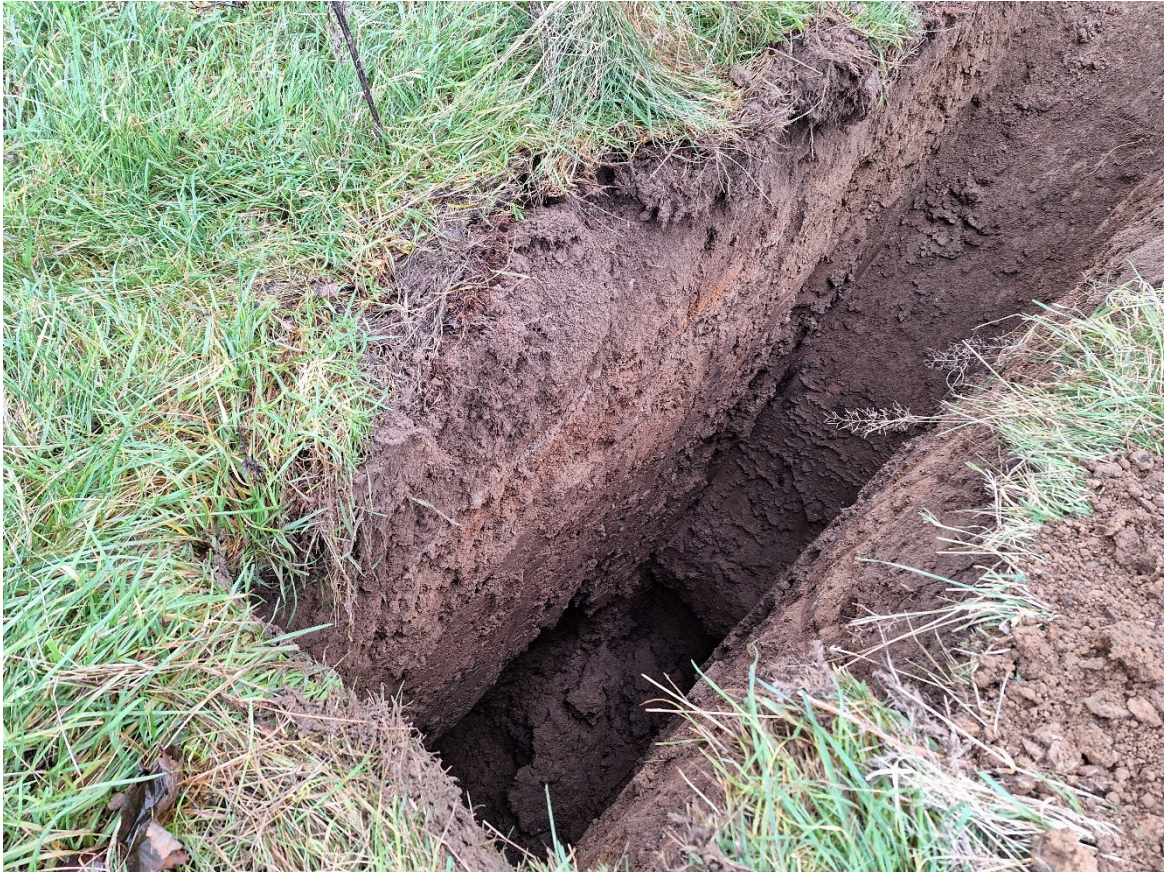
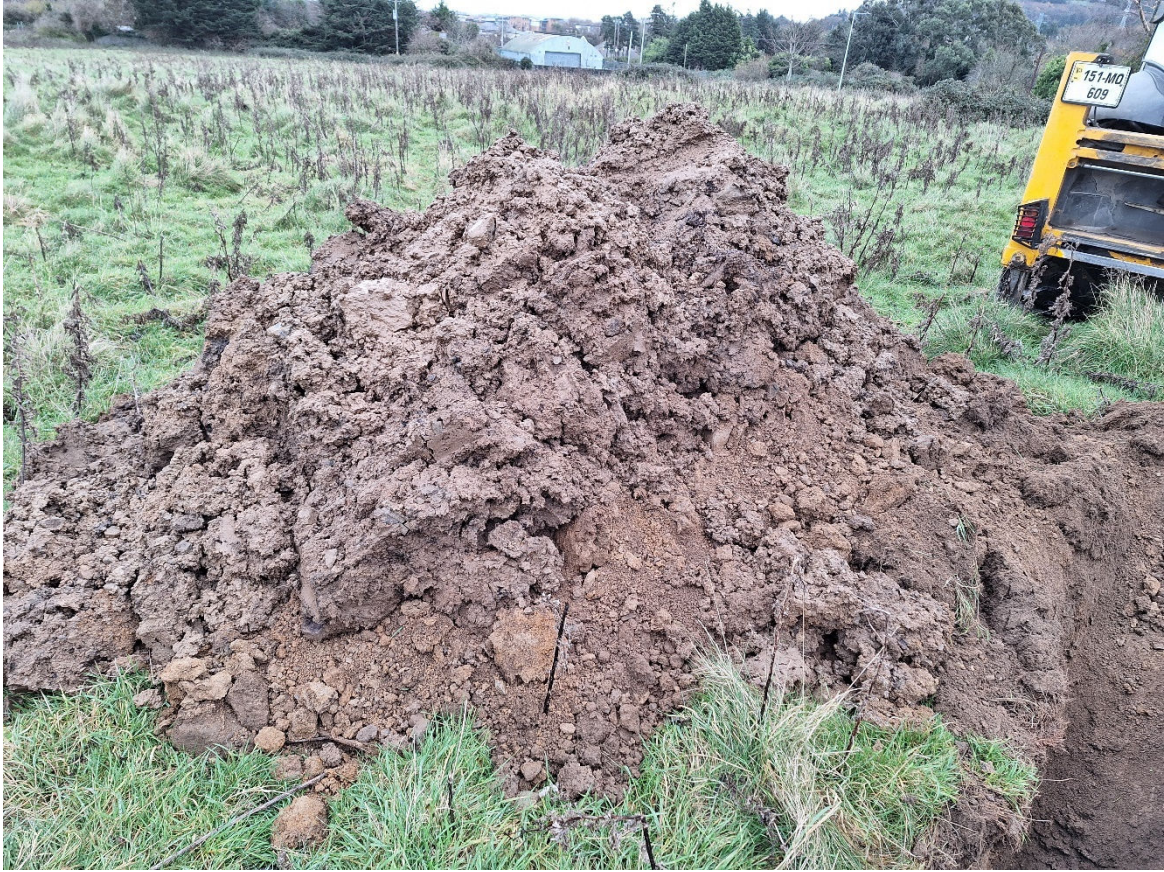
TP07

Plan .	Remarks Groundwater encountered at 2.00m BGL with slow inflow. Trial pit sidewalls spalling below 2.50m BGL. Trial pit backfilled upon completion.					
	<table border="1"> <tr> <td>Scale (approx)</td> <td>Logged By</td> <td>Figure No.</td> </tr> <tr> <td>1:25</td> <td>AM</td> <td>12844-05-23.TP07</td> </tr> </table>	Scale (approx)	Logged By	Figure No.	1:25	AM
Scale (approx)	Logged By	Figure No.				
1:25	AM	12844-05-23.TP07

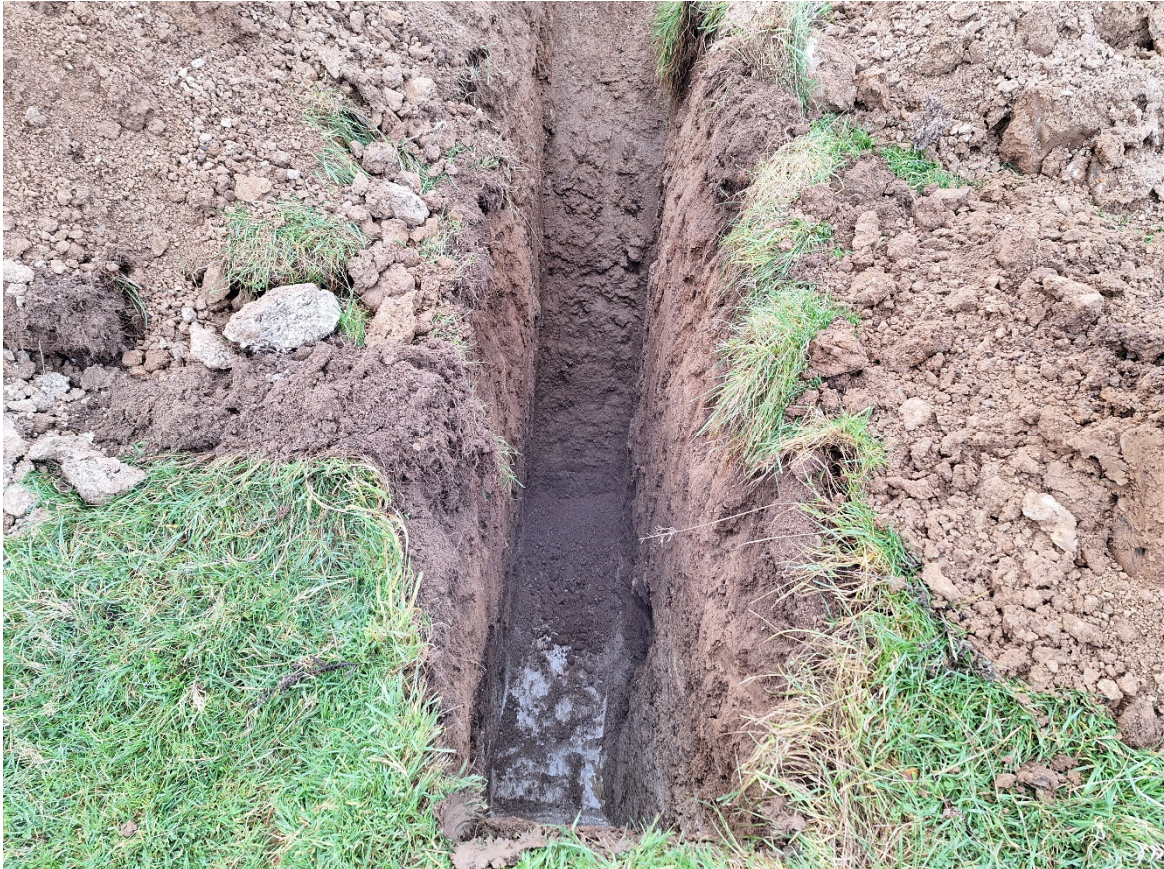
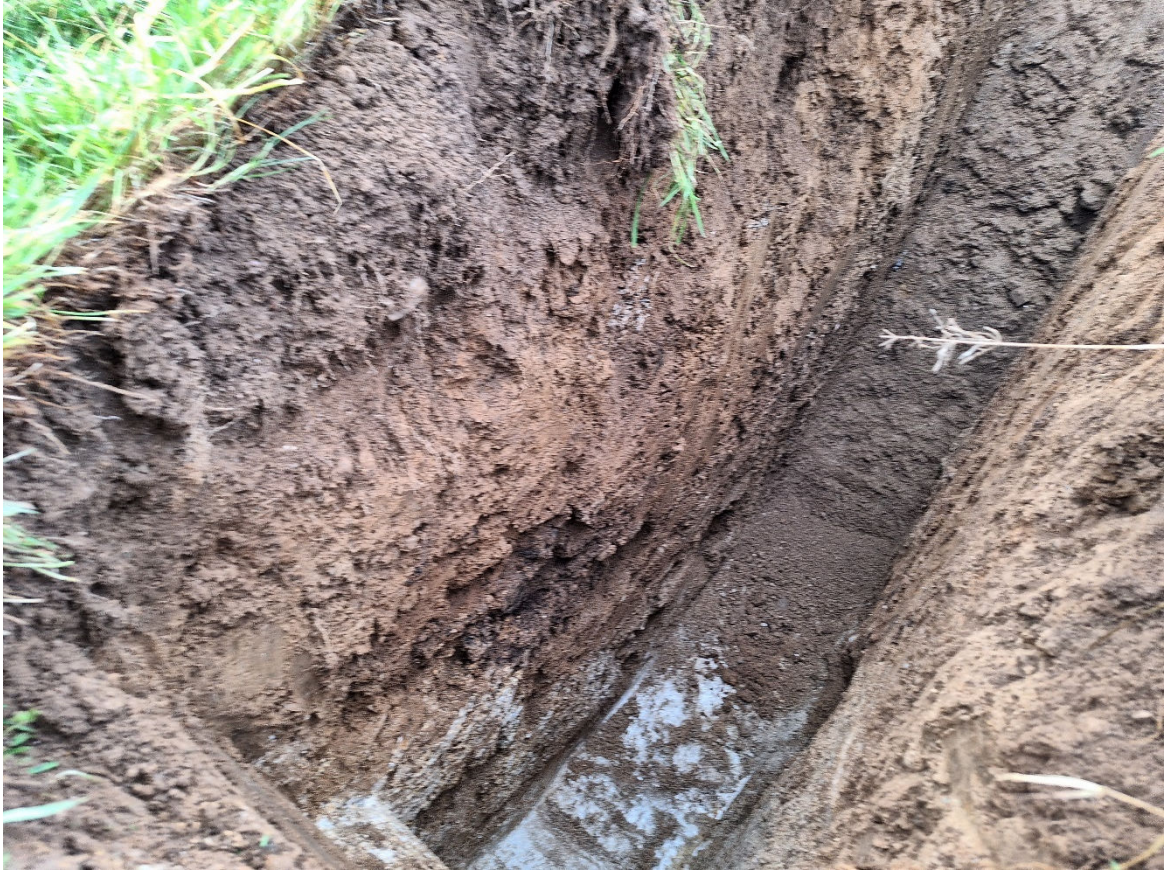
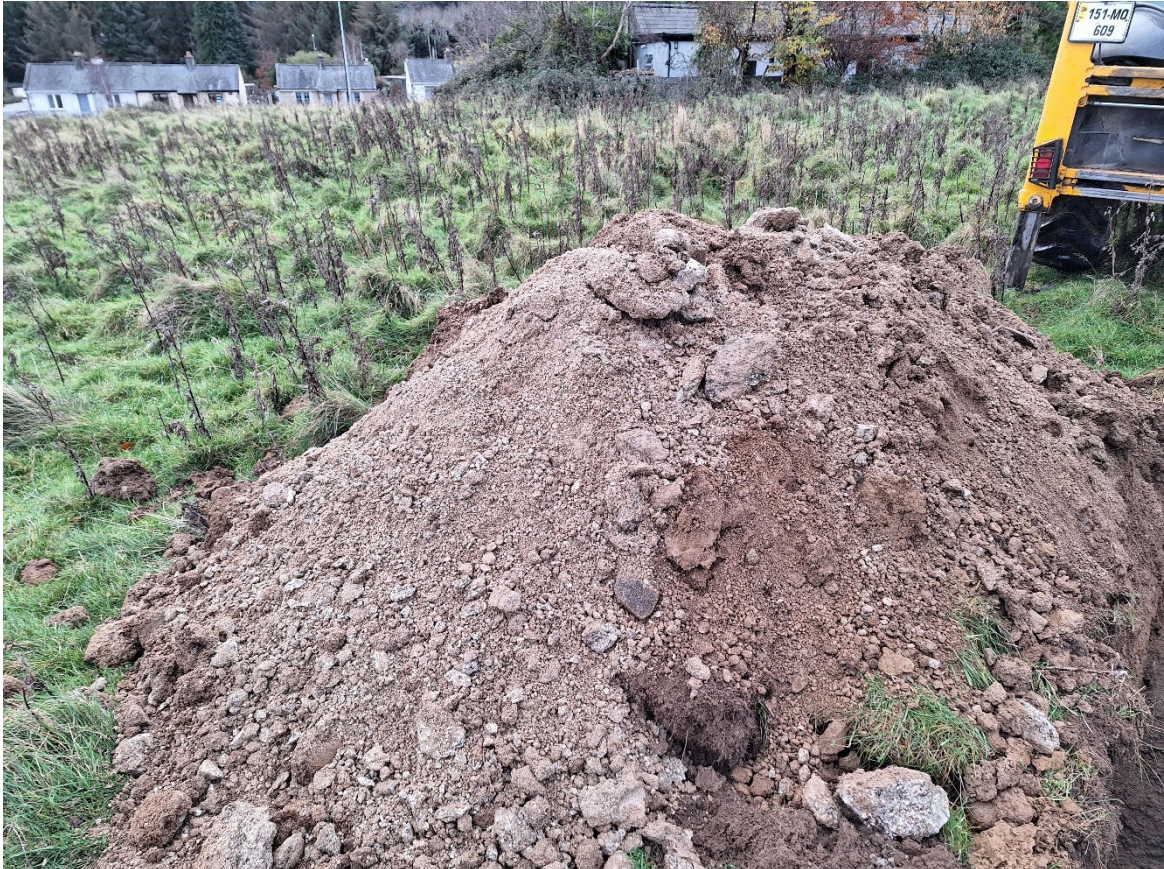
TP08

Plan .	Remarks Groundwater encountered at 2.00m BGL with slow inflow. Trial pit sidewalls spalling below 2.50m BGL. Trial pit backfilled upon completion.					
	<table border="1"> <tr> <td>Scale (approx)</td> <td>Logged By</td> <td>Figure No.</td> </tr> <tr> <td>1:25</td> <td>AM</td> <td>12844-05-23.TP08</td> </tr> </table>	Scale (approx)	Logged By	Figure No.	1:25	AM
Scale (approx)	Logged By	Figure No.				
1:25	AM	12844-05-23.TP08

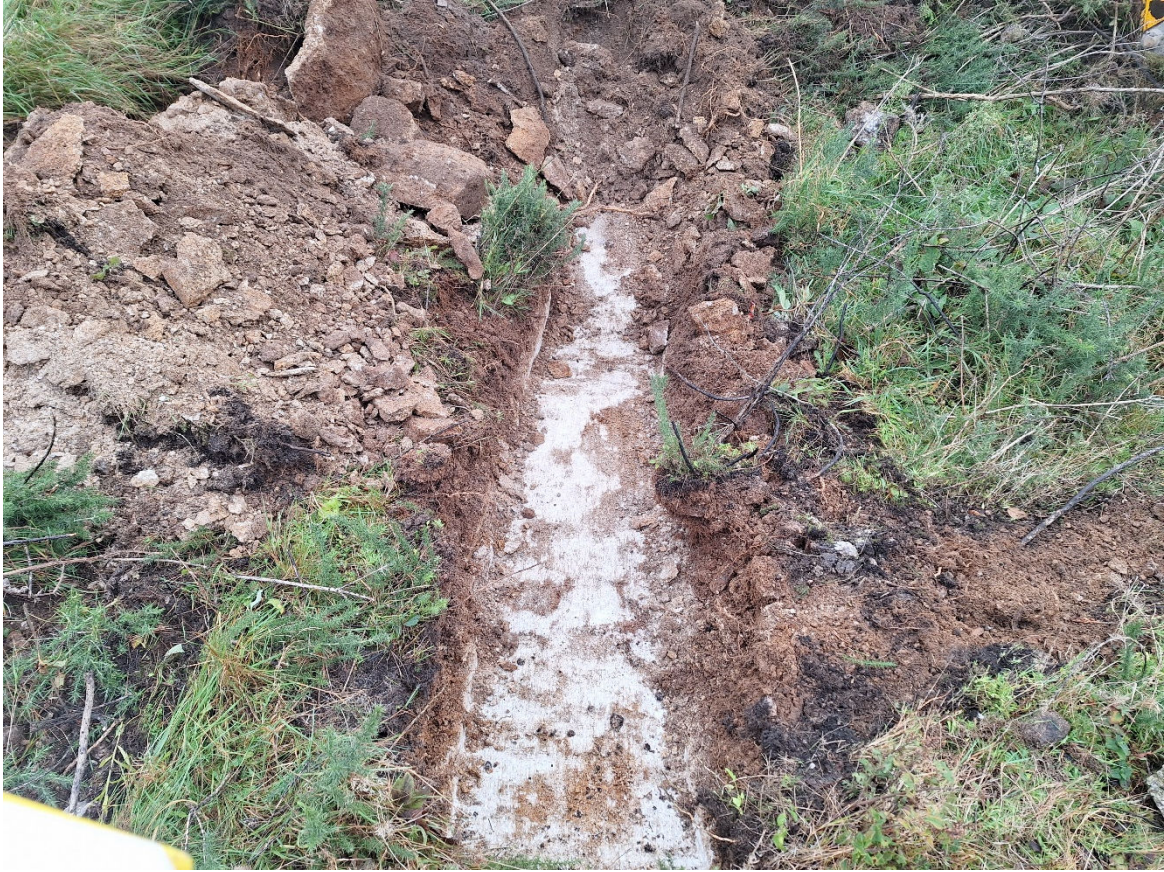
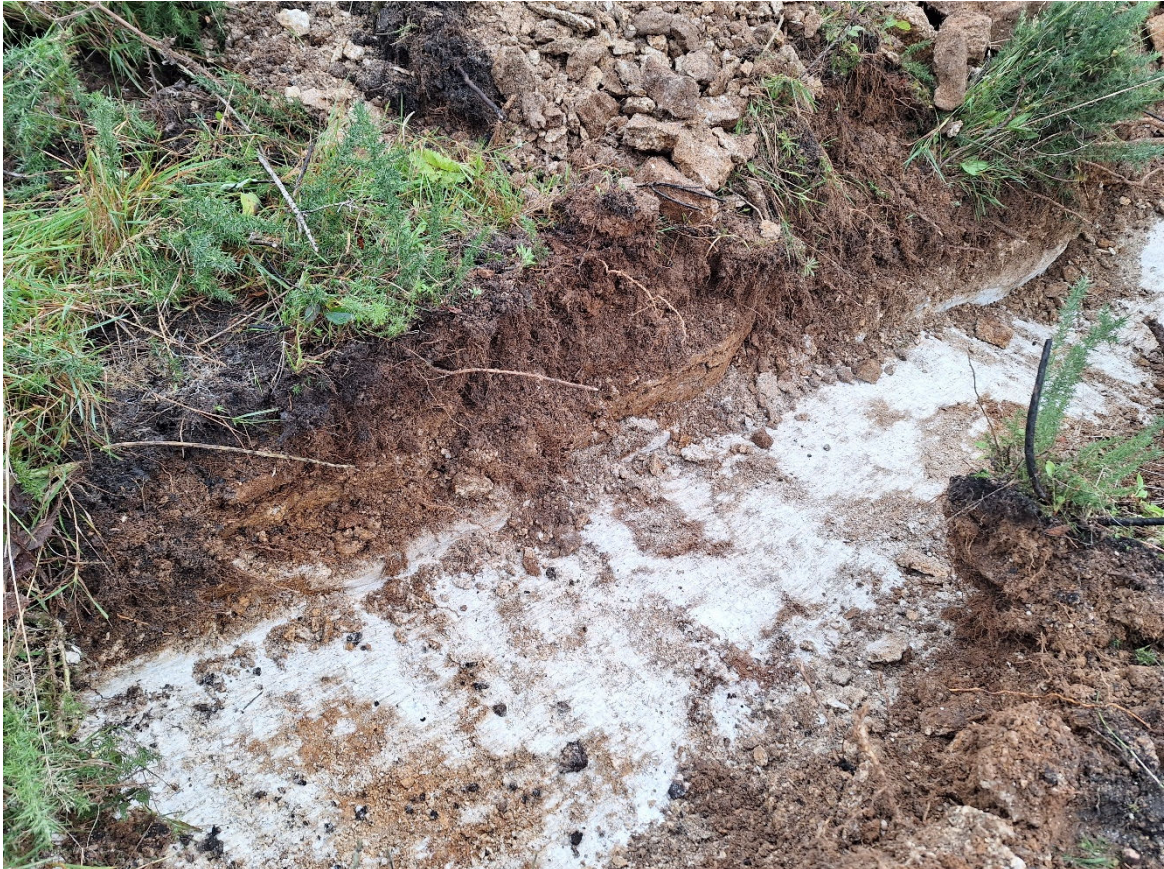
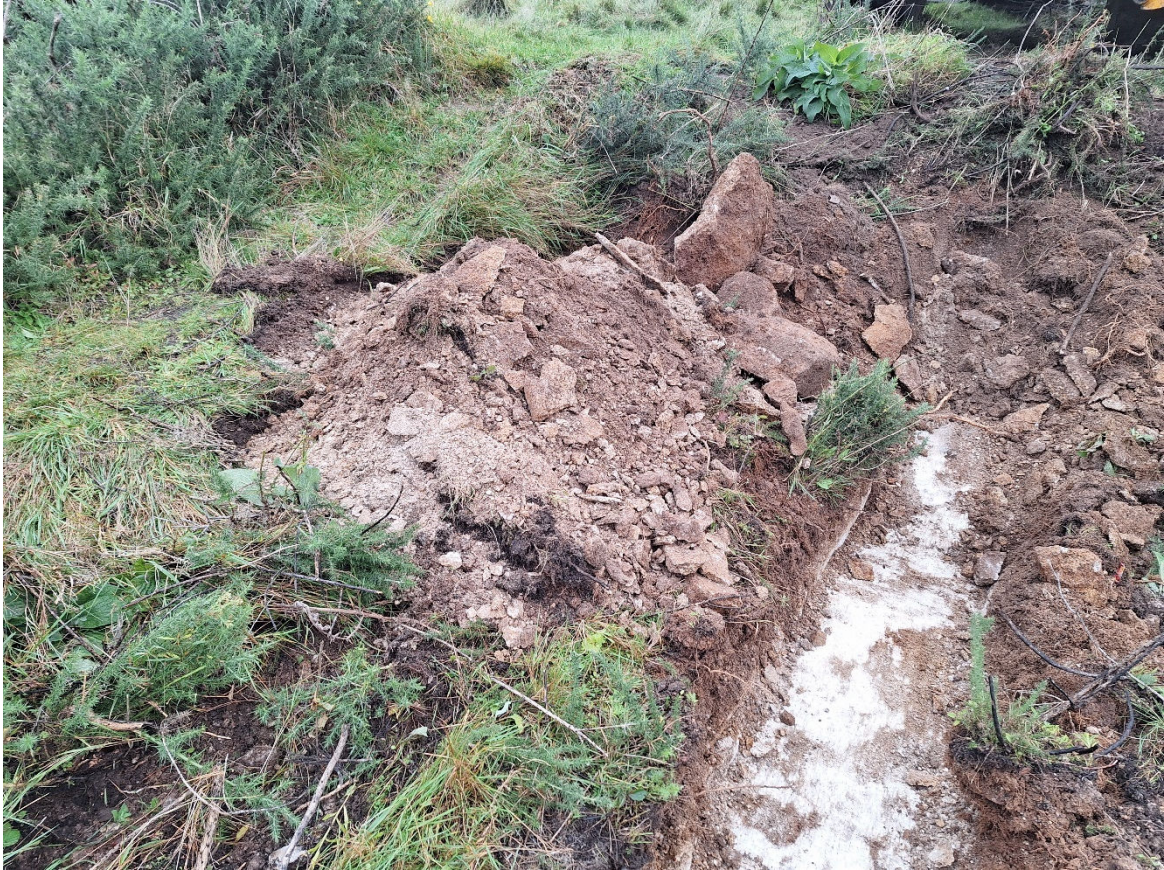
TP09

Plan 	Remarks No groundwater encountered. Trial pit stable. Trial pit terminated at 0.50m BGL due to encountering competent bedrock. Trial pit backfilled upon completion.		
	<table border="1"> <tr> <td>Scale (approx) 1:25</td> <td>Logged By AM</td> <td>Figure No. 12844-05-23.TP09</td> </tr> </table>	Scale (approx) 1:25	Logged By AM
Scale (approx) 1:25	Logged By AM	Figure No. 12844-05-23.TP09

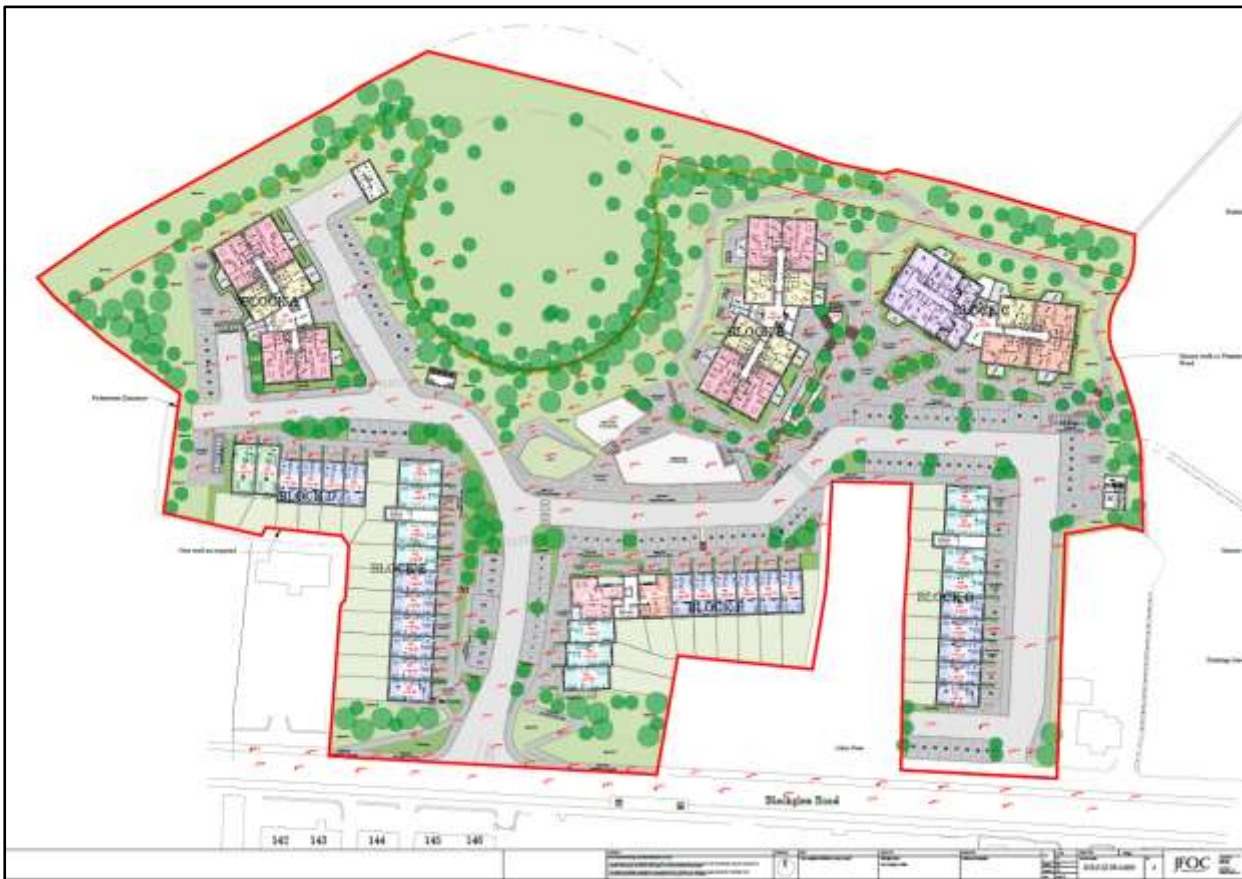
The mix is: 24 Affordable houses, 01 High support unit, 102 Social and Cost Rental units - made up of houses and apartments. and associated siteworks

Figure 2.1: Site Layout (Source: JFOC Architects)

The speed limit in the vicinity of the access point is 50km/h. Please refer to the proposed layout at **Figure 2.1** below for further details.
