Proposed Development of a Running Track & Associated Facilities at St. Thomas Estate, Tibradden Road, Rathfarnam, Dublin 16 in Proximity to a Protected Structure (St. Thomas House) PC/PKS/01/19

Appendix 7 – Tree Survey & Report

An Arboricultural Assessment on the site area for the New Running Track and Associated Facilities at 'St. Thomas Estate', Tibradden Road, Whitechurch, Dublin 16.

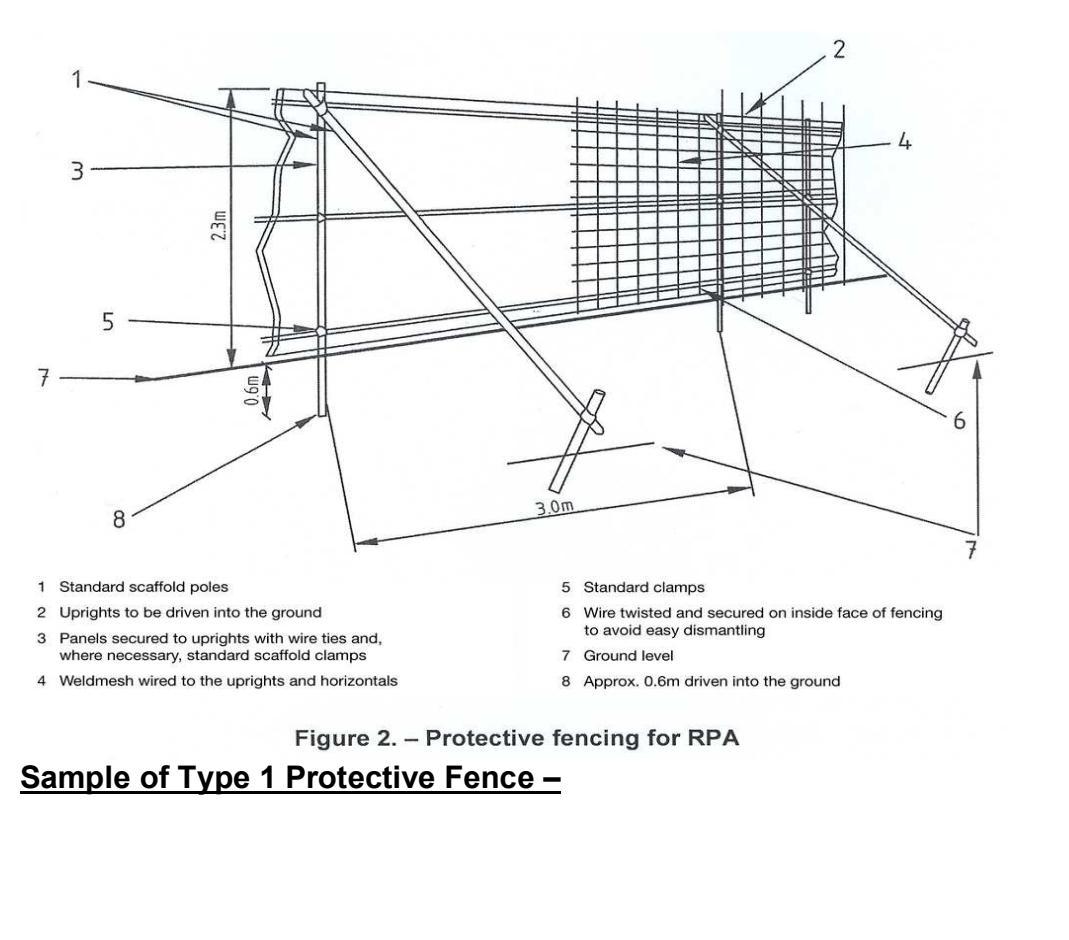
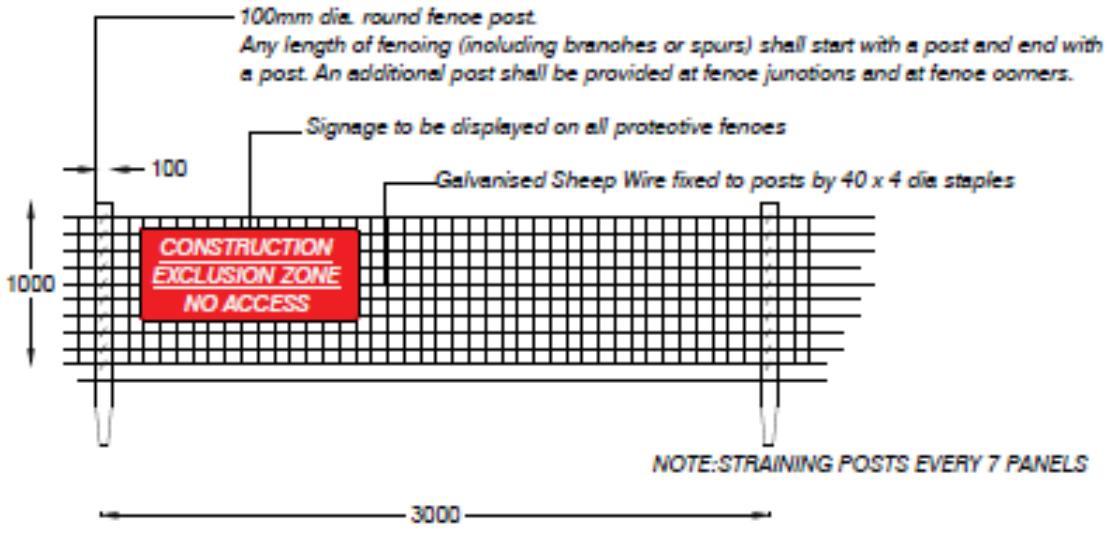
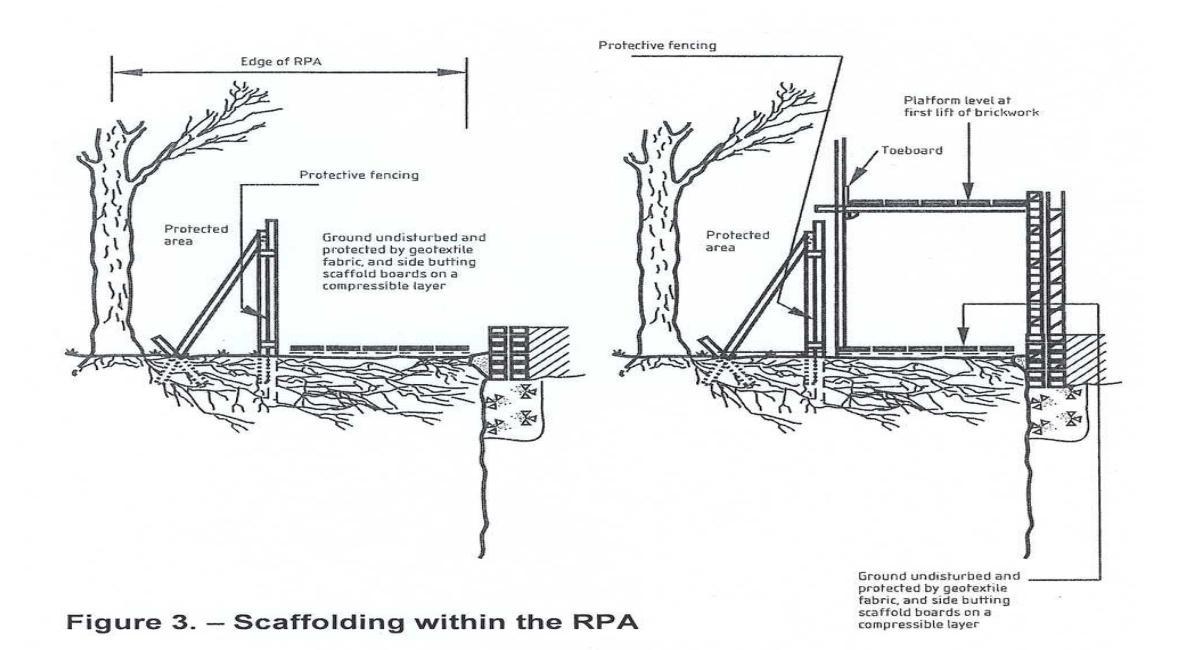
Sample of Temporary Tree Protection Fencing Detail.

The ground within the RPA of the trees <u>must be</u> protected from damage as per the recommendations of **section 6.2.3** of BS5837 2012. See detail within appendix 1 on ground protection using boarding for pedestrian loading.
